GRAND SERAIL
(Government Palace)-Beirut

Annex II
Aluminum Windows Schedule
May 2022

ABDULWAHED CHEHAB
CONSULTING ENGINEERING OFFICE

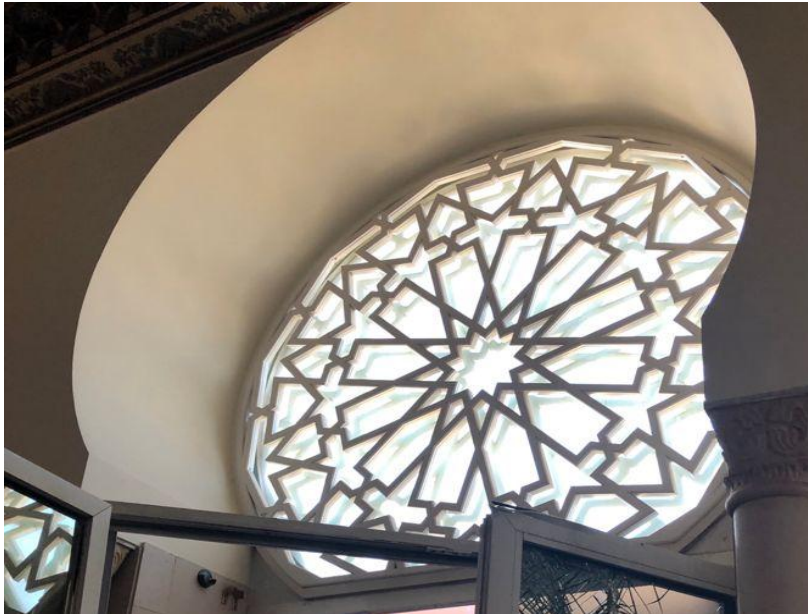
1.00	Bullet Proof	Fine	Rehab	As Seen on picture, need to be checked on site for frame to be checked
North (4)	F2	O-2

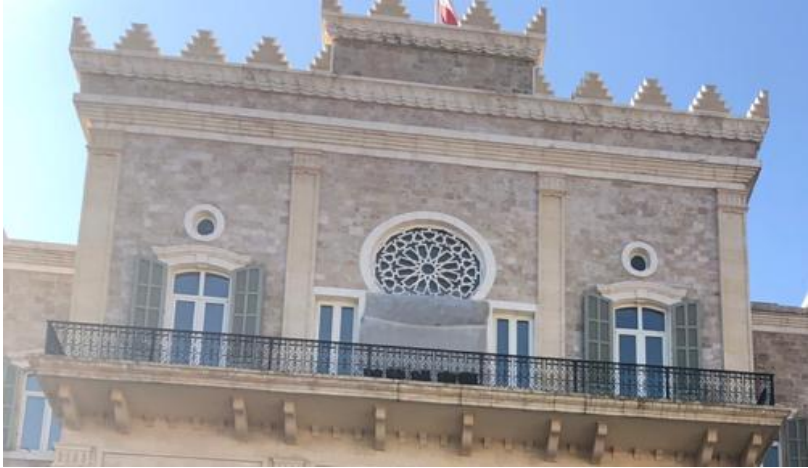
2.00	Bullet Proof	Fine	Rehab	As Seen on picture, need to be checked on site for frame to be checked
North (4) / East (1) / West (3)	GF	O-2

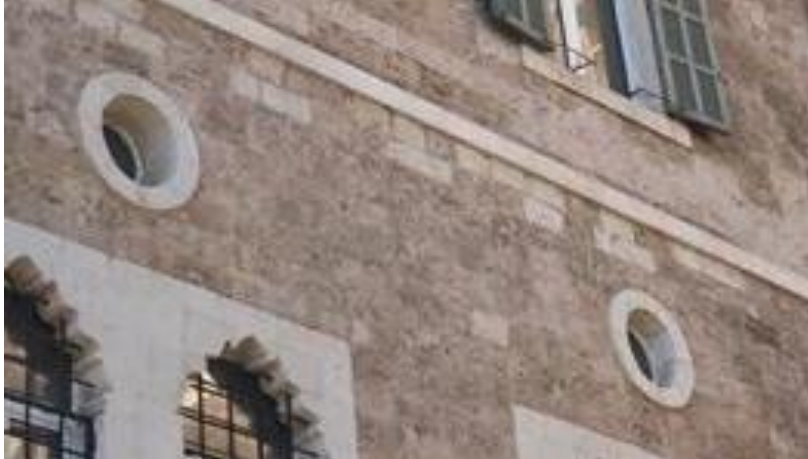
34.00	Bullet Proof	Fine	Rehab	As Seen on picture, need to be checked on site for frame to be checked

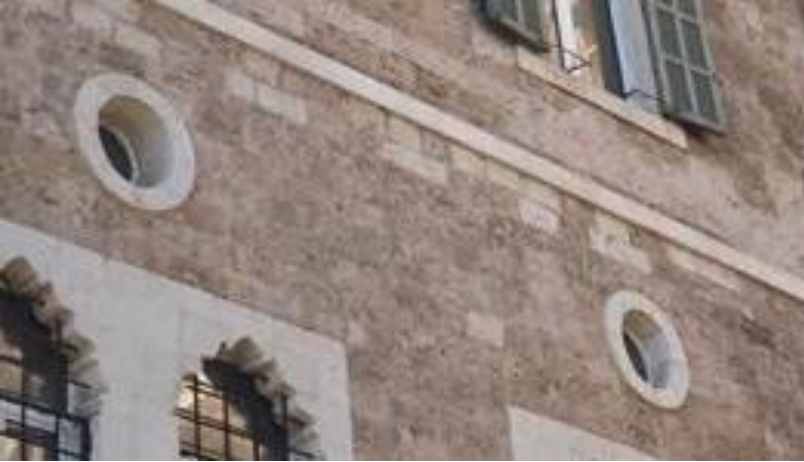
7.00	Double Glass	Fine	Rehab	As Seen on picture, need to be checked on site for frame to be checked
Zone B West								
West (3)	GF	O-2

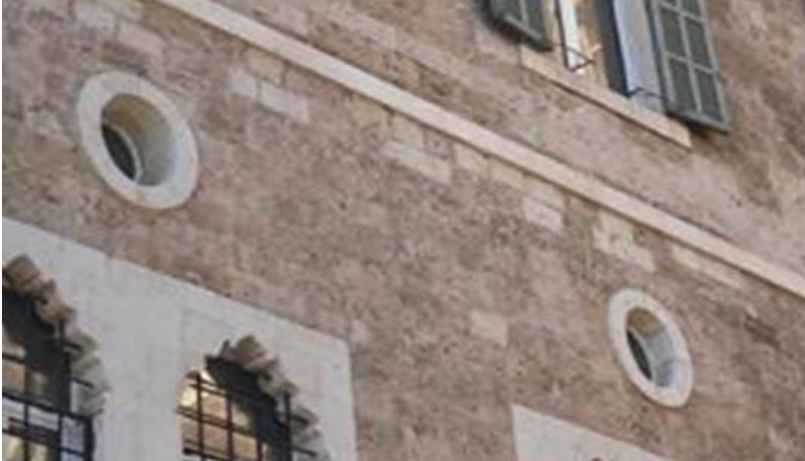
8.00	Double Glass	Fine	Rehab	As Seen on picture, need to be checked on site for frame to be checked
Zone C								
East (1) / West (3)	GF	O-2

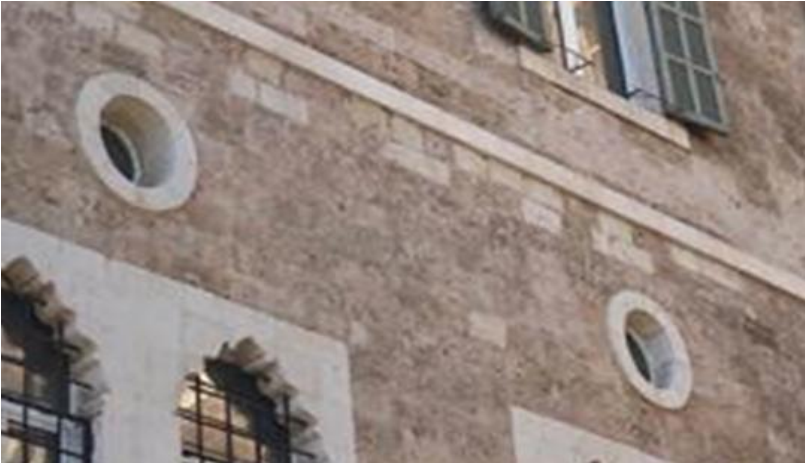
13.00	Double Glass	Fine	Rehab	As Seen on picture, need to be checked on site for frame to be checked
