**CERD 721 - Kousba Mixed Public School**

Lebanon Emergency Assistance Project (LEAP)

## Detailed Assessment and Verification Report

Tender Preparation and Construction Supervision Consultant for Shelters.  
Lebanon Emergency Assistance Project (LEAP)

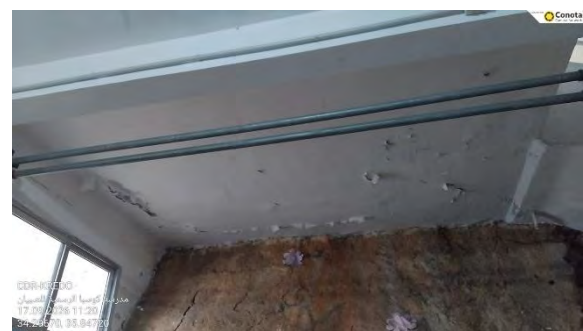
**Figure 6 - Humidity in Ceiling**

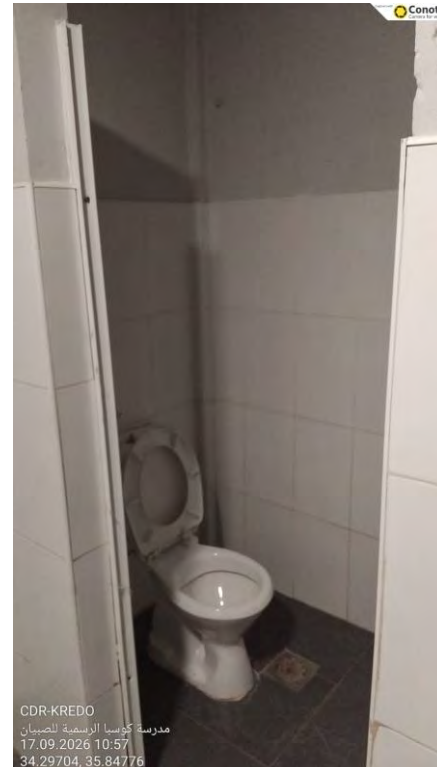
**Figure 8 - Missing Toilet Seat**

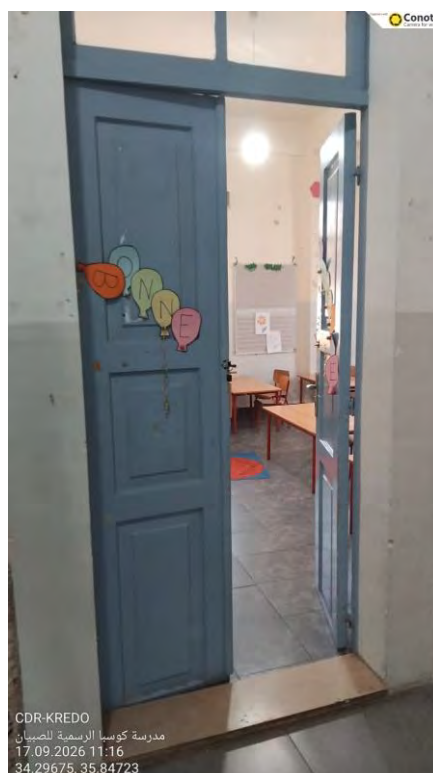
**Figure 12 - Crack in Wall**

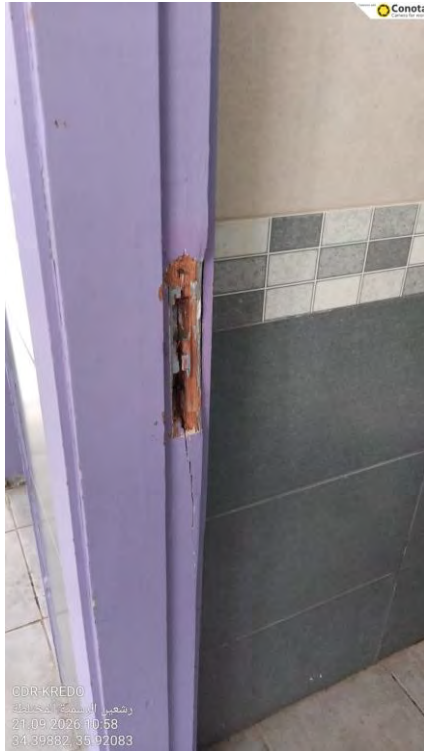
**Figure 15 - Rusty Steel Door**

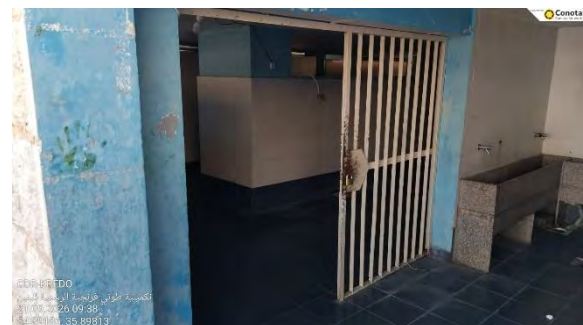
**Figure 8 - Damaged Toilet Door**

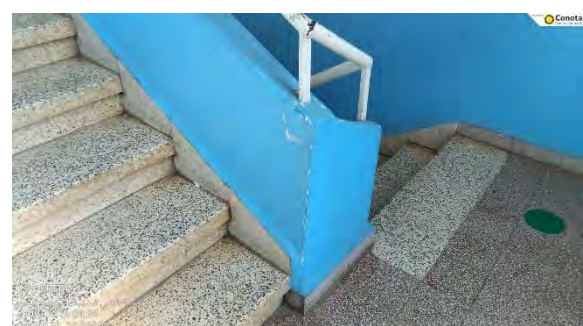
| Trade | Item | Damaged | Location, extent and quantity |
|---|---|---|---|
| Finishes | Paint - walls and ceilings - plasters | Yes | Paint 4,300 m <sup>2</sup><br>45 m handrail paint<br>Plaster repair 2.5 m <sup>2</sup> (in corridor wall & class ceiling) |

**Figure 10 - Damaged Plaster**

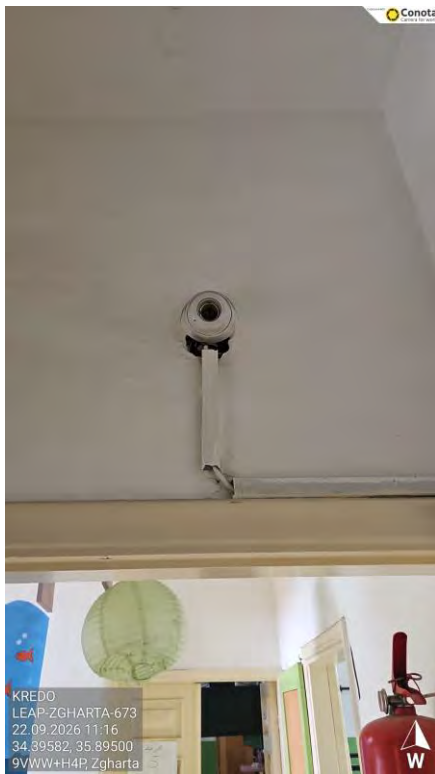
**Figure 7 – Damaged Lighting Fixtures**

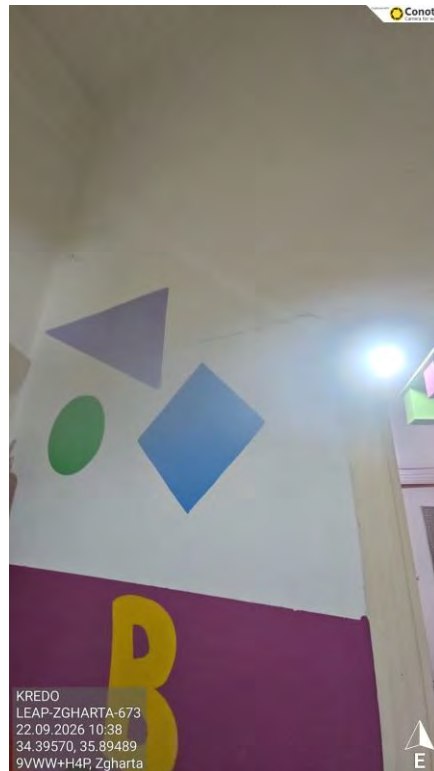
**Figure 8 - Wall Cracks**

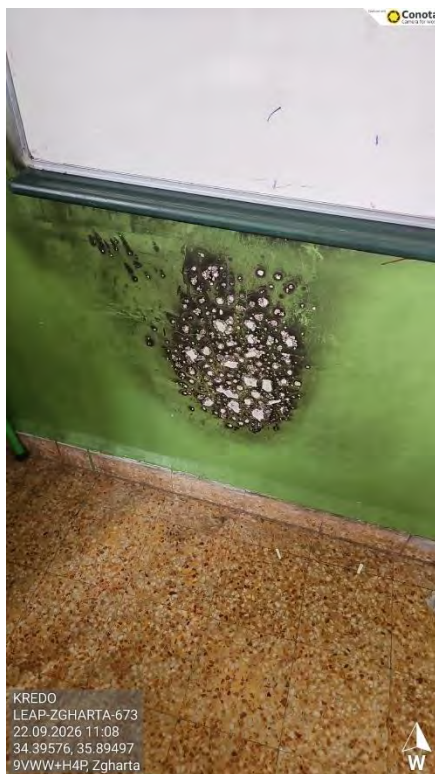
**Figure 9 – Damaged Paint**

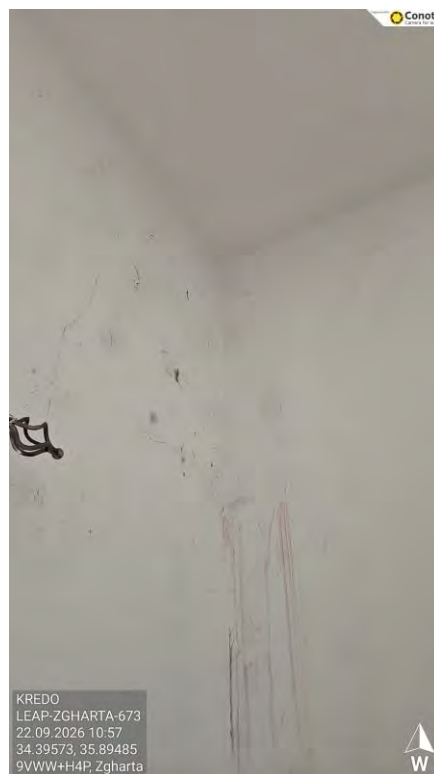
**Figure 10 - Water Leakage**

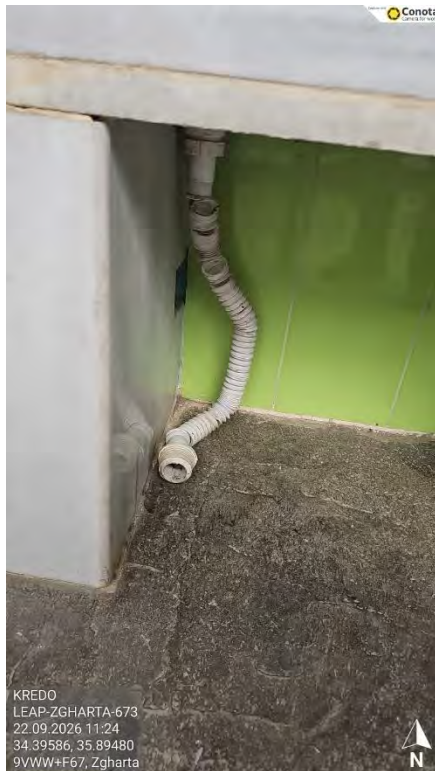
**Figure 11 – Damaged Floor Drain**

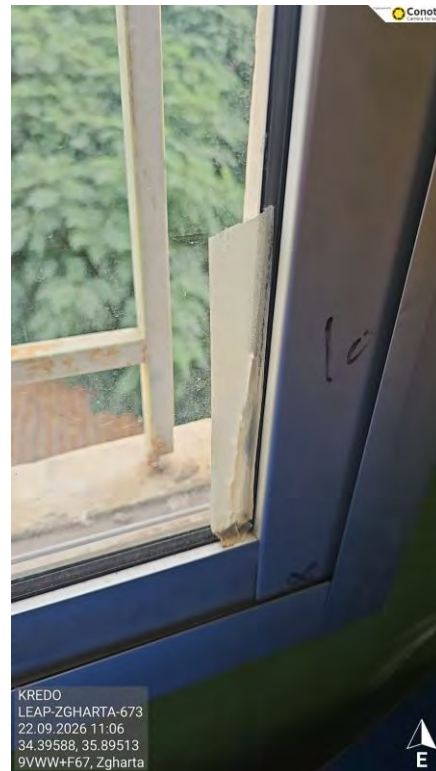
**Figure 12 - Cracked Glazing**

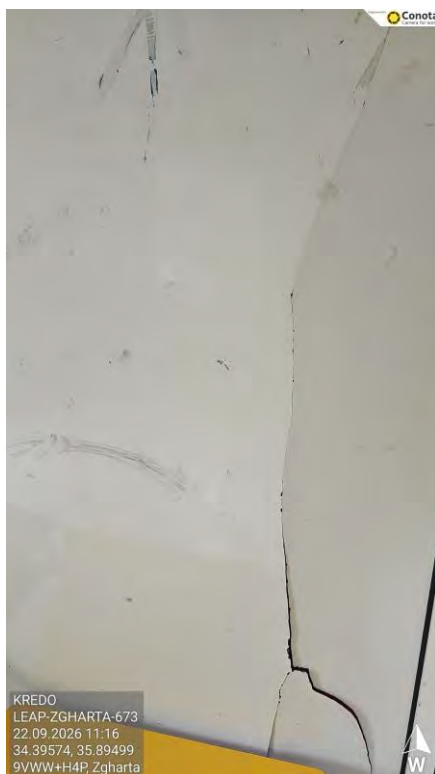
**Figure 13 – Damaged Plastering**

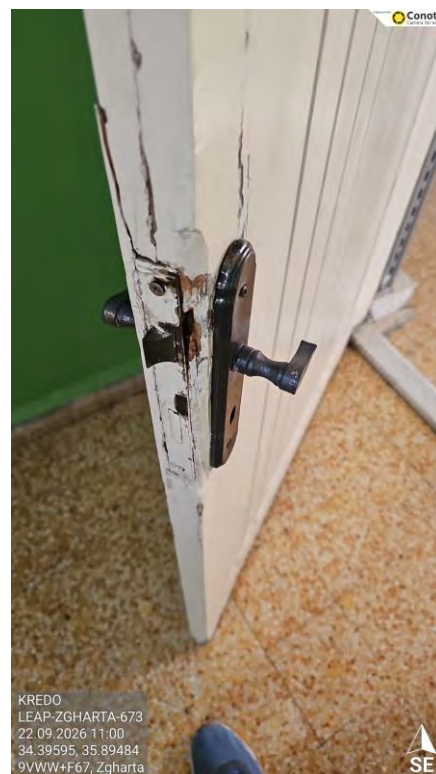
**Figure 14 – Damaged Door Handle**

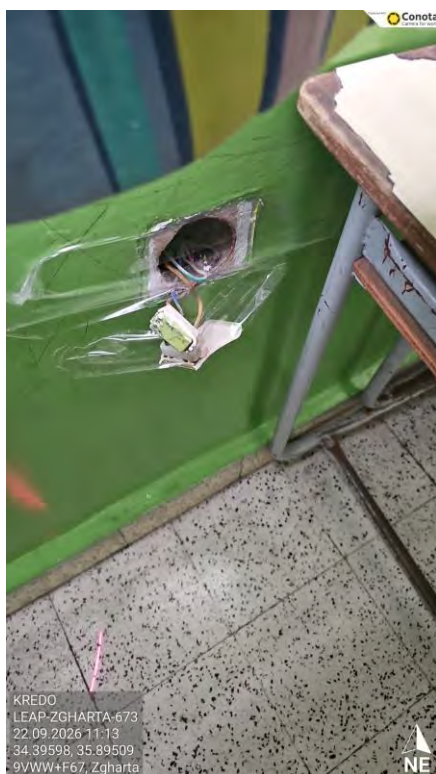
**Figure 15- Damaged sockets**

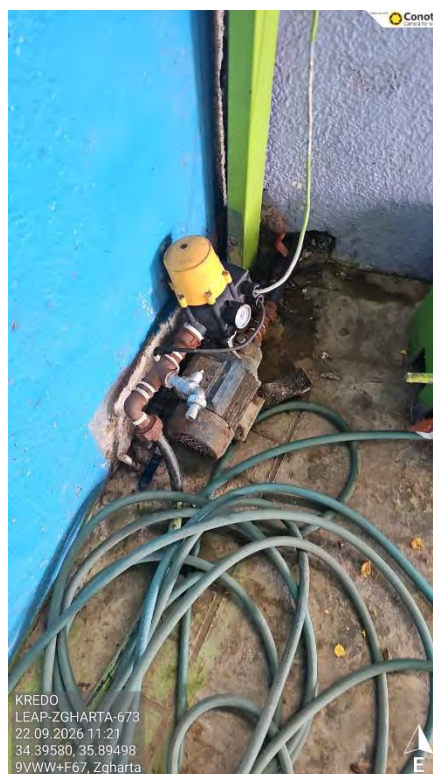
**Figure 16-Damaged Pump**

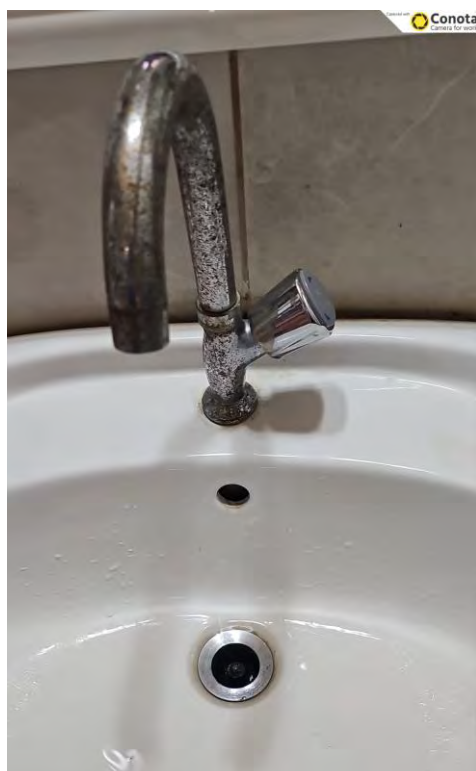
**Figure 17 – Rusty Mixers**

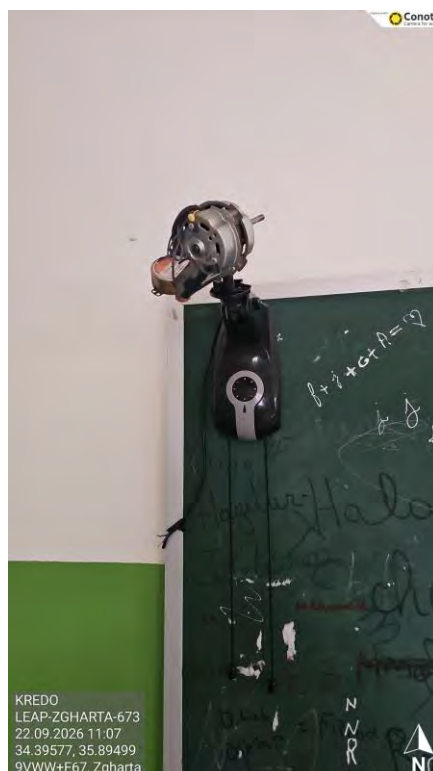
**Figure 18 - Damaged Fan**

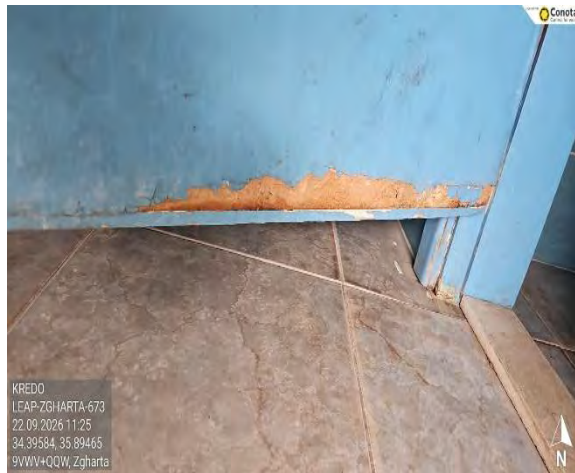
| Trade | Item | Damaged | Location, extent and quantity |
|---|---|---|---|
| Doors | Timber doors | Yes | 8 single doors with frames architraves shall be changed, 10 doors shall be repaired |

**Figure 19 - Damaged Doors**

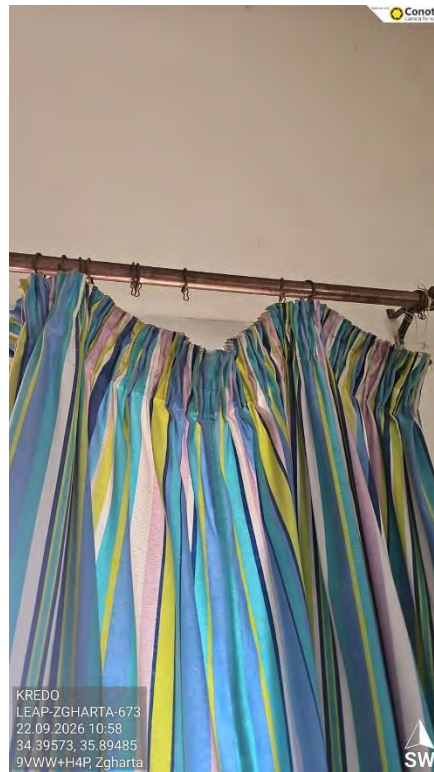
**Figure 20 - Damaged Curtains**

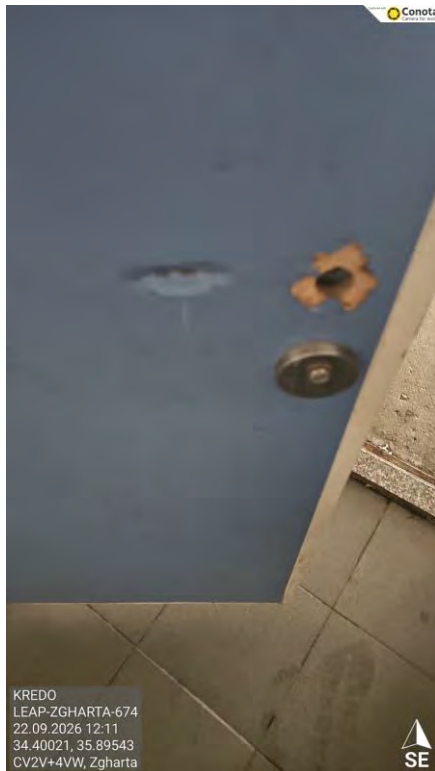
| Trade | Item | Damaged | Location, extent and quantity |
|---|---|---|---|
| Doors | Timber doors | Yes | 6 single doors with frames architraves shall be changed, 15 shall be repaired |

**Figure 7 – Damaged Door**

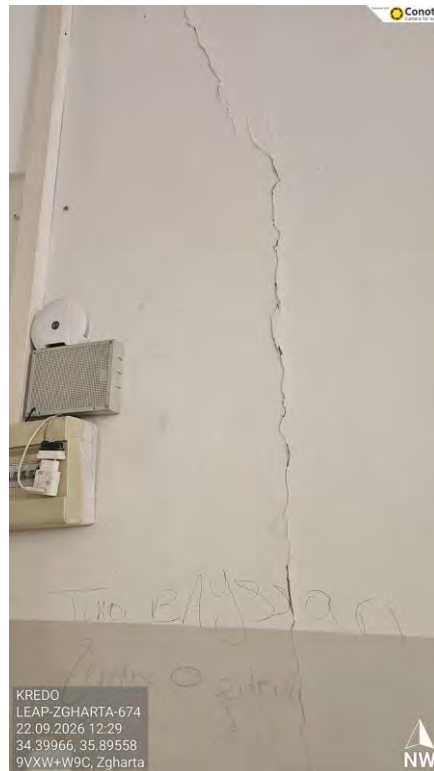
**Figure 8 - Wall Cracks**

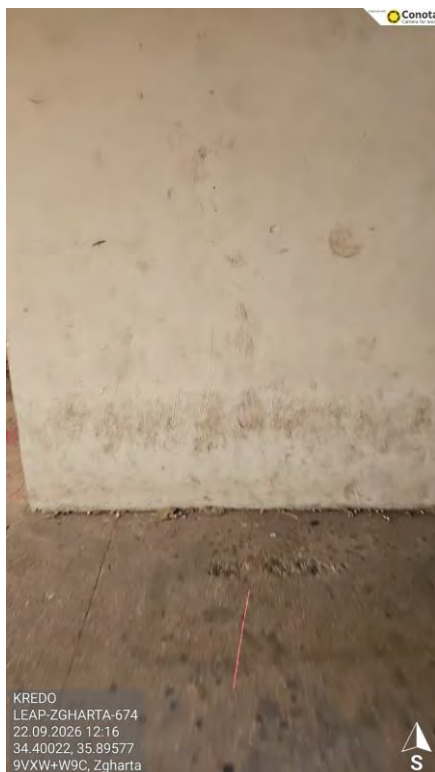
**Figure 9 - Damaged Paint**

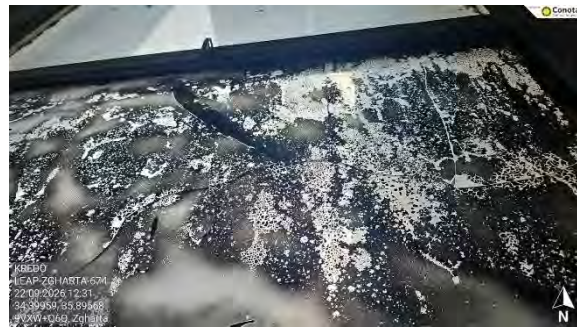
**Figure 12 - Cracked Glazing**

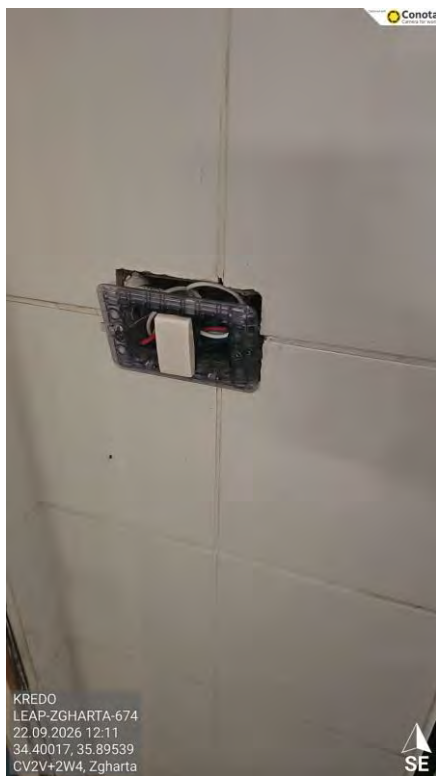
**Figure 13 - Damaged socket**

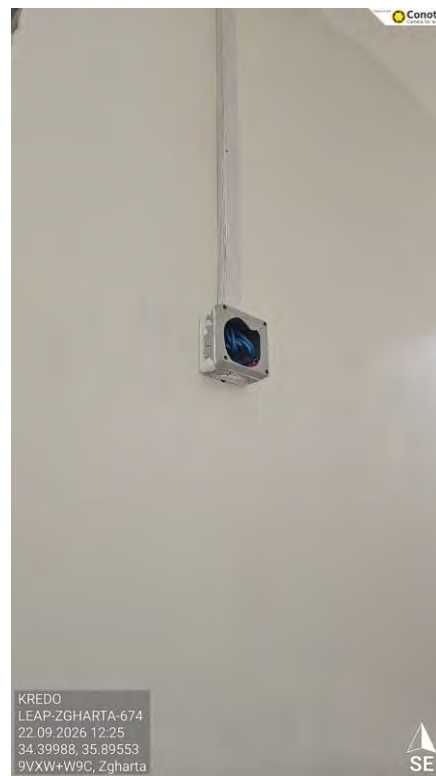
**Figure 14 - Damaged Fan Switch**

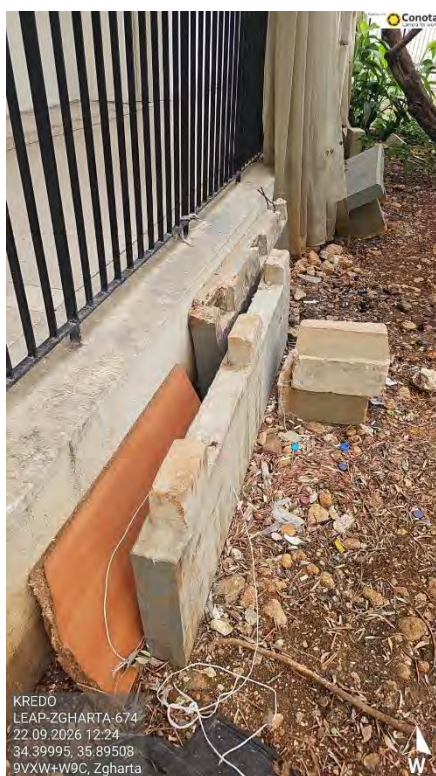
**Figure 15 - Damaged Concrete Bench seat**

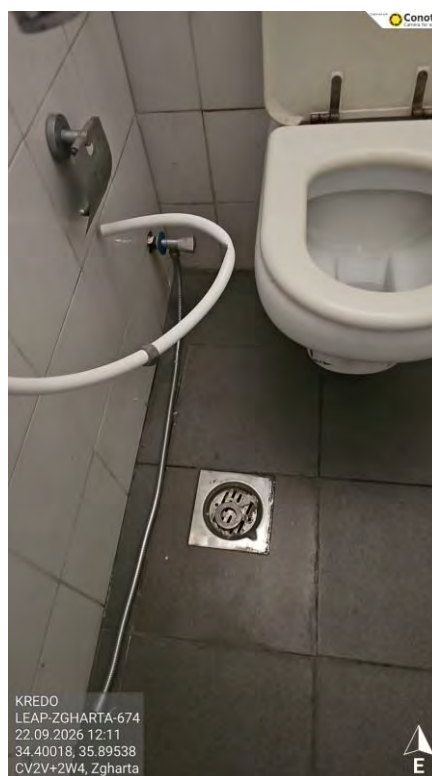
**Figure 16 - Damaged Bidet**

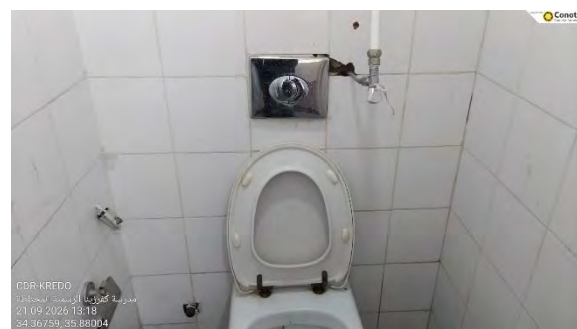
| Trade | Item | Damaged | Location, extent and quantity |
|---|---|---|---|
| | Water closets | Yes | 8 leaking flushers to be fixed |

**Figure 7 - Leaking Flusher**

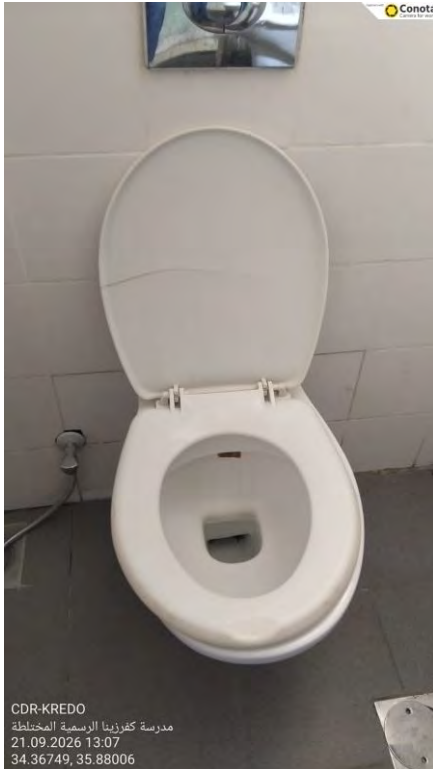
**Figure 8 - Broken Toilet Seat Cover**

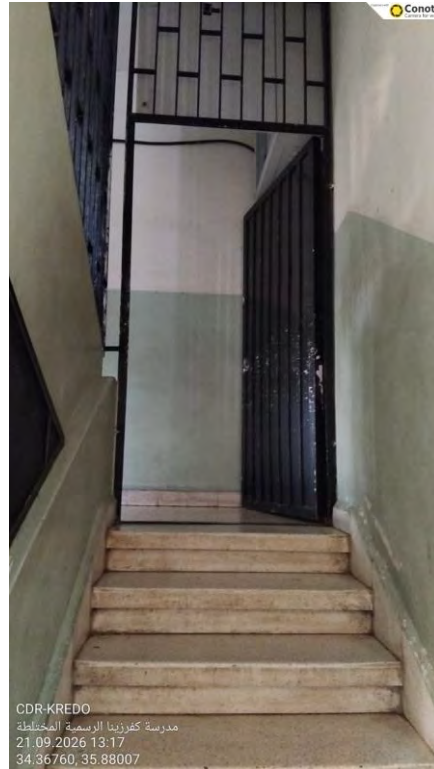
**Figure 9 - Damaged Gate Paint**

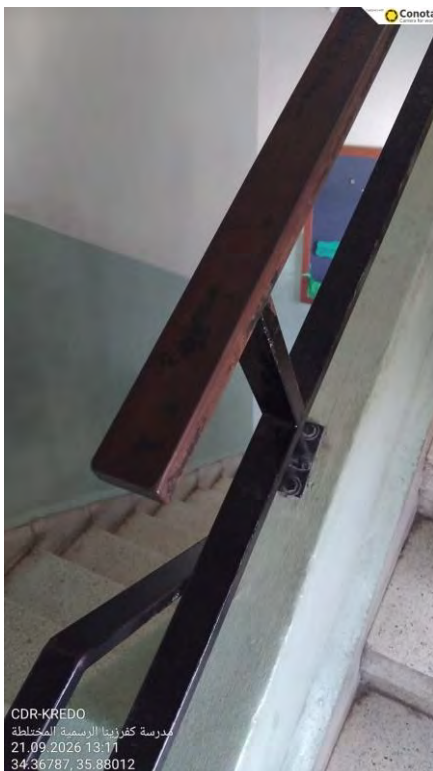
| Trade | Item | Damaged | Location, extent and quantity |
|---|---|---|---|
| Finishes | Paint - walls and ceilings - plasters | Yes | Paint 1,300 m <sup>2</sup><br>Plaster repair 2 m <sup>2</sup><br>20 m handrail to be painted |

**Figure 10 - Rusted Handrail**

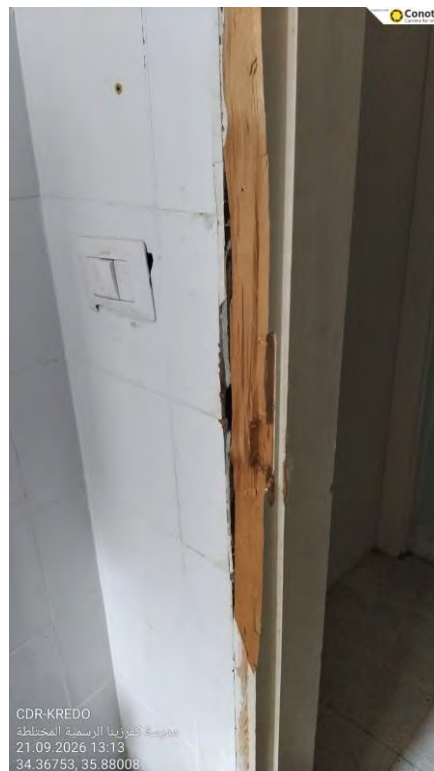
**Figure 11 - Broken Door Frame**

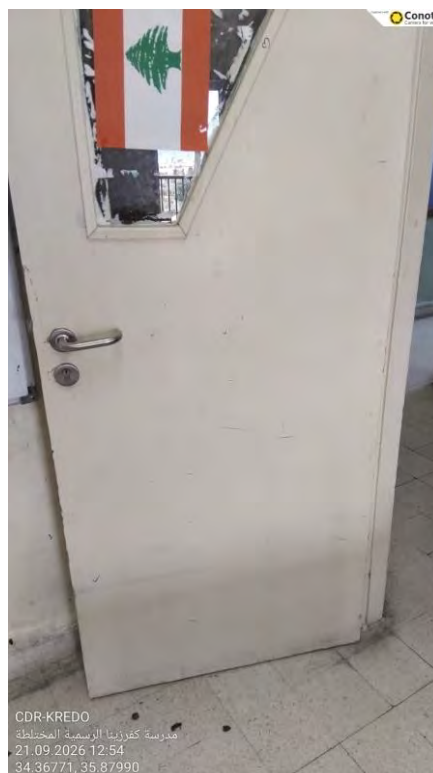
**Figure 22 - Damaged Door Paint**

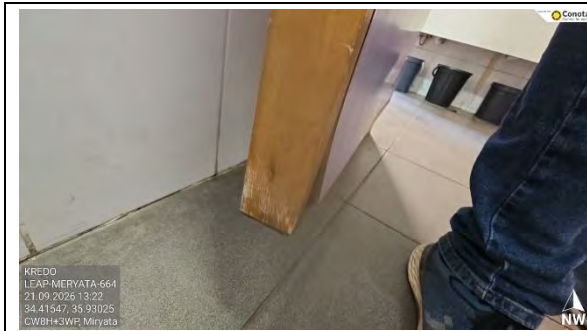
**Figure 7 – Damaged Doors**

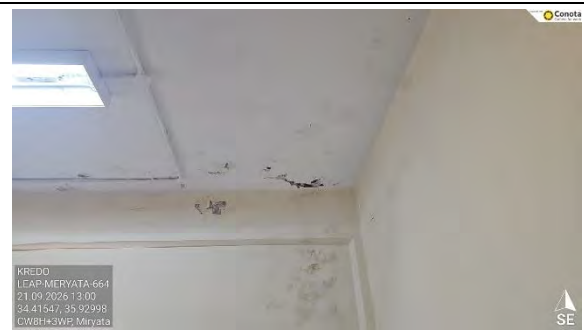
**Figure 8 - Wall Cracks**

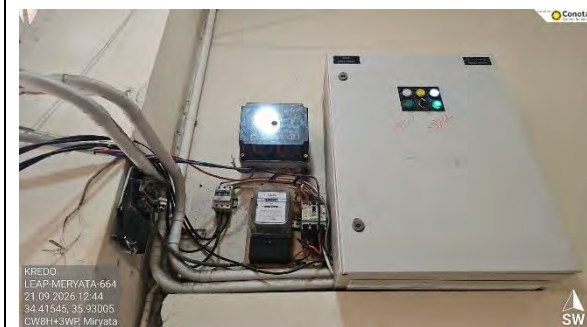
**Figure 9 – Unprotected Electrical Installation**

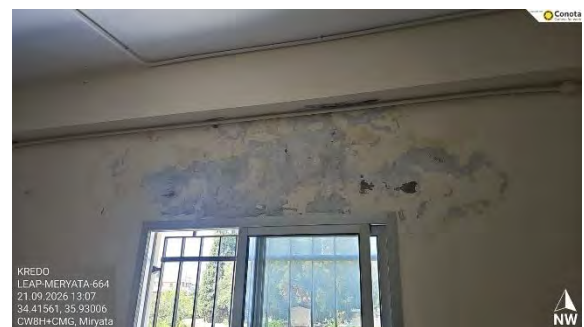
**Figure 10 - Water Leakage**

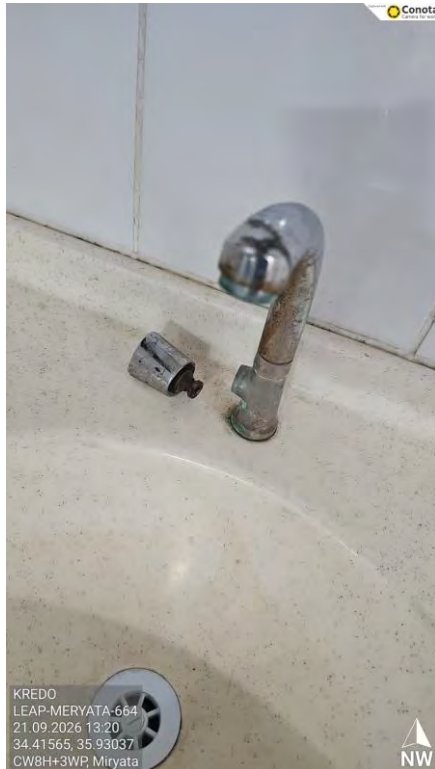
**Figure 11 – Damaged Mixers**

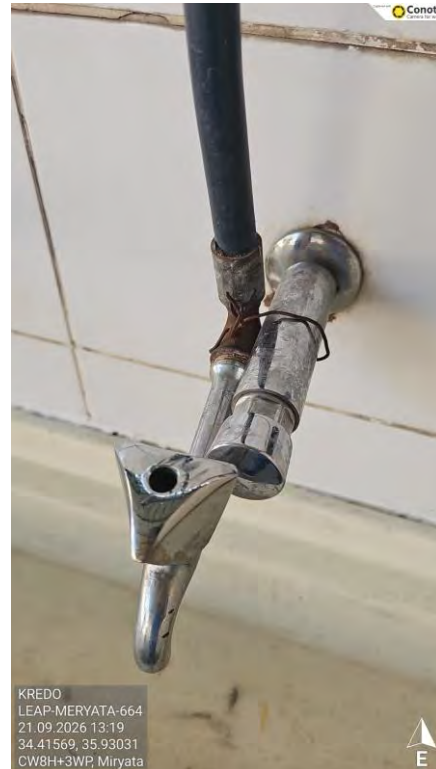
**Figure 12 – Damaged Taps**

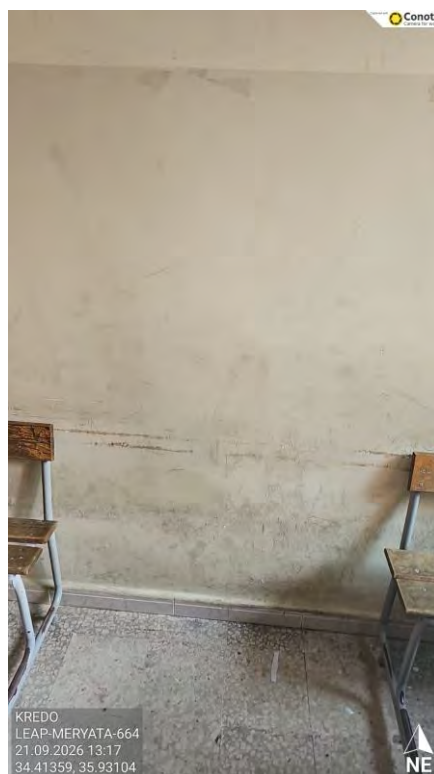
***Figure 13 – Damaged Wall Paint***

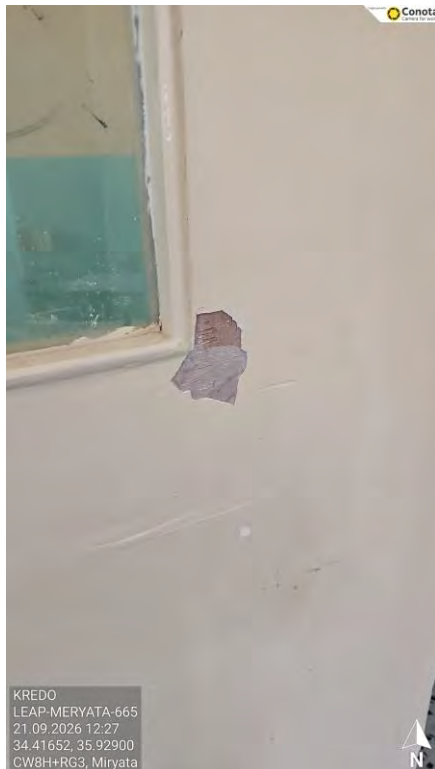
**Figure 7 – Damaged Door**

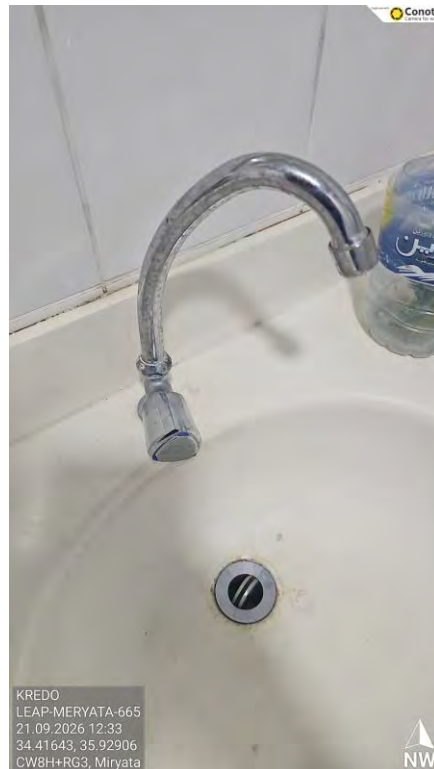
**Figure 8 – Damaged Mixers**

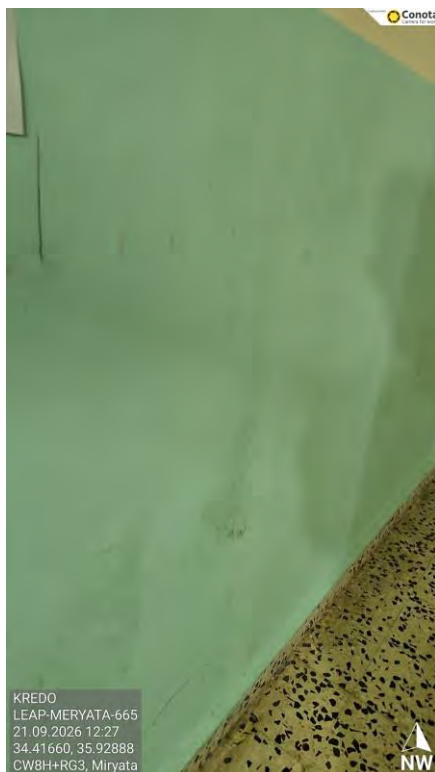
**Figure 9 – Damaged Paint**

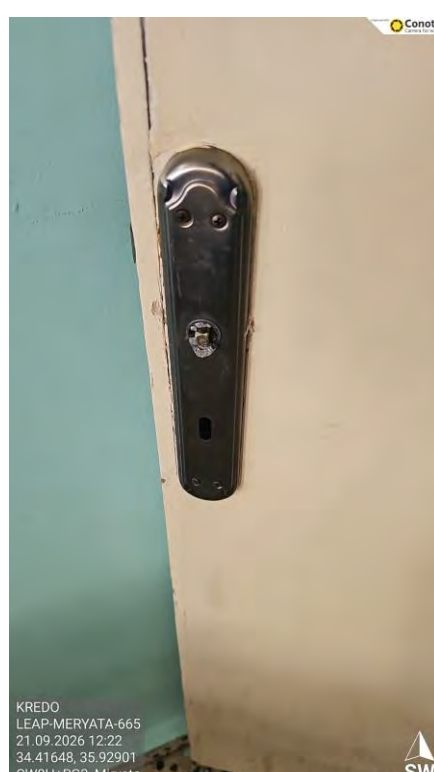
**Figure 10 – Damaged Door Handle**

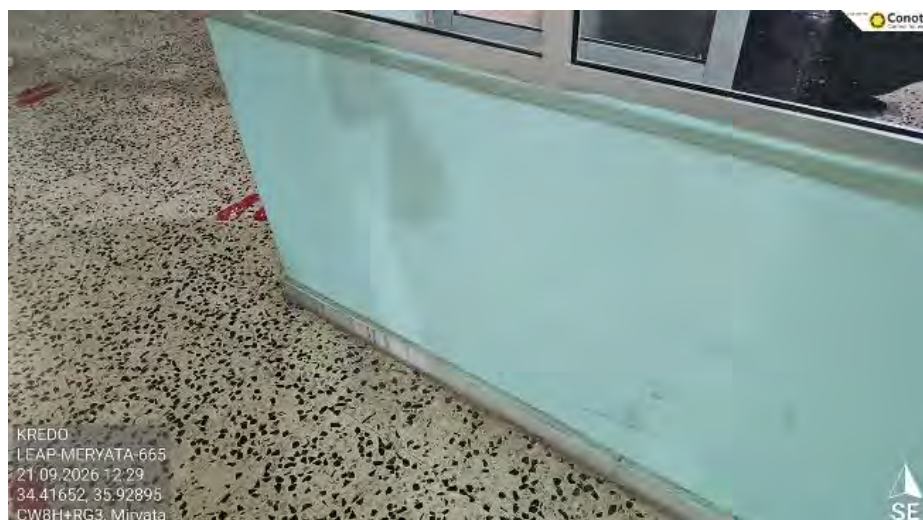
*Figure 11 – Damaged Paint*

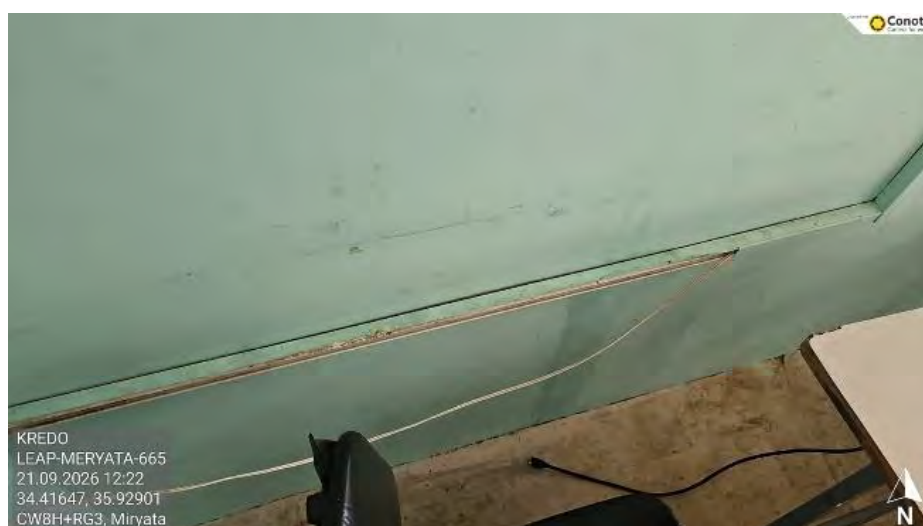
*Figure 12 – Damaged Cable Cover*
