**Lebanese Emergency Assistant Project (LEAP)**  
**Rehabilitation of Shelters (Public Schools)**

**Batch 3: Lot 1**

**in Caza of Baalbek**

**DETAILED ASSESSMENT REPORT**

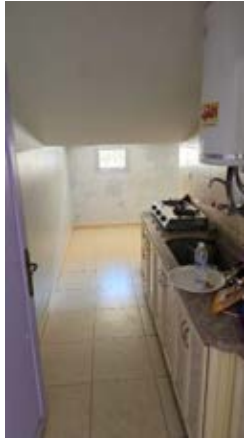
| Floor | Room / Area | Defect Description / Required Works | Qty | Unit | BOQ | Photo |
|---|---|---|---|---|---|---|
| 1st | Kitchen | Paint | 85 | m2 | 9.5.1 | |

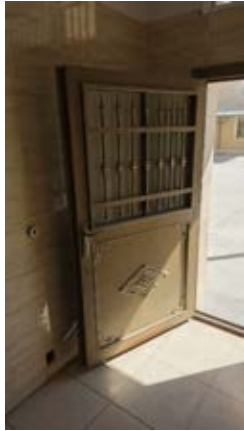
| Floor | Room / Area | Defect Description / Required Works | Qty | Unit | BOQ | Photo |
|---|---|---|---|---|---|---|
| 1st | Toilet- boys | Paint metal door | 1 | pcs | 5.2 | |

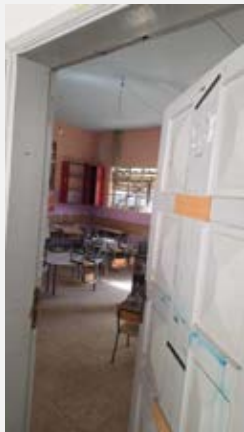
| Floor | Room / Area | Defect Description / Required Works | Qty | Unit | BOQ | Photo |
|---|---|---|---|---|---|---|
| 1st | 2 | Replace full wooden door | 1 | pcs | <b>8.1.1</b> | |

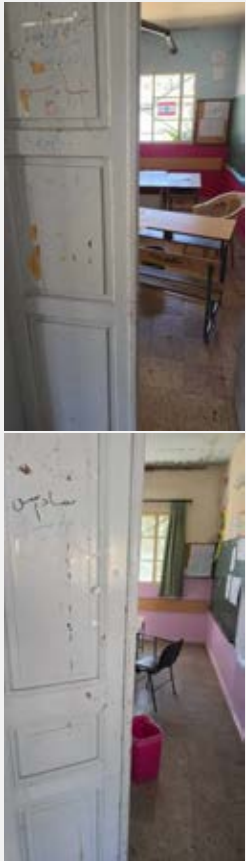
| Floor | Room / Area | Defect Description / Required Works | Qty | Unit | BOQ | Photo |
|---|---|---|---|---|---|---|
| 2nd | 6-7- | New complete Wooden door | 2 | pcs | 8.1.1 | |

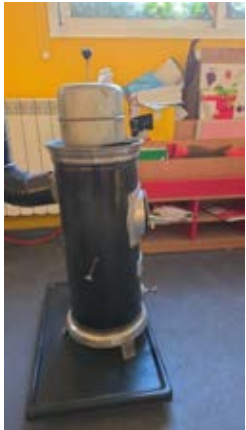
| Floor | Room / Area | Defect Description / Required Works | Qty | Unit | BOQ | Photo |
|---|---|---|---|---|---|---|
| 1st | 3-6-8-9-10-11-12-13 | New Sobyra | 8 | pcs | 1.2.2 | |

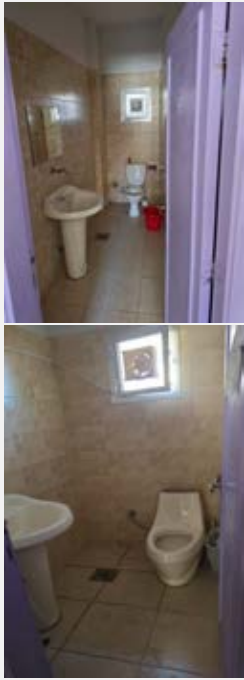
| Floor | Room / Area | Defect Description / Required Works | Qty | Unit | BOQ | Photo |
|---|---|---|---|---|---|---|
| 1st | Toilets 1 | Toilet seat Lid | 1 | pcs | 1.2.1 | |

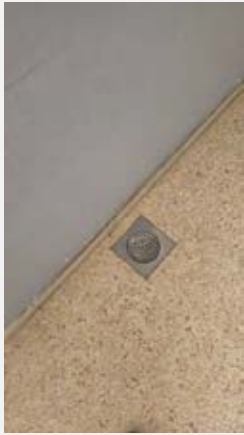
| Floor | Room / Area | Defect Description / Required Works | Qty | Unit | BOQ | Photo |
|---|---|---|---|---|---|---|
| 2nd | Coridor | Floor drain cover | 7 | pcs | 1.2.1 | |

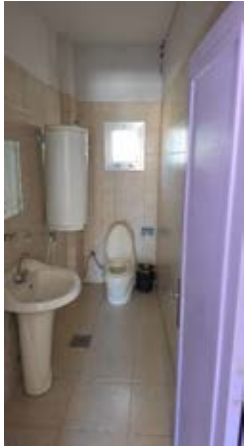
| Floor | Room / Area | Defect Description / Required Works | Qty | Unit | BOQ | Photo |
|---|---|---|---|---|---|---|
| 2nd | Toilets | New Flushing sytem for toilet seat | 4 | pcs | 1.2.1 | |

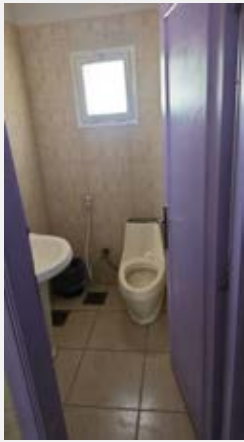
| Floor | Room / Area | Defect Description / Required Works | Qty | Unit | BOQ | Photo |
|---|---|---|---|---|---|---|
| 2nd | Toilets | Toilet seat Lid | 1 | pcs | 1.2.1 | |

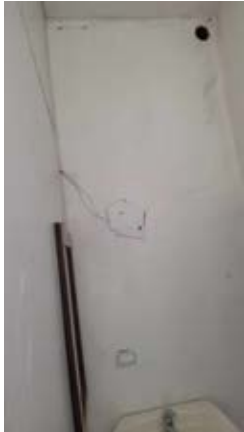
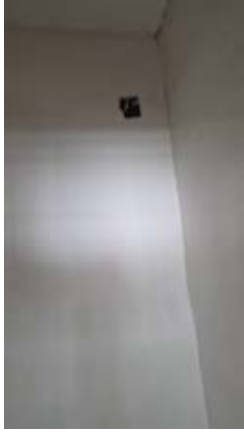
| Floor | Room / Area | Defect Description / Required Works | Qty | Unit | BOQ | Photo |
|---|---|---|---|---|---|---|
| 2nd | Toilets | Electrical outlet cover | 1 | pcs | 1.1.3 | <br> |

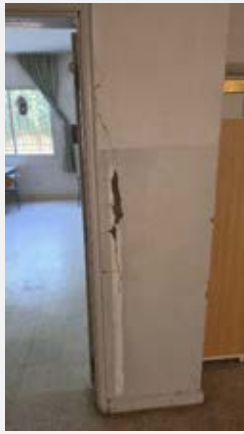
| Floor | Room / Area | Defect Description / Required Works | Qty | Unit | BOQ | Photo |
|---|---|---|---|---|---|---|
| 1st | 1 | Repair wall plaster | | | 9.1.2 | |

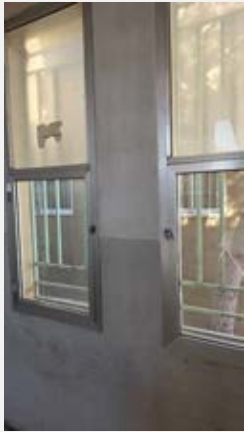
| Floor | Room / Area | Defect Description / Required Works | Qty | Unit | BOQ | Photo |
|---|---|---|---|---|---|---|
| 1st | | Window Handles | 2 | pcs | 8.2.3 | |

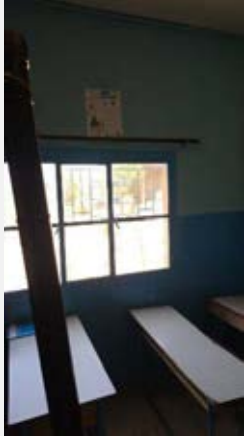
| Floor | Room / Area | Defect Description / Required Works | Qty | Unit | BOQ | Photo |
|---|---|---|---|---|---|---|
| 1st | 3-5- | Glass for the window section of a door | 3 | pcs | 5.2 | |

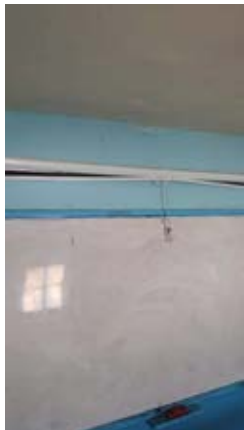
| Floor | Room / Area | Defect Description / Required Works | Qty | Unit | BOQ | Photo |
|---|---|---|---|---|---|---|
| 1st | 5-6-7- | New white board | 3 | pcs | <b>10.2.1</b> | |

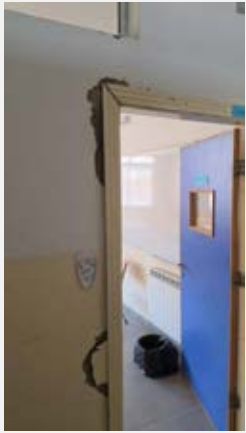
| Floor | Room / Area | Defect Description / Required Works | Qty | Unit | BOQ | Photo |
|---|---|---|---|---|---|---|
| 2nd | 4 | Repair plaster around wooden frame | 1 | pcs | 9.1.2 | |

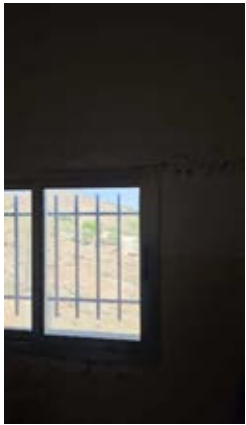
| Floor | Room / Area | Defect Description / Required Works | Qty | Unit | BOQ | Photo |
|---|---|---|---|---|---|---|
| 2nd | Staircase | Paint walls of staircase & Repair water leakage problems | 220 | m2 | 9.5.1 | |

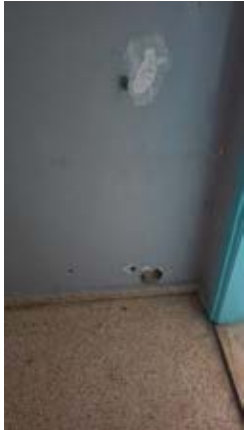
| Floor | Room / Area | Defect Description / Required Works | Qty | Unit | BOQ | Photo |
|---|---|---|---|---|---|---|
| 2nd | | Repair wall | 9 | m2 | 9.5.1 | |

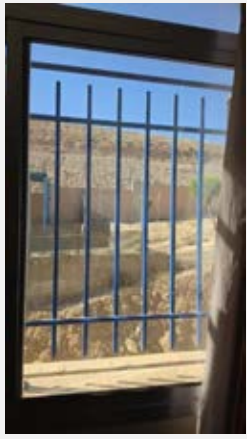
| Floor | Room / Area | Defect Description / Required Works | Qty | Unit | BOQ | Photo |
|---|---|---|---|---|---|---|
| 2nd | 4 | New Glass (1x1.4) | 1 | pcs | 5.2 | |

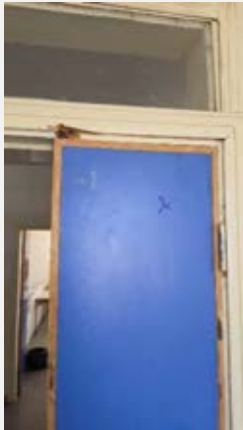
| Floor | Room / Area | Defect Description / Required Works | Qty | Unit | BOQ | Photo |
|---|---|---|---|---|---|---|
| 2nd | 4-6-7- | Repair Wooden frame of the door | 3 | pcs | 8.1.3 | |

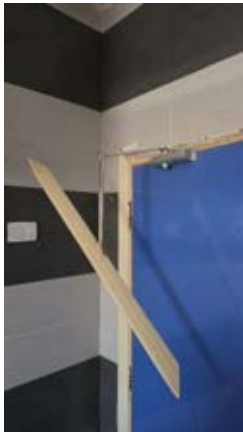
| Floor | Room / Area | Defect Description / Required Works | Qty | Unit | BOQ | Photo |
|---|---|---|---|---|---|---|
| 2nd | Toilets-1 | Repair wooden door | 1 | pcs | 8.1.3 | |

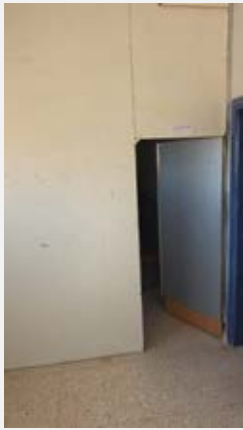
| Floor | Room / Area | Defect Description / Required Works | Qty | Unit | BOQ | Photo |
|---|---|---|---|---|---|---|
| 2nd | 6 | New Wooden door | 1 | pcs | 8.1.1 | |

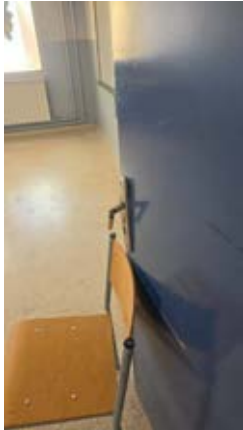
| Floor | Room / Area | Defect Description / Required Works | Qty | Unit | BOQ | Photo |
|---|---|---|---|---|---|---|
| 3rd | 1-3-5-7- | Door's Handles (x2) | 8 | pcs | 8.1.3 | |

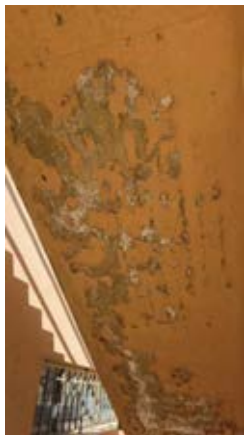
| Floor | Room / Area | Defect Description / Required Works | Qty | Unit | BOQ | Photo |
|---|---|---|---|---|---|---|
| Walls | | There's a serious water leakage problem coming from the roof and walls that need to be addressed, causing the leakage to get to classes and internal walls | | LS | <b>7.1</b> | |

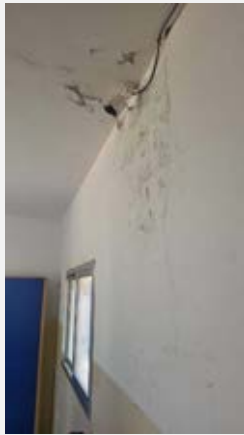
| Floor | Room / Area | Defect Description / Required Works | Qty | Unit | BOQ | Photo |
|---|---|---|---|---|---|---|
| 2nd | Entrance | Repair of water leakage problems | | LS | <b>7.1</b> | |

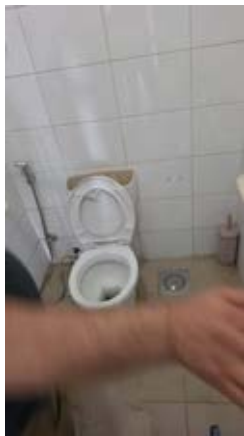
| Floor | Room / Area | Defect Description / Required Works | Qty | Unit | BOQ | Photo |
|---|---|---|---|---|---|---|
| 1st | Toilets | Water Tank Lid (cistern cover) | 1 | pcs | 1.2.1 | |

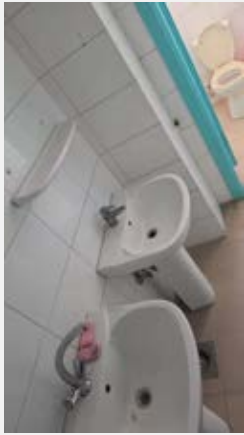
| Floor | Room / Area | Defect Description / Required Works | Qty | Unit | BOQ | Photo |
|---|---|---|---|---|---|---|
| 2nd | Toilets-boys | Faucet | 1 | pcs | 5.6 | |

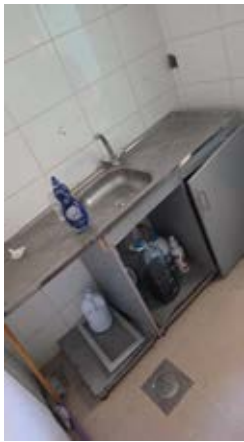
| Floor | Room / Area | Defect Description / Required Works | Qty | Unit | BOQ | Photo |
|---|---|---|---|---|---|---|
| 2nd | Kitchen | New Sink | 2 | pcs | 5.8 | |

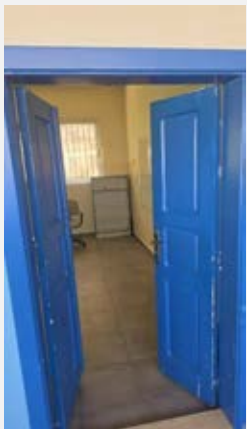
| Floor | Room / Area | Defect Description / Required Works | Qty | Unit | BOQ | Photo |
|---|---|---|---|---|---|---|
| 1st | 1-2-3-4-5-6-7 | Repair door | 7 | pcs | 8.1.3 | |

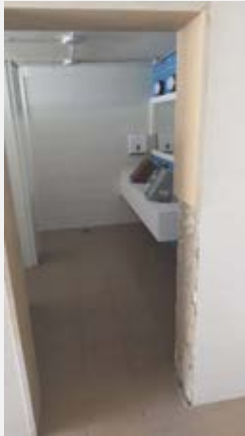
| Floor | Room / Area | Defect Description / Required Works | Qty | Unit | BOQ | Photo |
|---|---|---|---|---|---|---|
| 1st | Toilets-boys | Repair wall tiling | | LS | 9.2.4 | |

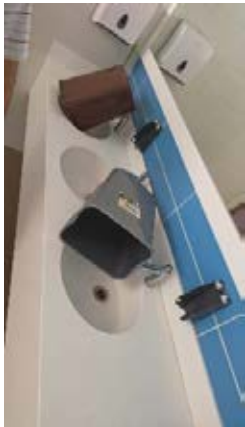
| Floor | Room / Area | Defect Description / Required Works | Qty | Unit | BOQ | Photo |
|---|---|---|---|---|---|---|
| 1st | Toilets-boys<br>Toilets-girls | Faucets<br>(x3 in boys wc - x2 in girls wc) | 5 | pcs | 5.6 | <br> |

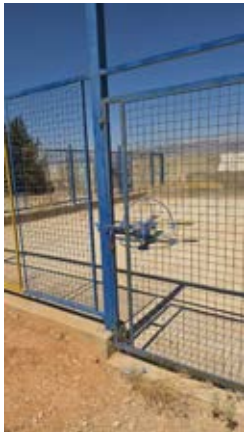
| Floor | Room / Area | Defect Description / Required Works | Qty | Unit | BOQ | Photo |
|---|---|---|---|---|---|---|
| Outdoor | Playground | Handles for metal door | 2 | pcs | 5.2 | |

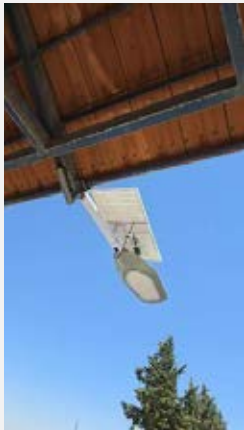
| Floor | Room / Area | Defect Description / Required Works | Qty | Unit | BOQ | Photo |
|---|---|---|---|---|---|---|
| Outdoor | | Provide new street lights similar to the one in the picture | 5 | pcs | <b>1.1.1</b> | |

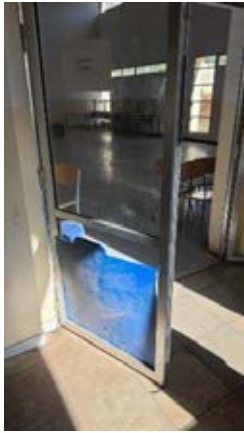
| Floor | Room / Area | Defect Description / Required Works | Qty | Unit | BOQ | Photo |
|---|---|---|---|---|---|---|
| 1st | Theatre | Glass for metal door | 1 | pcs | 5.2 | |

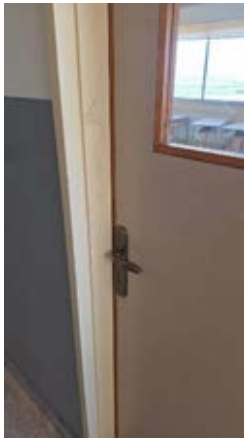
| Floor | Room / Area | Defect Description / Required Works | Qty | Unit | BOQ | Photo |
|---|---|---|---|---|---|---|
| 2nd | 5 | Repair door handles + lock | 1 | door | 8.1.3 | |

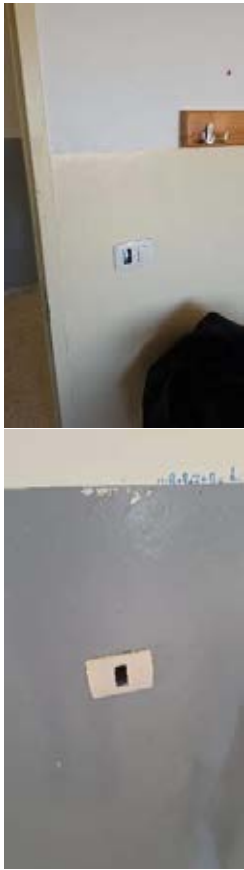
| Floor | Room / Area | Defect Description / Required Works | Qty | Unit | BOQ | Photo |
|---|---|---|---|---|---|---|
| 2nd | 2-coridor- | Electrical switch cover | 2 | pcs | 1.1.3 | |

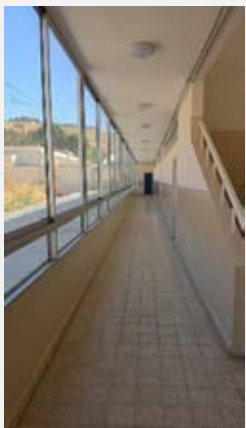
| Floor | Room / Area | Defect Description / Required Works | Qty | Unit | BOQ | Photo |
|---|---|---|---|---|---|---|
| 2nd | Coridor (80x 1.5m) | Paint walls | 400 | m2 | 9.5.1 | |

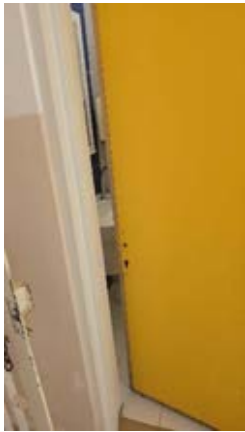
| Floor | Room / Area | Defect Description / Required Works | Qty | Unit | BOQ | Photo |
|---|---|---|---|---|---|---|
| 2nd | Toilets | Door Handles | 2 | pcs | <b>8.1.3</b> | |

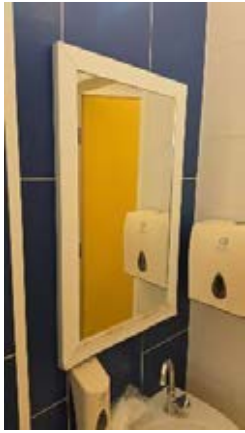
| Floor | Room / Area | Defect Description / Required Works | Qty | Unit | BOQ | Photo |
|---|---|---|---|---|---|---|
| 2nd | Toilets | Install new mirror | 1 | pcs | 10.1 | |

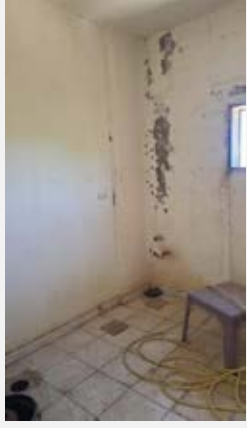
| Floor | Room / Area | Defect Description / Required Works | Qty | Unit | BOQ | Photo |
|---|---|---|---|---|---|---|
| 2nd | Toilets (3x 3m) | Paint walls | 36 | m2 | 9.5.1 | |

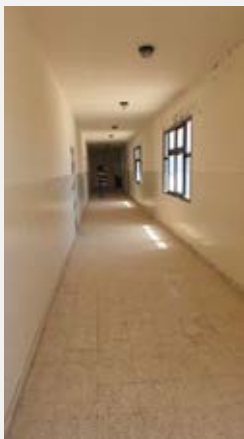
| Floor | Room / Area | Defect Description / Required Works | Qty | Unit | BOQ | Photo |
|---|---|---|---|---|---|---|
| 3rd | Coridor (60x2.5 m) | Paint walls | 375 | m2 | 9.5.1 | |

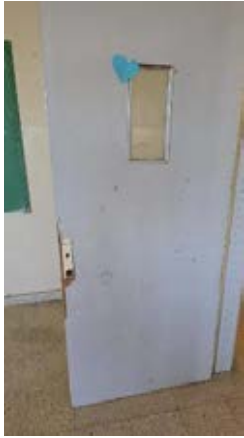
| Floor | Room / Area | Defect Description / Required Works | Qty | Unit | BOQ | Photo |
|---|---|---|---|---|---|---|
| 2nd | 1-3-5-8- | Install new wooden door | 4 | pcs | 8.1.1 | |

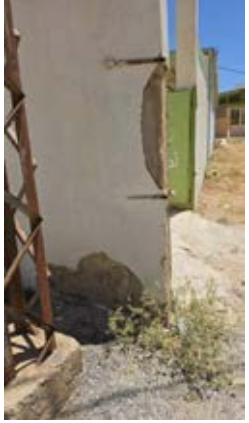
| Floor | Room / Area | Defect Description / Required Works | Qty | Unit | BOQ | Photo |
|---|---|---|---|---|---|---|
| Exterior | | Repair and maintenance of external plaster works around 5 windows | 5 | windows | 9.1.2 | |

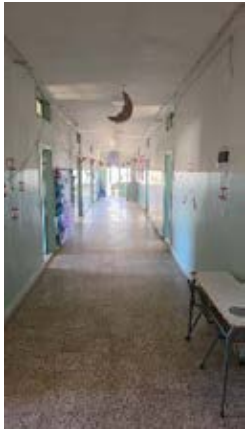
| Floor | Room / Area | Defect Description / Required Works | Qty | Unit | BOQ | Photo |
|---|---|---|---|---|---|---|
| 1st | Corridor | Floor Tiling Polishing | 75 | m2 | 9.2.7 | |

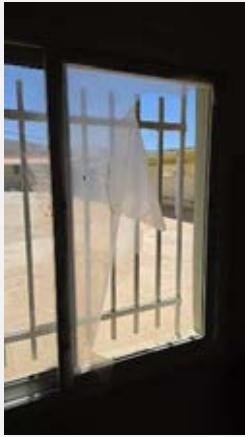
| Floor | Room / Area | Defect Description / Required Works | Qty | Unit | BOQ | Photo |
|---|---|---|---|---|---|---|
| 1st | Coridor | Window glass | 1 | pcs | 8.2.3 | |

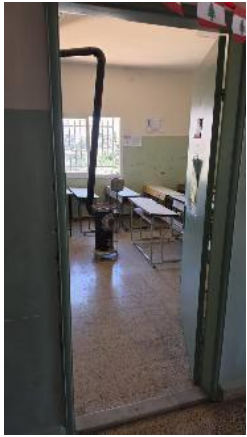
| Floor | Room / Area | Defect Description / Required Works | Qty | Unit | BOQ | Photo |
|---|---|---|---|---|---|---|
| 1st | 1-2-3-4-5-6-7-8-9-10-11 | Provide new Sobyas | 11 | pcs | 1.2.2 | |

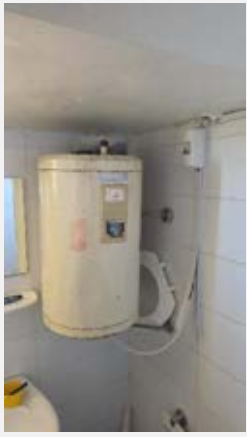
| Floor | Room / Area | Defect Description / Required Works | Qty | Unit | BOQ | Photo |
|---|---|---|---|---|---|---|
| 1st | Kitchen | Supply and installation of electric water heater. | 1 | pcs | 3.2 | |

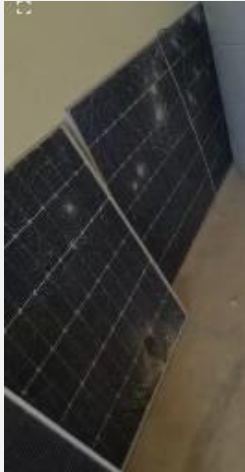
| Floor | Room / Area | Defect Description / Required Works | Qty | Unit | BOQ | Photo |
|---|---|---|---|---|---|---|
| | Solar Panel Energy | Provide new solar panels | 8 | pcs | 8.1 | <br><br> |

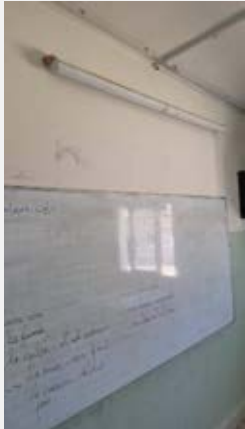
| Floor | Room / Area | Defect Description / Required Works | Qty | Unit | BOQ | Photo |
|---|---|---|---|---|---|---|
| 1st | 1-9-10-11 | Projector Screen | 4 | pcs | <b>12.1.1</b> | |

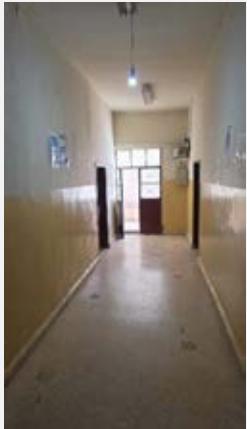
| Floor | Room / Area | Defect Description / Required Works | Qty | Unit | BOQ | Photo |
|---|---|---|---|---|---|---|
| 3rd | Coridor<br>(10 x2m) | Paint walls | 72 | m2 | 9.5.1 | |

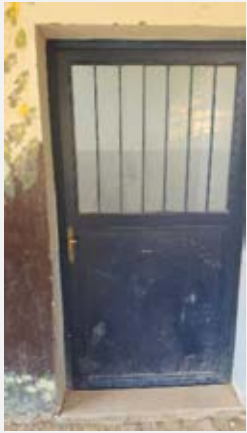
| Floor | Room / Area | Defect Description / Required Works | Qty | Unit | BOQ | Photo |
|---|---|---|---|---|---|---|
| 2nd | | Repair & paint metal door | 1 | pcs | 5.2 | |

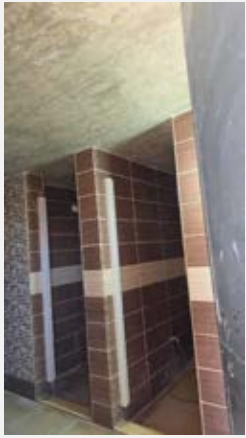
| Floor | Room / Area | Defect Description / Required Works | Qty | Unit | BOQ | Photo |
|---|---|---|---|---|---|---|
| 1st | Toilets | Paint Toilets Ceilings | 35 | m2 | 9.5.1 | |

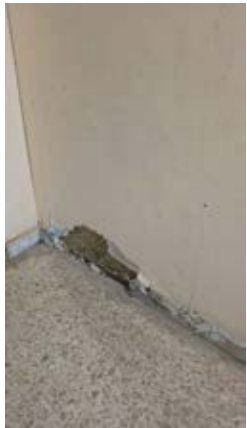
| Floor | Room / Area | Defect Description / Required Works | Qty | Unit | BOQ | Photo |
|---|---|---|---|---|---|---|
| 2nd | 2 | Repair and maintenance of gypsum wall. | 1 | pcs | 9.4.2 | |

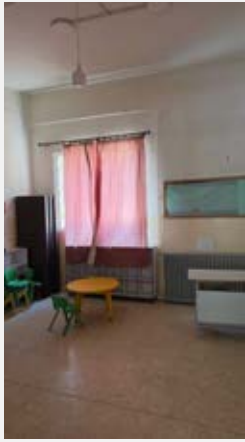
| Floor | Room / Area | Defect Description / Required Works | Qty | Unit | BOQ | Photo |
|---|---|---|---|---|---|---|
| 2nd | 7 | New White board | 1 | pcs | <b>10.2.1</b> | |

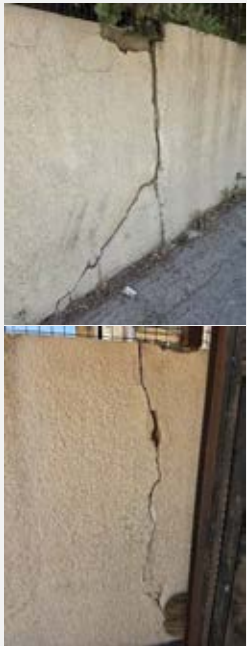
| Floor | Room / Area | Defect Description / Required Works | Qty | Unit | BOQ | Photo |
|---|---|---|---|---|---|---|
| 1st | Walls | reatment and repair of deteriorated wall surfaces<br>(damaged because of bombings) | 25 | m2 | 2.4 | |

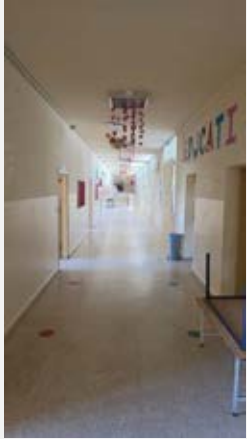
| Floor | Room / Area | Defect Description / Required Works | Qty | Unit | BOQ | Photo |
|---|---|---|---|---|---|---|
| 2nd | Coridor (50x3) | Paint | 450 | m2 | 9.5.1 | |

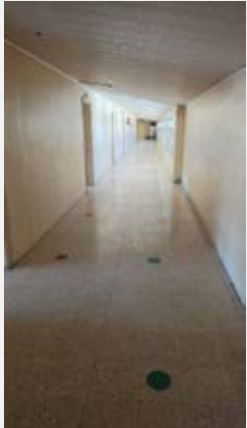
| Floor | Room / Area | Defect Description / Required Works | Qty | Unit | BOQ | Photo |
|---|---|---|---|---|---|---|
| 3rd | Coridor (50x3) | Paint | 450 | m2 | 9.5.1 | |

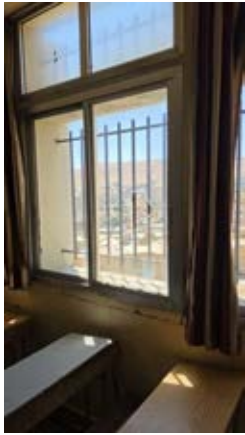
| Floor | Room / Area | Defect Description / Required Works | Qty | Unit | BOQ | Photo |
|---|---|---|---|---|---|---|
| 2nd | 1-2-3-7 | Window Glass<br>(x1 in classes: 1-2-7<br>x2 in class3) | 5 | pcs | 8.2.3 | |

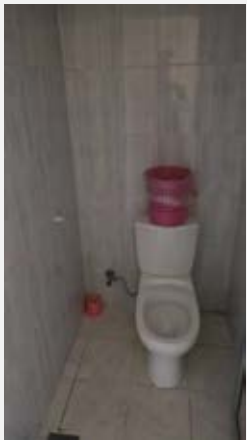
| Floor | Room / Area | Defect Description / Required Works | Qty | Unit | BOQ | Photo |
|---|---|---|---|---|---|---|
| 3rd | Toilets-girls | Handheld bidet sprayer | 1 | pcs | 5.6 | |

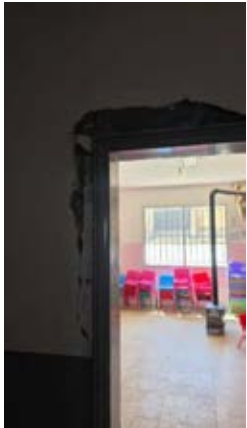
| Floor | Room / Area | Defect Description / Required Works | Qty | Unit | BOQ | Photo |
|---|---|---|---|---|---|---|
| 1st | 7 | Repair Wall Plaster around the door's frame | 1 | | 9.1.2 | |

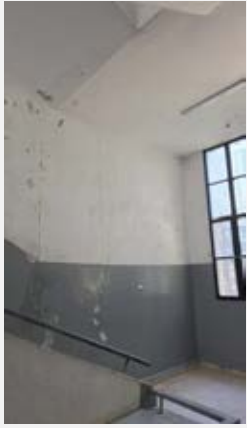
| Floor | Room / Area | Defect Description / Required Works | Qty | Unit | BOQ | Photo |
|---|---|---|---|---|---|---|
| All Floors (1 to 3) | Staircase | Paint walls of staircase | 450 | m2 | 9.5.1 | |

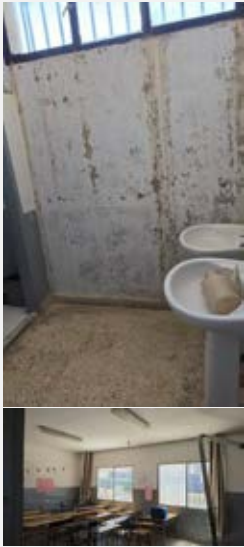
| Floor | Room / Area | Defect Description / Required Works | Qty | Unit | BOQ | Photo |
|---|---|---|---|---|---|---|
| 2nd | Toilets | Paint | 6 | m2 | 9.5.1 | |

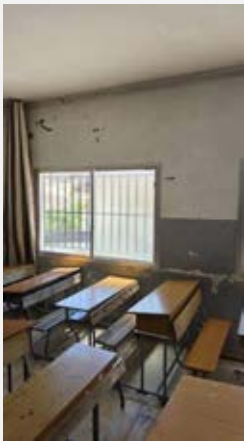
| Floor | Room / Area | Defect Description / Required Works | Qty | Unit | BOQ | Photo |
|---|---|---|---|---|---|---|
| 3rd | 1-2-3-4-5-6-7-8-9-10-11 | Paint | 1452 | m2 | 9.5.1 | |

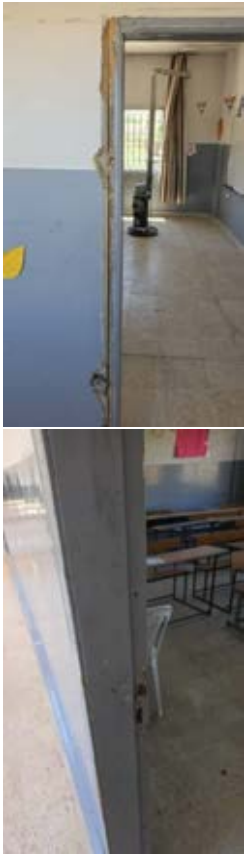
| Floor | Room / Area | Defect Description / Required Works | Qty | Unit | BOQ | Photo |
|---|---|---|---|---|---|---|
| 3rd | 2 | Repair wall plaster | 1 | | 9.1.2 | |

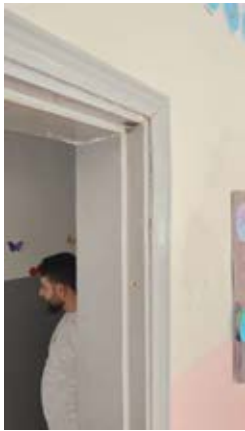
| Floor | Room / Area | Defect Description / Required Works | Qty | Unit | BOQ | Photo |
|---|---|---|---|---|---|---|
| 1st | 7 | Repair wooden door's frame | | | <b>8.1.3</b> | |

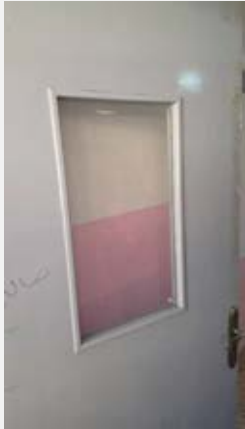
| Floor | Room / Area | Defect Description / Required Works | Qty | Unit | BOQ | Photo |
|---|---|---|---|---|---|---|
| 1st | 9 | Glass for door | 1 | pcs | <b>8.1.3</b> | |

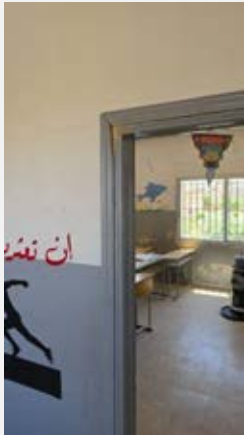
| Floor | Room / Area | Defect Description / Required Works | Qty | Unit | BOQ | Photo |
|---|---|---|---|---|---|---|
| 3rd | 3-6- | Repair frame of wooden door | 2 | pcs | <b>8.1.3</b> | |

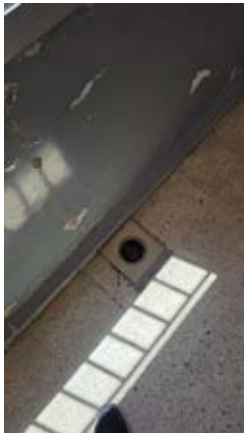
| Floor | Room / Area | Defect Description / Required Works | Qty | Unit | BOQ | Photo |
|---|---|---|---|---|---|---|
| 3rd | | Floor drain cover | 1 | pcs | <b>1.2.1</b> | |
