**CERD 174 - El Fidar Mixed Intermediate Public School**

Lebanon Emergency Assistance Project (LEAP)

## Detailed Assessment and Verification Report

Tender Preparation and Construction Supervision Consultant for Shelters.

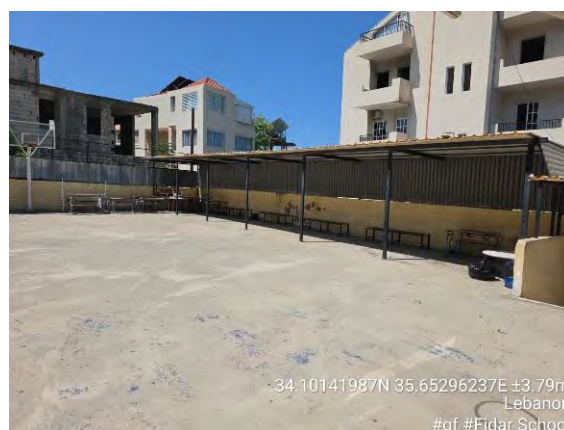
**Figure 5- Playground in bad condition**

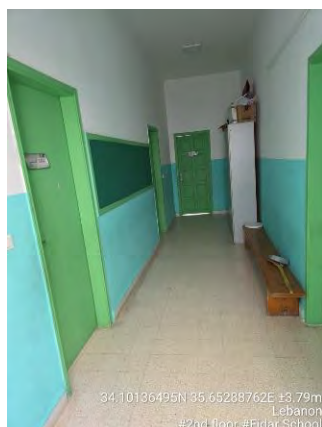
**Figure 6- Walls, Ceiling and Doors in bad condition**

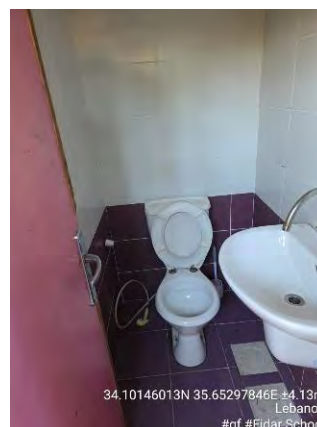
**Figure 7- Toilet door with deteriorated paint finish and damaged accessories**

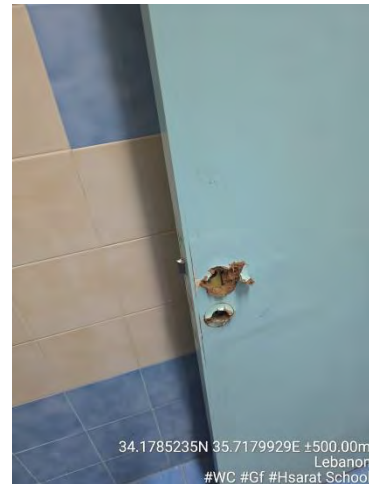
| Trade | Item | Damaged | Location, extent and quantity |
|---|---|---|---|
| Doors | Timber doors | Yes | 11 doors to be repaired and one to be replaced |

**Figure 6- Damaged Door**

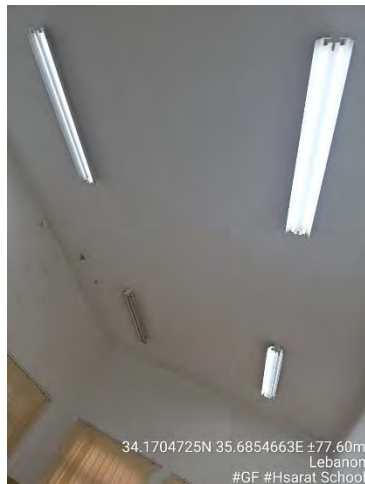
**Figure 7- Damaged Lighting Fixtures**

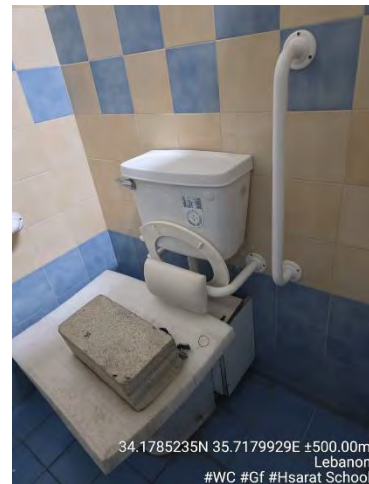
| Trade | Item | Damaged | Location, extent and quantity |
|---|---|---|---|
| | Water closets | Yes | 2 to be replaced |

**Figure 8- Broken Toilet Seat**

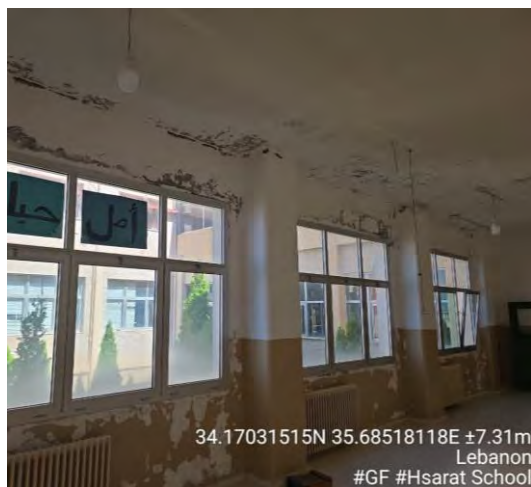
**Figure 9- Damaged Walls Due to Water  
Leakage**

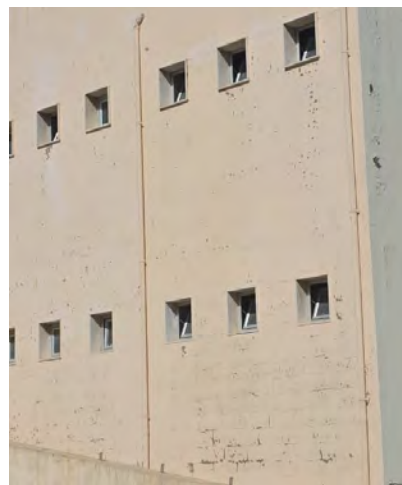
| No. | Element | Yes | No | Location and description |
|---|---|---|---|---|
| 1 | Facade cracks | X | | |

**Figure 10- Façade Cracks**

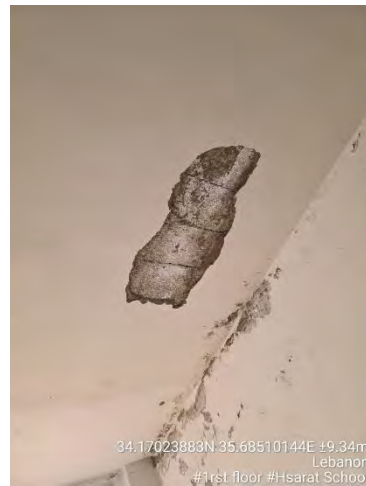
**Figure 12- Damaged Plaster**

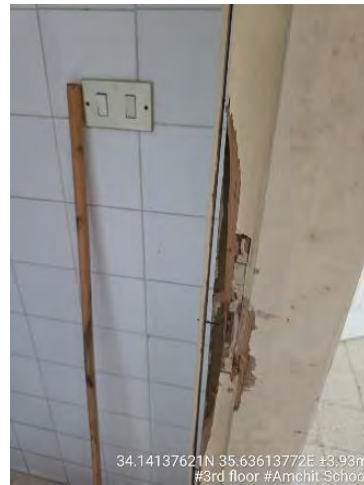
| Trade | Item | Damaged | Location, extent and quantity |
|---|---|---|---|
| Doors | Timber doors | Yes | 20 doors to be repaired |

**Figure 6- Broken Door**

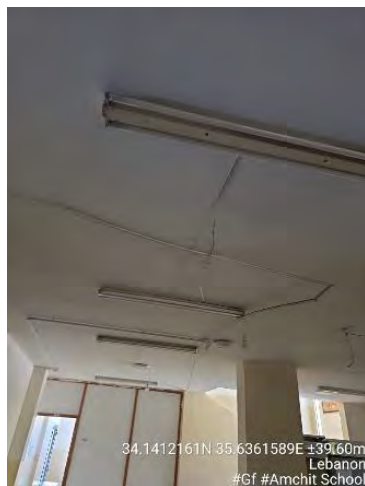
**Figure 7- Damaged Lighting Fixtures**

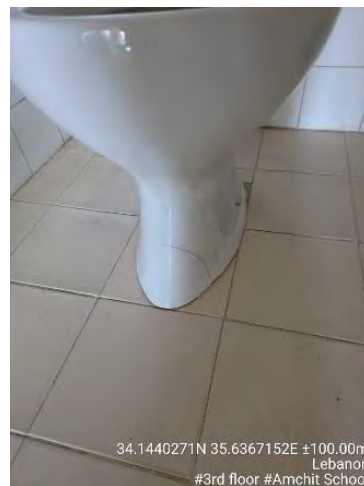
**Figure 8- Broken Toilet Seat**

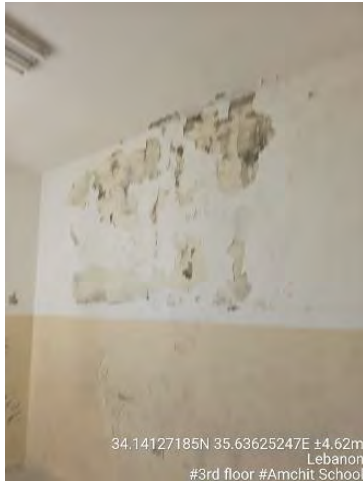
**Figure 9- Damaged Walls**

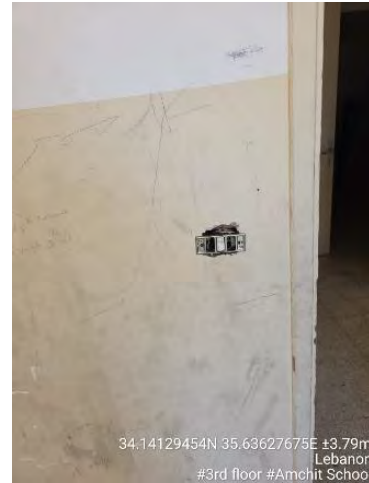
**Figure 10- Damaged Electricity Switch**

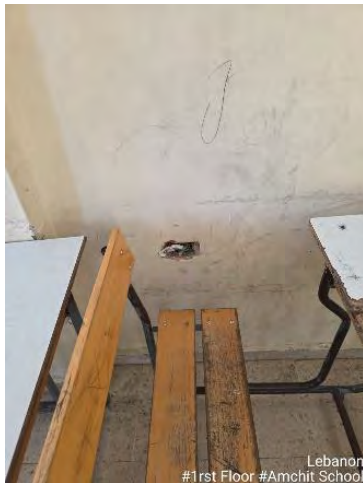
**Figure 11- Damaged Electricity Socket**

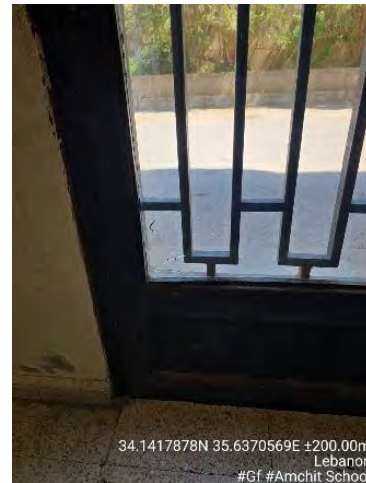
**Figure 12- Broken Glass**

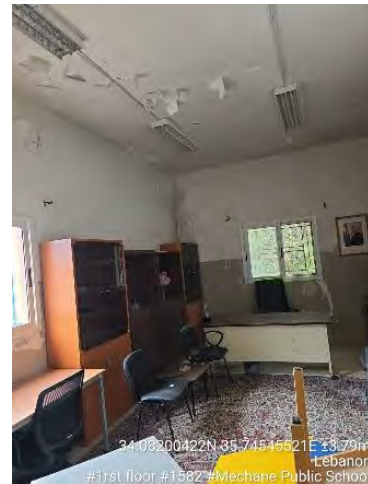
| Trade | Item | Damaged | Location, extent and quantity |
|---|---|---|---|
| Doors | Timber doors | Yes | 10 Classroom and toilet doors to be repaired |

**Figure 5- Walls, Ceiling and doors in bad condition**

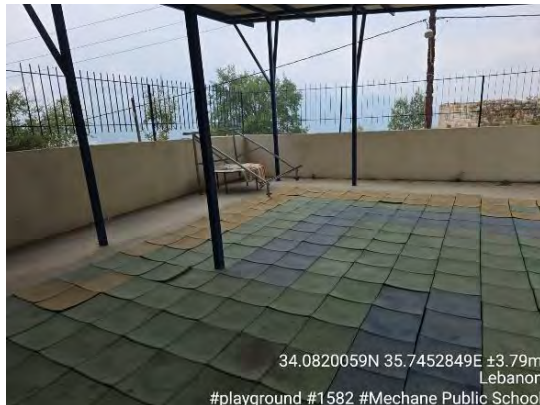
**Figure 6- Playground in bad conditions**

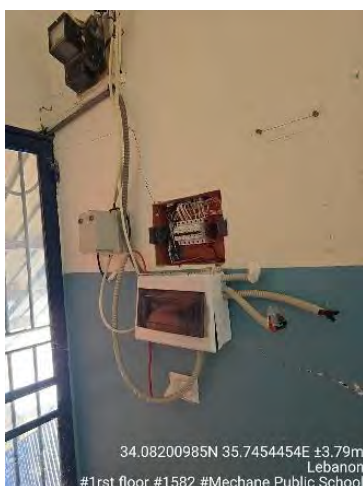
| No. | Element | Yes | No | Location and description |
|---|---|---|---|---|
| 1 | Facade cracks | X | | Visible shear cracks on the façade |

**Figure 8- Electrical panel in bad condition along with visible shear crack**

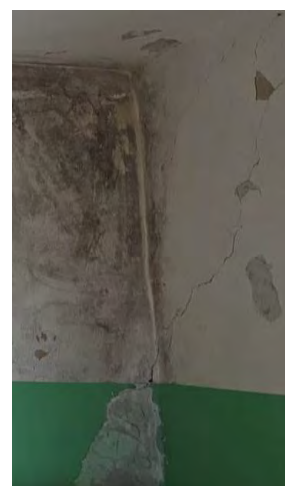
| No. | Element | Yes | No | Location and description |
|---|---|---|---|---|
| 3 | Wall cracks | X | | Visible shear cracks on several walls |

**Figure 9- Shear crack in wall**

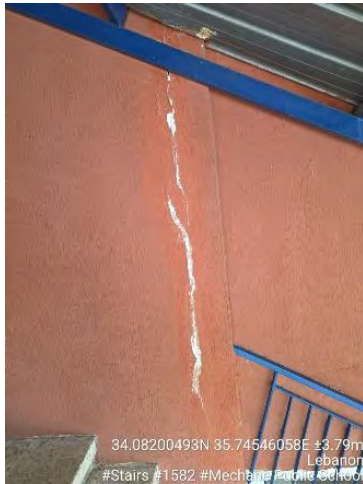
| No. | Element | Yes | No | Location and description |
|---|---|---|---|---|
| 4 | Column cracks | X | | Visible cracks in columns of GF |

**Figure 10- Crack in Columns**

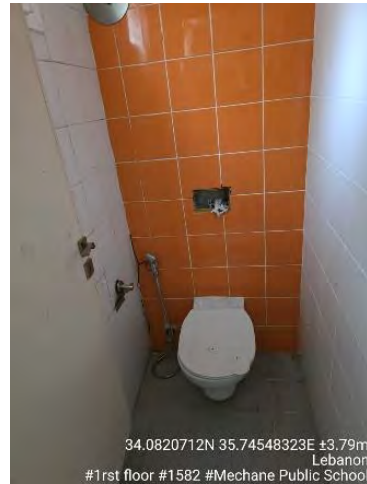
**Figure 11- Damaged Toilet Seat**

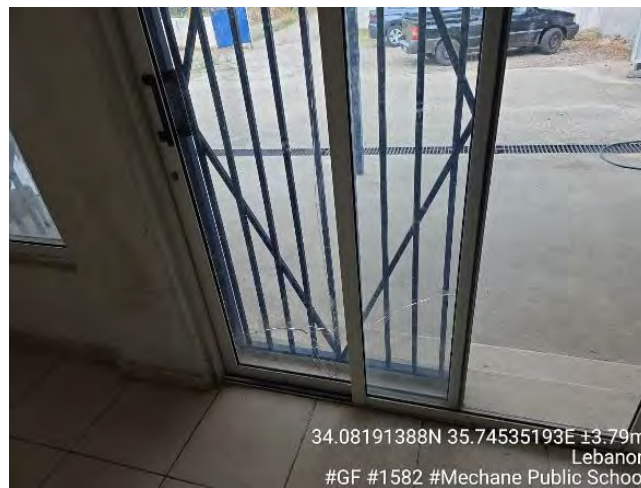
| Trade | Item | Damaged | Location, extent and quantity |
|---|---|---|---|
| Aluminum and glazing | Aluminum glazing | Yes | 90cm x 120cm broken glass |

**Figure 12- Broken Glass**

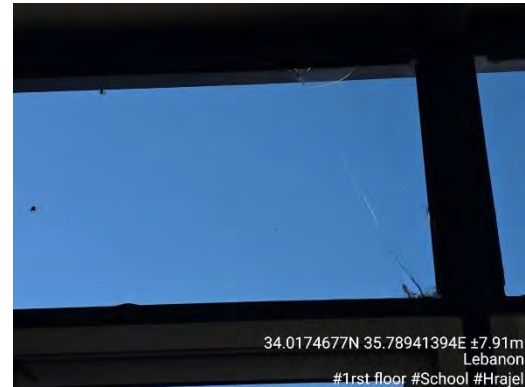
**Figure 7- Broken Glass**

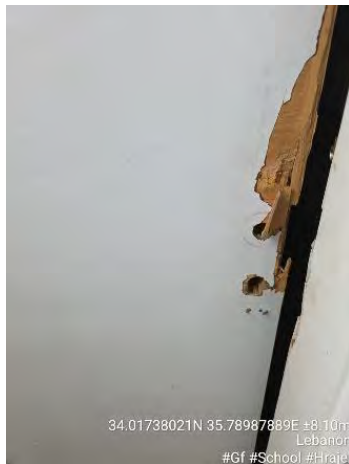
| Trade | Item | Damaged | Location, extent and quantity |
|---|---|---|---|
| Doors | Timber doors | Yes | 40 doors to be repaired |

**Figure 8- Broken door**

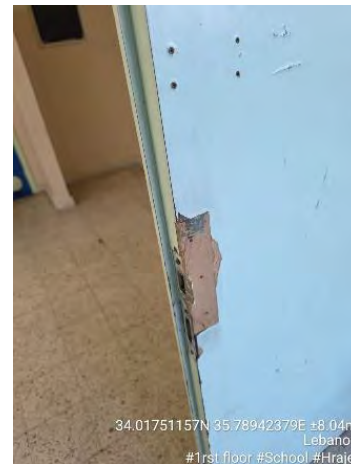
**Figure 9- Broken door**

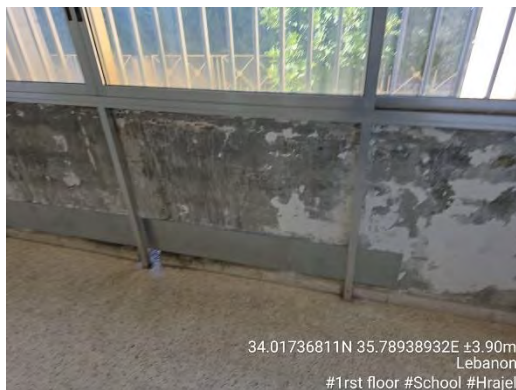
**Figure 10- Wall paint in bad condition**

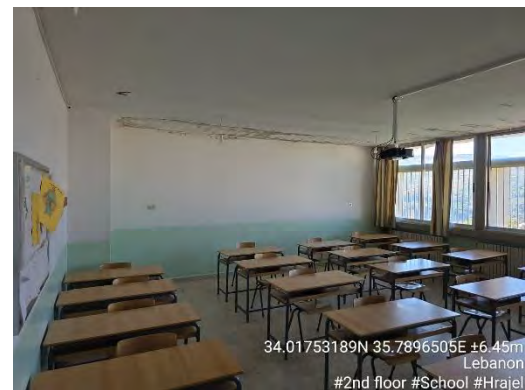
**Figure 11- Classroom's wall paint in bad condition**

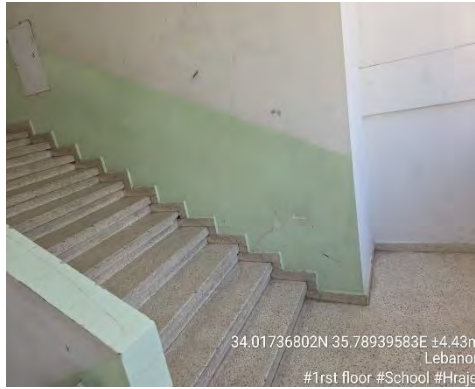
***Figure 12- Cracks in staircase***

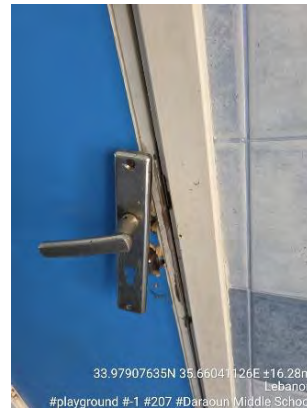
**Figure 8- Broken door handle**

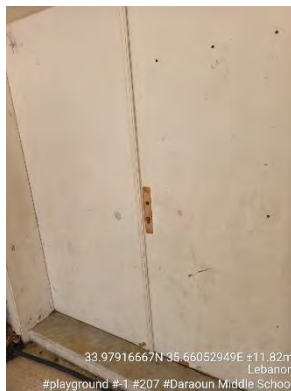
**Figure 9- Missing door accessories**

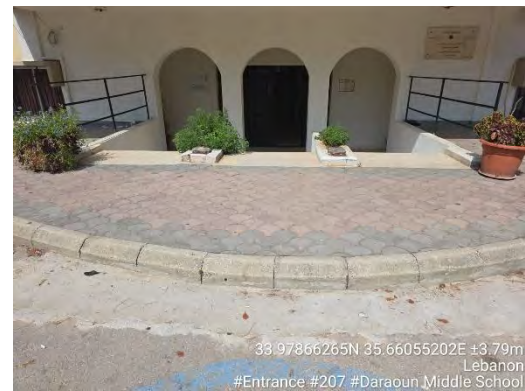
**Figure 10- Handrail need painting**

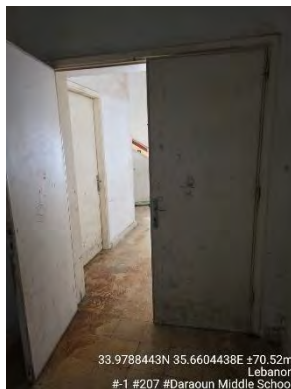
**Figure 11- Broken door**

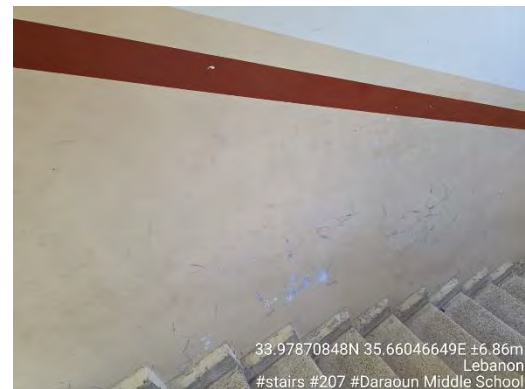
**Figure 12- Cracks in staircase**

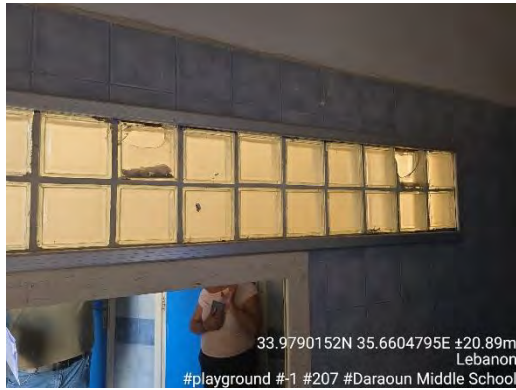
**Figure 13- Broken glass**

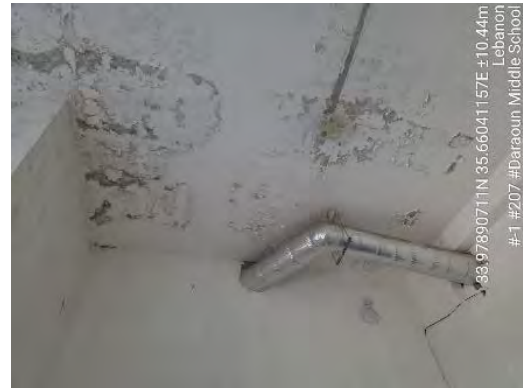
| No. | Element | Yes | No | Location and description |
|---|---|---|---|---|
| 2 | Facade water leak | X | | Due to finishing cracks between columns and masonry |

**Figure 14- Water leakage**

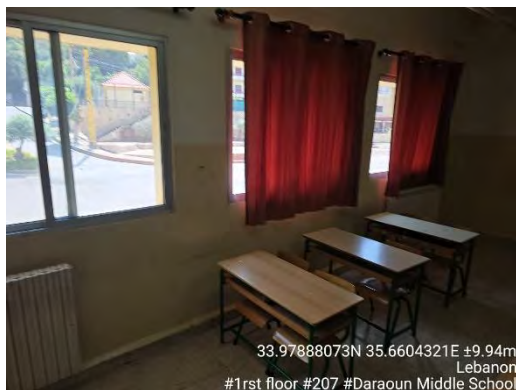
**Figure 15- Crack between beam and wall**

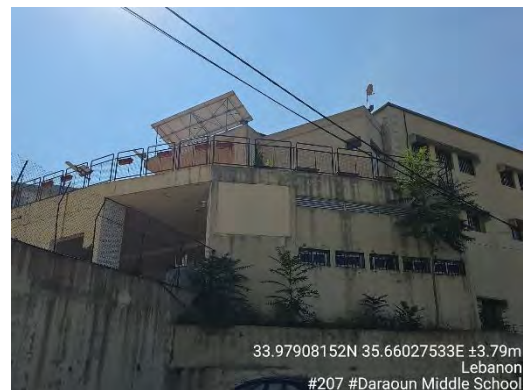
**Figure 16- Humidity from elevation**

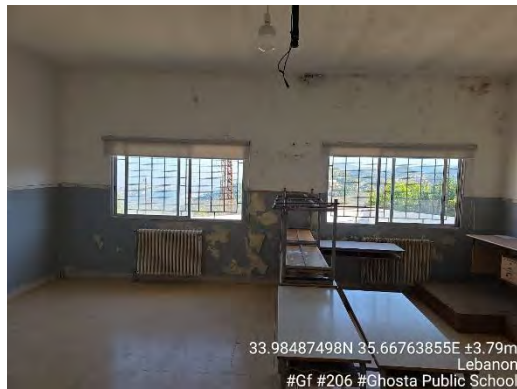
**Figure 5- Ceiling & Walls in bad condition**

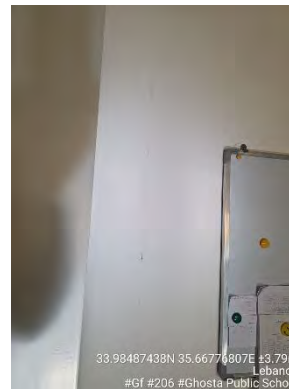
| No. | Element | Yes | No | Location and description |
|---|---|---|---|---|
| 3 | Wall cracks | X | | Finishing cracks between columns and masonry |

**Figure 6- Finishing Crack**

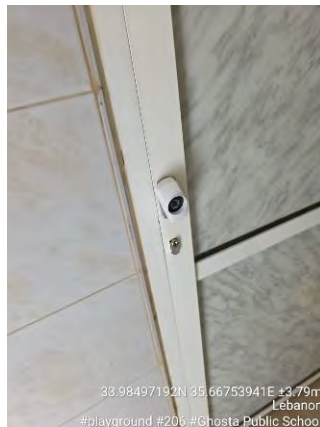
**Figure 7- Damaged Door accessories**

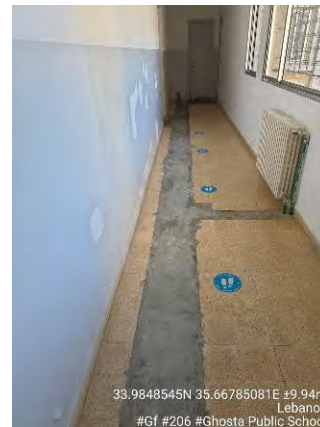
| Trade | Item | Damaged | Location, extent and quantity |
|---|---|---|---|
| | Floor tiles | Yes | 50 m <sup>2</sup> of floor tiles affected due to pipe repairs related to shelter use |

**Figure 8- Damaged Tiles due to pipe replacing  
for shelter use**

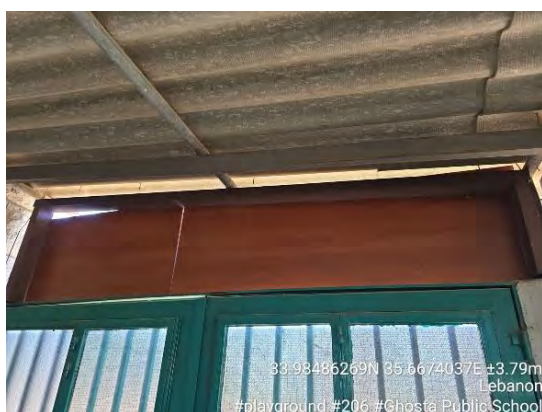
**Figure 9- Broken Glass**

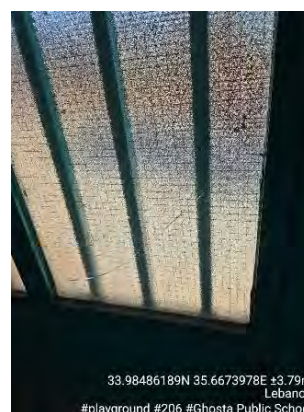
**Figure 10- Broken Glass**

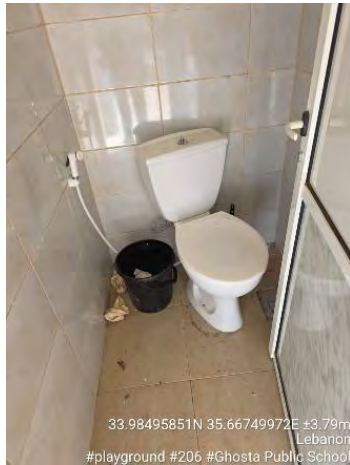
| Trade | Item | Damaged | Location, extent and quantity |
|---|---|---|---|
| | Water closets | Yes | One piece is broken |

**Figure 11- Damaged Toilet Seat**

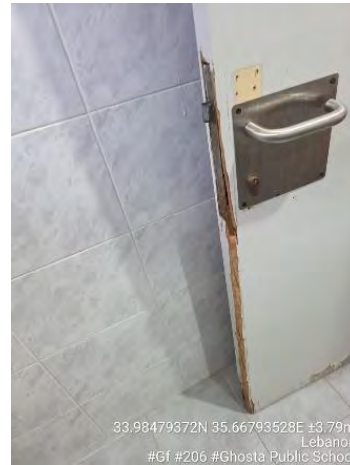
| Trade | Item | Damaged | Location, extent and quantity |
|---|---|---|---|
| Doors | Timber doors | Yes | 15 doors to be repaired |

**Figure 12- Damaged Wooden Door**

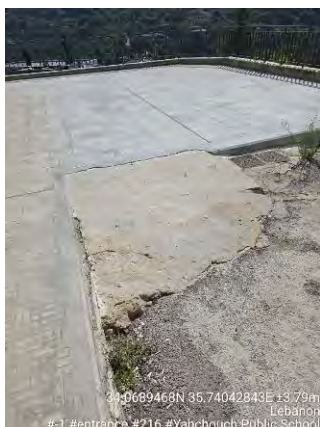
**Figure 7- Ramp in bad condition**

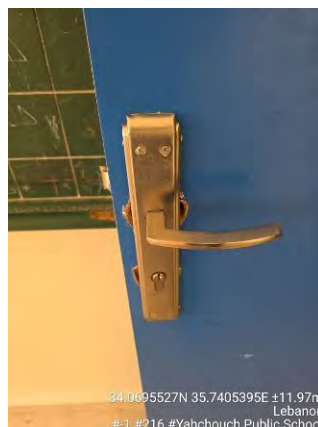
**Figure 8- Damaged door's handle**

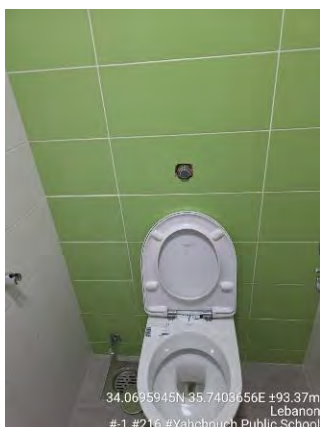
**Figure 9- Damaged Sanitary Accessories**

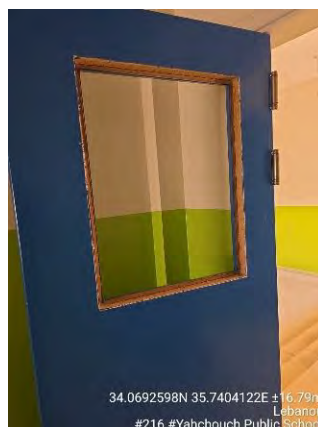
**Figure 10- Broken glass**

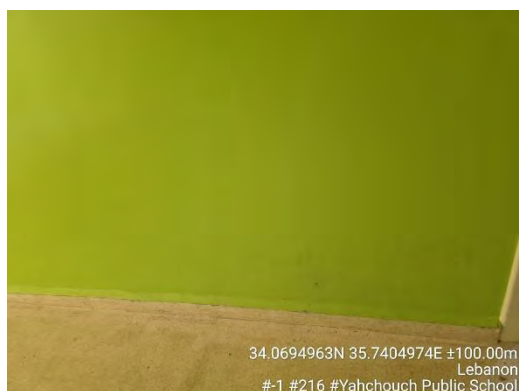
**Figure 11- Walls to be painted**

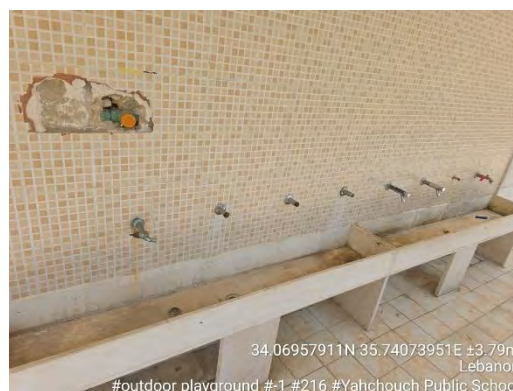
**Figure 12- Broken taps**

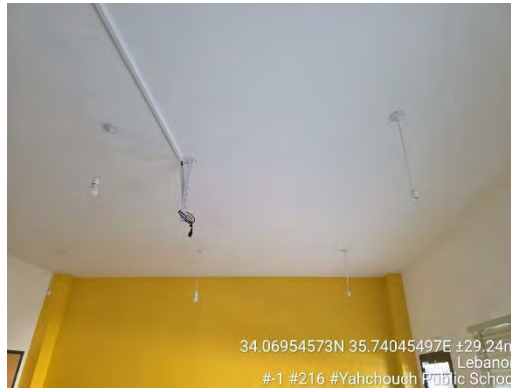
***Figure 13- Missing light bulbs***
