Consultancy Services for  
Tender Preparation and Construction Supervision Consultant for  
Shelters  
Lebanon Emergency Assistance Project (LEAP)

**ASSESSMENT REPORT  
BATCH 2 - LOT 2**

July 2026

**BATCH 2 - LOT 2**  
**TRIPOLI & NORTH LEBANON SCHOOLS**  
**GENERAL INDEX**

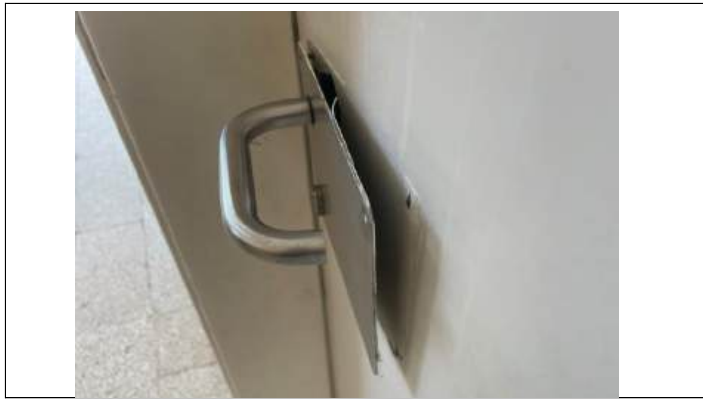
Pic showing the bad condition of handles

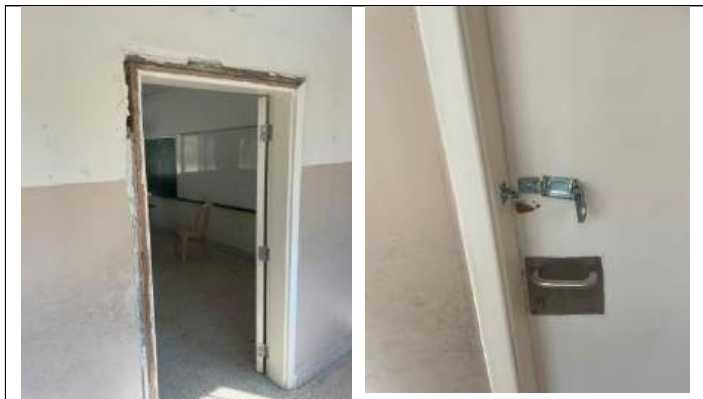
pic showing the bad condition of the locks

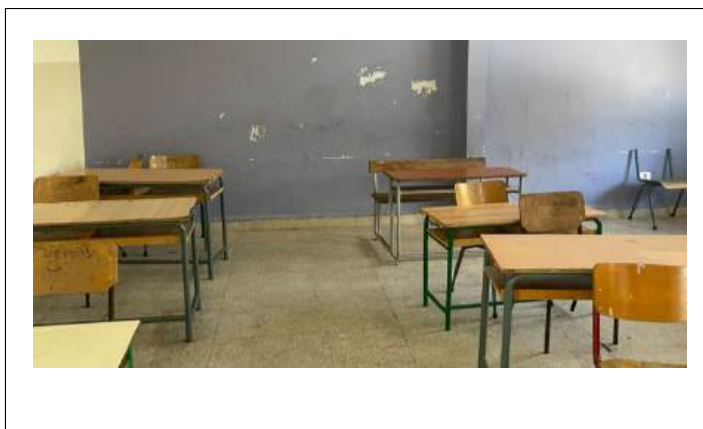
Pic showing the bad condition of wall painting

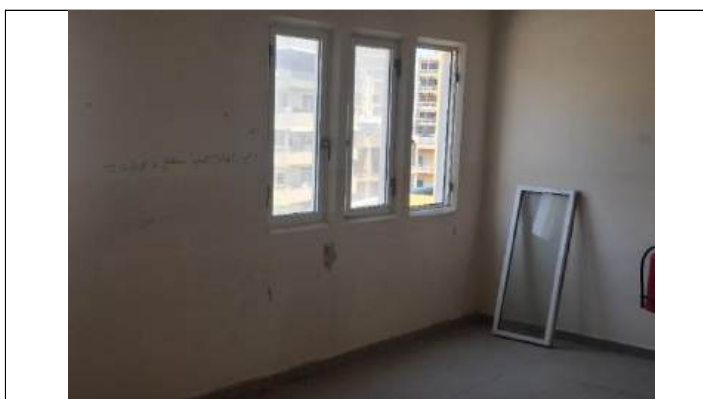
pic showing the Broken  
Aluminum window

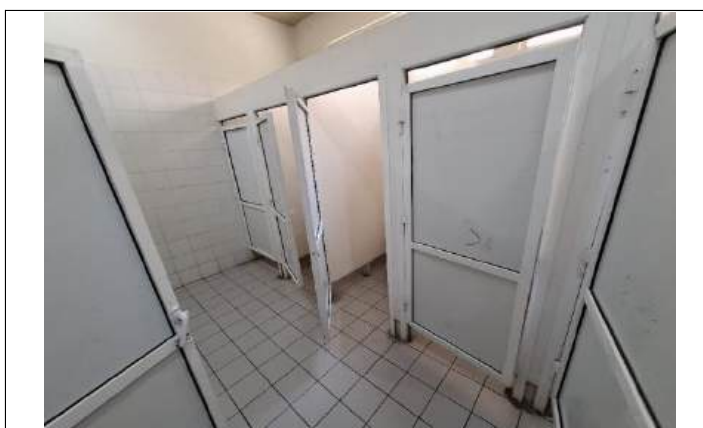
Wc doors partition

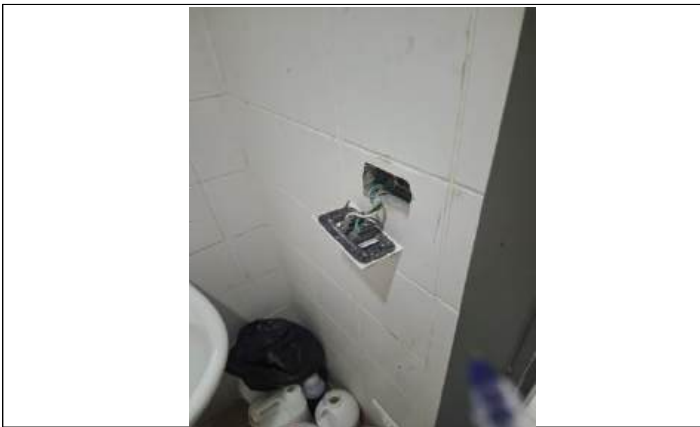
Electrical socket to be repaired

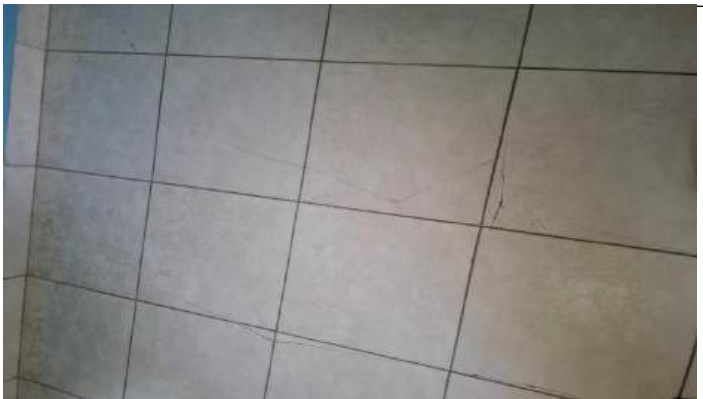
Pic showing the broken tiles at entrance and which need to be replaces

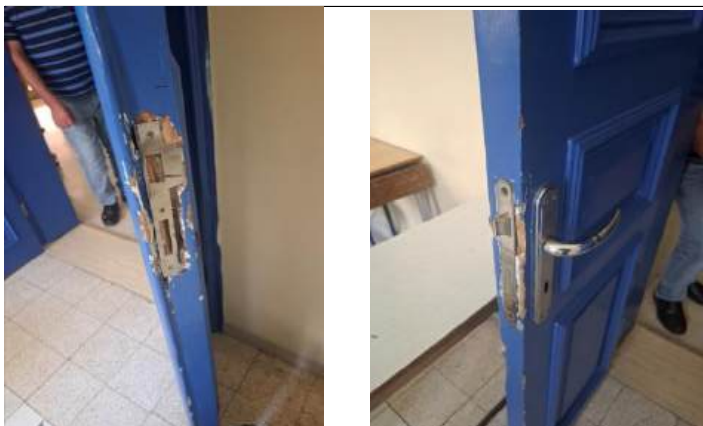
Lever handle and lock to door to be replaced and door to be painted

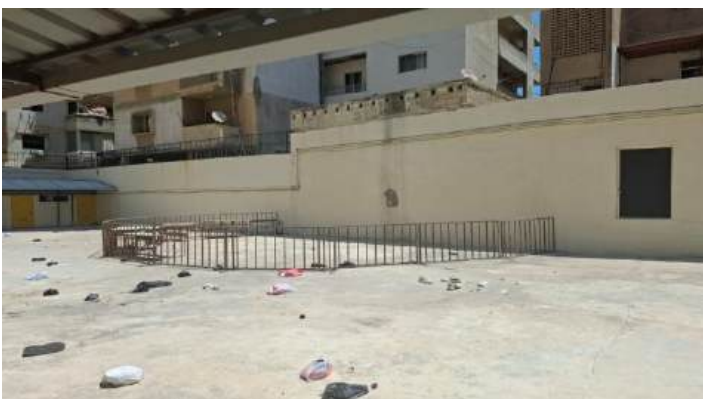
Fence needs to be rehabilitated

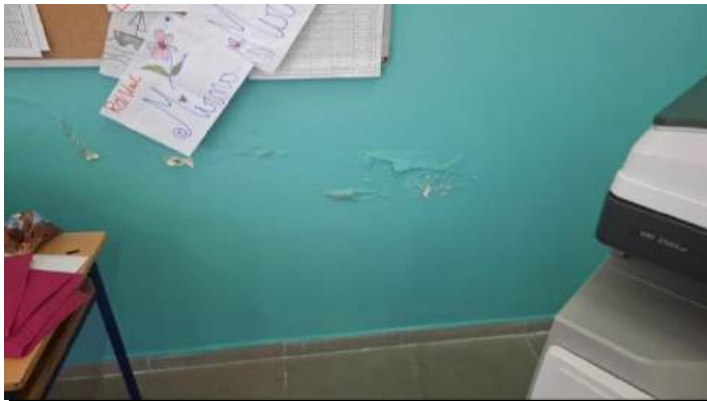
pic showing the humidity inside  
the wall

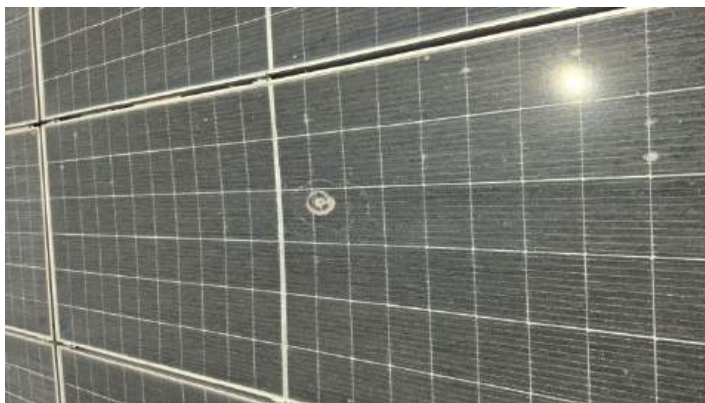
Broken solar panel

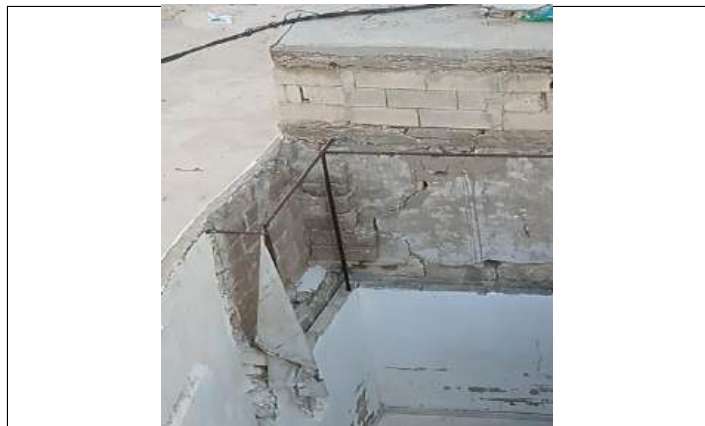
Fence needs to be rehabilitated  
( pic from inside the room)

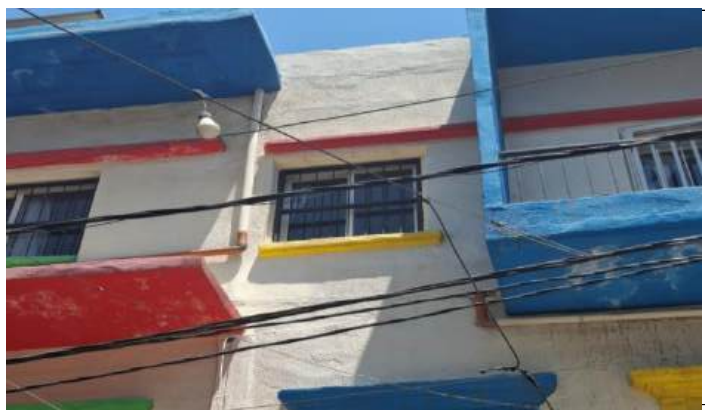
Storm water pipes causing leak  
inside the building

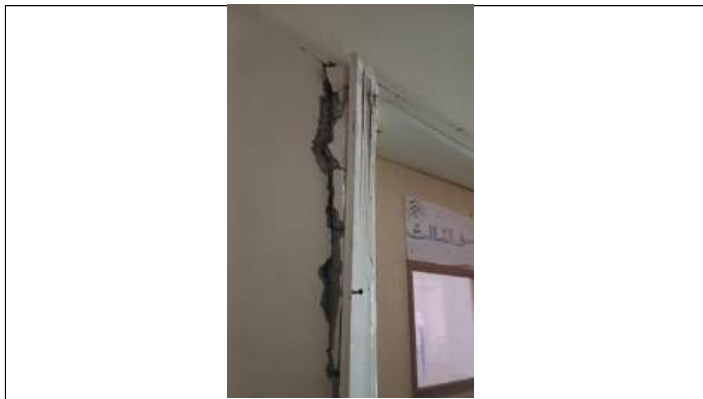
Broken wooden door need to be repaired

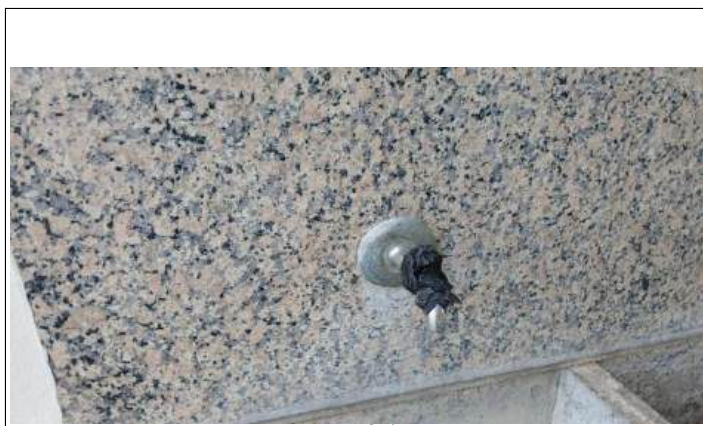
status of the washing basin

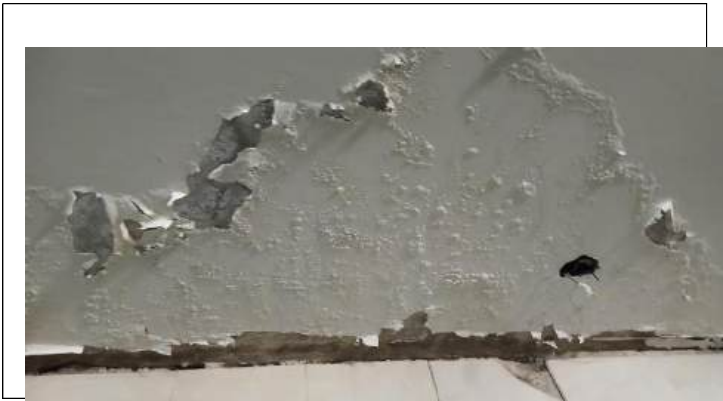
Humidity and water leak from  
elevations shown inside the  
building

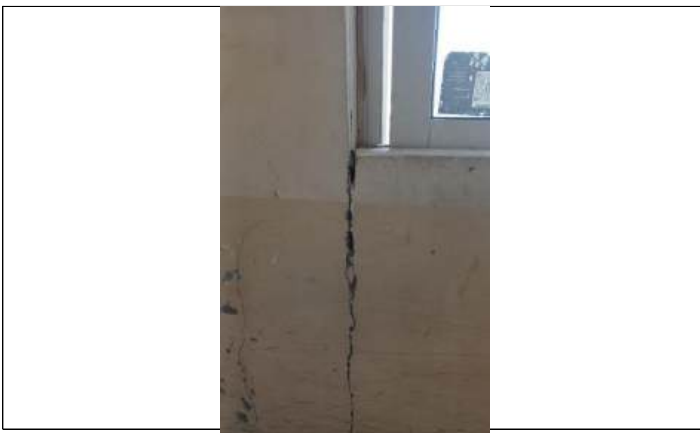
crackst to be repaired

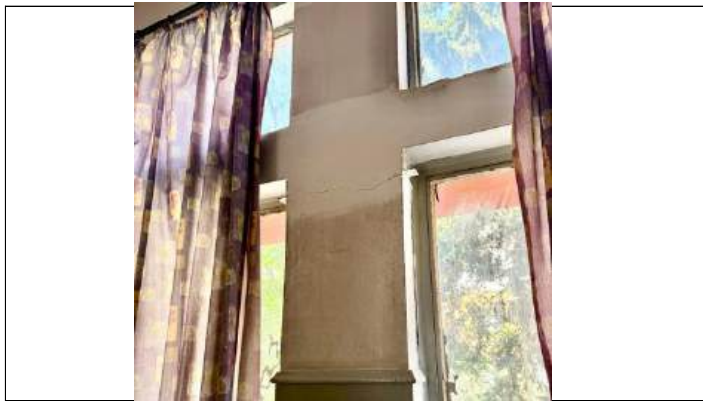
Pic showing crack in the column

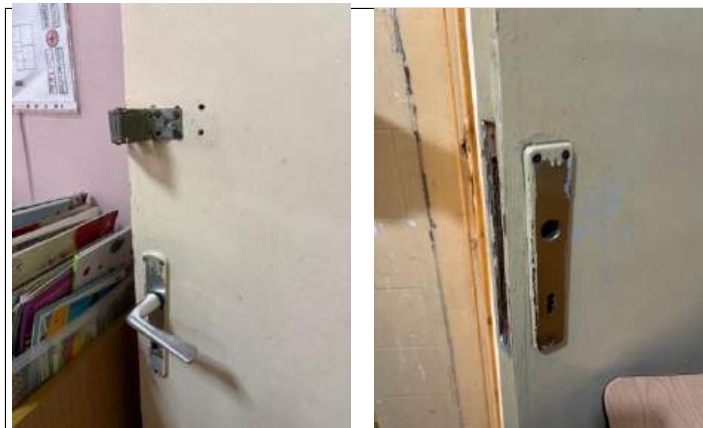
Lever handle and lock to door to be replaced and door to be painted

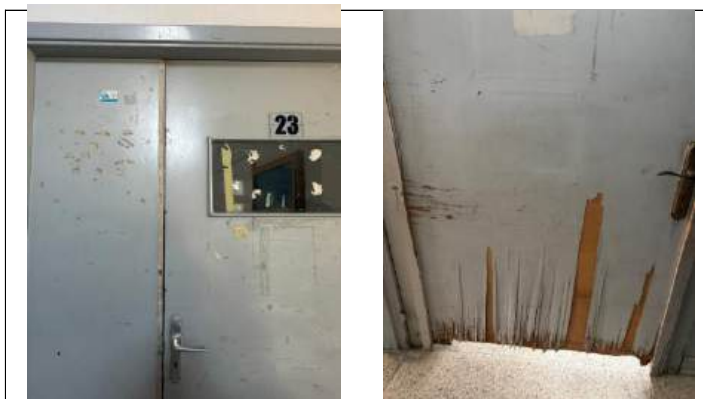
damage in doors needs t be fixed

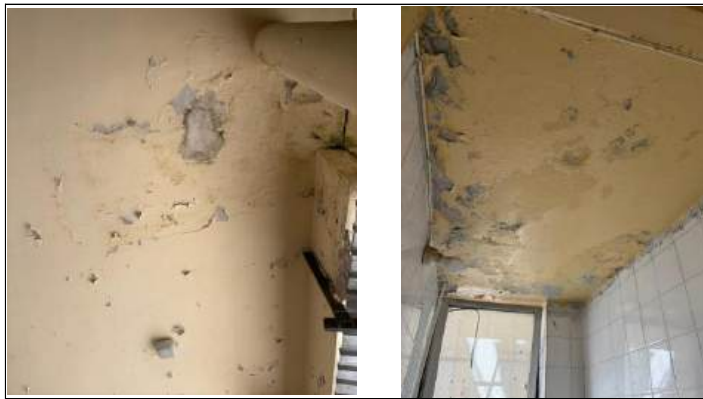
pic showing the humidity in the ceiling

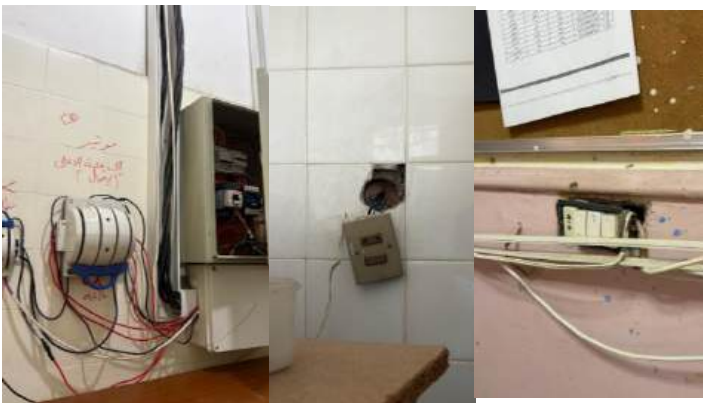
exposed electrical works

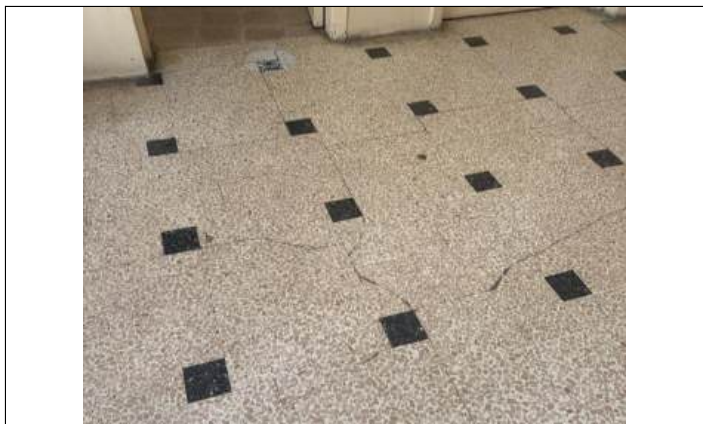
pic showing crack in the ground

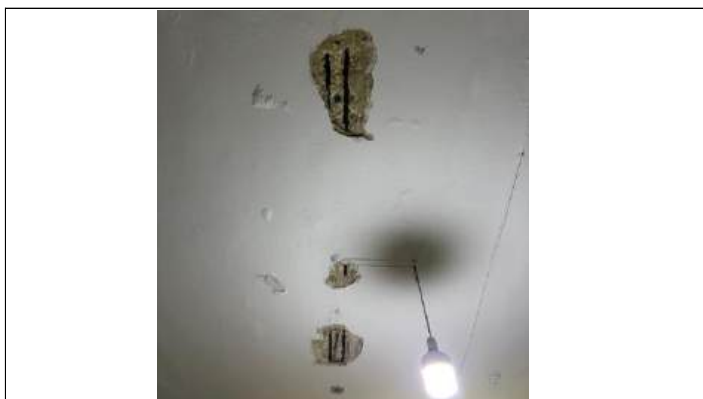
damage in the ceiling

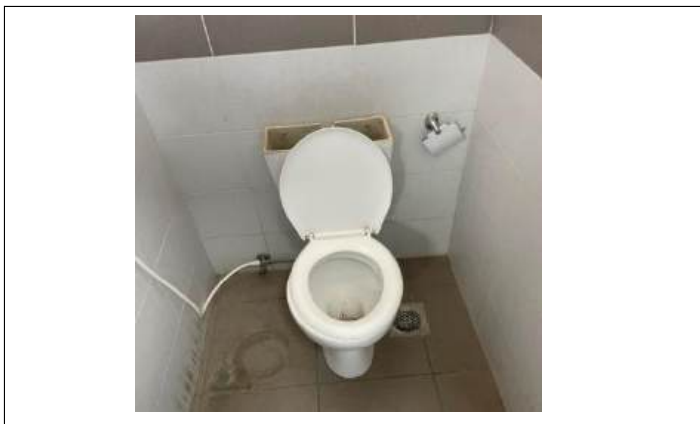
pic showing damage in the toilet

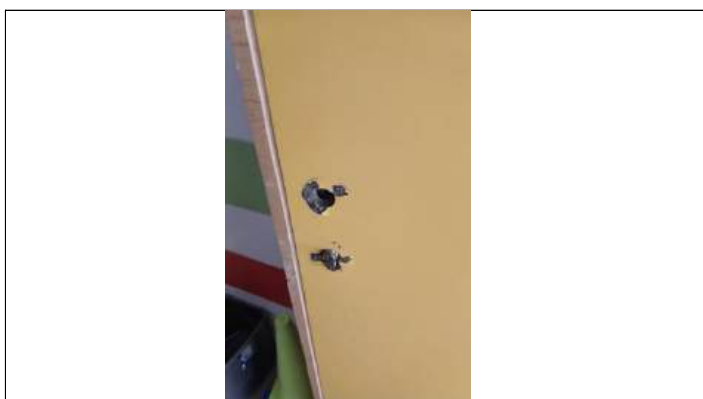
Broken wooden door need to be repaired

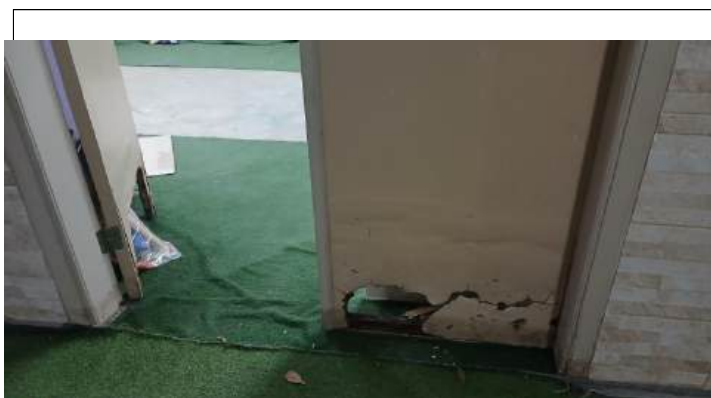
Broken wooden door need to be repaired

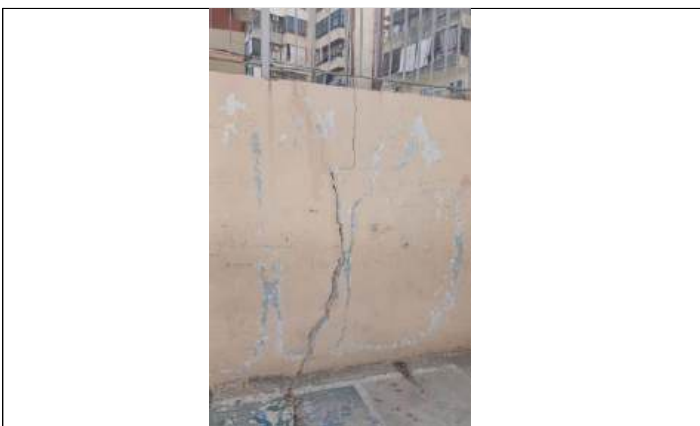
crackst to be repaired

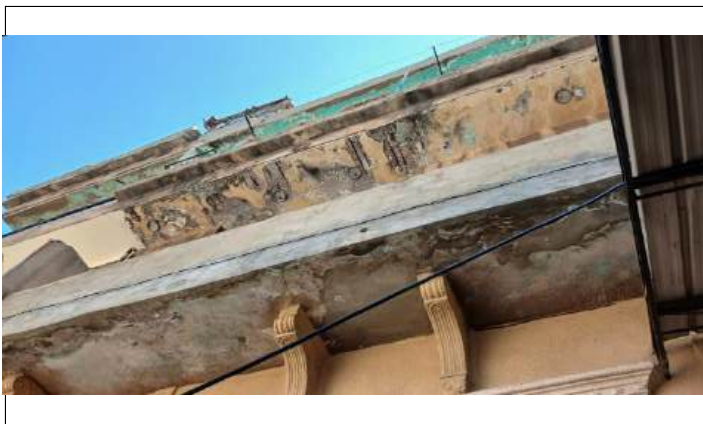
Broken concret need to be repaired

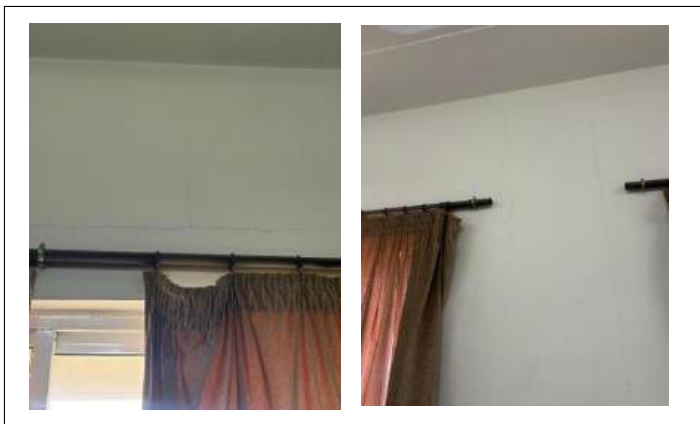
pic showing crack in the walls

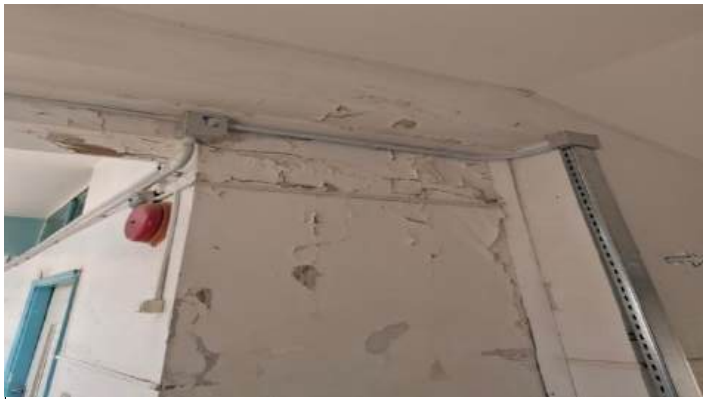
Water leak thru ceiling and walls

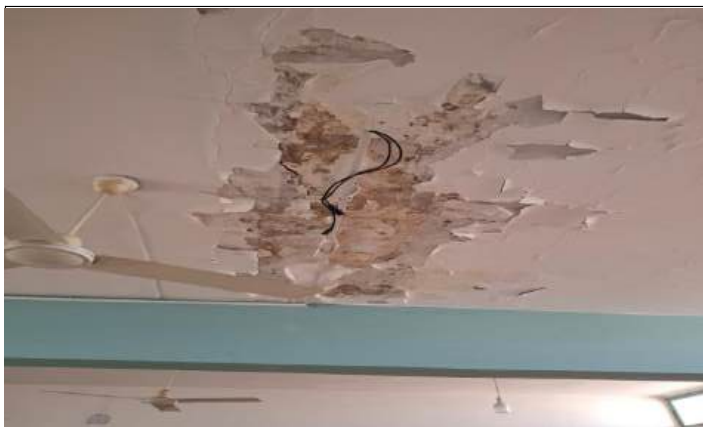
Water leak thru ceiling

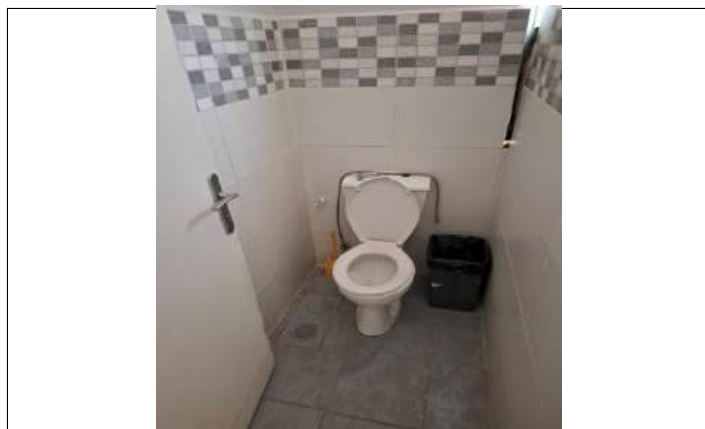
pic showing a wc not working and required to be replaced

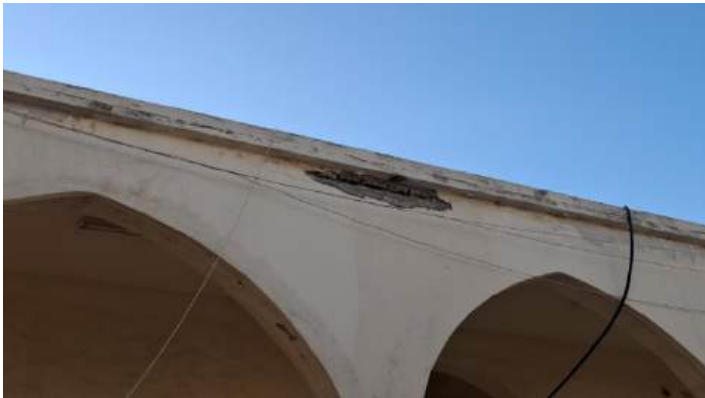
crack and rusted steel which  
required special method to rehab

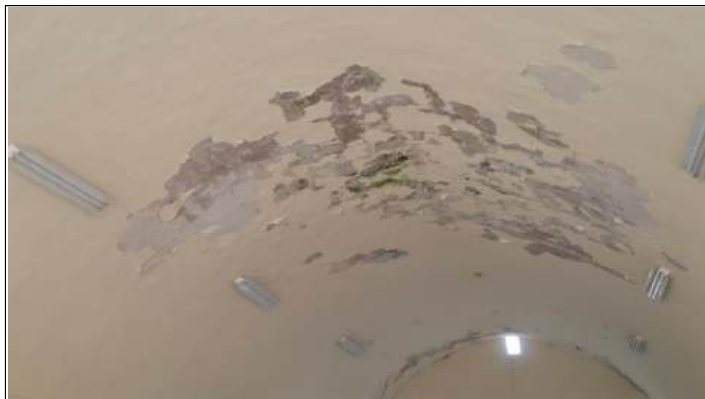
Water leak thru ceiling and walls

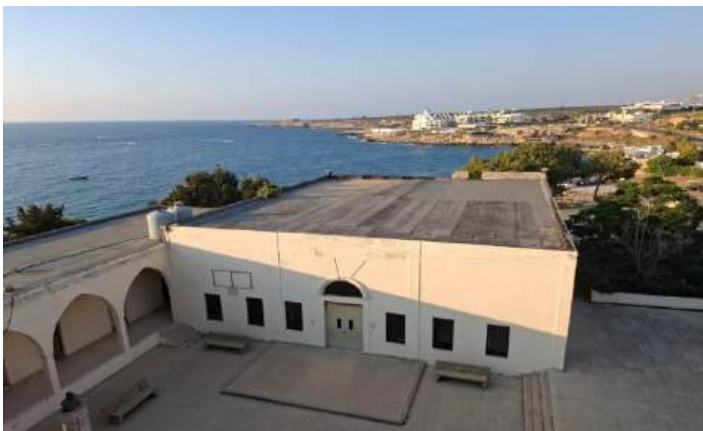
Picture showing the water proofing membrane

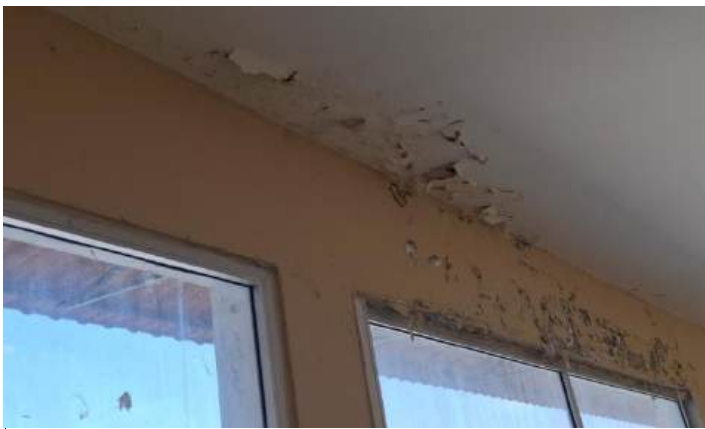
Water leak thru ceiling and  
elevation

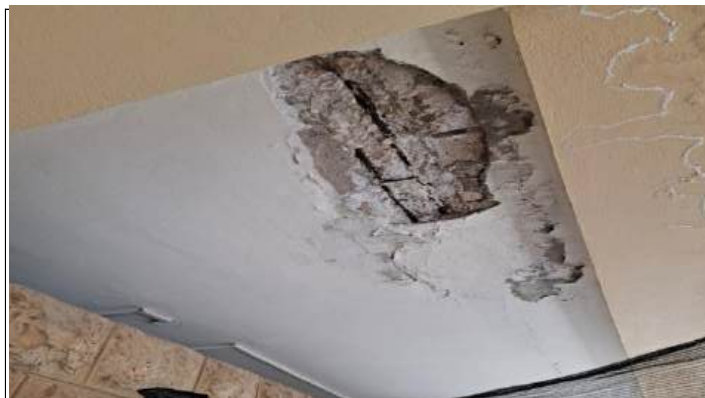
the bad condition of the structure  
of the slab due to humidity and  
water leak, and which required  
maintenance

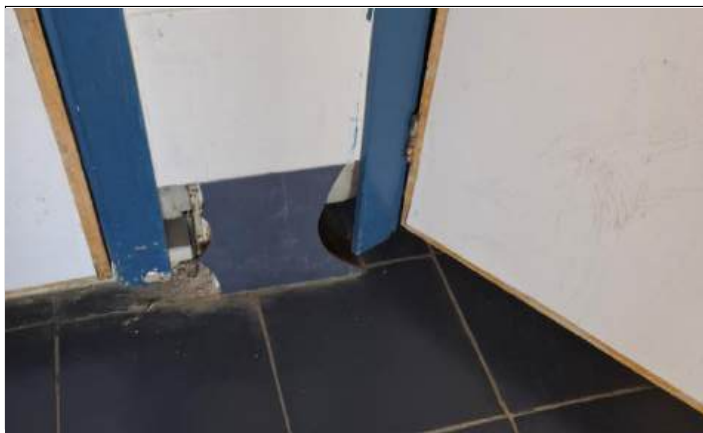
this pic shows the broken tiles inside the wc and which need to be repaired

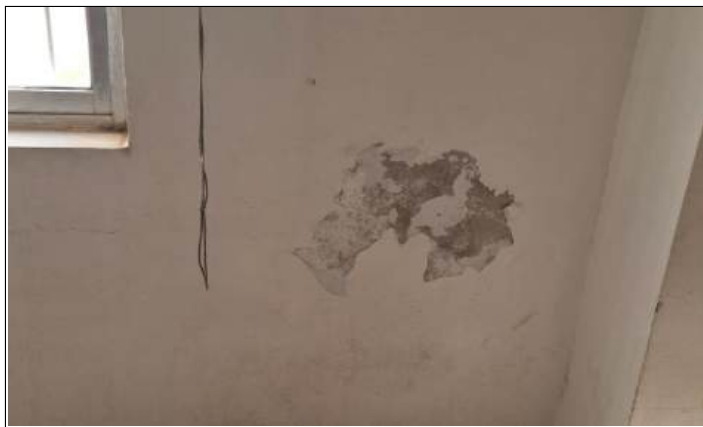
Water leak thru elevation

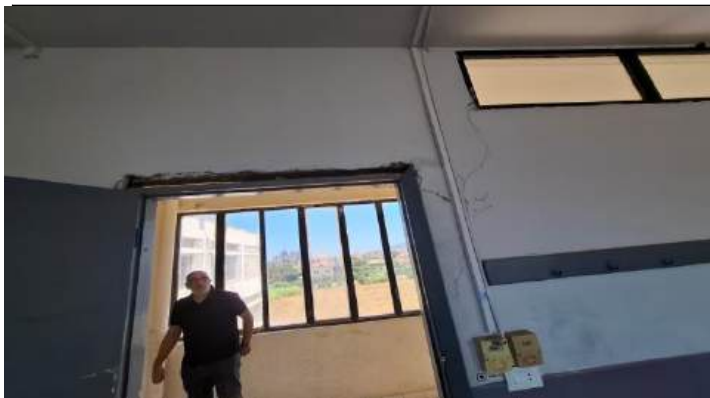
picture showing the bad condition of the wooden door, wall cracks can be also notified

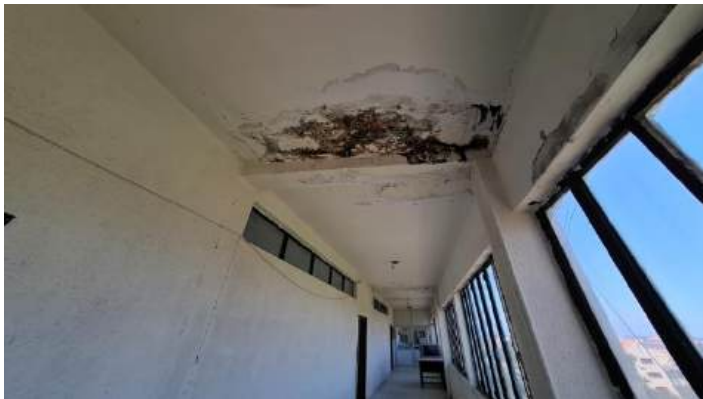
Water leak thru ceiling and elevation

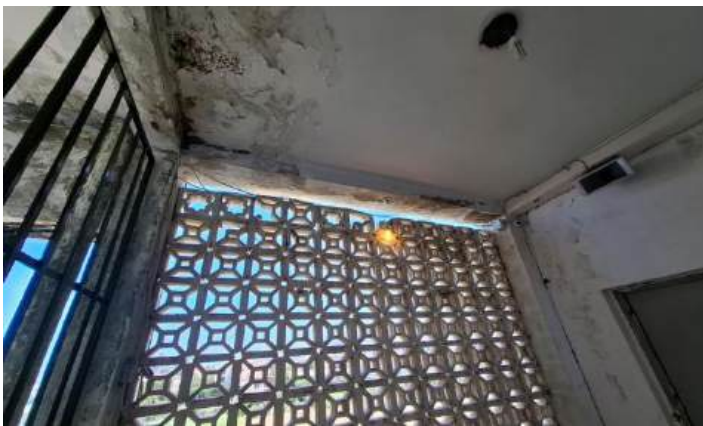
Water leak thru ceiling and elevation

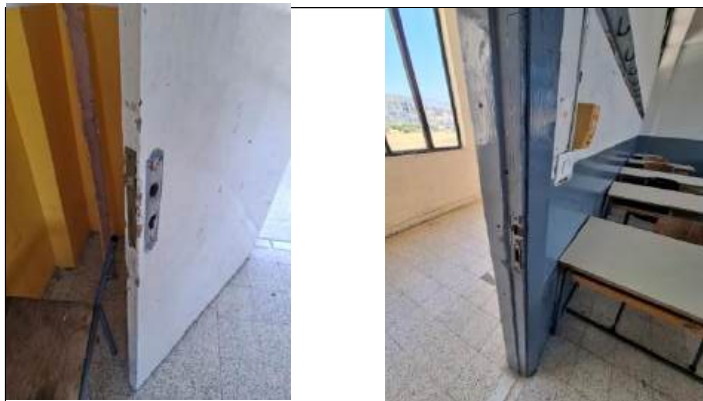
Pic showing the ironmongery of the wooden door

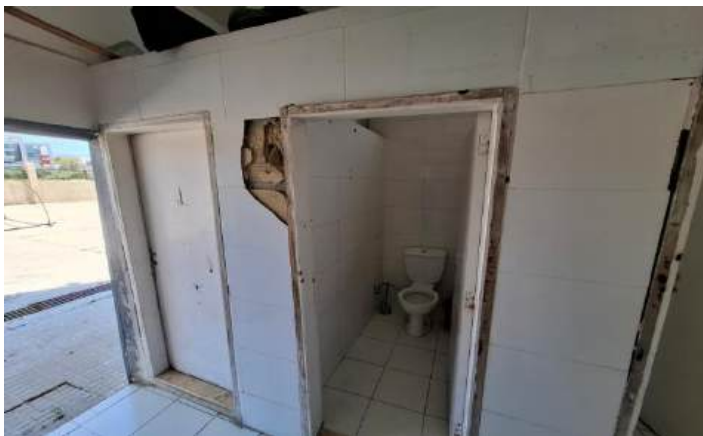
Broken tiles and broken door inside the WC

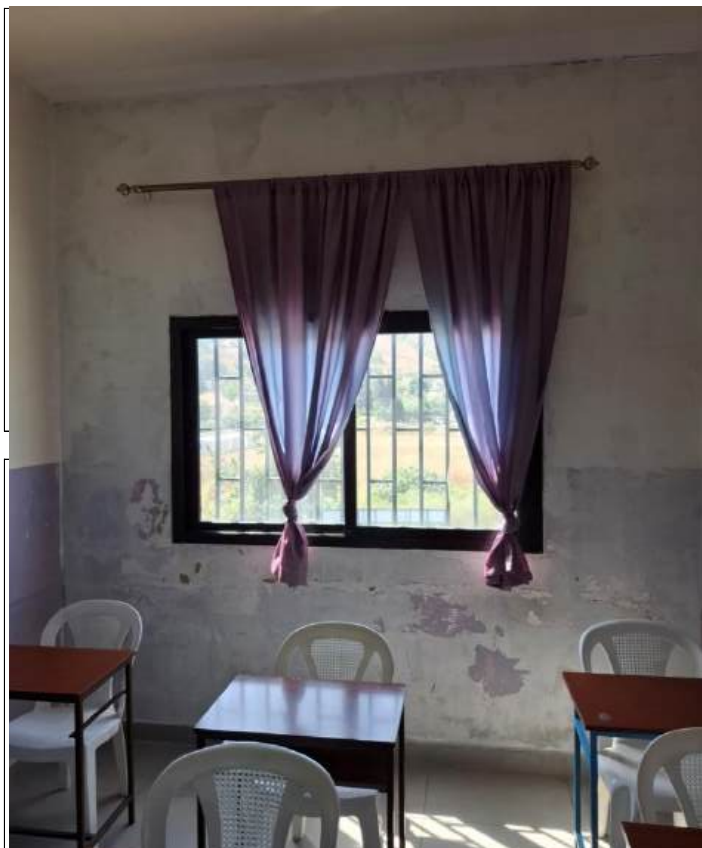
Water leak thru elevation

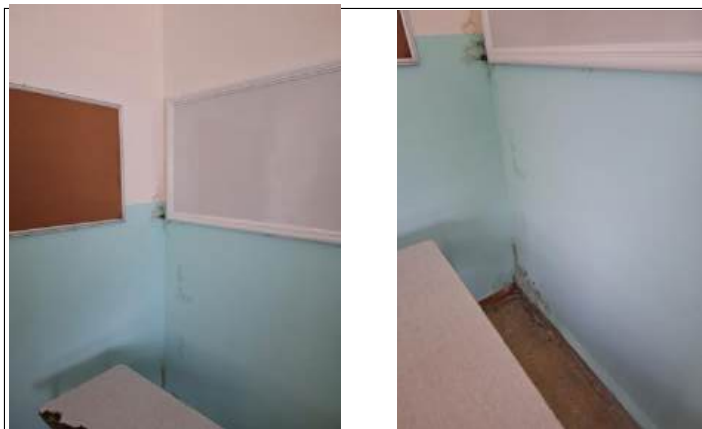
Picture showing the drainage leak from the wc located above this room

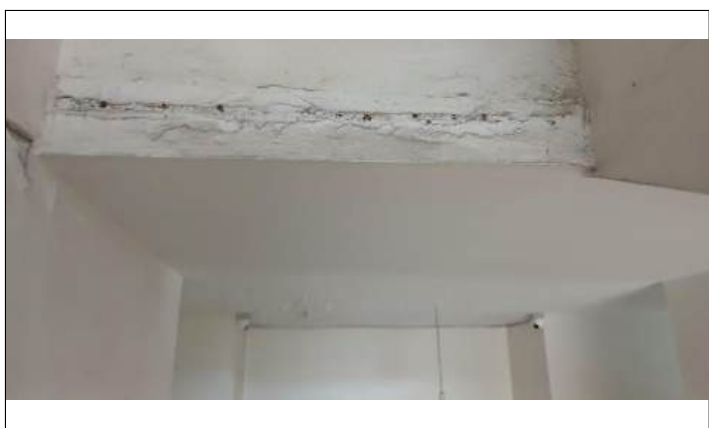
Humidity and water leak

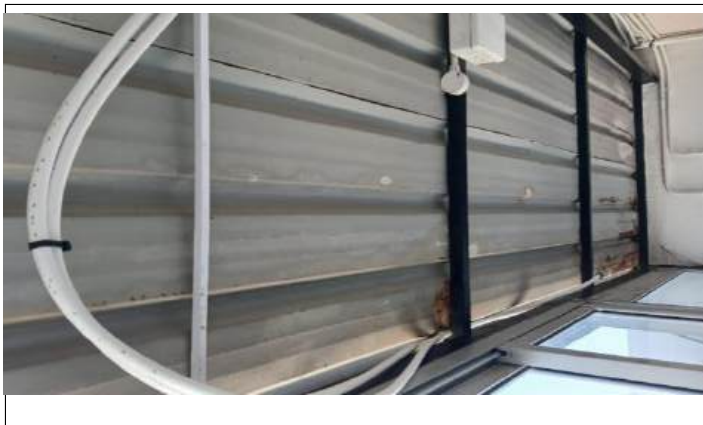
Humidity and water leak from  
roof

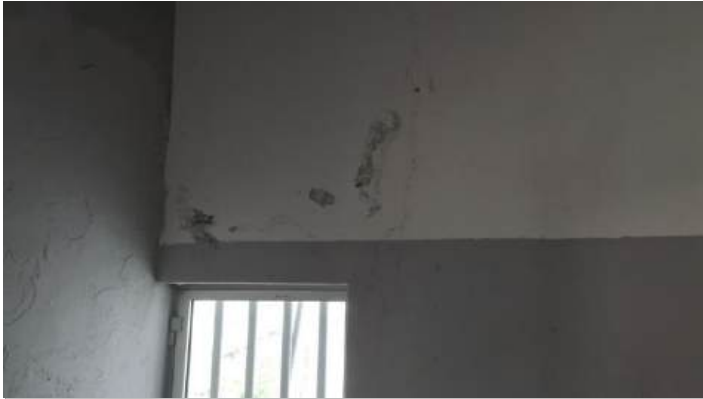
water leak thru elevation walls

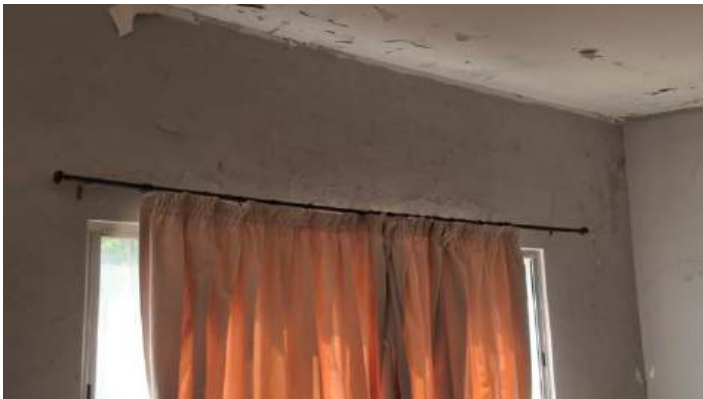
water leak thru elevation walls

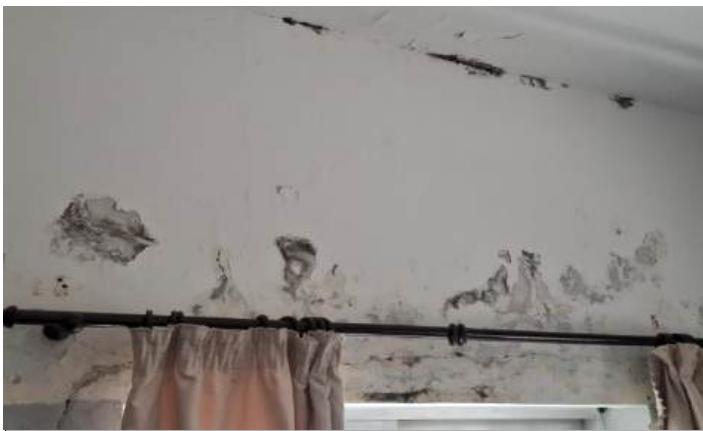
water leak thru elevation walls

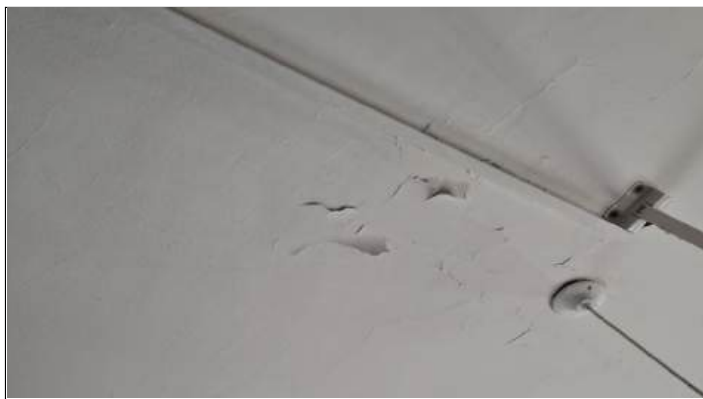
Pic showing the humidity and the  
water leak thru slab

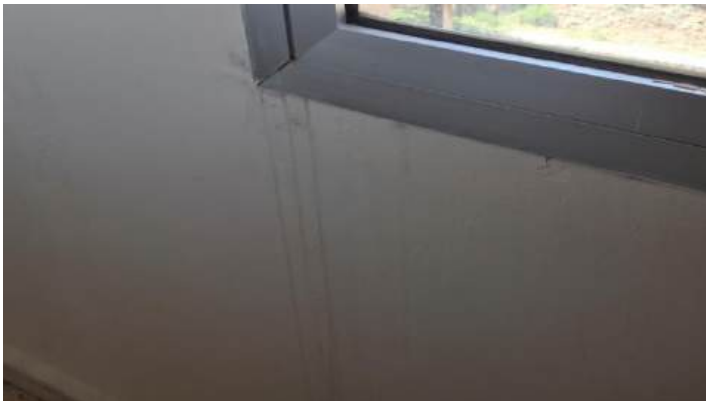
Water leak from aluminum  
window

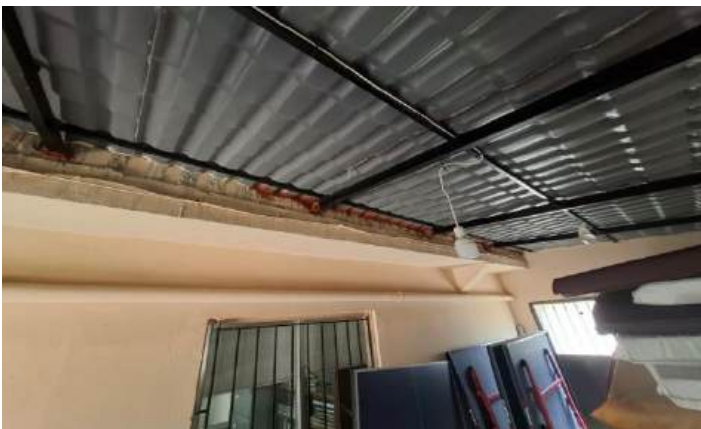
Water leak thru TOT

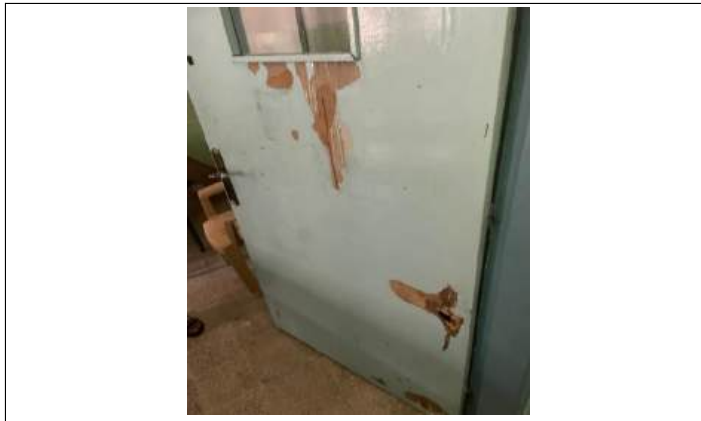
Lever handle and lock to door to be replaced and door to be rehabilitated

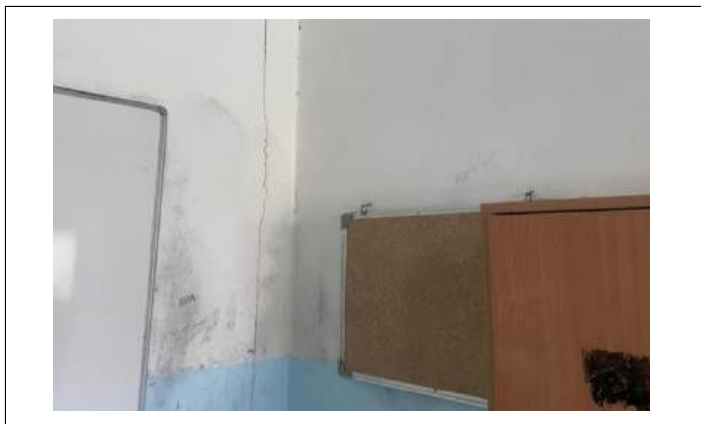
Crack in column
