**Lebanese Emergency Assistant Project (LEAP)**  
**Rehabilitation of Shelters (Public Schools)**

**Batch 3: Lot 4**

**DETAILED ASSESSMENT REPORT**

**Detailed Site Assessment and Verification Report**

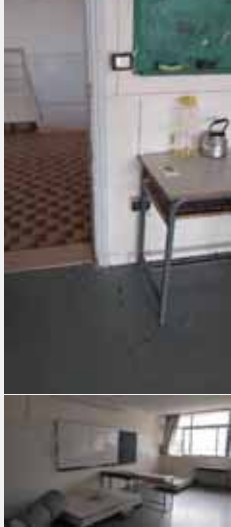
| Finishing | | | | | | |
|---|---|---|---|---|---|---|
| 3d | 6 | Paint | 85 | m2 | 9.5.1 | |

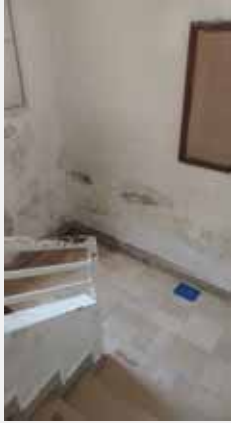
| Floor | Room / Area | Defect Description / Required Works | Qty | Unit | BOQ | Photo |
|---|---|---|---|---|---|---|
| Stairs | | Repaint | 180 | m2 | 9.5.1 | |

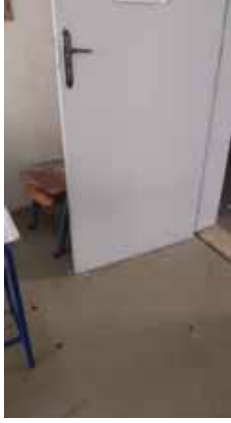
| Floor | Room / Area | Defect Description / Required Works | Qty | Unit | BOQ | Photo |
|---|---|---|---|---|---|---|
| 1st | 4 | Paint | 85 | m2 | 9.5.1 | |

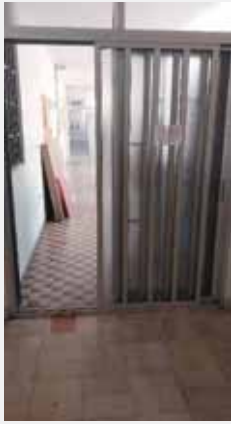
| Floor | Room / Area | Defect Description / Required Works | Qty | Unit | BOQ | Photo |
|---|---|---|---|---|---|---|
| 2d | Corridor | Aluminum door Repair | 1 | pc | 8.2.3 | |

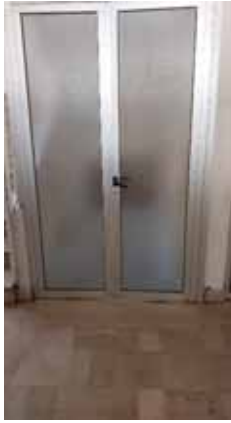
| Floor | Room / Area | Defect Description / Required Works | Qty | Unit | BOQ | Photo |
|---|---|---|---|---|---|---|
| 2d | Entrance | Aluminum door replace lock | 1 | pc | 8.2.3 | |

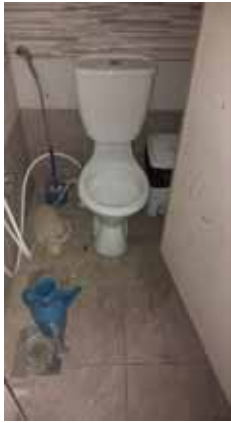
| Floor | Room / Area | Defect Description / Required Works | Qty | Unit | BOQ | Photo |
|---|---|---|---|---|---|---|
| 1st | Toilets | Supply & install new WCs seat covers | 3 | pcs | 1.2.1 | |

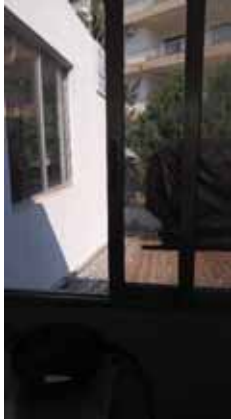
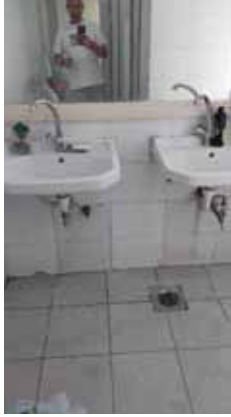
| Floor | Room / Area | Defect Description / Required Works | Qty | Unit | BOQ | Photo |
|---|---|---|---|---|---|---|
| 3d | toilet | Supply & install new WCs seat covers | 1 | pc | 1.2.1 | |

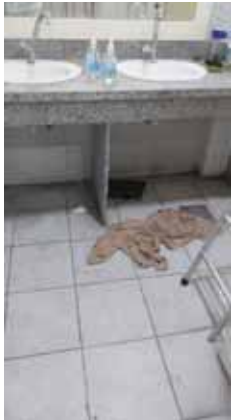
| Floor | Room / Area | Defect Description / Required Works | Qty | Unit | BOQ | Photo |
|---|---|---|---|---|---|---|
| 2d | toilet | Replace all faucets | 2 | pcs | 5.6 | |

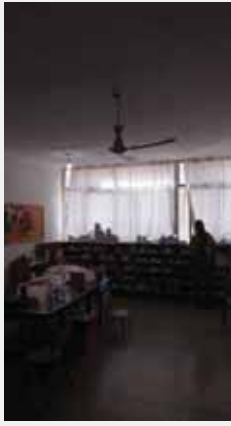
| Floor | Room / Area | Defect Description / Required Works | Qty | Unit | BOQ | Photo |
|---|---|---|---|---|---|---|
| 1st | 2 | Repair fan | 1 | pc | 1.2.2 | |

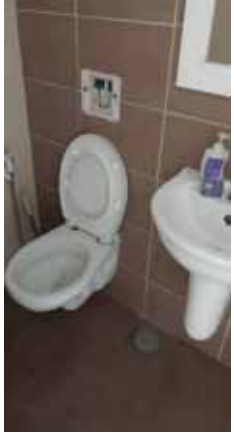
| Floor | Room / Area | Defect Description / Required Works | Qty | Unit | BOQ | Photo |
|---|---|---|---|---|---|---|
| All floors | Toilets | Defected non working toilet flush | 9 | pcs | 1.2.1 | |

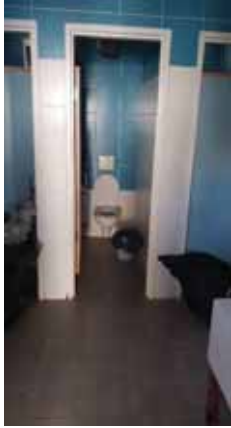
| Floor | Room / Area | Defect Description / Required Works | Qty | Unit | BOQ | Photo |
|---|---|---|---|---|---|---|
| 1st & 2nd | Toilets | Severe water leakage | 2 | pcs | 7.2 | |

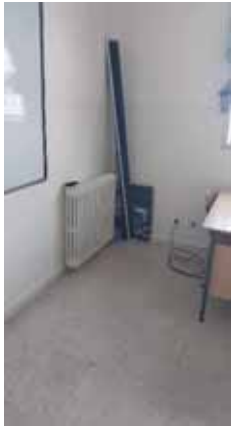
| Floor | Room / Area | Defect Description / Required Works | Qty | Unit | BOQ | Photo |
|---|---|---|---|---|---|---|
| 1st | | Broken screen to be replaced | 1 | pc | 10.2.2 | |

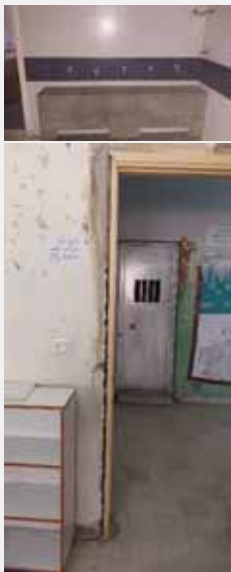
| Finishing | | | | | | |
|---|---|---|---|---|---|---|
| 1st | 1 | Paint | 70 | m2 | 9.5.1 | |

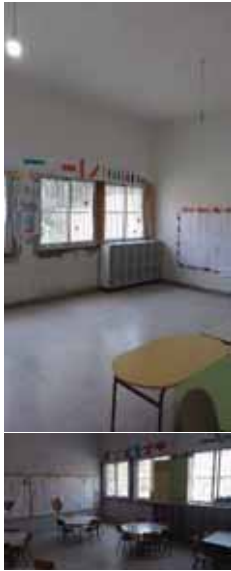
| Finishing | | | | | | |
|---|---|---|---|---|---|---|
| 1st | 2 | Paint | 70 | m2 | 9.5.1 | |

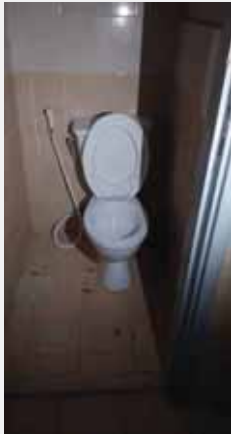
| Floor | Room / Area | Defect Description / Required Works | Qty | Unit | BOQ | Photo |
|---|---|---|---|---|---|---|
| 3d | Toilet | Repair WCs | 2 | pcs | 5.1 | |

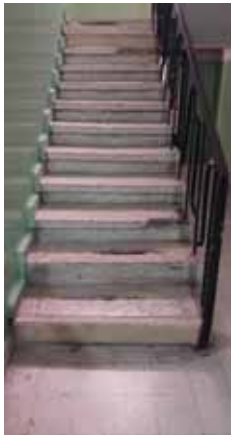
| Floor | Room / Area | Defect Description / Required Works | Qty | Unit | BOQ | Photo |
|---|---|---|---|---|---|---|
| 1st | Stairs | Repair/Replace mosaic stairs | 5 | pcs | 9.2.5 | |

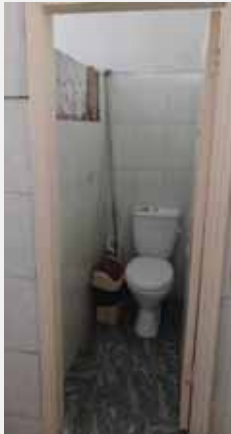
| Floor | Room / Area | Defect Description / Required Works | Qty | Unit | BOQ | Photo |
|---|---|---|---|---|---|---|
| 2nd | Toilets | Replace ceramic tiles | 5 | pcs | 9.2.4 | |

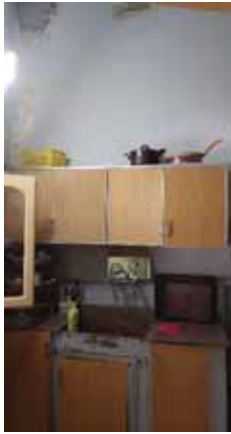
| Floor | Room / Area | Defect Description / Required Works | Qty | Unit | BOQ | Photo |
|---|---|---|---|---|---|---|
| 2nd | Kitchen | Replace cupboards leaves | 7 | pcs | 6.1.1 | |

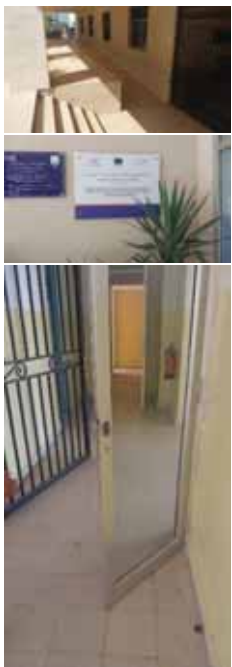
| Aluminum | | | | | | |
|---|---|---|---|---|---|---|
| 1st | 1 | Replace handles for x3 aluminum doors | 3 | pcs | 8.2.3 | |

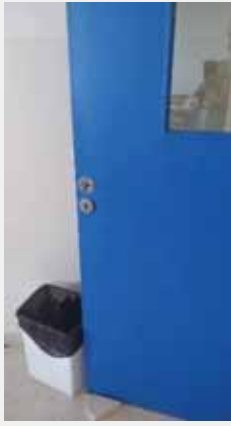
| Floor | Room / Area | Defect Description / Required Works | Qty | Unit | BOQ | Photo |
|---|---|---|---|---|---|---|
| 2nd | 2-8- | Replace door handles | 2 | for 2 doors | 8.1.3 | |

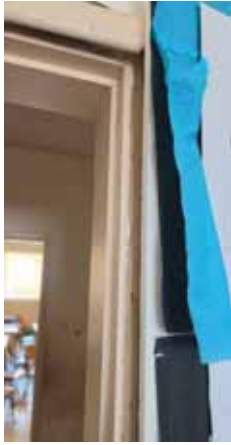
| Floor | Room / Area | Defect Description / Required Works | Qty | Unit | BOQ | Photo |
|---|---|---|---|---|---|---|
| 1st | 05/06/2026 | Fix Door Frames | 8 | pcs | <b>8.1.3</b> | |

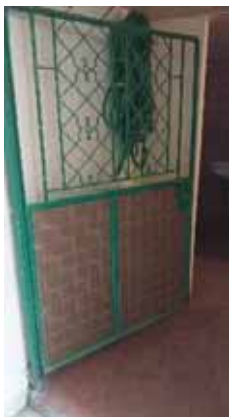
| Floor | Room / Area | Defect Description / Required Works | Qty | Unit | BOQ | Photo |
|---|---|---|---|---|---|---|
| 1st | Toilets | Installation of glass for the bathroom metal door | 1 | pcs | 5.2 | |

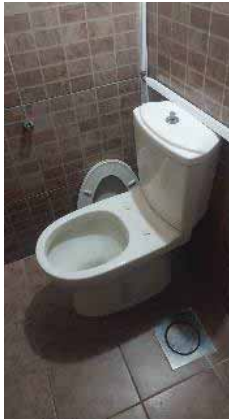
| Floor | Room / Area | Defect Description / Required Works | Qty | Unit | BOQ | Photo |
|---|---|---|---|---|---|---|
| 1st | Toilets | new handheld bidet sprayer | 1 | pcs | 1.2.1 | |

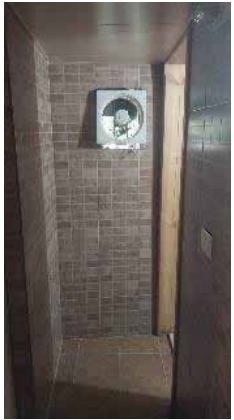
| Floor | Room / Area | Defect Description / Required Works | Qty | Unit | BOQ | Photo |
|---|---|---|---|---|---|---|
| 1st | Toilets | Replace Aspirator | 1 | pcs | 1.2.2 | |

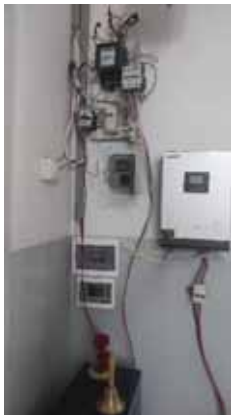
| Floor | Room / Area | Defect Description / Required Works | Qty | Unit | BOQ | Photo |
|---|---|---|---|---|---|---|
| 1st | Entrance | Repair and organization of electrical installations | 1 | unit | 1.1.2 | |

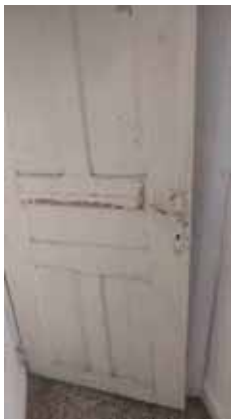
| Floor | Room / Area | Defect Description / Required Works | Qty | Unit | BOQ | Photo |
|---|---|---|---|---|---|---|
| 1st | 1-3-5- | Repair wooden door | 6 | pcs | 8.1.3 | |

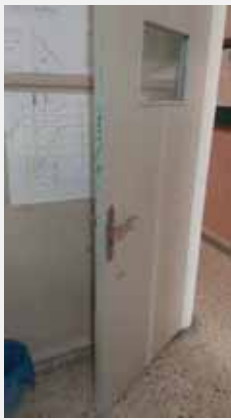
| Floor | Room / Area | Defect Description / Required Works | Qty | Unit | BOQ | Photo |
|---|---|---|---|---|---|---|
| 1st | 1-3-5- | Paint wooden door<br>(x3 of them are mentioned above to be repaired as well) | 80 | m2 | 8.1.3 | |

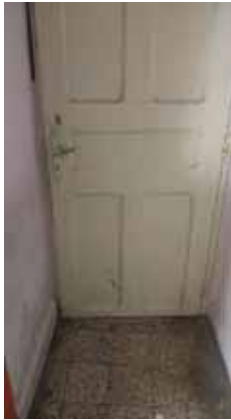
| Floor | Room / Area | Defect Description / Required Works | Qty | Unit | BOQ | Photo |
|---|---|---|---|---|---|---|
| 1st | 3-5- | Install new handles for the door | 5 | pcs | <b>8.1.3</b> | |

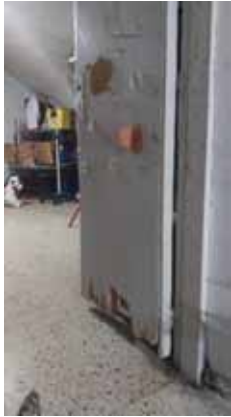
| Floor | Room / Area | Defect Description / Required Works | Qty | Unit | BOQ | Photo |
|---|---|---|---|---|---|---|
| 1st | 5 | Install a new wooden door | 1 | pcs | <b>8.1.1</b> | |

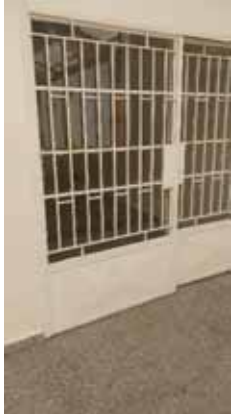
| Floor | Room / Area | Defect Description / Required Works | Qty | Unit | BOQ | Photo |
|---|---|---|---|---|---|---|
| 1st | | Replace Glass of metal door | 3 | pcs | 5.2 | |

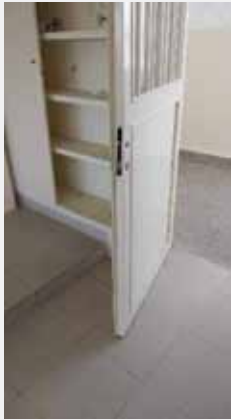
| Floor | Room / Area | Defect Description / Required Works | Qty | Unit | BOQ | Photo |
|---|---|---|---|---|---|---|
| 3rd | | Replace Locks for 5 metal doors | 5 | pcs | 5.2 | |

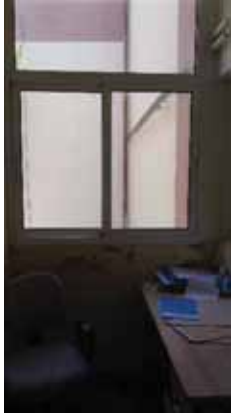
| Floor | Room / Area | Defect Description / Required Works | Qty | Unit | BOQ | Photo |
|---|---|---|---|---|---|---|
| 2nd | Entrance | Repair Aluminum windows | 2 | pcs | 8.2.3 | |

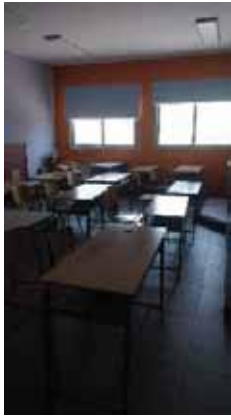
| Floor | Room / Area | Defect Description / Required Works | Qty | Unit | BOQ | Photo |
|---|---|---|---|---|---|---|
| 1st | 1 | Repair aluminum windows | 2 | pcs | 8.2.3 | |

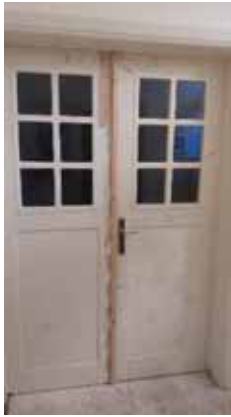
| Floor | Room / Area | Defect Description / Required Works | Qty | Unit | BOQ | Photo |
|---|---|---|---|---|---|---|
| 1st | Activity room | Repair & paint wooden door | 1 | pcs | 8.1.3 | |

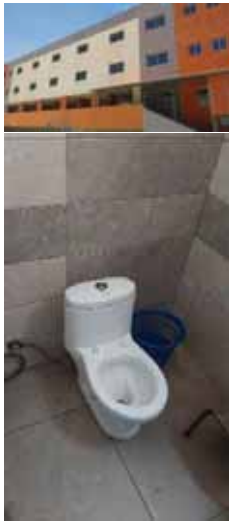
| Floor | Room / Area | Defect Description / Required Works | Qty | Unit | BOQ | Photo |
|---|---|---|---|---|---|---|
| 1st | Toilets-1 | New Toilet seat lids | 4 | pcs | 1.2.1 | |

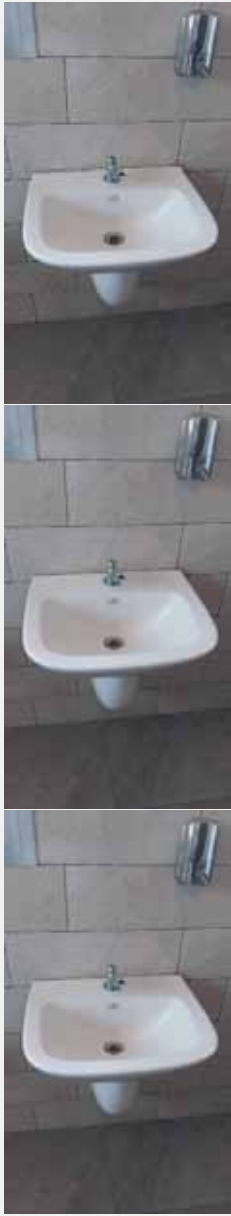
| Floor | Room / Area | Defect Description / Required Works | Qty | Unit | BOQ | Photo |
|---|---|---|---|---|---|---|
| 3rd | Toilets | Install new faucets | 2 | pcs | 5.6 | |

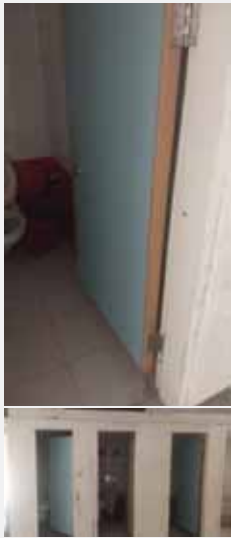
| Floor | Room / Area | Defect Description / Required Works | Qty | Unit | BOQ | Photo |
|---|---|---|---|---|---|---|
| 1st | Toilets-Nursery | Replace door's locks | 3 | pcs | <b>8.1.3</b> | |

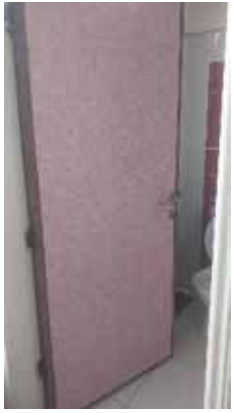
| Floor | Room / Area | Defect Description / Required Works | Qty | Unit | BOQ | Photo |
|---|---|---|---|---|---|---|
| 2nd | Toilets | Replace door's handles | 2 | pcs | 8.1.3 | |

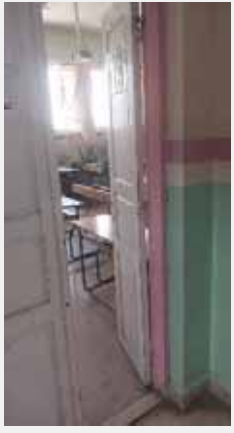
| Floor | Room / Area | Defect Description / Required Works | Qty | Unit | BOQ | Photo |
|---|---|---|---|---|---|---|
| 3rd | 1-2-3-4-5-6- | New handles for doors (x2 for each door) | 12 | pcs | 8.1.3 | |

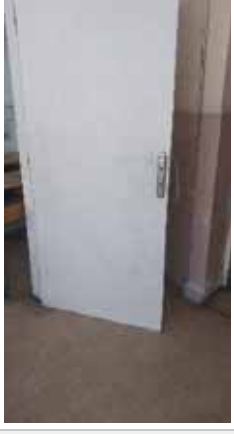
| Floor | Room / Area | Defect Description / Required Works | Qty | Unit | BOQ | Photo |
|---|---|---|---|---|---|---|
| 3rd | Entrance | Paint wooden door | 4 | m2 | 8.1.3 | |

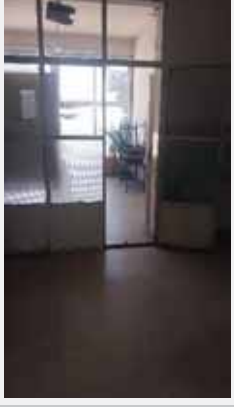
| Floor | Room / Area | Defect Description / Required Works | Qty | Unit | BOQ | Photo |
|---|---|---|---|---|---|---|
| 3rd | Entrance | Replace glass | 1 | pcs | 8.1.3 | |

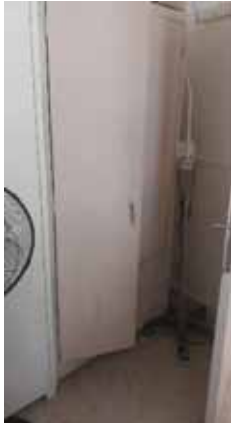
| Floor | Room / Area | Defect Description / Required Works | Qty | Unit | BOQ | Photo |
|---|---|---|---|---|---|---|
| 3rd | Entrance | Replace Storage unit | 1 | pcs | 6.1.2 | |

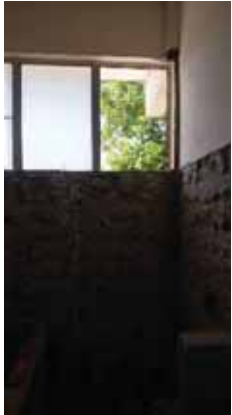
| Metal | | | | | | |
|---|---|---|---|---|---|---|
| 2nd | Toilet | Replace windows' broken glass | 2 | pcs | 5.2 | |

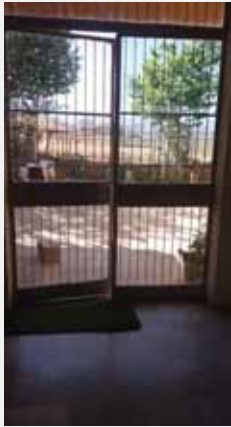
| Floor | Room / Area | Defect Description / Required Works | Qty | Unit | BOQ | Photo |
|---|---|---|---|---|---|---|
| 1st | Entrance | New glass for the metal entrance door | 1 | pcs | 5.2 | |

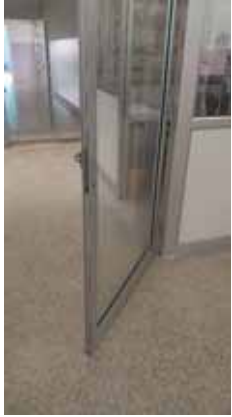
| Aluminum | | | | | | |
|---|---|---|---|---|---|---|
| 1st | Corridor | Provide & Install aluminum door's handle & lock | 1 | pcs | 8.2.3 | |

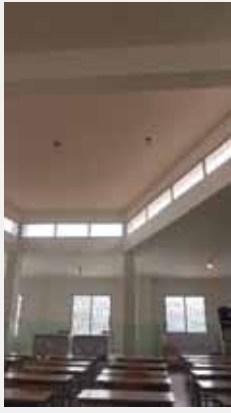
| Floor | Room / Area | Defect Description / Required Works | Qty | Unit | BOQ | Photo |
|---|---|---|---|---|---|---|
| 2nd | Test Room-3-4-5 | Install new lamps | 18 | pcs | 1.1.1 | |

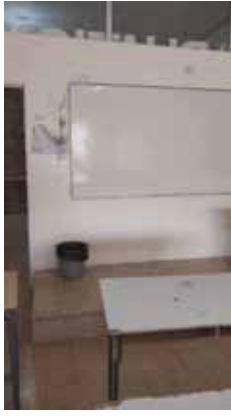
| Floor | Room / Area | Defect Description / Required Works | Qty | Unit | BOQ | Photo |
|---|---|---|---|---|---|---|
| 1st | 03/06/2026 | New white board | 7 | pcs | 10.2.1 | |

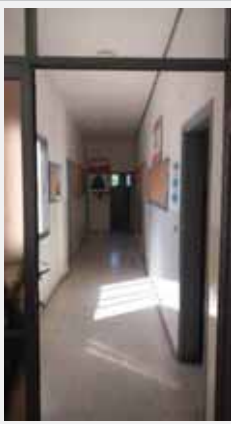
| Floor | Room / Area | Defect Description / Required Works | Qty | Unit | BOQ | Photo |
|---|---|---|---|---|---|---|
| 3rd | coridor | Paint walls & ceiling | 120 | m2 | 9.5.1 | |

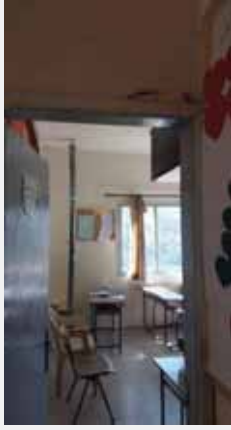
| Floor | Room / Area | Defect Description / Required Works | Qty | Unit | BOQ | Photo |
|---|---|---|---|---|---|---|
| 3rd | 4 | Repair wall plaster around door's frame | 1 | pcs | 9.1.2 | |

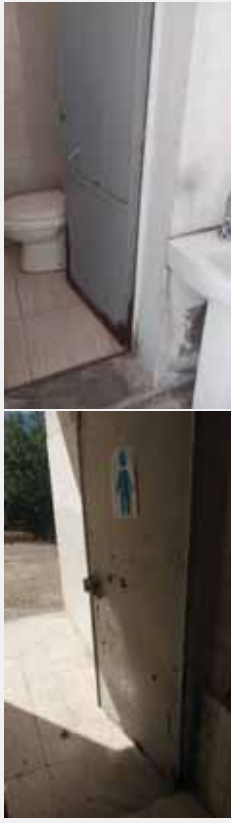
| Floor | Room / Area | Defect Description / Required Works | Qty | Unit | BOQ | Photo |
|---|---|---|---|---|---|---|
| 1st | Toilet: boys - girls | Paint metal doors<br>(x3 at boys wc and x2 at girls wc) | 5 | pcs | 5.2 | |

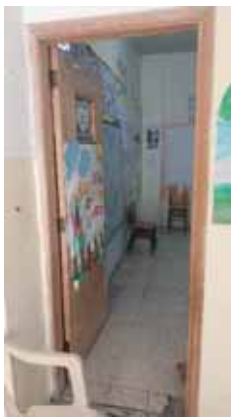
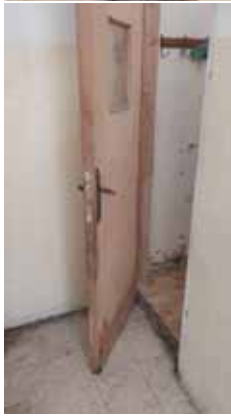
| Floor | Room / Area | Defect Description / Required Works | Qty | Unit | BOQ | Photo |
|---|---|---|---|---|---|---|
| 1st | 1-Kindergarten | Paint wooden doors and frame | 5 | pcs | 8.1.3 | |

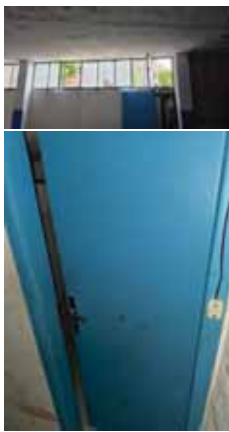
| Floor | Room / Area | Defect Description / Required Works | Qty | Unit | BOQ | Photo |
|---|---|---|---|---|---|---|
| 1st | Playground | Install new window glasses | 3 | pcs | 5.2 | |

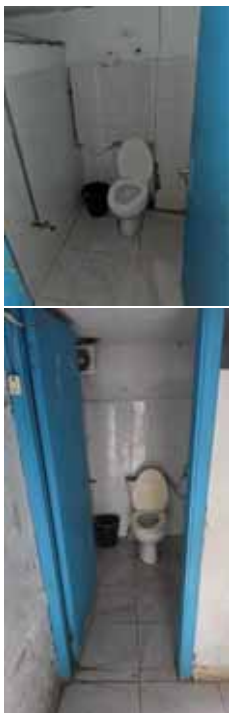
| Floor | Room / Area | Defect Description / Required Works | Qty | Unit | BOQ | Photo |
|---|---|---|---|---|---|---|
| 1st | Toilets | Repair plumbing | 3 | units | 1.2.1 | |

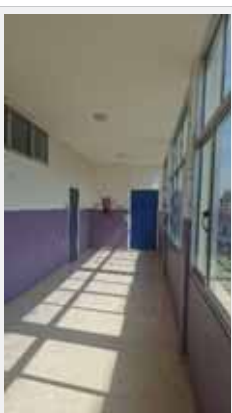
| Finishing | | | | | | |
|---|---|---|---|---|---|---|
| 2nd | Corridor | Paint walls | 300 | m2 | 9.5.1 | |

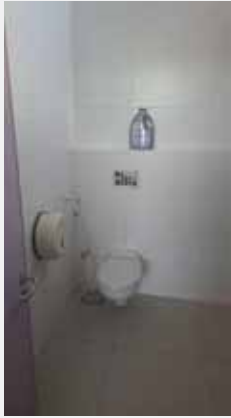
| Floor | Room / Area | Defect Description / Required Works | Qty | Unit | BOQ | Photo |
|---|---|---|---|---|---|---|
| Ground floor | Toilet-Kindergarten | Repair or Install new flushing sytem for the toilet seat | 1 | pcs | 1.2.1 | |

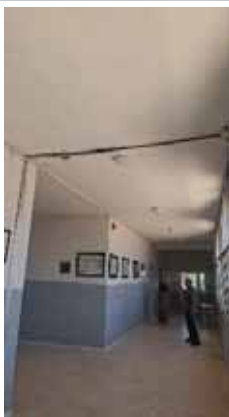
| Floor | Room / Area | Defect Description / Required Works | Qty | Unit | BOQ | Photo |
|---|---|---|---|---|---|---|
| 2nd | Roof | Expansion Joint waterproof | 20 | lm | 7.1 | |

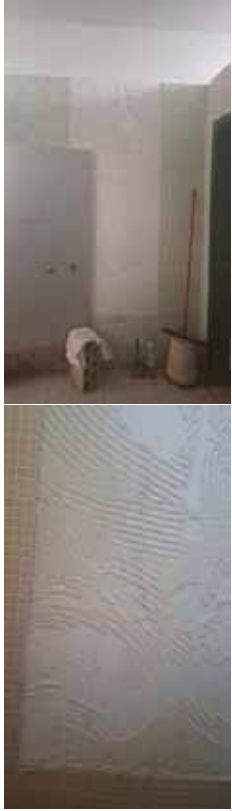
| Finishing | | | | | | |
|---|---|---|---|---|---|---|
| Ground Floor | Toilets-girls<br>Toilets-boys | Repair broken tiles | 6 | m2 | 9.2.4 | |

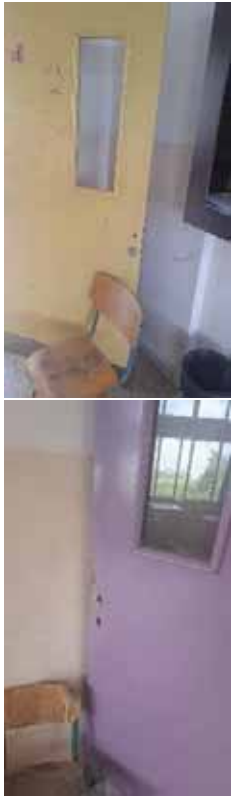
| Floor | Room / Area | Defect Description / Required Works | Qty | Unit | BOQ | Photo |
|---|---|---|---|---|---|---|
| 1st | classrooms | Wood door locks & handles | 22 | pcs | 8.1.3 | |

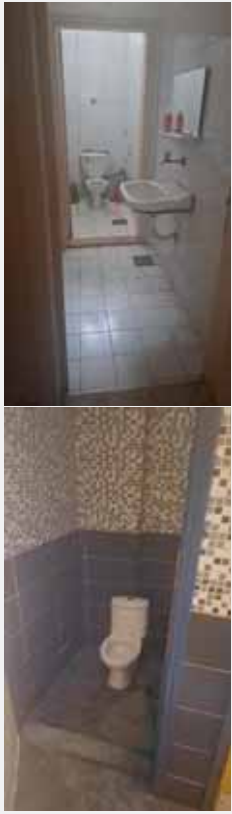
| Floor | Room / Area | Defect Description / Required Works | Qty | Unit | BOQ | Photo |
|---|---|---|---|---|---|---|
| Ground Floor | Toilets | Install new flushing system | 11 | pcs | 1.2.1 | |

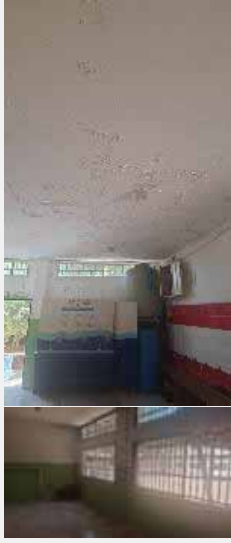
| Floor | Room / Area | Defect Description / Required Works | Qty | Unit | BOQ | Photo |
|---|---|---|---|---|---|---|
| Ground Floor | | Repair waterproofing failure caused by the upper-floor toilets | | LS | 7.2 | |

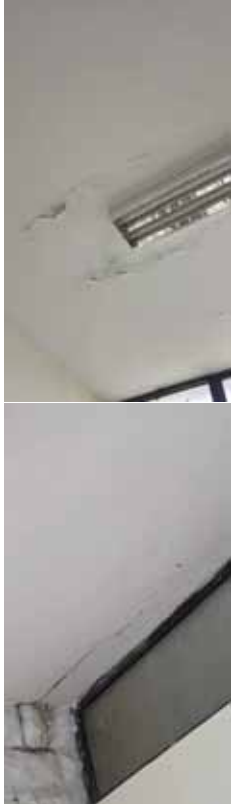
| Finishing | | | | | | |
|---|---|---|---|---|---|---|
| 3rd | 1-2-5-6- | Paint | 340 | m2 | 9.5.1 | |
