**CERD 615 - Akkar El Aatiqa Mixed Public School**

Batch 4 - Lot 1 - Akkar

### Lebanon Emergency Assistance Project (LEAP)

### Detailed Assessment and Verification Report

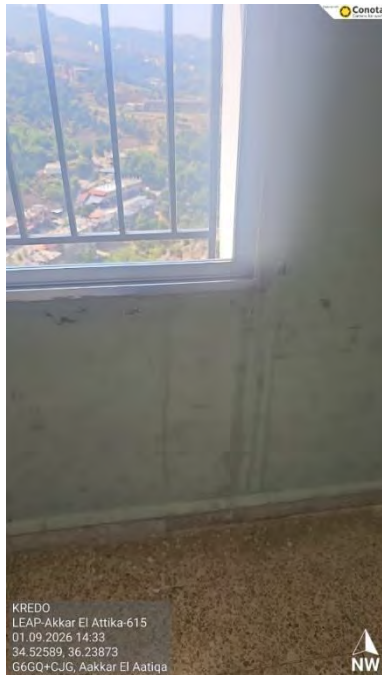
| No. | Element | Yes | No | Location and description |
|---|---|---|---|---|
| 2 | Facade water leak | X | | From windows roof, and one façade |

**Figure 4 – Water Leakage**

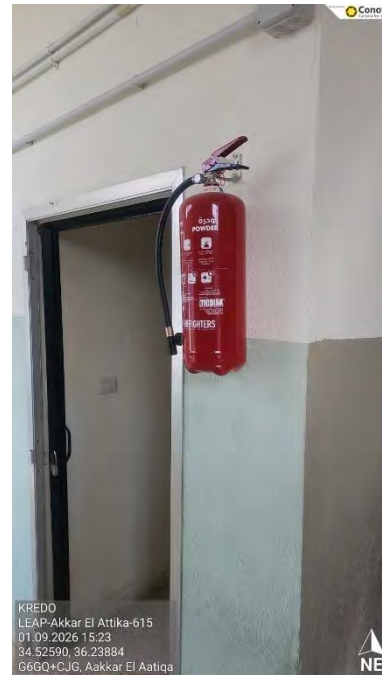
| Item | Condition found |
|---|---|
| Fire extinguishers, alarms and smoke detectors | Fire extinguishers available, Alarms and smoke detectors not available |

**Figure 5 – Fire Extinguishers**

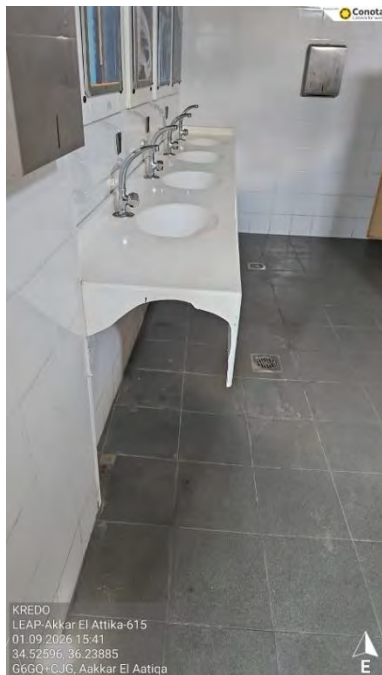
| Trade | Item | Damaged | Location, extent and quantity |
|---|---|---|---|
| Sanitary and plumbing | Wash basins | Yes | 2 washbasins |

**Figure 6 – Damaged Wash Basin**

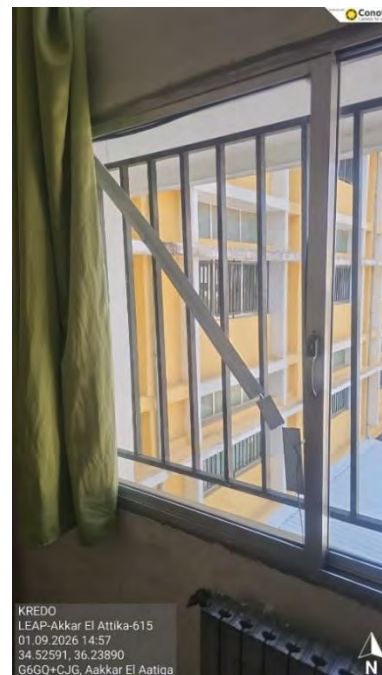
| Trade | Item | Damaged | Location, extent and quantity |
|---|---|---|---|
| Aluminum and glazing | Aluminum glazing | Yes | 4 m <sup>2</sup> aluminum windows |

**Figure 7 – Damaged Window**

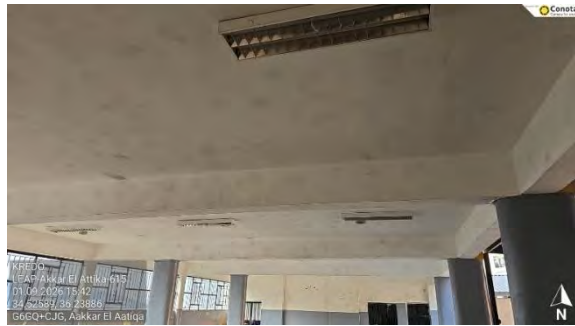
| Trade | Item | Damaged | Location, extent and quantity |
|---|---|---|---|
| Finishes | Paint - walls and ceilings - plasters | Yes | 2,260 m <sup>2</sup> paint |

**Figure 8 – Damaged Paint**

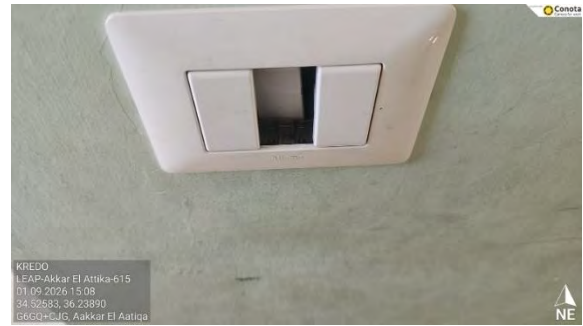
| Trade | Item | Damaged | Location, extent and quantity |
|---|---|---|---|
| Electrical | Sockets and switches | Yes | 5 Sockets and switches |

**Figure 9 – Damaged Socket**

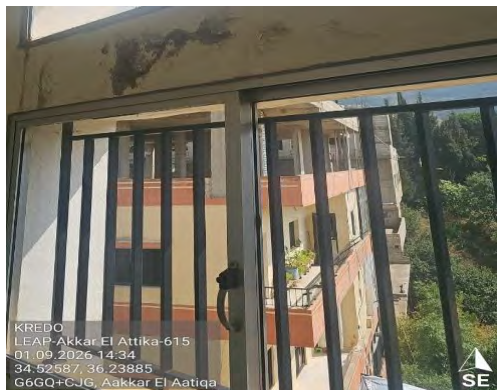
**Figure 10 – Window Protection**

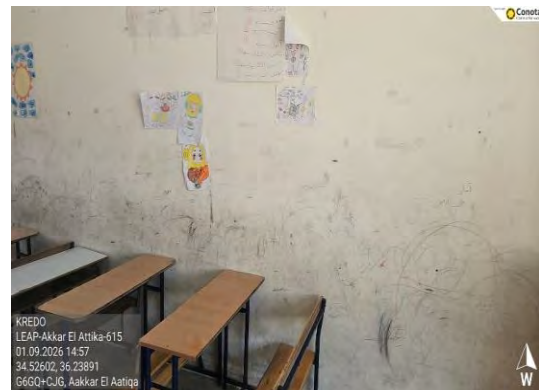
**Figure 11 – Damaged Wall Paint**

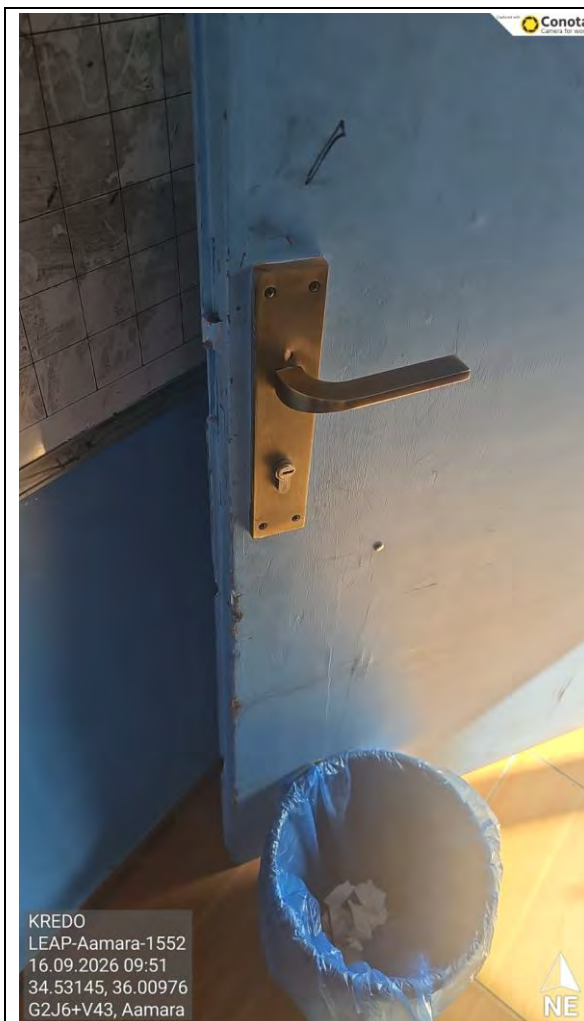
**Figure 7 - Doors in Bad Condition**

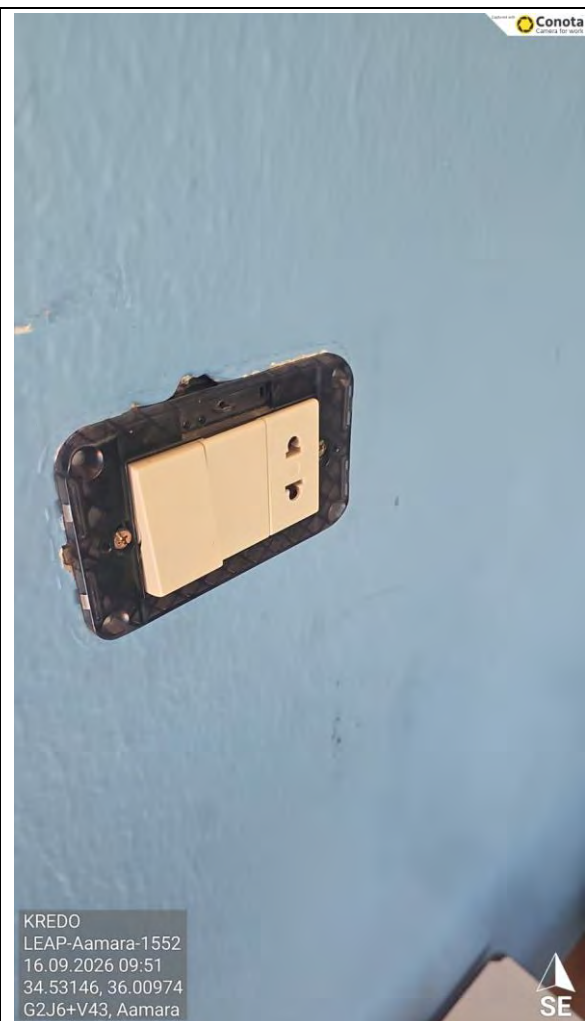
**Figure 8 - Missing Socket Cover**

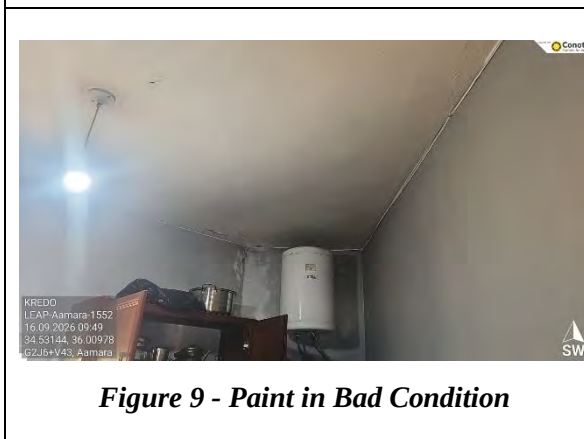
**Figure 9 - Paint in Bad Condition**

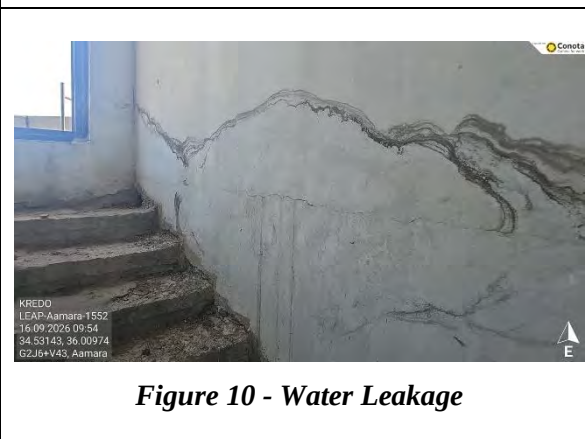
**Figure 10 - Water Leakage**

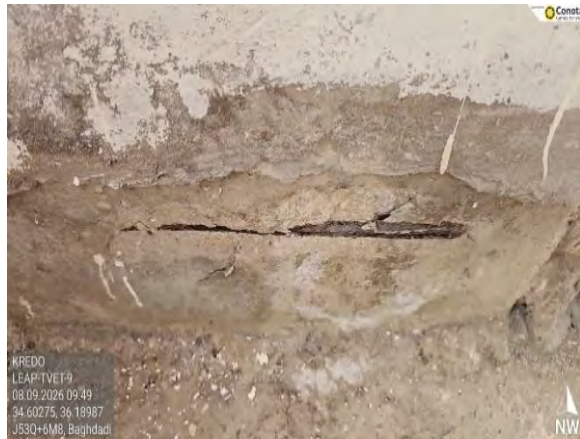
| No. | Element | Yes | No | Location and description |
|---|---|---|---|---|
| 8 | Spalled concrete with exposed reinforcement | X | | |

**Figure 7- Spalled concrete with exposed reinforcement.**

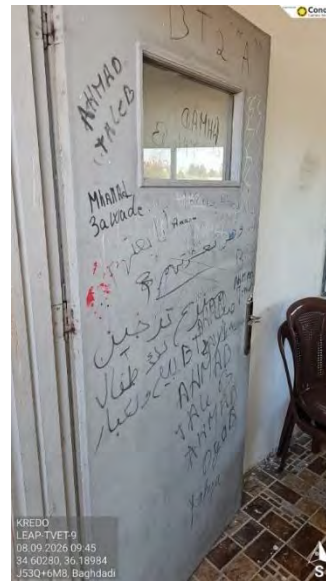
| Trade | Item | Damaged | Location, extent and quantity |
|---|---|---|---|
| Doors | Timber doors | Yes | 10 doors with frames architraves shall be changed,<br>4 doors shall be repaired |

**Figure 8- Doors in bad condition**

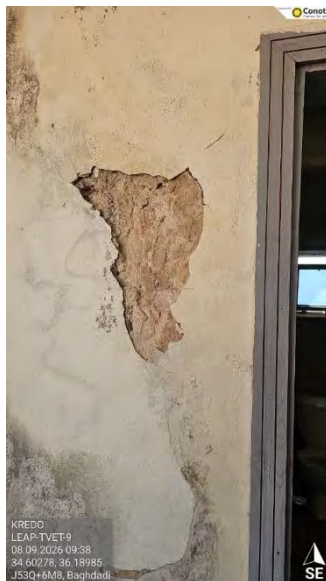
| No. | Element | Yes | No | Location and description |
|---|---|---|---|---|
| 3 | Wall cracks | X | | |

**Figure 9- Wall Cracks**

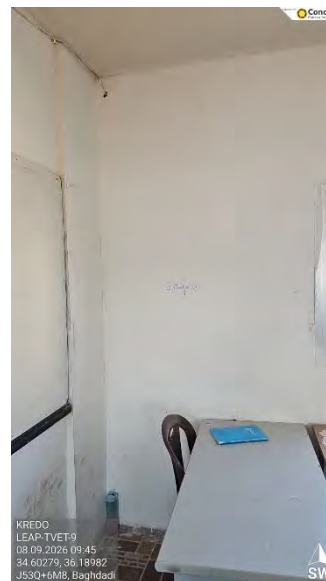
**Figure 10- Paint in bad condition**

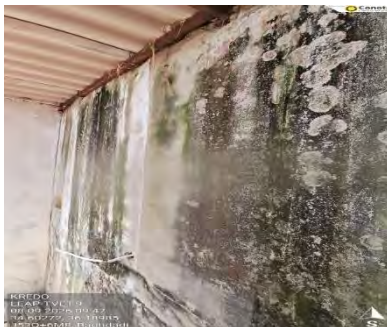
| No. | Element | Yes | No | Location and description |
|---|---|---|---|---|
| 2 | Facade water leak | X | | |

**Figure 11- Water Leakage**

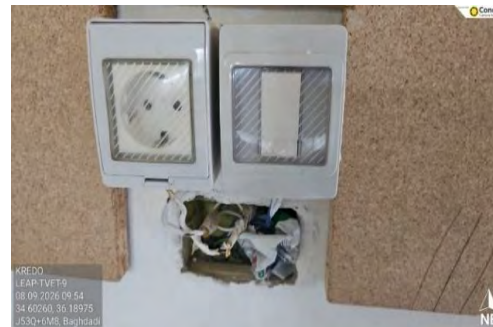
**Figure 12- Damaged Socket**

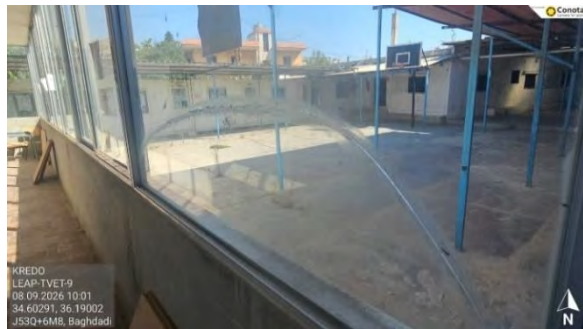
**Figure 13- Cracked Glazing**

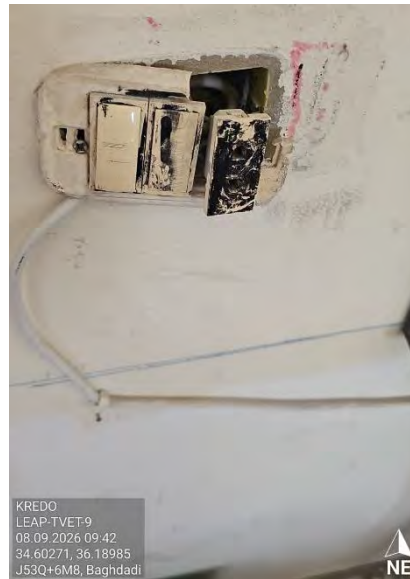
**Figure 14- Damaged Switches**

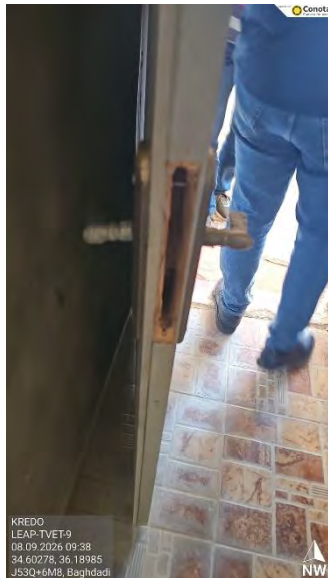
**Figure 15- Door Handles in bad condition**

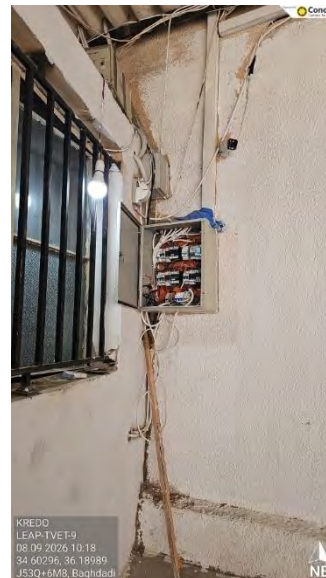
**Figure 16- Electrical installation without protection**

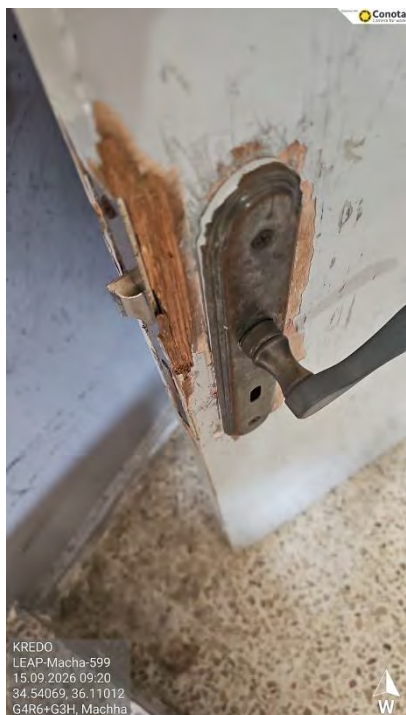
| Trade | Item | Damaged | Location, extent and quantity |
|---|---|---|---|
| Doors | Timber doors | Yes | 1 double and 14 single doors with frames architraves shall be changed, 6 doors shall be repaired |

**Figure 7 - Doors in bad condition**

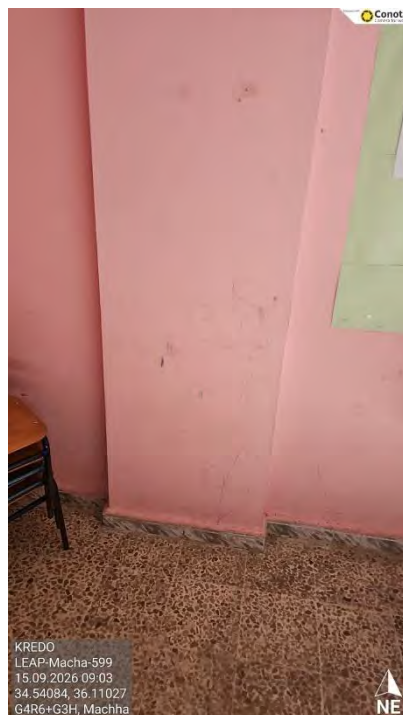
**Figure 8 - Paint in Bad condition**

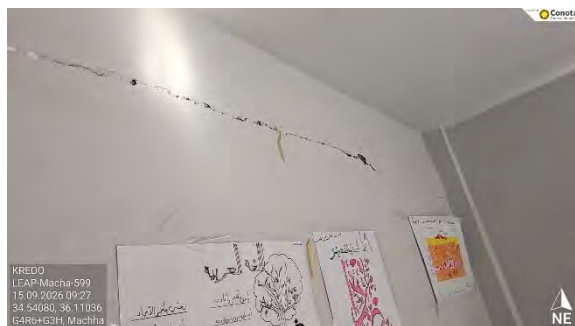
| No. | Element | Yes | No | Location and description |
|---|---|---|---|---|
| 3 | Wall cracks | X | | |

**Figure 9 - Wall cracks**

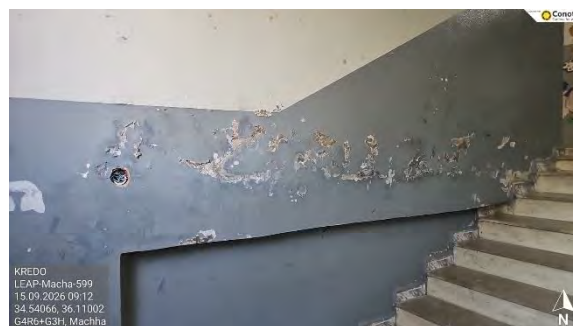
| No. | Element | Yes | No | Location and description |
|---|---|---|---|---|
| 2 | Facade water leak | X | | |

**Figure 10 - Water leakage**

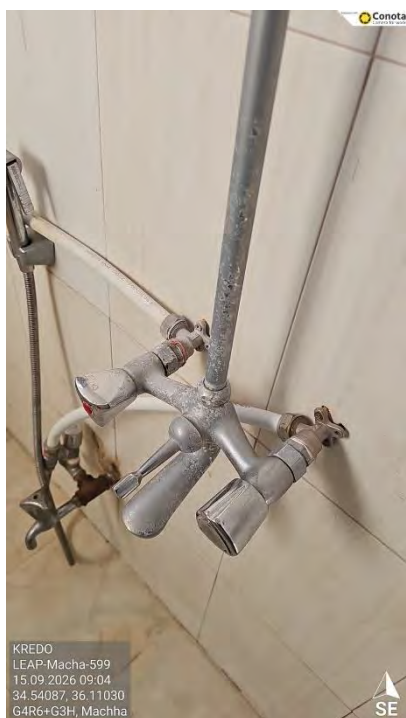
**Figure 11 - Damaged mixers**

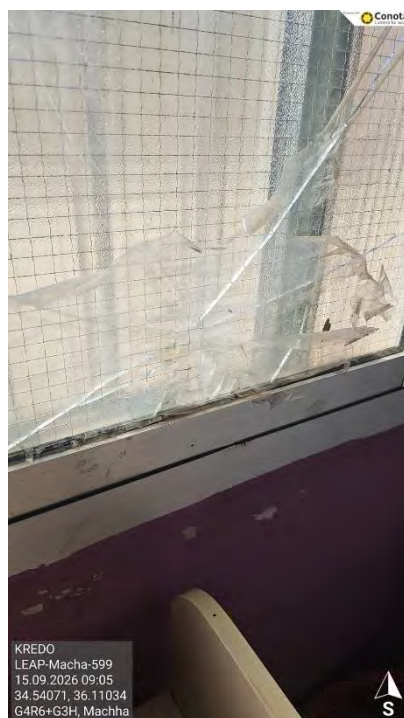
**Figure 12 - Cracked glazing**

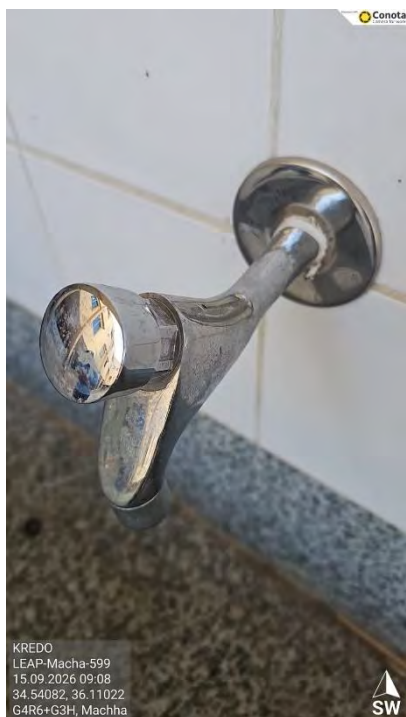
**Figure 13 - Damaged Taps**

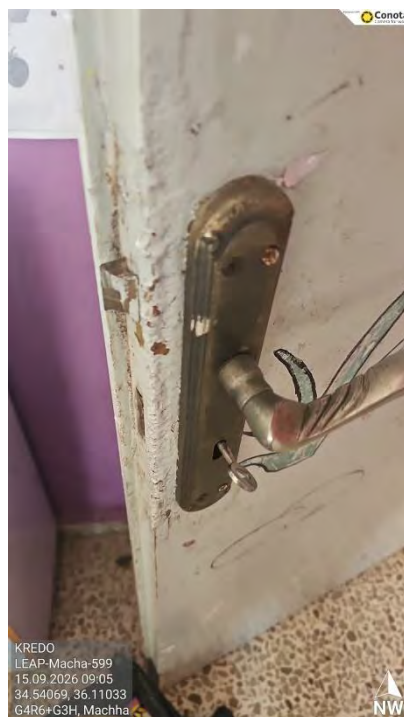
**Figure 14 - Door Handles in bad condition**

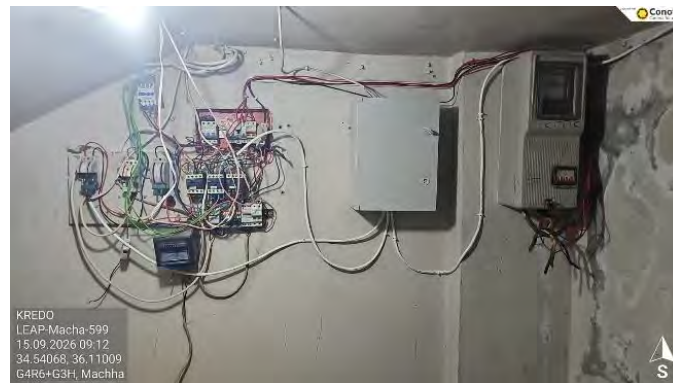
***Figure 15 – Unprotected electrical installation***

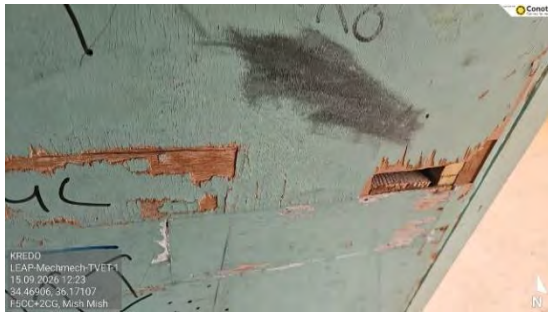
| Trade | Item | Damaged | Location, extent and quantity |
|---|---|---|---|
| Doors | Timber doors | Yes | 30 single doors with frames architraves shall be changed, and 10 doors shall be repaired |

**Figure 7 - Doors in Bad Condition**

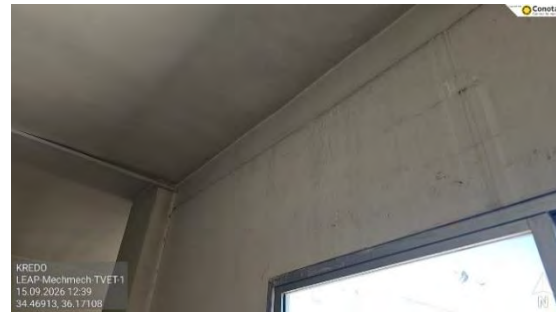
| No. | Element | Yes | No | Location and description |
|---|---|---|---|---|
| 3 | Wall cracks | X | | |

**Figure 8 - Wall Cracks**

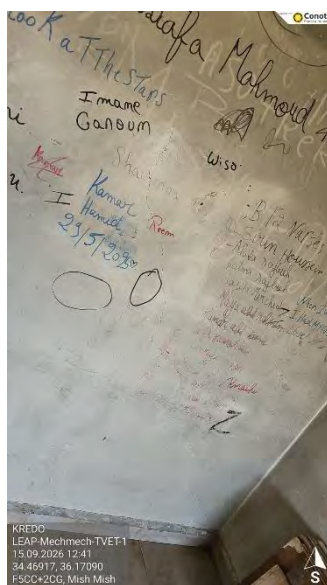
**Figure 9 - Paint in Bad Condition**

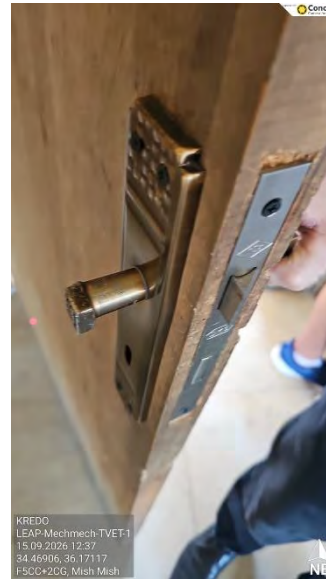
**Figure 10 - Damaged Door Handle**

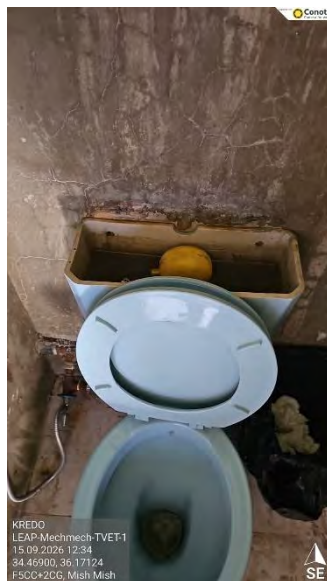
**Figure 11 - Damaged Toilet seat**

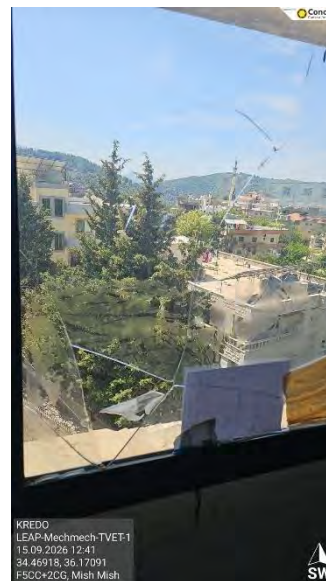
**Figure 12 - Cracked Window Glazing**

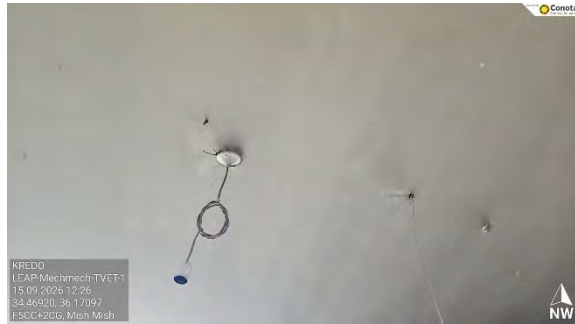
**Figure 13 - Damaged Fixtures**

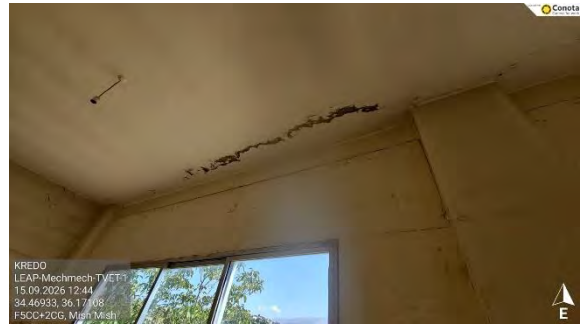
| No. | Element | Yes | No | Location and description |
|---|---|---|---|---|
| 2 | Facade water leak | X | | |

**Figure 14 - Water Leakage**

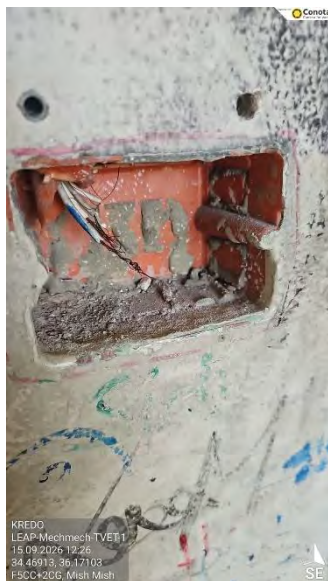
**Figure 15 - Damaged sockets**

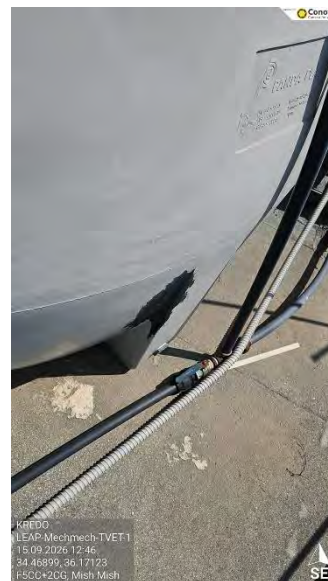
| Trade | Item | Damaged | Location, extent and quantity |
|---|---|---|---|
| | Water tanks and pumps | Yes | 1 water tank damaged |

**Figure 16 - water Tank Leakage**

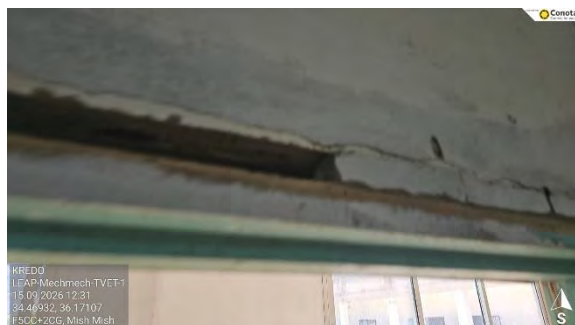
**Figure 17 - Damaged plaster**

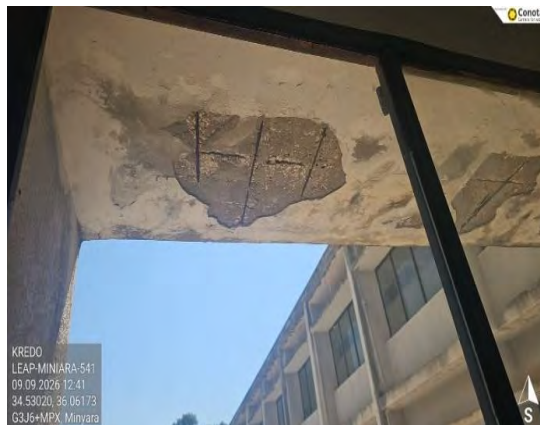
| No. | Element | Yes | No | Location and description |
|---|---|---|---|---|
| 8 | Spalled concrete with exposed reinforcement | X | | |

**Figure 4 – Spalled concrete with exposed reinforcement**

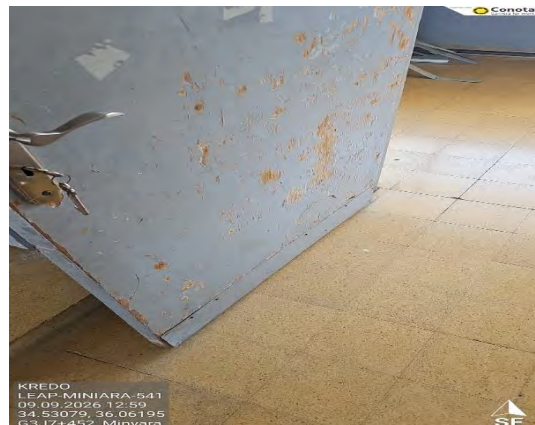
| Trade | Item | Damaged | Location, extent and quantity |
|---|---|---|---|
| Doors | Timber doors | Yes | 25 doors with frames architraves shall be changed, 5 doors shall be repaired and 8 sets of architraves |

**Figure 5 - Damaged door**

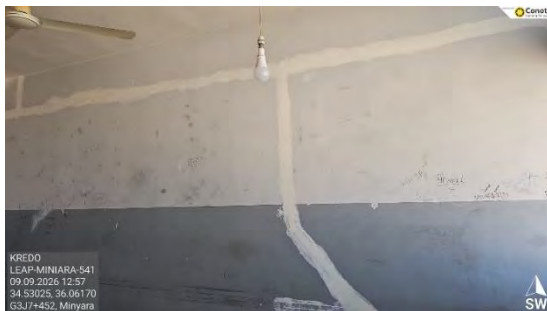
| No. | Element | Yes | No | Location and description |
|---|---|---|---|---|
| 3 | Wall cracks | X | | |

**Figure 6 – Wall cracks**

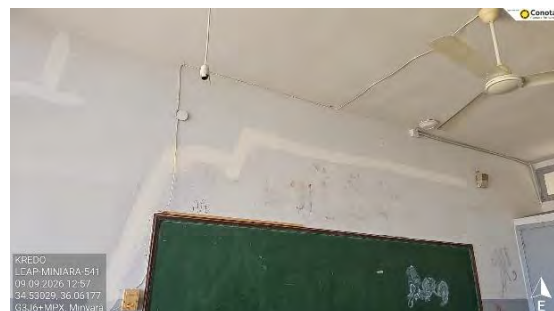
**Figure 7 - Damaged paint**

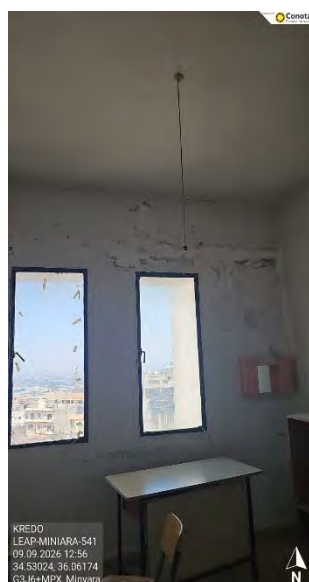
| No. | Element | Yes | No | Location and description |
|---|---|---|---|---|
| 2 | Facade water leak | X | | |

**Figure 8 – Water Leakage**

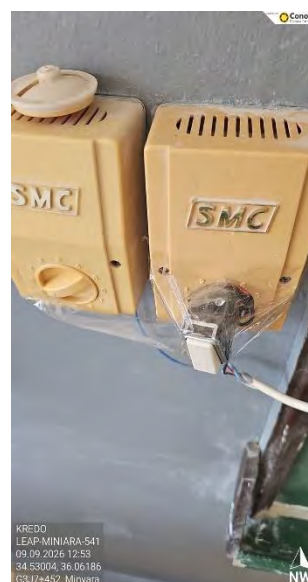
**Figure 9 – Damaged Fan Switches**

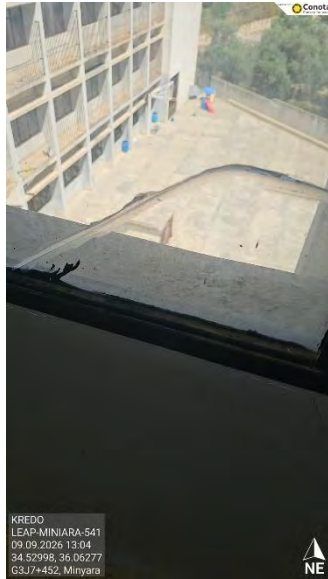
**Figure 10 – Damaged glazing**

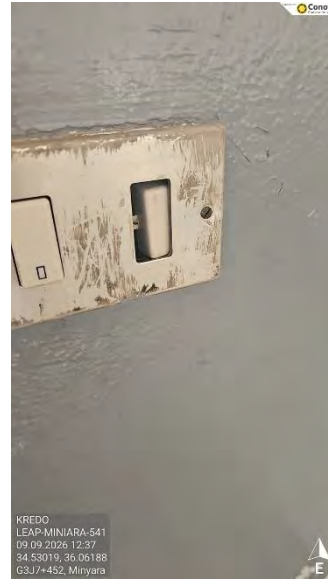
**Figure 11 - Damaged switches**

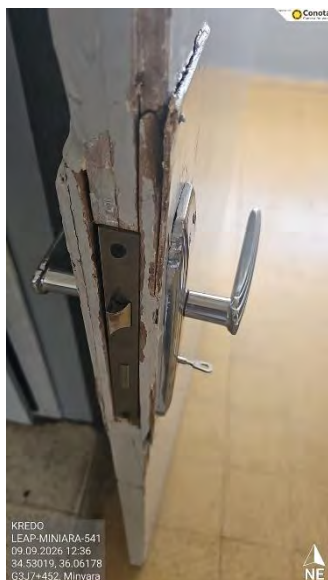
**Figure 12 - Damaged door handle**

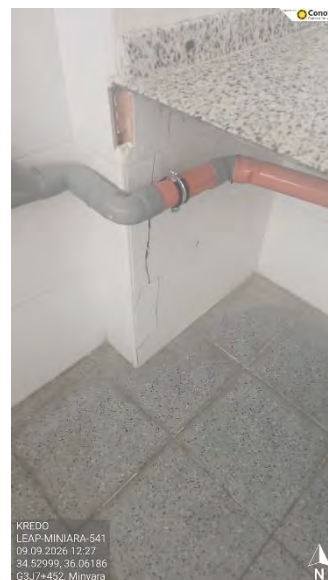
**Figure 13 – Damaged floor tiles**
