## **CONSOLIDATED PRELIMINARY RAPID DAMAGE ASSESSMENT**

### **Sector 2 — Water: Networks, Wells, Pumping Stations & Reservoirs**

Six Pilot-Zone Villages

### **Lebanon Emergency Assistance Project (LEAP)**

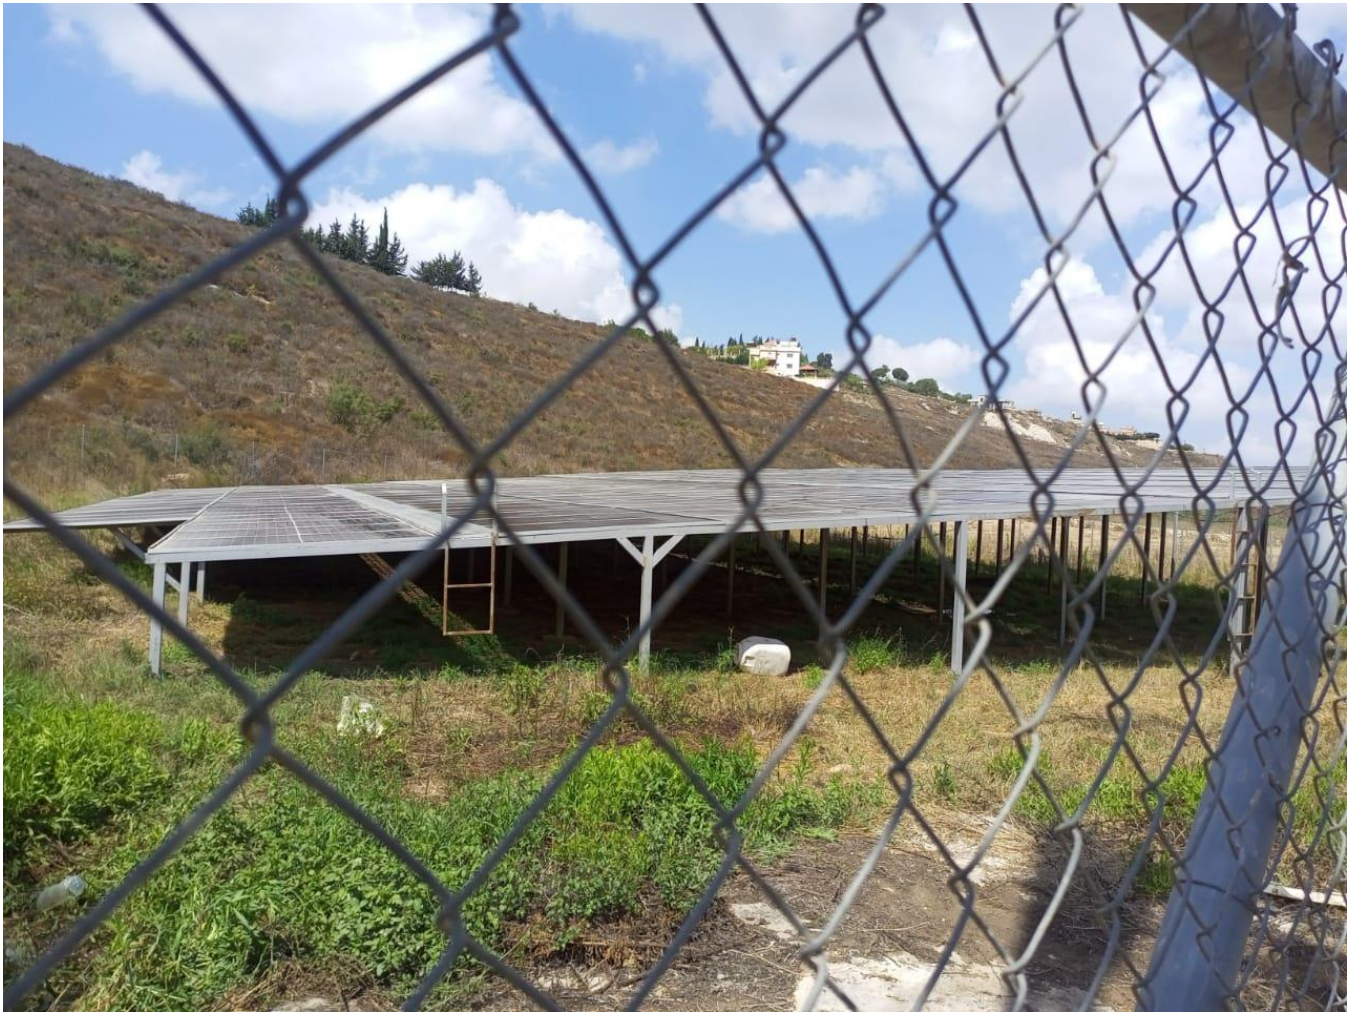
| Asset ID | Asset | Sev. | Finding / quantity |
|---|---|---|---|
| S2-1 | Solar pumping system | <b>Moderate</b> | Ground-mounted solar photovoltaic array serving the artesian-well pump. The array carries ~280 panels, of which 40 are to be replaced; the mounting frames and the remainder of the array are intact, so output is reduced rather than lost. The well site is shared with the neighbouring village, each village having its own separate array.<br>BOQ item 2.04.2, Well Solar Array (S2-1): 40 replacement photovoltaic modules of not less than 545 Wp. |

*S2-1 — Solar pumping system (33.25854, 35.41270)*

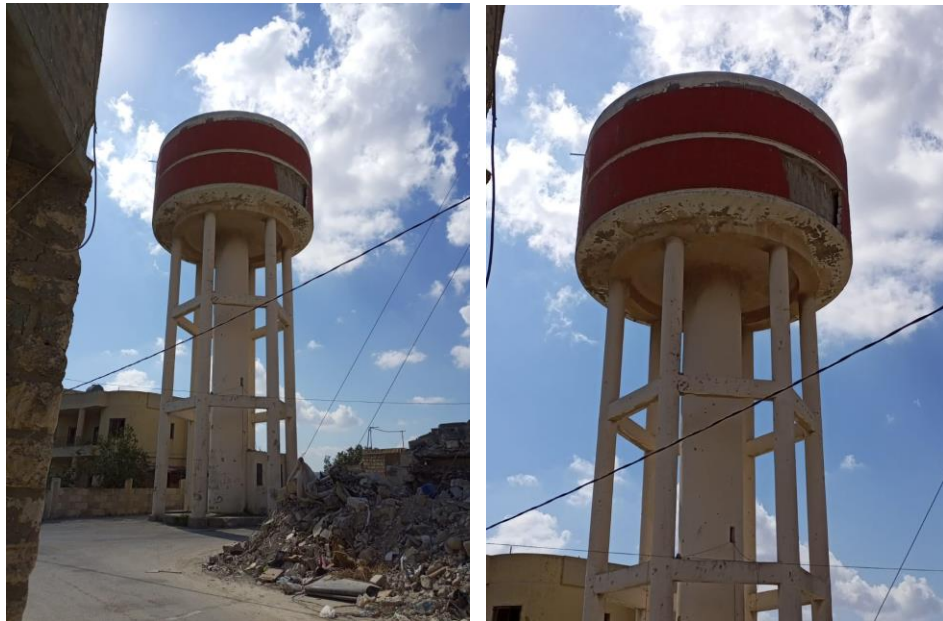
| Asset ID | Asset | Sev. | Finding / quantity |
|---|---|---|---|
| S2-2 | Elevated water tank | <b>Moderate</b> | The village's elevated water tank is a reinforced-concrete tank carried on a ring of columns with cross |

| Asset ID | Asset | Sev. | Finding / quantity |
|---|---|---|---|
| | | | bracing. A section of the tank shell is broken open on one face and the concrete around the underside of the tank has spalled over much of its circumference, with shrapnel pitting across the columns and the bracing beams. The supporting frame stands plumb and undamaged and the tank retains its form<br>BOQ — items 2.02.1 to 2.02.5, Elevated Water Tank 280 m <sup>3</sup> (S2-2) |

*S2-2 — Elevated water tank (33.26082, 35.41960)*

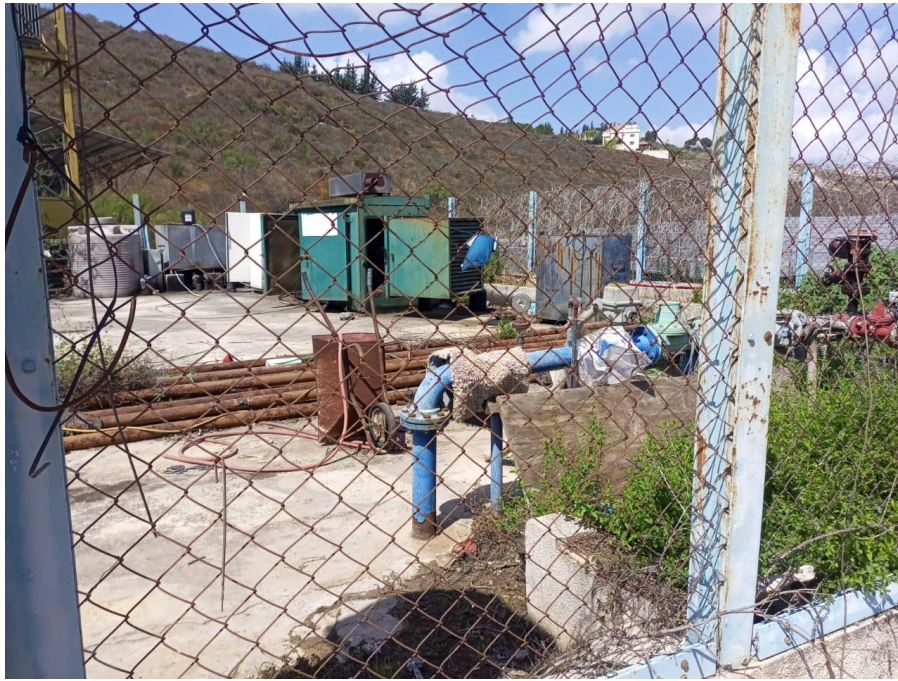
| Asset ID | Asset | Sev. | Finding / quantity |
|---|---|---|---|
| <b>S2-3</b> | Water well | <b>Minor</b> | The artesian well serving Burj Qalaouiye, reported at ~400 m depth, stands in a fenced compound holding the wellhead and discharge pipework, a generator enclosure, a control cabinet and storage tanks. All of this equipment is in place and undamaged, and no damage to the well itself was identified. The visible defects are limited to corrosion of the perimeter fence and its posts.<br>BOQ — item 2.02.6, Water Well Compound (S2-3): 110 lm of 2.00 m high galvanised chain-link perimeter fencing. |

*S2-3 — Water well (33.25854, 35.41273)*

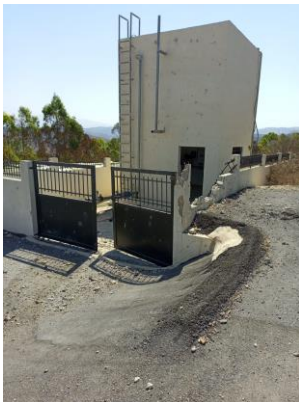
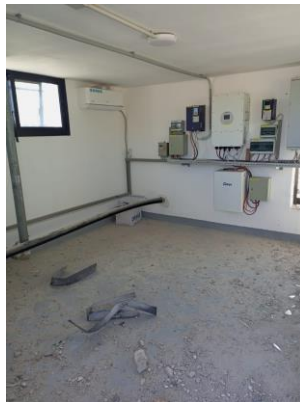
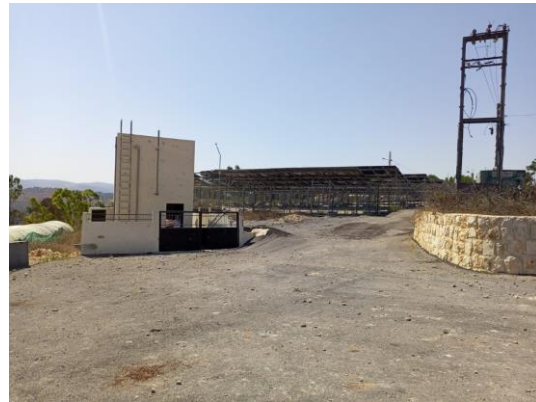
| Asset ID | Asset | Sev. | Finding / quantity |
|---|---|---|---|
| S2-1 | Water pumping station | <b>Moderate</b> | The artesian-well pumping station is around 300 m depth. A section of its perimeter wall and gate is breached, the concrete facade is pockmarked with shrapnel, and the equipment room housing the pump and solar control panels has broken window glass and bent metal fragments on the floor. The building remains structurally sound; repairs concern the perimeter wall, gate, glazing and equipment-room fit-out.<br>BOQ— items 3.02.1 to 3.02.6, Pumping Station (S2-1): |

*S2-1 — Water pumping station (33.28405, 35.43227)*

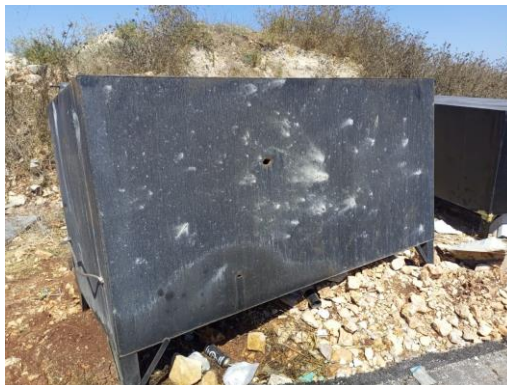
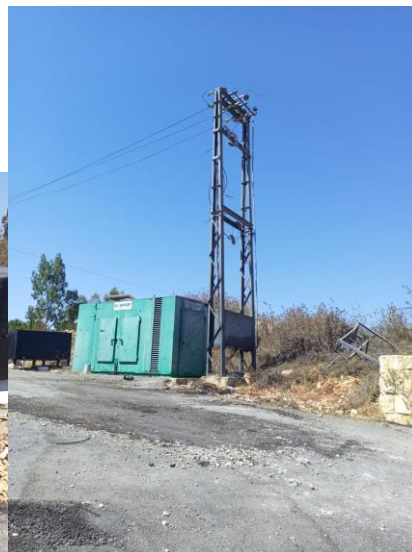
| Asset ID | Asset | Sev. | Finding / quantity |
|---|---|---|---|
| S2-2 | Solar array — well/pumping station and alternative power solution | <b>Severe</b> | The Froun artesian-well pumping station was equipped with approximately 370 photovoltaic panels, providing a total installed capacity of about 244 kWp. The solar array has sustained extensive damage: a significant section of the panel-canopy structure is visibly warped, and numerous panels are punctured across the array. The system is currently non-operational, and 333 panels are carried for replacement in the BOQ. In the absence of solar power generation, the pumping station is being operated using a 350 kVA generator rented by the municipality to maintain water services. The generator is supplied by two fuel tanks, each with a capacity of 2,000 litres; both tanks have also sustained multiple punctures and require replacement. |

*S2-2 — Solar array — well/pumping station & alternative Power solution to operate the pumping station with damaged fuel tank (33.28405, 35.43227)*

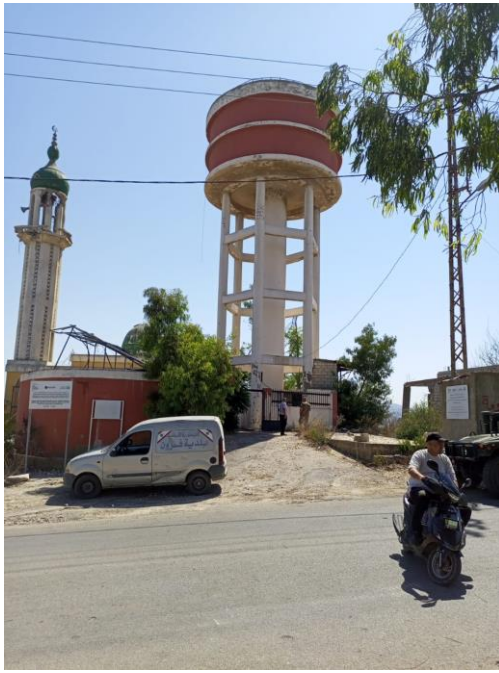
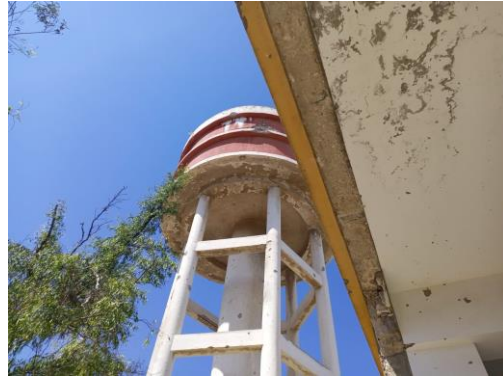
| Asset ID | Asset | Sev. | Finding / quantity |
|---|---|---|---|
| S2-3 | Drinking-water storage tank (Froun 1) | <b>Moderate</b> | Standing on its concrete column frame, the 'Froun 1' drinking-water tank — elevated circular, 300 m <sup>3</sup> per the SLWE registry — An opening in the tank was reported by the field team. The storage compartment needs repair. Further structural assessment is needed<br>BOQ— items 3.02.12 and 3.02.13, Drinking-Water Storage Tank 'Froun 1' 300 m <sup>3</sup> (S2-3): |

*S2-3 — Drinking-water storage tank (Froun 1) (33.29144, 35.42947)*

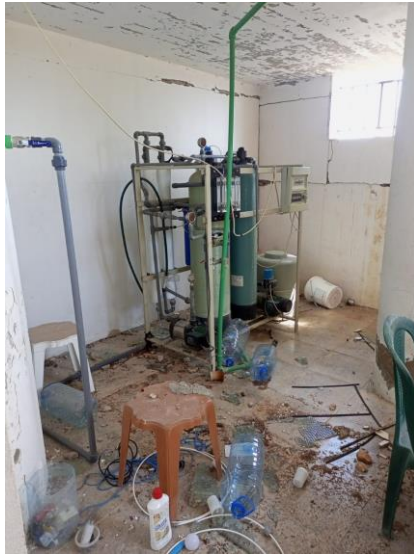
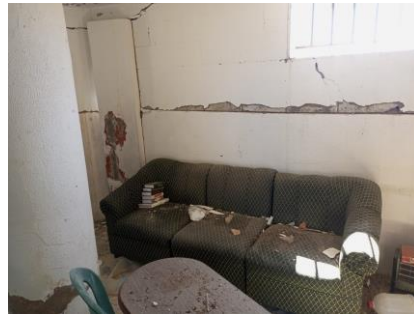
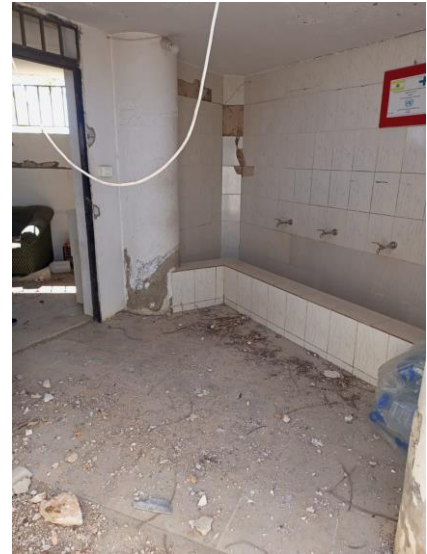
| Asset ID | Asset | Sev. | Finding / quantity |
|---|---|---|---|
| S2-4 | Water treatment (below tank) | <b>Moderate</b> | The facility site covers approximately 25 m <sup>2</sup><br>Cracking runs horizontally through the walls of the treatment and booster station under the tank, plaster has fallen away at the wall-column junctions, and the plant-room ceiling is spalled. The reverse-osmosis skid, its pressure vessels and the booster pump stand in place and appear undisplaced; broken glass, plaster and stone debris cover the floor of the plant room, the adjoining room and the tiled draw-off point alike. |

| Asset ID | Asset | Sev. | Finding / quantity |
|---|---|---|---|
| | | | The structure is serviceable, and works concern crack treatment, replastering, glazing and a full clean-out |

*S2-4 — Water treatment/booster station (below tank) (33.29144, 35.42947)*

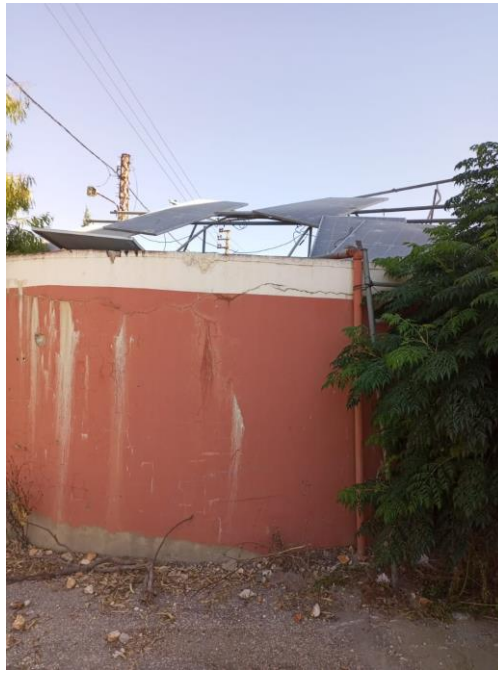
| Asset ID | Asset | Sev. | Finding / quantity |
|---|---|---|---|
| S2-5 | PV system —treatment station | Severe | Ten photovoltaic panels were installed on the roof of the elevated water reservoir to power the reverse osmosis (RO) system. The PV installation has been completely damaged and is currently non-operational BOQ— item 3.04.5, Treatment Station Photovoltaic System (S2-5): 10 replacement photovoltaic modules of not less than 550 Wp. |

*S2-5 — Solar array — booster/treatment station (33.29144, 35.42947)*

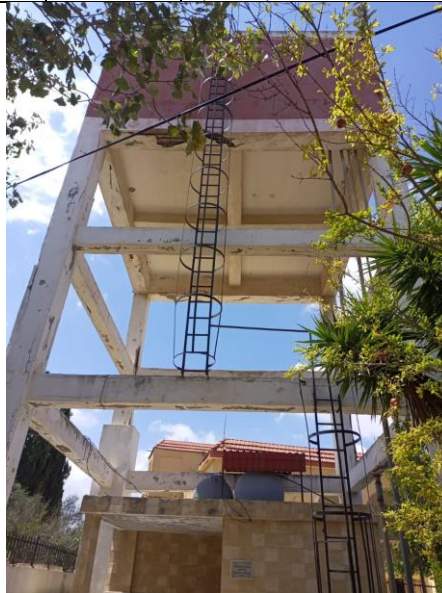
| Asset ID | Asset | Sev. | Finding / quantity |
|---|---|---|---|
| S2-1 | Water reservoir | <b>Moderate</b> | Elevated water reservoir tank, part of the village's piped drinking-water network. The tank remains carried on its supporting frame, which shows spalling, cracking and loss of coating; the field team reported the frame as severely damaged. The extent of the structural damage to the frame must be further inspected on site.<br>BOQ— items 4.02.1 to 4.02.3 |

*S2-1 — Water reservoir (33.27107, 35.43141)*

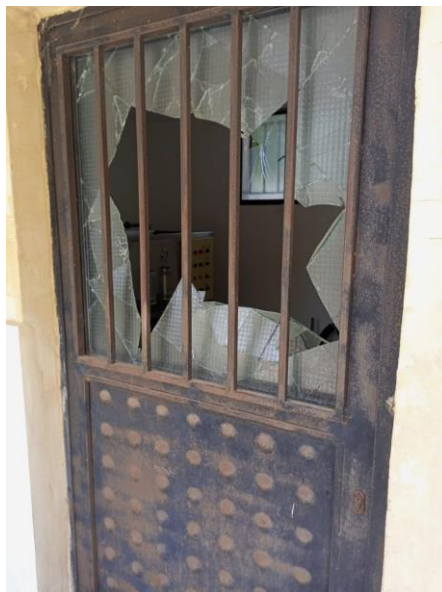
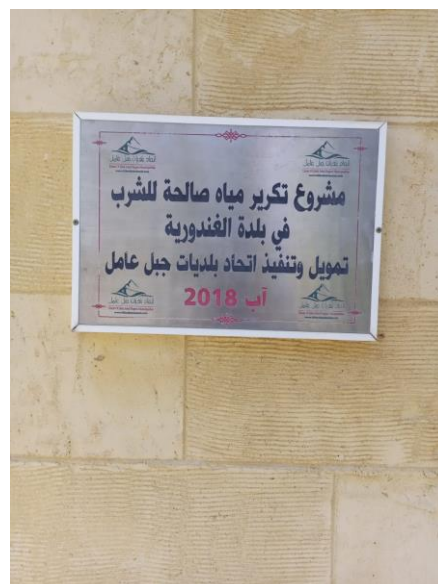
| Asset ID | Asset | Sev. | Finding / quantity |
|---|---|---|---|
| S2-3 | Water treatment filter room | <b>Minor</b> | Filter room of the village potable-water treatment facility. The wired glazing of the steel entrance door and of the internal window is shattered and the room stands open to the weather; the motor control panel |

| | | | inside is in place and undamaged. The rating is Minor because the treatment equipment is intact and the loss is confined to the door and window glazing.<br>BOQ— items 4.02.4 and 4.02.5, |

*S2-3 — Water treatment filter room (33.27107, 35.43141)*

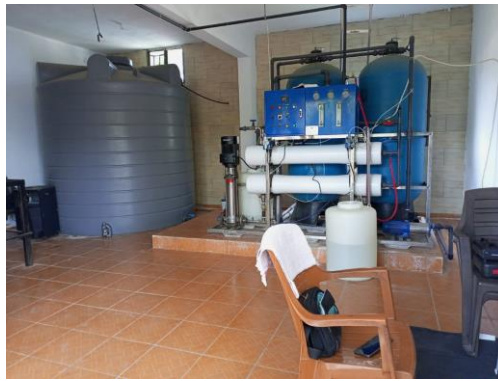
| Asset ID | Asset | Sev. | Finding / quantity |
|---|---|---|---|
| S2-2 | Water filtration plant | <b>N/A</b> | The village water filtration plant occupies a tiled room housing a storage tank, a filtration skid with pressure vessels and membrane housings, a chemical dosing tank and a booster pump. The room, its |

| Asset ID | Asset | Sev. | Finding / quantity |
|---|---|---|---|
| | | | finishes and the plant equipment are undamaged. The plant needs a power source before it can operate. No damage was recorded and no item is carried in the BOQ for this asset. The power supply the plant requires is restored through the works to the solar arrays (S2-1 and S2-3) and to the pumping station (S2-5). |

*S2-2 — Water filtration plant (33.24793, 35.41974)*

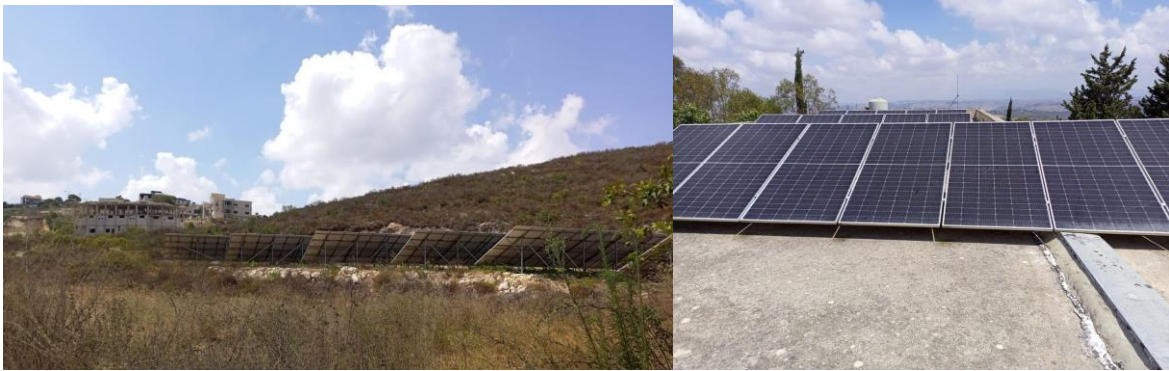
| Asset ID | Asset | Sev. | Finding / quantity |
|---|---|---|---|
| <b>S2-3</b> | Solar array for the sub-network pump | <b>Moderate</b> | A rooftop array of ~35 solar panels powers a single pump that supplies part of the village through a sub-network. Of these, 7 panels are damaged; the mounting frames, the roof slab and the rest of the array are intact. Output is reduced in proportion to the damaged panels rather than lost, which is why the rating is Moderate.<br>BOQ— item 5.04.2, Sub-Network Pump Rooftop Solar Array (S2-3): 7 replacement photovoltaic modules of not less than 545 Wp. |

*S2-3 — Solar array for the sub-network pump (33.24793, 35.41974)*

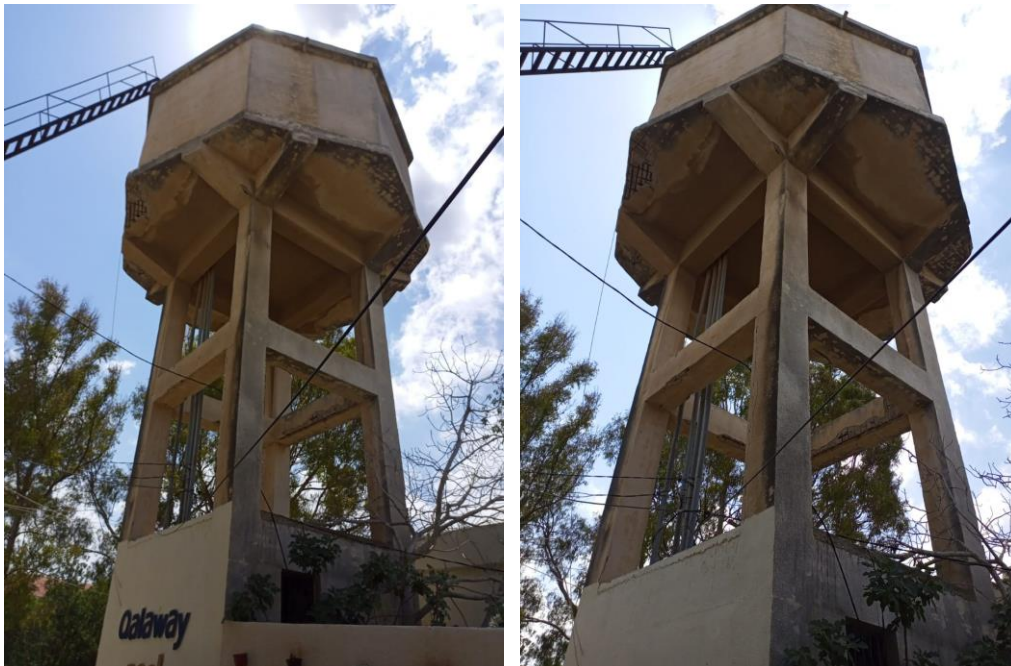
| Asset ID | Asset | Sev. | Finding / quantity |
|---|---|---|---|
| <b>S2-4</b> | Elevated water tank | <b>Minor</b> | The main water tank for the village is an elevated hexagonal reinforced-concrete tank carried on a four-column frame and fed from the well. Concrete has spalled from the underside haunches of the tank in two areas, exposing the reinforcement mesh, and the tank roof is damaged. The columns, the bracing beams and the riser pipework are sound and no leakage is evident, so the loss is of concrete cover rather than of structural section — which is why the rating is minor<br>BOQ— items 5.02.1 to 5.02.4, Elevated Water Tank ‘Qalawiyeh 1’ 180 m <sup>3</sup> (S2-4):. |

*S2-4 — Elevated water tank (33.24793, 35.41974)*

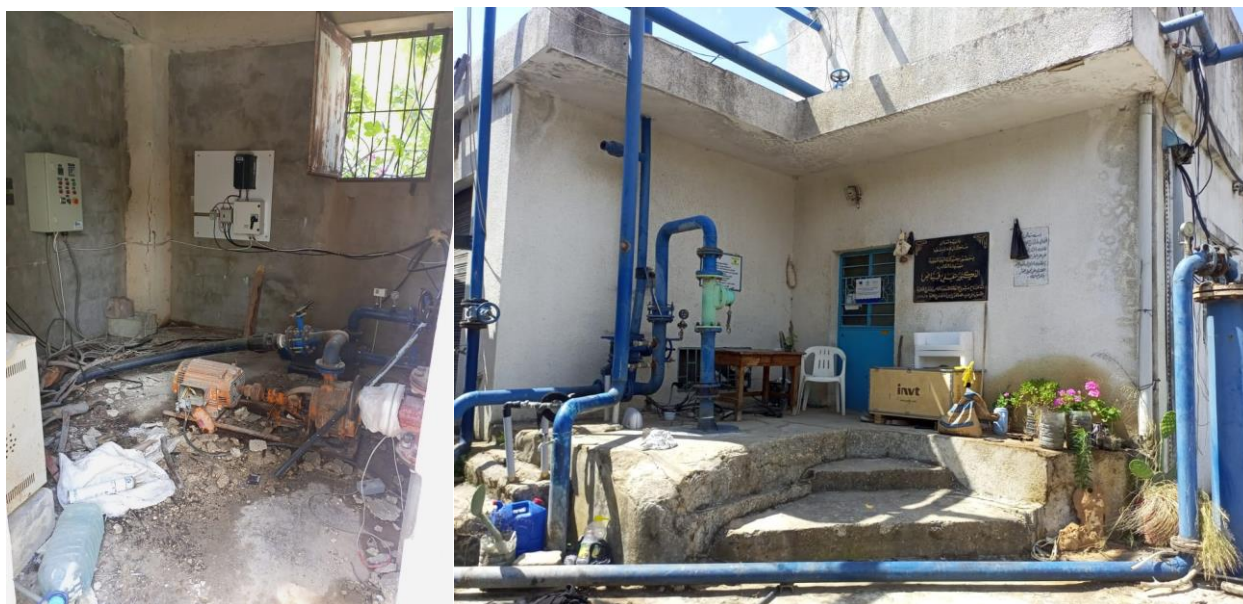
| Asset ID | Asset | Sev. | Finding / quantity |
|---|---|---|---|
| <b>S2-5</b> | Water pumping station | <b>Major</b> | The pump room serving the water tank stands but is out of service. The pump motor lies detached from its bed on the floor among broken concrete and loose cabling, the delivery pipework and valves are disturbed, and the room walls are cracked. The control panel and the drive unit remain mounted and intact, so the works are re-setting and repairing the pumping set rather than rebuilding the station — which is what the Major rating records.<br>BOQ — items 5.02.5 to 5.02.8, |

*S2-5 — Water pumping station (33.24793, 35.41974)*

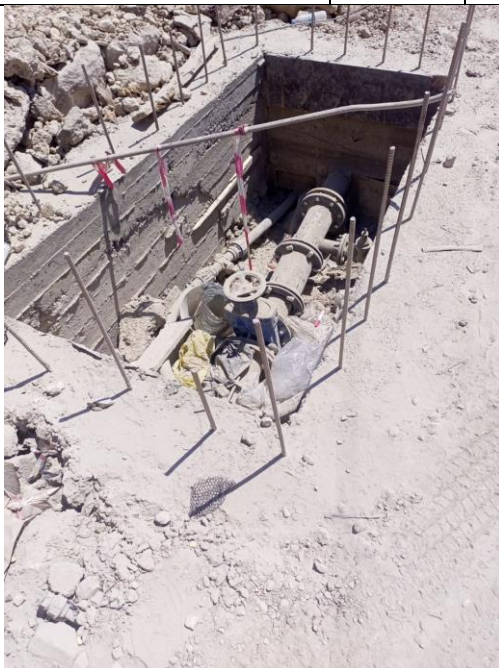
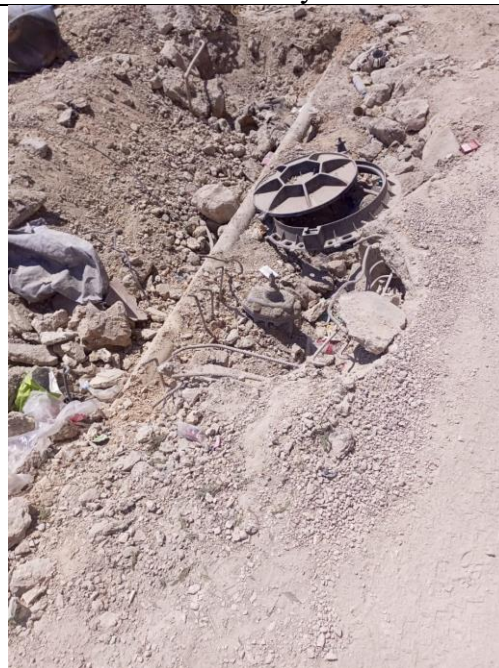
| Asset ID | Asset | Sev. | Finding / quantity |
|---|---|---|---|
| S2-1 | Water distribution network | <b>Moderate</b> | The Municipality confirmed that the networks is in good condition some provision shall be taken for the distribution area where buildings have been totally destroyed and might affect the surrounding network. Some areas where repair was ongoing need and stopped the 2026 war need to be completed as shown in the pictures<br>BOQ — items 6.01.1 to 6.01.9, Water Distribution Networks (S2-1): estimated 2,500 lm |

*S2-1 — Water distribution network (33.28090, 35.39675)*

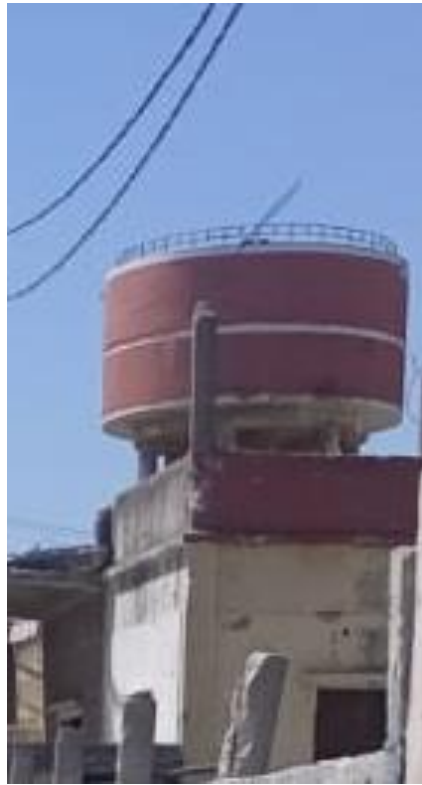
| <b>S2-2</b> | Water reservoir for irrigation | <b>Minor</b> | Elevated circular 300 m <sup>3</sup> with minor visible damages with no visible leakage. More investigation should be required to confirm<br>BOQ— items 6.02.1 to 6.02.3, Drinking-Water Storage Tank 300 m <sup>3</sup> (S2-2): |

*S2-2 — Water reservoir (33.27501, 35.39954)*

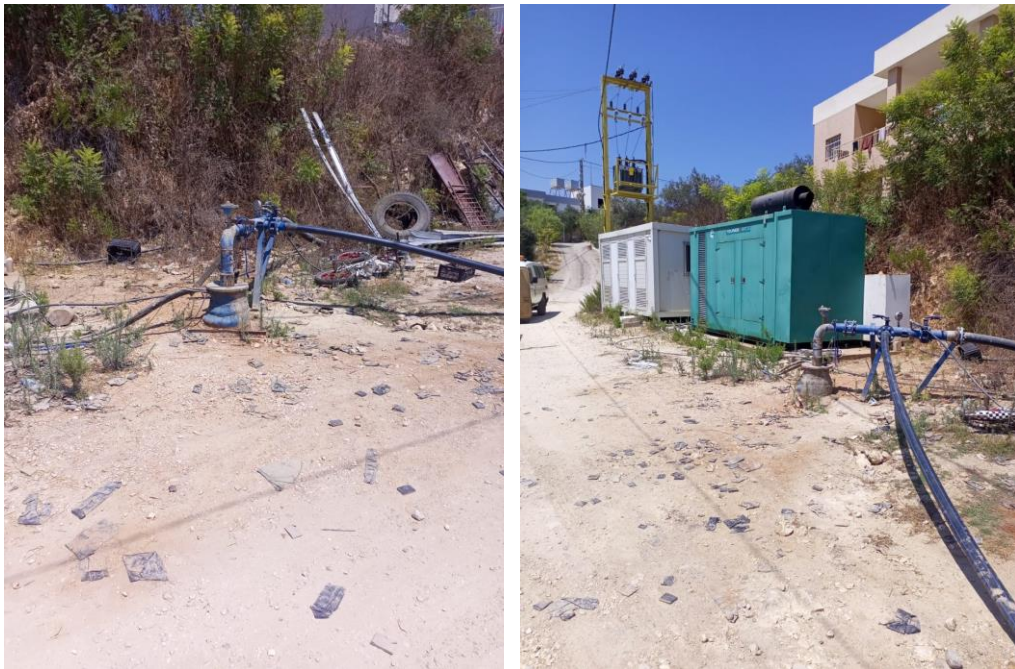
| <b>S2-3</b> | Village water well and pumping station | <b>Major</b> | The village well is not delivering water. The field engineer reported that its pump (150 hp) is damaged and needs replacement; the chlorine dosing room and the standby generator stand alongside, and the installation. Connections onward to the village tank were reported in good shape, which places the failure at the well head rather than in the distribution network.<br>Intervention Carried out by others |

*S2-3 — Village water well and pumping station (33.27639, 35.39294)*

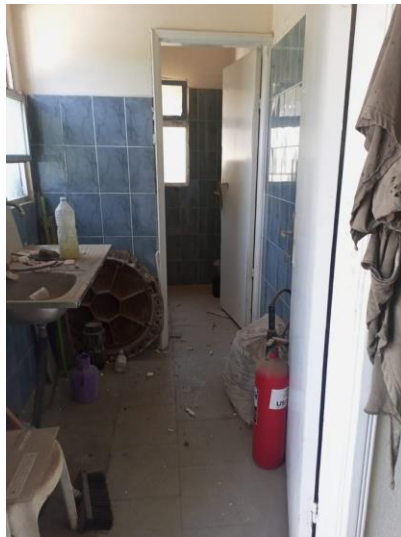
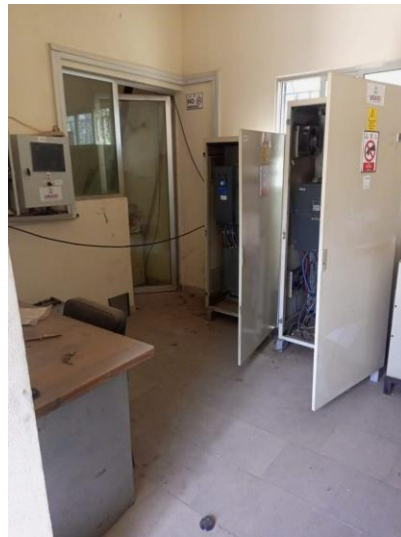
| Asset ID | Asset | Sev. | Finding / quantity |
|---|---|---|---|
| S2-2 | Pumping station (USAID/BALADI solar) | <b>Minor</b> | Pumping station building and equipment NOT significantly affected — needs only minor rehabilitation. Cannot operate because the connecting network is damaged. 7 Pannels damaged . |

*S2-2 — pumping station interior: equipment, only minor rehabilitation needed*

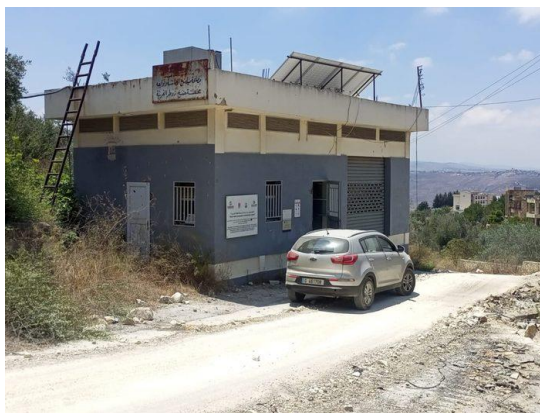
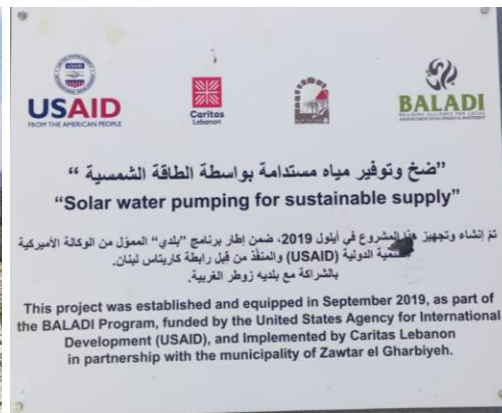
*S2-2 / S2-5 — pumping station building and solar panel location*

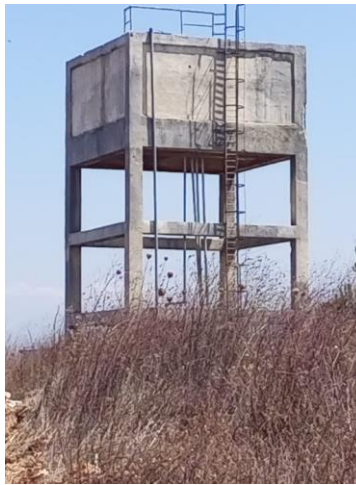
| Asset ID | Asset | Sev. | Finding / quantity |
|---|---|---|---|
| S2-3 | Reservoirs / storage tanks | <b>Major</b> | Elevated reservoir standing but showing cracks. Feeder and distribution lines from well head to station to reservoir severely damaged. [Tank 01 (underground rectangular) 50 m <sup>3</sup> ; Tank 02 (elevated rectangular) 200 m <sup>3</sup> .]<br><br>Bill № 7 carries no item for crack treatment or structural repair to the elevated reservoir. |

*S2-3 — elevated reservoir standing but showing cracks*

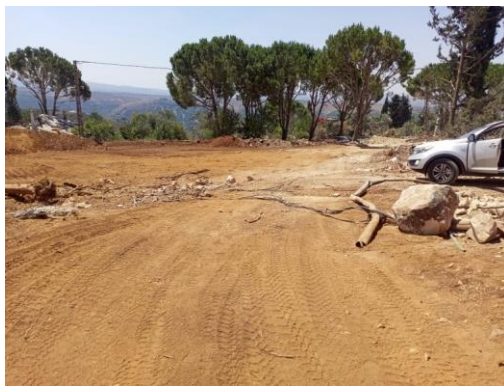
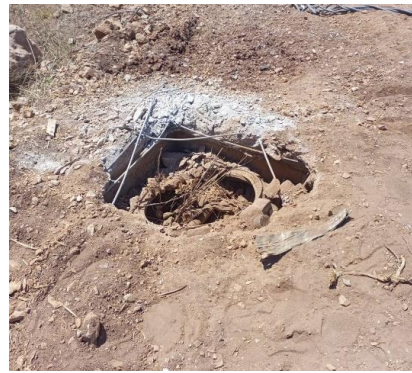
| Asset ID | Asset | Sev. | Finding / quantity |
|---|---|---|---|
| S2-1 | Well (Hay El Jiran) & well head | <b>Destroyed</b> | Well head destroyed. Requires dismantling the well submersible pump and reconstruction of the line from pump to reservoir and to the booster pumps (900 lm carried in the BOQ). Well itself needs maintenance/ reconstruction . [Pre-war: 1 well, flow 49 m <sup>3</sup> /h, depth 600 m.]<br><br>Update: well in under maintenance |
| S2-4 | Distribution & transmission network | <b>Severe</b> | Network from well head to pumping station to reservoir destroyed; multiple internal lines damaged (documented line-by-line in the water annex). [Pre-war distribution network ~25 km.] The BOQ carries 900 lm of the pump-to-reservoir-to-booster transmission line and 5,000 lm of distribution network, both provisional quantities subject to remeasurement. |

*S2-1 / S2-4 — destroyed well head and network from well head to station/reservoir*

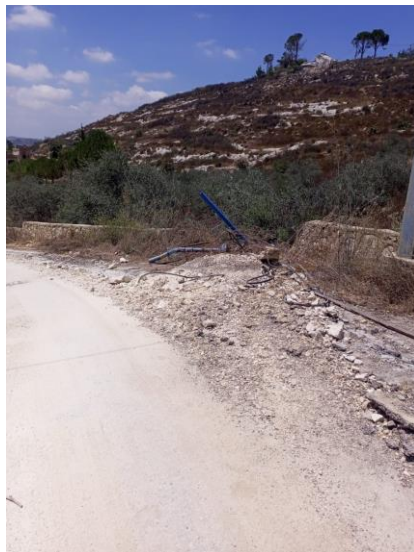
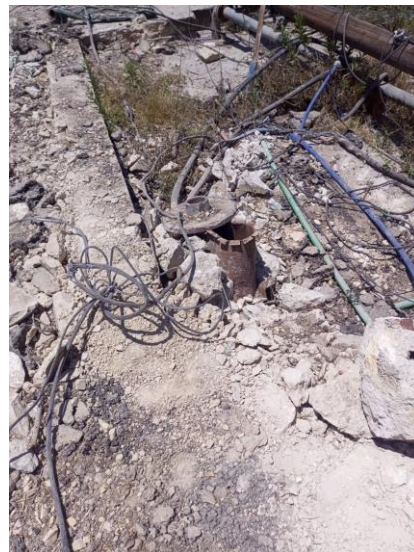
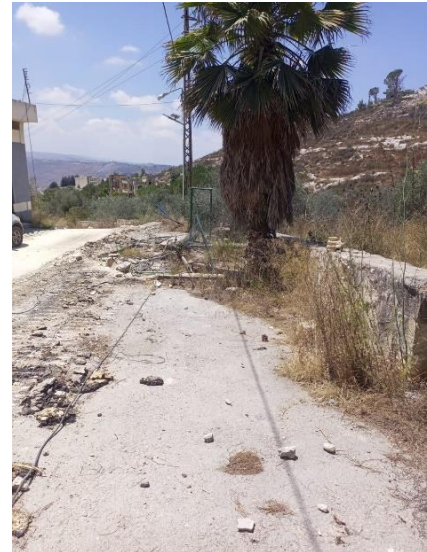
*S2-1 — well requires maintenance*

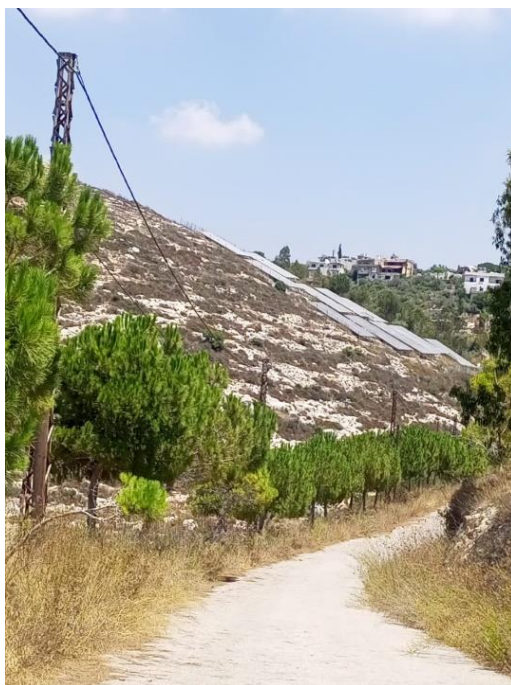
| Asset ID | Asset | Sev. | Finding / quantity |
|---|---|---|---|
| S2-5 | Solar PV panel (at pumping station) | Severe | Solar pumping panel severely reduced — only ~130 panels remain of ~462 pre-war.<br><br>Intervention completed by others |

*S2-5 — solar PV panels damaged near the pumping station*
