**Lebanese Emergency Assistant Project (LEAP)**  
**Rehabilitation of Shelters (Public Schools)**

**Batch 3: Lot 3**

**in Cazas of West Bekaa & Rachaya**

**DETAILED ASSESSMENT REPORT**

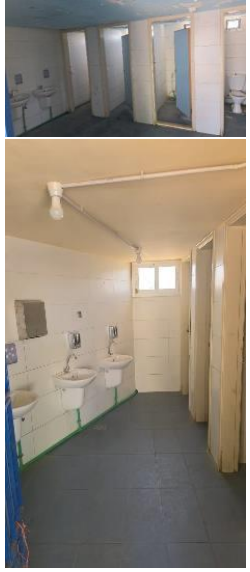
| Floor | Room / Area | Defect Description / Required Works | Qty | Unit | BOQ | Photo |
|---|---|---|---|---|---|---|
| 1st | Toilets: boys | Paint | 15 | m2 | 9.5.1 | |

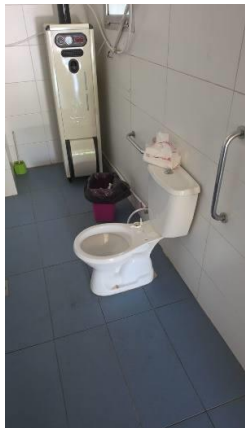
| Floor | Room / Area | Defect Description / Required Works | Qty | Unit | BOQ | Photo |
|---|---|---|---|---|---|---|
| 1st | Toilets: Handicapped | Toilet seat Lid | 1 | pcs | 1.2.1 | |

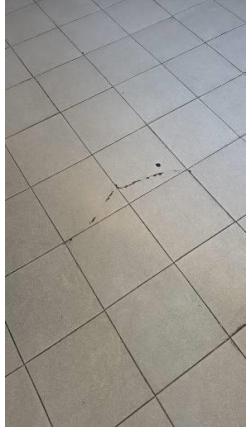
| Floor | Room / Area | Defect Description / Required Works | Qty | Unit | BOQ | Photo |
|---|---|---|---|---|---|---|
| 2nd | | Repair of ceramic floor tiling (30 × 30 cm), approximately 200 tiles | 20 | m2 | 9.2.4 | |

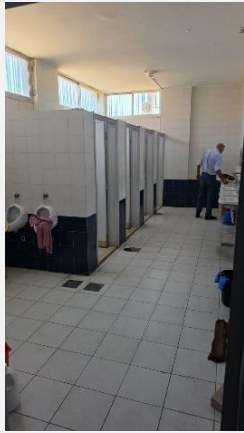
| Floor | Room / Area | Defect Description / Required Works | Qty | Unit | BOQ | Photo |
|---|---|---|---|---|---|---|
| 2nd | Toilets: boys | New complete toilet seat set | 1 | pcs | 1.2.1 | |

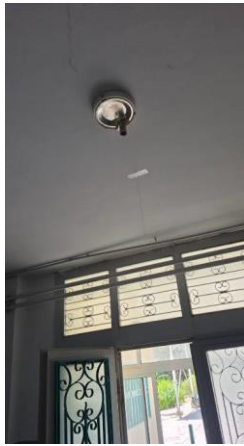
| Floor | Room / Area | Defect Description / Required Works | Qty | Unit | BOQ | Photo |
|---|---|---|---|---|---|---|
| 1st | Entrance Hall | Lamps | 20 | pcs | 1.1.1 | |

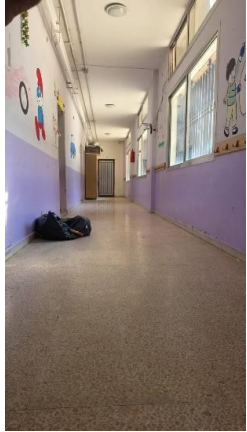
| Floor | Room / Area | Defect Description / Required Works | Qty | Unit | BOQ | Photo |
|---|---|---|---|---|---|---|
| Ground Floor | Coridor (30 x2m) | Paint | 250 | m2 | 9.5.1 | |

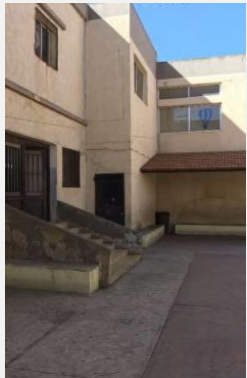
| Floor | Room / Area | Defect Description / Required Works | Qty | Unit | BOQ | Photo |
|---|---|---|---|---|---|---|
| Ground Floor | Outdoor Playground | Paint all external walls in the outdoor playground | 500 | m2 | 9.5.4 | |

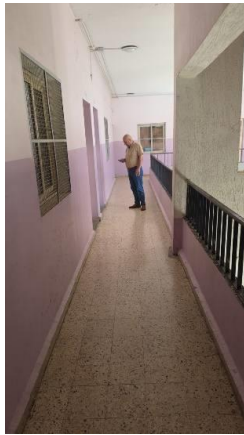
| Floor | Room / Area | Defect Description / Required Works | Qty | Unit | BOQ | Photo |
|---|---|---|---|---|---|---|
| 1st | Coridor -1 | Paint | 360 | m2 | 9.5.1 | |

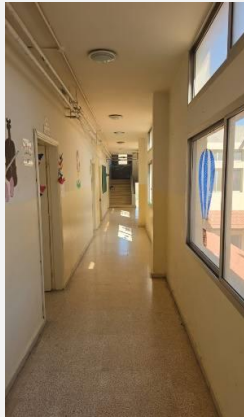
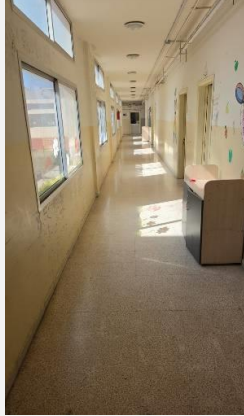
| Floor | Room / Area | Defect Description / Required Works | Qty | Unit | BOQ | Photo |
|---|---|---|---|---|---|---|
| 1st | Coridor: 2-3-4<br>(Coridor-2: 20x1.5 m<br>Coridor-3: 30x1.5 m<br>Coridor-4: 10x3m) | Paint | 500 | m2 | 9.5.1 | |

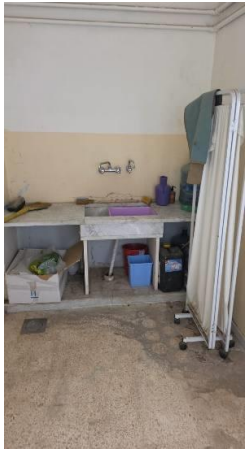
| Floor | Room / Area | Defect Description / Required Works | Qty | Unit | BOQ | Photo |
|---|---|---|---|---|---|---|
| 1st | Kitchen | Paint | 85 | m2 | 9.5.1 | |

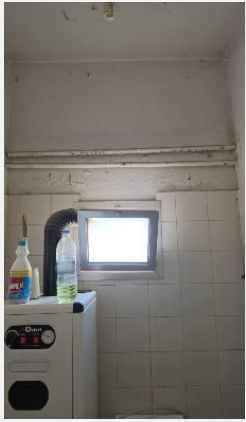
| Floor | Room / Area | Defect Description / Required Works | Qty | Unit | BOQ | Photo |
|---|---|---|---|---|---|---|
| 1st | Toilets | Paint | 35 | m2 | 9.5.1 | |

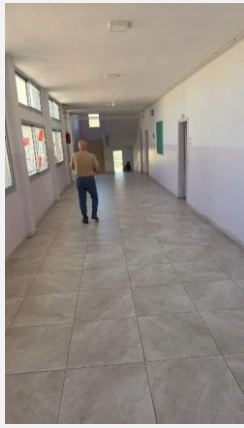
| Floor | Room / Area | Defect Description / Required Works | Qty | Unit | BOQ | Photo |
|---|---|---|---|---|---|---|
| 2nd | Coridor<br>(15x 3m) | Paint | 150 | m2 | 9.5.1 | |

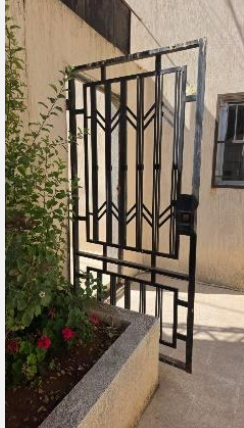
| Floor | Room / Area | Defect Description / Required Works | Qty | Unit | BOQ | Photo |
|---|---|---|---|---|---|---|
| Ground Floor | Metal Gate | Paint metal gate | 1 | pcs | 5.2 | |

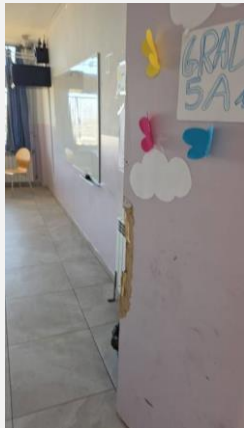
| Floor | Room / Area | Defect Description / Required Works | Qty | Unit | BOQ | Photo |
|---|---|---|---|---|---|---|
| 2nd | 2 | Replace entire wooden door | 1 | pcs | <b>8.1.1</b> | |

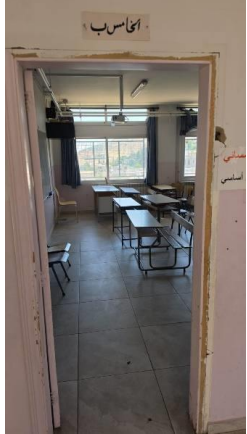
| Floor | Room / Area | Defect Description / Required Works | Qty | Unit | BOQ | Photo |
|---|---|---|---|---|---|---|
| 2nd | 3 | Repair or replace frame of wooden door | 1 | pcs | 8.1.3 | |

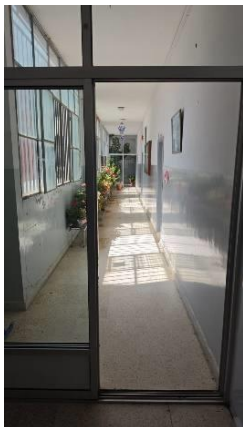
| Floor | Room / Area | Defect Description / Required Works | Qty | Unit | BOQ | Photo |
|---|---|---|---|---|---|---|
| 1st | Coridor<br>(30 x2m + 20x<br>2m) | Paint | 400 | m2 | 9.5.1 | |

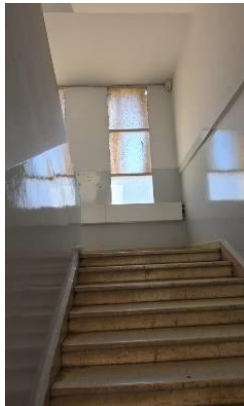
| Floor | Room / Area | Defect Description / Required Works | Qty | Unit | BOQ | Photo |
|---|---|---|---|---|---|---|
| 1st | Staircase | Paint walls | 40 | m2 | 9.5.1 | |

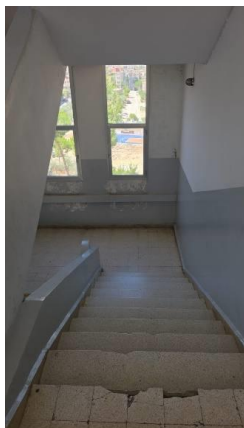
| Floor | Room / Area | Defect Description / Required Works | Qty | Unit | BOQ | Photo |
|---|---|---|---|---|---|---|
| Staircase | | Paint walls | 50 | m2 | 9.5.1 | |

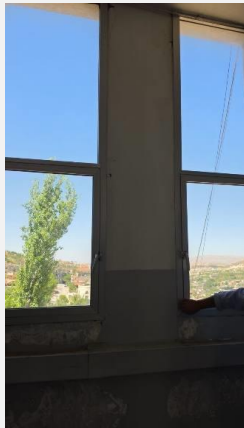
| Floor | Room / Area | Defect Description / Required Works | Qty | Unit | BOQ | Photo |
|---|---|---|---|---|---|---|
| Staircase | | Repair aluminum windows | 6 | pcs | <b>8.2.3</b> | |

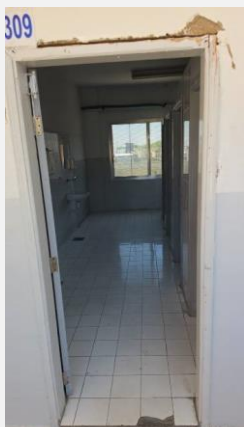
| Floor | Room / Area | Defect Description / Required Works | Qty | Unit | BOQ | Photo |
|---|---|---|---|---|---|---|
| 3rd | Toilets | Repair or replace frame of wooden door | 1 | pcs | <b>8.1.3</b> | |

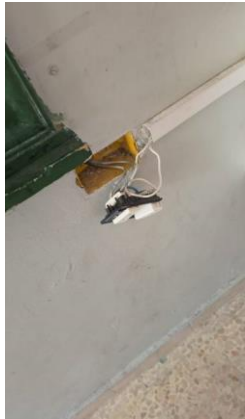
| Floor | Room / Area | Defect Description / Required Works | Qty | Unit | BOQ | Photo |
|---|---|---|---|---|---|---|
| 3rd | | Repair and maintenance of an electrical outlet | 1 | pcs | <b>1.1.3</b> | |

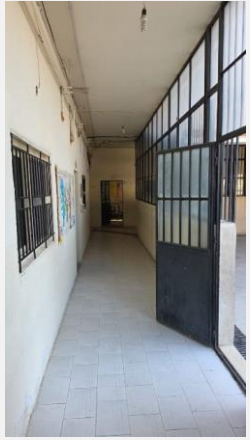
| Floor | Room / Area | Defect Description / Required Works | Qty | Unit | BOQ | Photo |
|---|---|---|---|---|---|---|
| 1st | Coridor (40 x 1.5m) | Paint | 300 | m2 | 9.5.1 | |

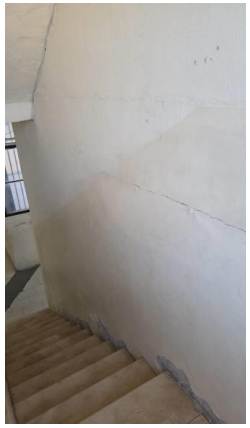
| Floor | Room / Area | Defect Description / Required Works | Qty | Unit | BOQ | Photo |
|---|---|---|---|---|---|---|
| 1st | Staircase | Paint Walls | 50 | m2 | 9.5.1 | |

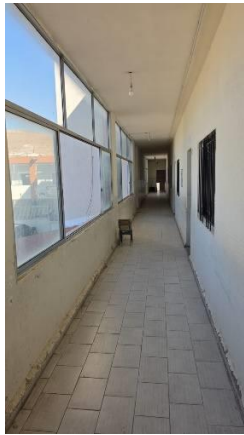
| Floor | Room / Area | Defect Description / Required Works | Qty | Unit | BOQ | Photo |
|---|---|---|---|---|---|---|
| 2nd | Coridor<br>(35 x 1.5m) | Paint | 280 | m2 | 9.5.1 | |

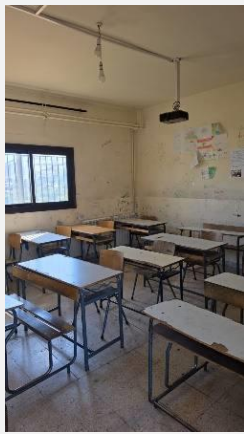
| Floor | Room / Area | Defect Description / Required Works | Qty | Unit | BOQ | Photo |
|---|---|---|---|---|---|---|
| 3rd | 1-2-3-4-5-6 | Paint | 510 | m2 | 9.5.1 | |

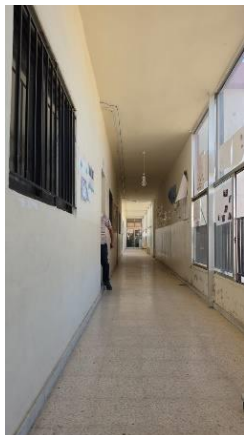
| Floor | Room / Area | Defect Description / Required Works | Qty | Unit | BOQ | Photo |
|---|---|---|---|---|---|---|
| 3rd | Coridor<br>(35x 1.5m) | Paint | 280 | m2 | 9.5.1 | |

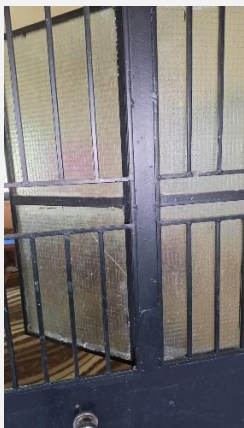
| Floor | Room / Area | Defect Description / Required Works | Qty | Unit | BOQ | Photo |
|---|---|---|---|---|---|---|
| 1st | 2 | Lock for metal door | 1 | pcs | 5.2 | |

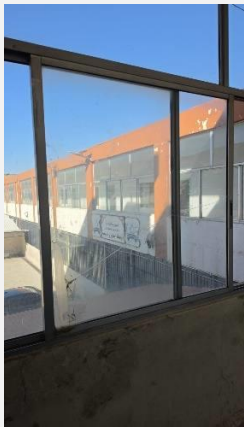
| Floor | Room / Area | Defect Description / Required Works | Qty | Unit | BOQ | Photo |
|---|---|---|---|---|---|---|
| 2nd | Coridor | glass for aluminum window | 1 | pcs | 8.2.3 | |

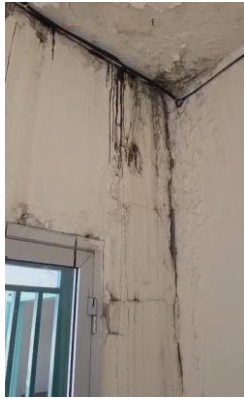
| Floor | Room / Area | Defect Description / Required Works | Qty | Unit | BOQ | Photo |
|---|---|---|---|---|---|---|
| All School | all classes / walls | Severe deterioration in walls, due to bombings in almost all the school, which is causing a leakage problem as well. | 400 | m2 | 7.1 | |

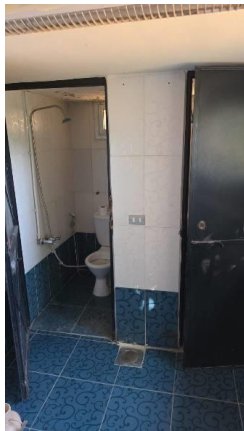
| Floor | Room / Area | Defect Description / Required Works | Qty | Unit | BOQ | Photo |
|---|---|---|---|---|---|---|
| 1st | Toilets: girls | New complete toilet seat set | 1 | pcs | 1.2.1 | |

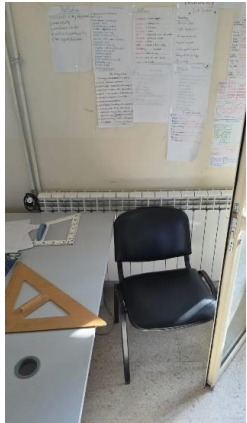
| Floor | Room / Area | Defect Description / Required Works | Qty | Unit | BOQ | Photo |
|---|---|---|---|---|---|---|
| All school | Radiators | Possibility of repair and maintenance of dysfunctional radiators units | | LS | 1.2.2 | |

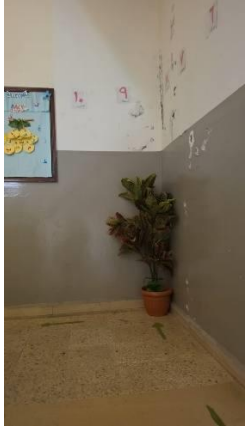
| Floor | Room / Area | Defect Description / Required Works | Qty | Unit | BOQ | Photo |
|---|---|---|---|---|---|---|
| Staircase | | Paint walls | 50 | m2 | 9.5.1 | |

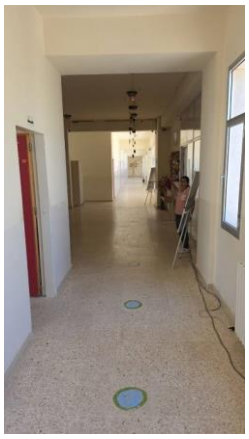
| Floor | Room / Area | Defect Description / Required Works | Qty | Unit | BOQ | Photo |
|---|---|---|---|---|---|---|
| 1st<br>(60x3m) | Coridor | Paint | 550 | m2 | 9.5.1 | |

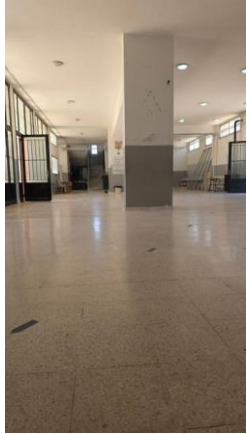
| Finishing | | | | | | |
|---|---|---|---|---|---|---|
| Ground Floor | Indoor Playground-1 | Paint walls | 500 | m2 | 9.5.1 | |

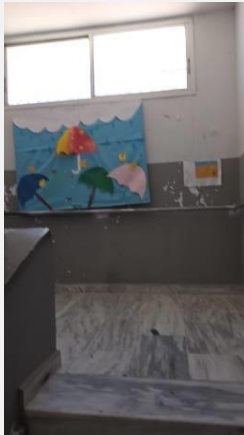
| Floor | Room / Area | Defect Description / Required Works | Qty | Unit | BOQ | Photo |
|---|---|---|---|---|---|---|
| | Staircase | Paints walls | 45 | m2 | 9.5.1 | |

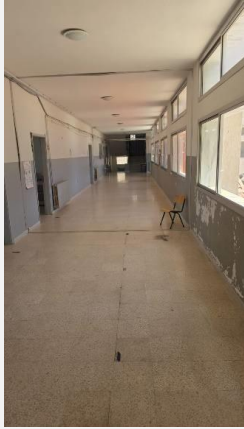
| Floor | Room / Area | Defect Description / Required Works | Qty | Unit | BOQ | Photo |
|---|---|---|---|---|---|---|
| 2nd | Coridor<br>(25x4m<br>25x4m<br>30x4m) | Paint | 850 | m2 | 9.5.1 | |

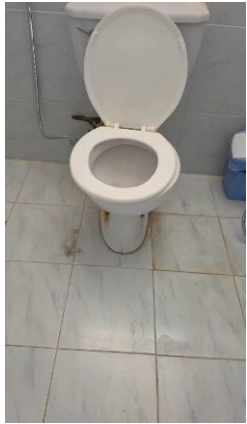
| Floor | Room / Area | Defect Description / Required Works | Qty | Unit | BOQ | Photo |
|---|---|---|---|---|---|---|
| 2nd | Toilets | Complete Toilet Seat Set | 1 | pcs | <b>1.2.1</b> | |

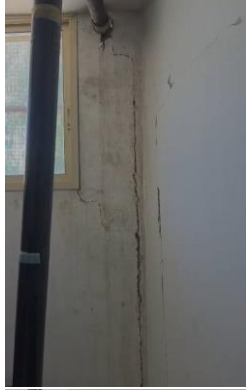
| Floor | Room / Area | Defect Description / Required Works | Qty | Unit | BOQ | Photo |
|---|---|---|---|---|---|---|
| All School | all classes / walls | Severe deterioration in walls, due to bombings in almost all the school, which is causing a leakage problem as well. | | LS | 9.1.2 & 9.5.1 | |

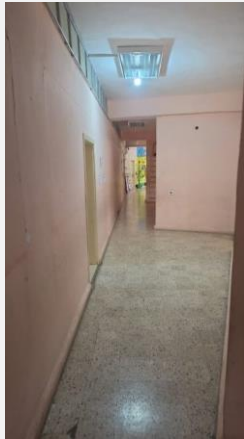
| Floor | Room / Area | Defect Description / Required Works | Qty | Unit | BOQ | Photo |
|---|---|---|---|---|---|---|
| 1st | Corridor<br>(70× 5m) | Paint | 800 | m2 | <b>9.5.1</b> | |

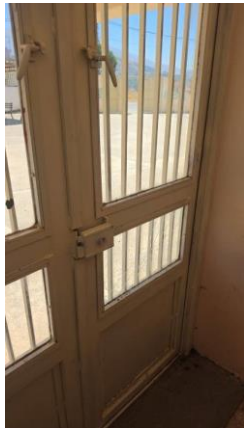
| Floor | Room / Area | Defect Description / Required Works | Qty | Unit | BOQ | Photo |
|---|---|---|---|---|---|---|
| 1st | | Glass | 1 | pcs | <b>5.2</b> | |

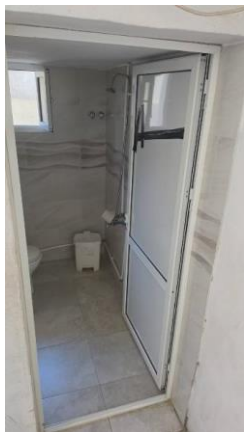
| Floor | Room / Area | Defect Description / Required Works | Qty | Unit | BOQ | Photo |
|---|---|---|---|---|---|---|
| 1st | Toilets | Replace full aluminum door | 1 | pcs | <b>8.2.2</b> | |

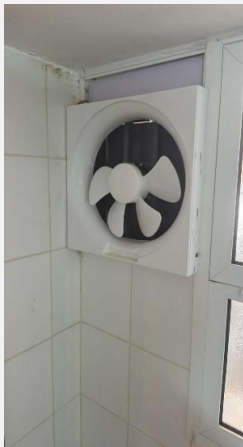
| Floor | Room / Area | Defect Description / Required Works | Qty | Unit | BOQ | Photo |
|---|---|---|---|---|---|---|
| 1st | Toilets | Replacement of exhaust fan | 1 | pcs | <b>1.2.2</b> | |

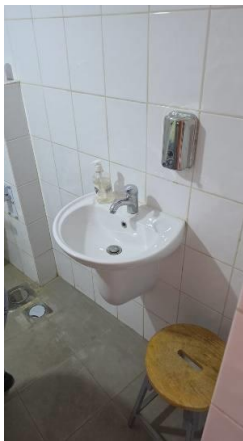
| Floor | Room / Area | Defect Description / Required Works | Qty | Unit | BOQ | Photo |
|---|---|---|---|---|---|---|
| 1st | Toilets | Faucet | 1 | pcs | <b>5.6</b> | |

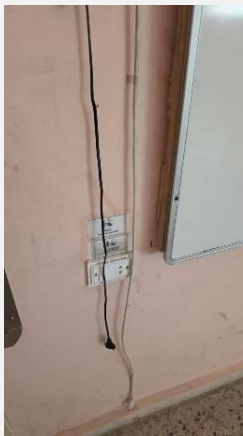
| Floor | Room / Area | Defect Description / Required Works | Qty | Unit | BOQ | Photo |
|---|---|---|---|---|---|---|
| 1st | 1-3-4-5-6-7-8-9 | Repair and maintenance of an electrical outlet<br>(x1 in class1 - x4 in class3 - x3 in class4, 6, 7, 8, 9 - x2 in class5) | 22 | pcs | <b>1.1.3</b> | |

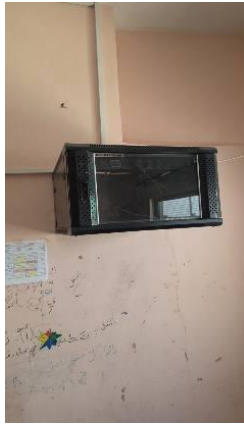
| Floor | Room / Area | Defect Description / Required Works | Qty | Unit | BOQ | Photo |
|---|---|---|---|---|---|---|
| 1st | 1 | Repair Projector mount box | 1 | pcs | <b>1.1.9</b> | |

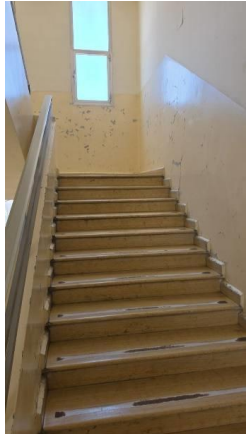
| Floor | Room / Area | Defect Description / Required Works | Qty | Unit | BOQ | Photo |
|---|---|---|---|---|---|---|
| 2nd | Staircase | Paint staircase walls | 50 | m2 | 9.5.1 | |

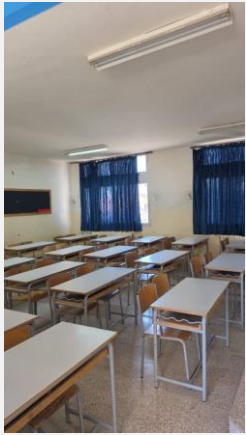
| Floor | Room / Area | Defect Description / Required Works | Qty | Unit | BOQ | Photo |
|---|---|---|---|---|---|---|
| 3rd | 1-2-3-4-5-6-7 | Paint | 595 | m2 | 9.5.1 | |

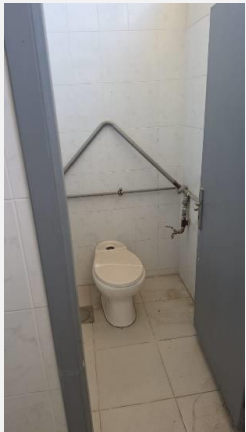
| Floor | Room / Area | Defect Description / Required Works | Qty | Unit | BOQ | Photo |
|---|---|---|---|---|---|---|
| 1st | Toilets: boys- | Install complete set of toilet seat | 1 | pcs | 1.2.1 | |

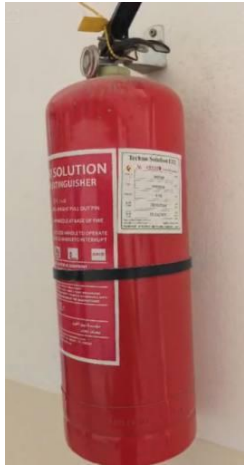
| Floor | Room / Area | Defect Description / Required Works | Qty | Unit | BOQ | Photo |
|---|---|---|---|---|---|---|
| All Shool | | Possibility of proving new Fire extinguisher. | 25 | pcs | 4.1 | |

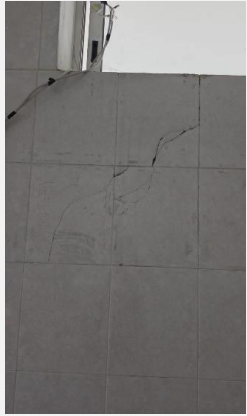
| Floor | Room / Area | Defect Description / Required Works | Qty | Unit | BOQ | Photo |
|---|---|---|---|---|---|---|
| 1st | Toilets | Replace broken ceramics tile | 3 | pcs | 9.2.4 | |

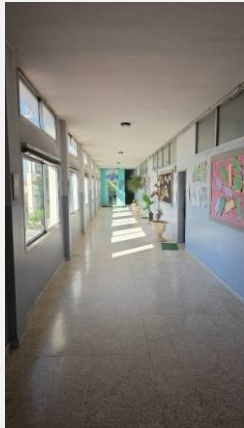
| Floor | Room / Area | Defect Description / Required Works | Qty | Unit | BOQ | Photo |
|---|---|---|---|---|---|---|
| 3rd | Corridor (30x3 m) | Paint | 280 | m2 | 9.5.1 | |

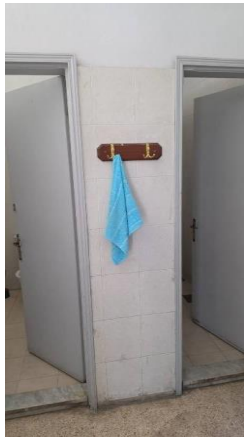
| Floor | Room / Area | Defect Description / Required Works | Qty | Unit | BOQ | Photo |
|---|---|---|---|---|---|---|
| 1st | Toilets | Paint wooden doors (x2) | 8 | m2 | 8.1.3 | |

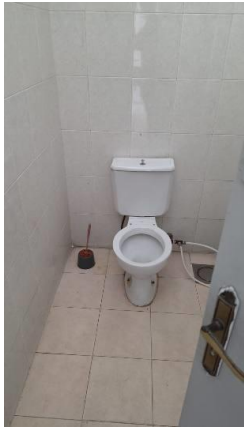
| Floor | Room / Area | Defect Description / Required Works | Qty | Unit | BOQ | Photo |
|---|---|---|---|---|---|---|
| 1st | Toilets | New Complete toilet seat set | 2 | pcs | 1.2.1 | |

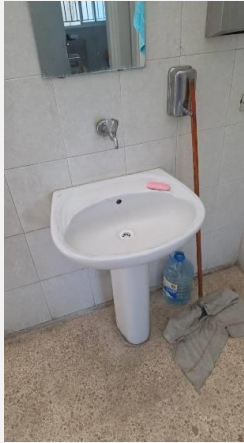
| Floor | Room / Area | Defect Description / Required Works | Qty | Unit | BOQ | Photo |
|---|---|---|---|---|---|---|
| 1st | Toilets | Replacement of washbasin | 1 | pcs | 5.4 | |
