**Lebanese Emergency Assistant Project (LEAP)**  
**Rehabilitation of Shelters (Public Schools)**

**Batch 3: Lot 2**  
**in Caza of Zahle**

**DETAILED ASSESSMENT REPORT**

**Batch 3-LOT 2 — ZAHLE**

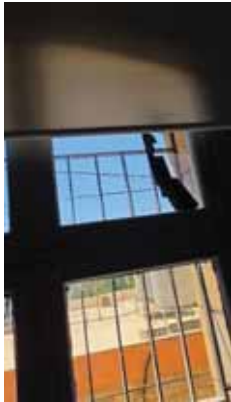
| Floor | Room / Area | Defect Description / Required Works | Qty | Unit | BOQ | Photo |
|---|---|---|---|---|---|---|
| 1st | 1-2- | Glass for window<br>(x1 in each classroom) | 2 | pcs | 5.2 | |

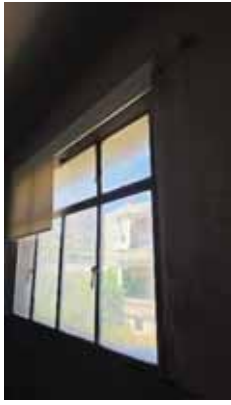
| Floor | Room / Area | Defect Description / Required Works | Qty | Unit | BOQ | Photo |
|---|---|---|---|---|---|---|
| 2nd | 8-9- | Glass<br>(x1 in class 8 x2 in class 9) | 3 | pcs | 5.2 | |

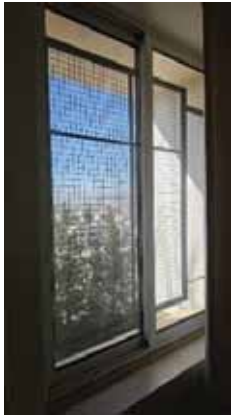
| Floor | Room / Area | Defect Description / Required Works | Qty | Unit | BOQ | Photo |
|---|---|---|---|---|---|---|
| 3rd | 4 | Net for aluminum window | 1 | pcs | 8.2.3 | |

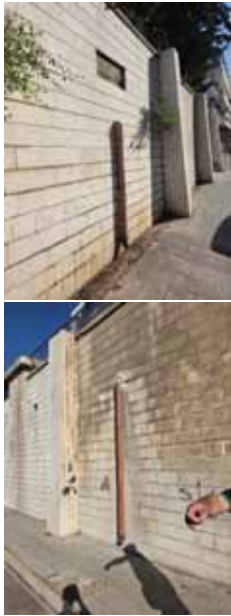
| Floor | Room / Area | Defect Description / Required Works | Qty | Unit | BOQ | Photo |
|---|---|---|---|---|---|---|
| Exterior | External Pipes | These drainage pipes were installed on the exterior walls of the school, as they explained, serve displaced families by channeling kitchen and dishwashing wastewater outside. However, the wastewater began accumulating on the public road, creating several issues. The municipality stated that it could only intervene to solve if the matter was held through an organization to assist them. | | LS | 1.2.1 | |

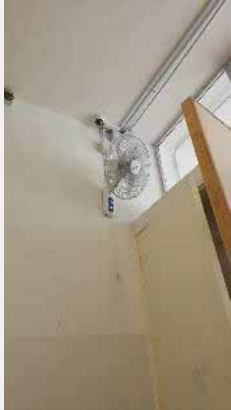
| Floor | Room / Area | Defect Description / Required Works | Qty | Unit | BOQ | Photo |
|---|---|---|---|---|---|---|
| 2nd | 2-3- | Wall-mounted fan | 2 | pcs | 1.2.2 | |

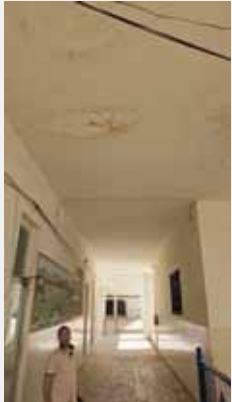
| Finishing | | | | | | |
|---|---|---|---|---|---|---|
| 1st | Hallways | Paint walls & ceiling | 200 | m2 | 9.5.1 | |

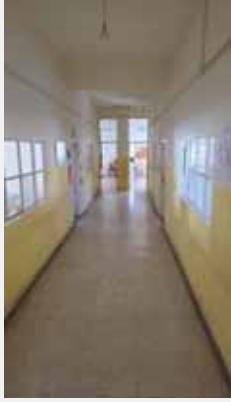
| Floor | Room / Area | Defect Description / Required Works | Qty | Unit | BOQ | Photo |
|---|---|---|---|---|---|---|
| 2nd | Corridor | Paint Walls | 200 | m2 | 9.5.1 | |

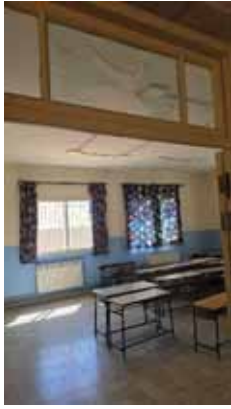
| Floor | Room / Area | Defect Description / Required Works | Qty | Unit | BOQ | Photo |
|---|---|---|---|---|---|---|
| 2nd | 6 | New fixed glass | 1 | pcs | 8.1.3 | |

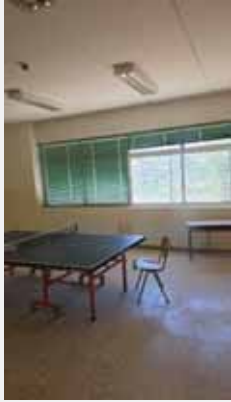
| Finishing | | | | | | |
|---|---|---|---|---|---|---|
| 1st | 1-2-3-4-5 | Paint | 425 | m2 | 9.5.1 | |

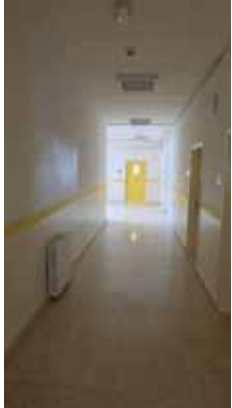
| Floor | Room / Area | Defect Description / Required Works | Qty | Unit | BOQ | Photo |
|---|---|---|---|---|---|---|
| 2nd | Coridor | Paint | 140 | m2 | 9.5.1 | |

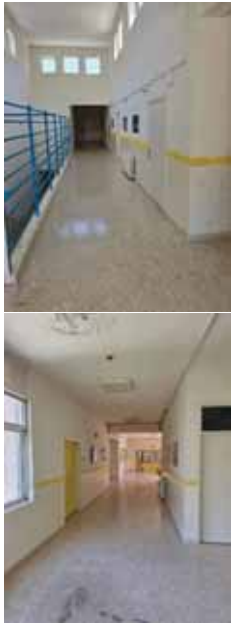
| Floor | Room / Area | Defect Description / Required Works | Qty | Unit | BOQ | Photo |
|---|---|---|---|---|---|---|
| 3rd | Coridor | Paint | 200 | m2 | 9.5.1 | |

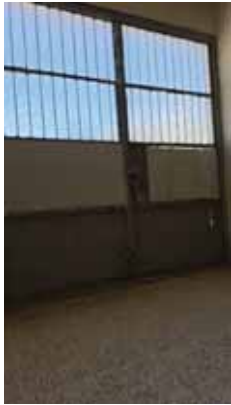
| Floor | Room / Area | Defect Description / Required Works | Qty | Unit | BOQ | Photo |
|---|---|---|---|---|---|---|
| 1st | Playground - Indoor 2 | Repair & Paint metal door | 2 | pcs | 5.2 | |

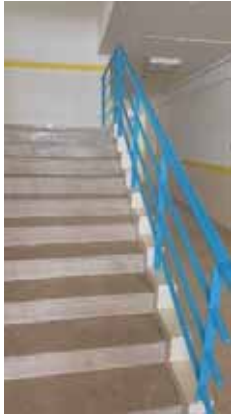
| Floor | Room / Area | Defect Description / Required Works | Qty | Unit | BOQ | Photo |
|---|---|---|---|---|---|---|
| All Floors | Staircase handrail | Painting of staircase metal handrails throughout the entire building | 20 | lm | 5.5 | |

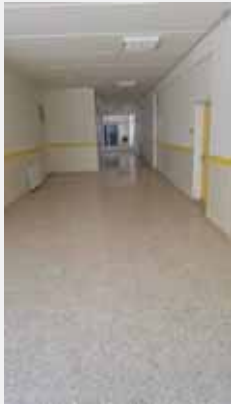
| Floor | Room / Area | Defect Description / Required Works | Qty | Unit | BOQ | Photo |
|---|---|---|---|---|---|---|
| 1st | Sport room | Doors Handles | 2 | pcs | 8.1.3 | |

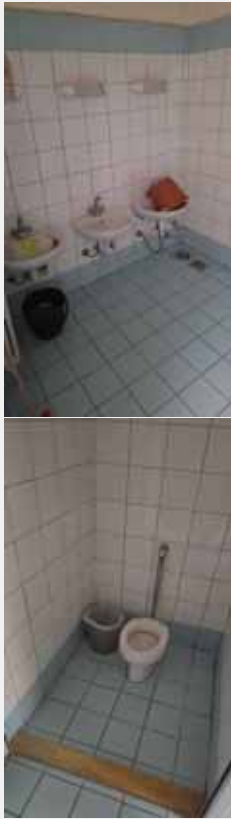
| Floor | Room / Area | Defect Description / Required Works | Qty | Unit | BOQ | Photo |
|---|---|---|---|---|---|---|
| 3rd | Kindergarten - Toilets | flushing mechanism for toilet seat | 2 | pcs | 1.2.1 | |

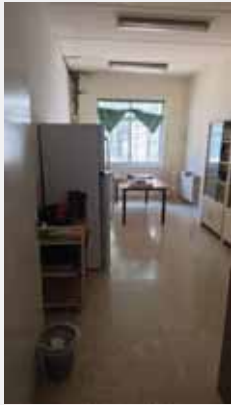
| Floor | Room / Area | Defect Description / Required Works | Qty | Unit | BOQ | Photo |
|---|---|---|---|---|---|---|
| 3rd | Kindergarten 10-11-12-13-14 | Curtains<br>(x2 in each classroom) | 10 | pcs | 10.5 | |

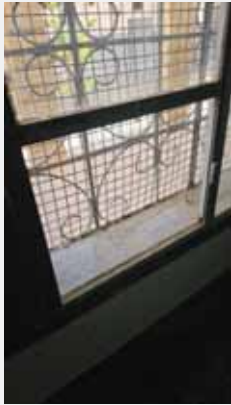
| Floor | Room / Area | Defect Description / Required Works | Qty | Unit | BOQ | Photo |
|---|---|---|---|---|---|---|
| 1st | 4 | Glass | 1 | pcs | 5.2 | |

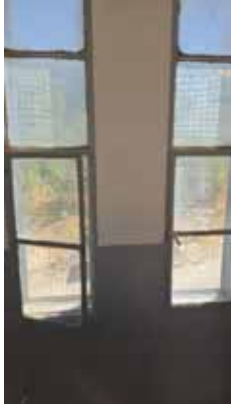
| Floor | Room / Area | Defect Description / Required Works | Qty | Unit | BOQ | Photo |
|---|---|---|---|---|---|---|
| 1st | Staircase | windows glass | 2 | pcs | 5.2 | |

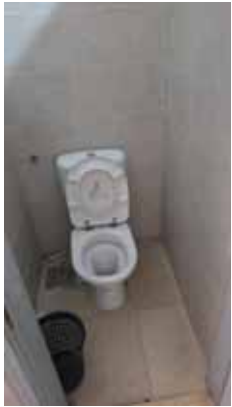
| Floor | Room / Area | Defect Description / Required Works | Qty | Unit | BOQ | Photo |
|---|---|---|---|---|---|---|
| 1st | Toilet: boys-girls | Handheld bidet sprayer<br>(x4 in each toilet) | 8 | pcs | 1.2.1 | |

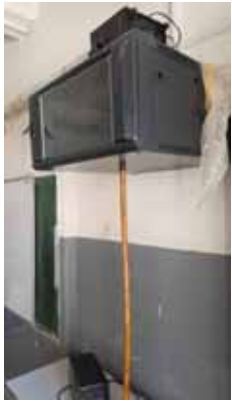
| Floor | Room / Area | Defect Description / Required Works | Qty | Unit | BOQ | Photo |
|---|---|---|---|---|---|---|
| 1st | 3- | Maintenance of wall mounted IT<br>equipment cabinet. | 1 | pcs | 5 | |

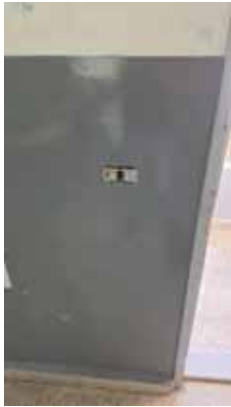
| Floor | Room / Area | Defect Description / Required Works | Qty | Unit | BOQ | Photo |
|---|---|---|---|---|---|---|
| 2nd | 1-2-3- | Electrical outlet cover | 3 | pcs | 1.1.3 | |

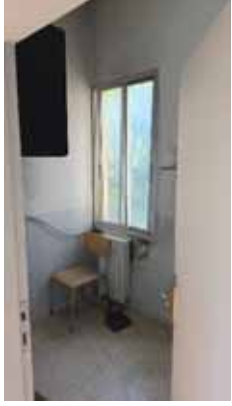
| Finishing | | | | | | |
|---|---|---|---|---|---|---|
| 2nd | Kitchen | Paint | 35 | m2 | 9.5.1 | |

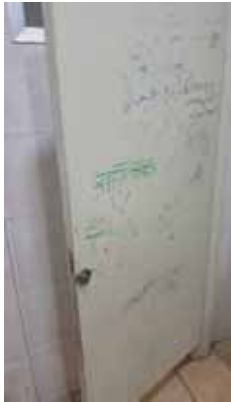
| Floor | Room / Area | Defect Description / Required Works | Qty | Unit | BOQ | Photo |
|---|---|---|---|---|---|---|
| 1st | Toilet: 1-2 | Paint x3 doors<br>(x2 doors in Toilet-1 and x1 door in Toilet-2) | 12 | m2 | 8.1.3 | |

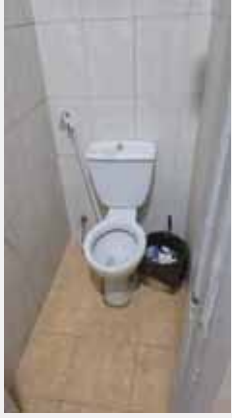
| Floor | Room / Area | Defect Description / Required Works | Qty | Unit | BOQ | Photo |
|---|---|---|---|---|---|---|
| 2nd | Toilets | New Toilet seat lid | 2 | pcs | 1.2.1 | |

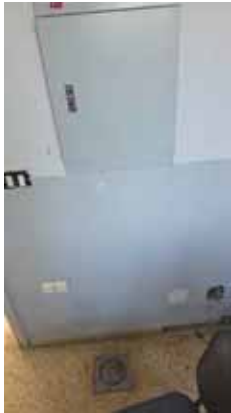
| Floor | Room / Area | Defect Description / Required Works | Qty | Unit | BOQ | Photo |
|---|---|---|---|---|---|---|
| 3rd | Kitchen | Electrical boxes | 2 | pcs | 1.1.3 | |

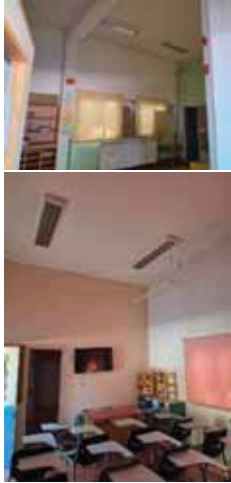
| Finishing | | | | | | |
|---|---|---|---|---|---|---|
| 1st | 1-2-3- | Paint | 255 | m2 | 9.5.1 | |

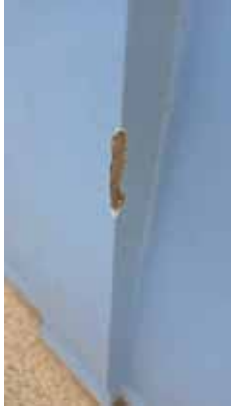
| Floor | Room / Area | Defect Description / Required Works | Qty | Unit | BOQ | Photo |
|---|---|---|---|---|---|---|
| 2nd | Coridor | Repair walls | 20 | m2 | 9.1.2 & 9.5.1 | |

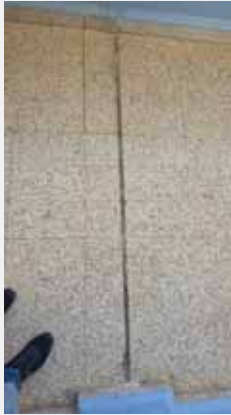
| Floor | Room / Area | Defect Description / Required Works | Qty | Unit | BOQ | Photo |
|---|---|---|---|---|---|---|
| 2nd | Coridor | Repair Flooring Joints | 2 | pcs | 9.2.4 | |

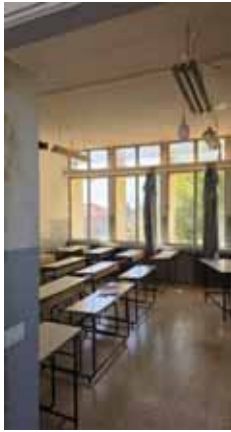
| Floor | Room / Area | Defect Description / Required Works | Qty | Unit | BOQ | Photo |
|---|---|---|---|---|---|---|
| 3rd | 1-2-3-4- | Paint Walls | 340 | m2 | 9.5.1 | |

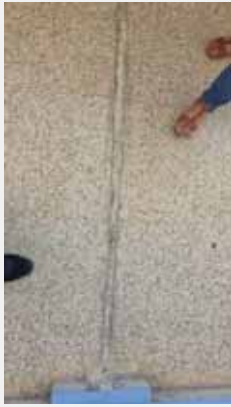
| Floor | Room / Area | Defect Description / Required Works | Qty | Unit | BOQ | Photo |
|---|---|---|---|---|---|---|
| 3rd | Coridor | Repair Flooring Joints | 1 | pcs | 9.2.4 | |

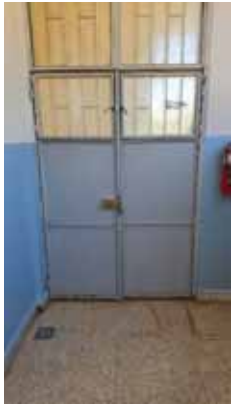
| Floor | Room / Area | Defect Description / Required Works | Qty | Unit | BOQ | Photo |
|---|---|---|---|---|---|---|
| 2nd | Coridor | Paint metal door | 1 | [cs | 5.2 | |

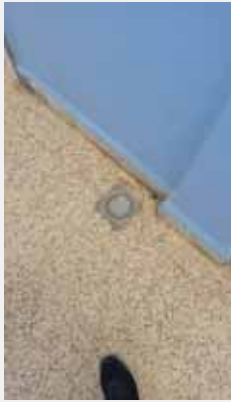
| Floor | Room / Area | Defect Description / Required Works | Qty | Unit | BOQ | Photo |
|---|---|---|---|---|---|---|
| 3rd | Coridor | Sanitary Maintenance | 1 | pcs | 1.2.1 | |

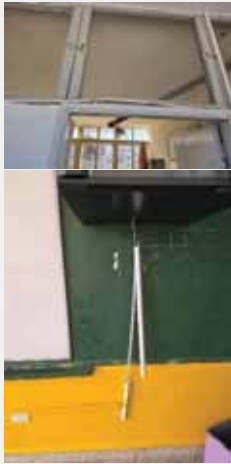
| Floor | Room / Area | Defect Description / Required Works | Qty | Unit | BOQ | Photo |
|---|---|---|---|---|---|---|
| 2nd | 2-4-6- | Cache-Cable<br>(x2 in class2, x1 in class 4 and class 6) | 4 | pcs | 1.1.2 | |

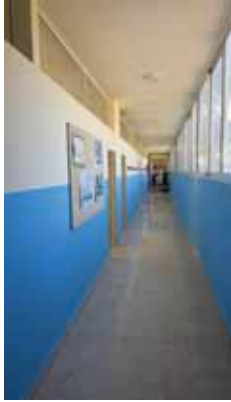
| Floor | Room / Area | Defect Description / Required Works | Qty | Unit | BOQ | Photo |
|---|---|---|---|---|---|---|
| 2nd | Coridor | Paint Walls & Ceiling<br>(40 x 1.2m) | 300 | m2 | 9.5.1 | |

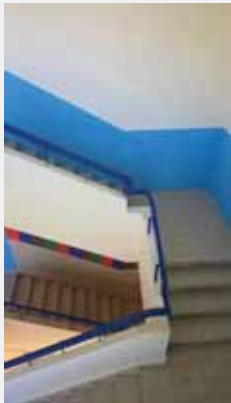
| Floor | Room / Area | Defect Description / Required Works | Qty | Unit | BOQ | Photo |
|---|---|---|---|---|---|---|
| Staircase<br>(30 x 1.5m) | | Paint | 50 | m2 | 9.5.1 | |

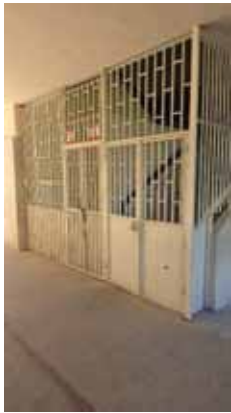
| Floor | Room / Area | Defect Description / Required Works | Qty | Unit | BOQ | Photo |
|---|---|---|---|---|---|---|
| Gate | | Paint Metal Gate | 1 | pcs | 5.2 | |

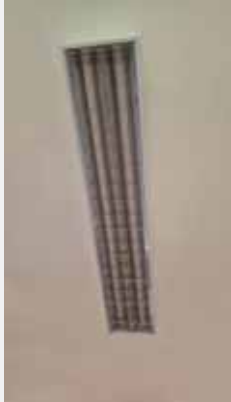
| Floor | Room / Area | Defect Description / Required Works | Qty | Unit | BOQ | Photo |
|---|---|---|---|---|---|---|
| 2nd | Coridor | Neon Lights | 14 | pcs | 1.1.1 | |

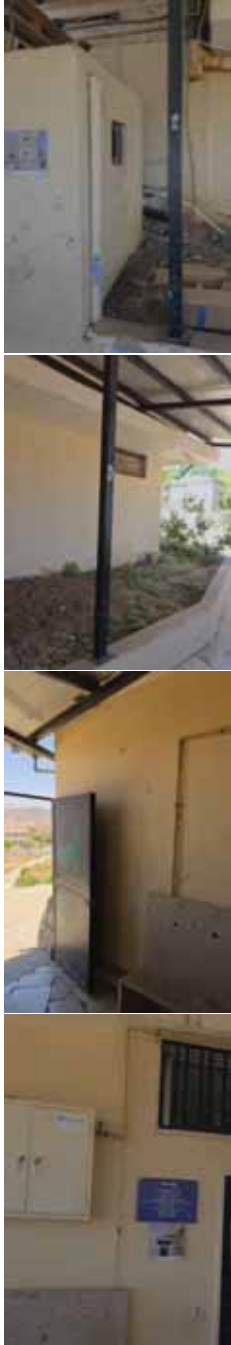
| Finishing | | | | | | |
|---|---|---|---|---|---|---|
| 1st | Entrance | Paint All walls on the entrance of the school | 100 | m2 | 9.5.1 | |

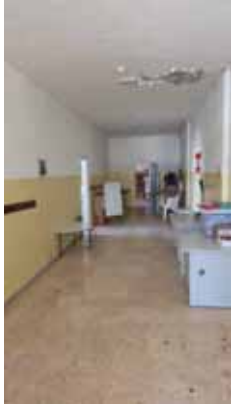
| Floor | Room / Area | Defect Description / Required Works | Qty | Unit | BOQ | Photo |
|---|---|---|---|---|---|---|
| 1st | Hallway | Paint | 150 | m2 | 9.5.1 | |

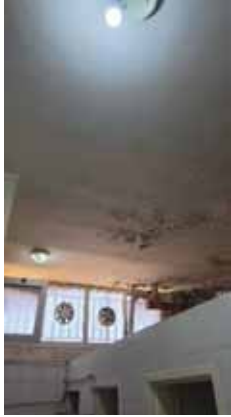
| Finishing | | | | | | |
|---|---|---|---|---|---|---|
| 1st | Toilets | Paint | 25 | m2 | 9.5.1 | |

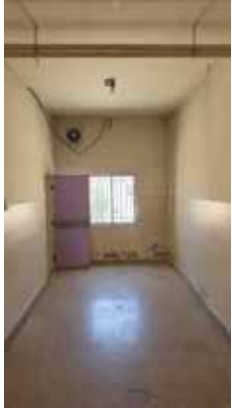
| Floor | Room / Area | Defect Description / Required Works | Qty | Unit | BOQ | Photo |
|---|---|---|---|---|---|---|
| 2nd | Hallway next to toilets | Paint | 70 | m2 | 9.5.1 | |

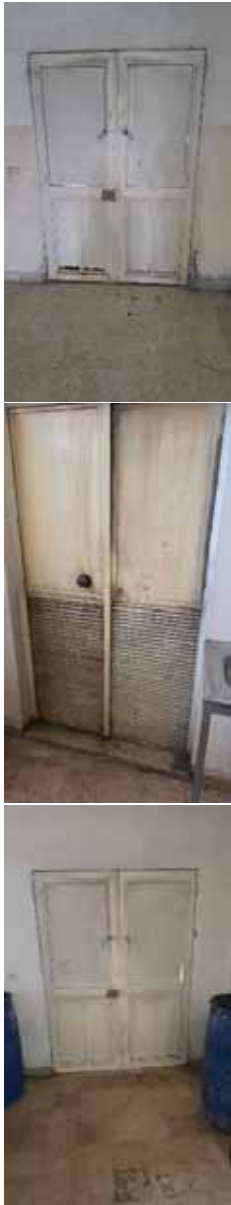
| Floor | Room / Area | Defect Description / Required Works | Qty | Unit | BOQ | Photo |
|---|---|---|---|---|---|---|
| 1st | Coridor | Paint metal doors | 3 | pcs | 5.2 | |

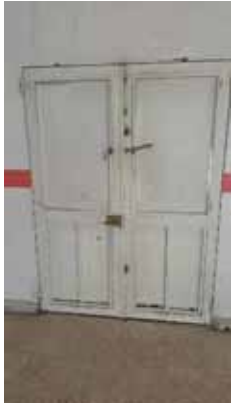
| Floor | Room / Area | Defect Description / Required Works | Qty | Unit | BOQ | Photo |
|---|---|---|---|---|---|---|
| Playground | | Paint Door | 1 | pcs | 8.1.3 | |

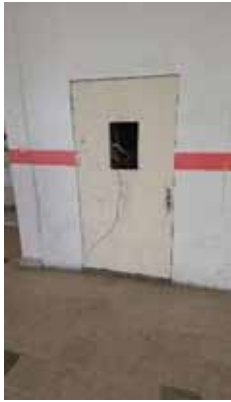
| Floor | Room / Area | Defect Description / Required Works | Qty | Unit | BOQ | Photo |
|---|---|---|---|---|---|---|
| Playground | | Repair wooden door | 1 | pcs | 8.1.3 | |

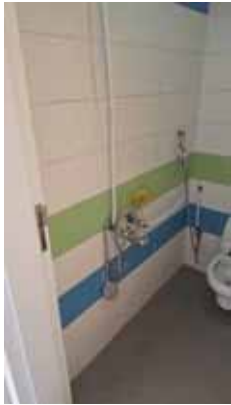
| Floor | Room / Area | Defect Description / Required Works | Qty | Unit | BOQ | Photo |
|---|---|---|---|---|---|---|
| 1st | Playground Toilets | Shower mixer tap | 1 | pcs | 5.11 | |

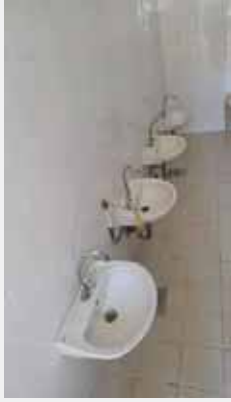
| Floor | Room / Area | Defect Description / Required Works | Qty | Unit | BOQ | Photo |
|---|---|---|---|---|---|---|
| 1st | Playground Toilets | Faucets | 5 | pcs | 5.6 | |

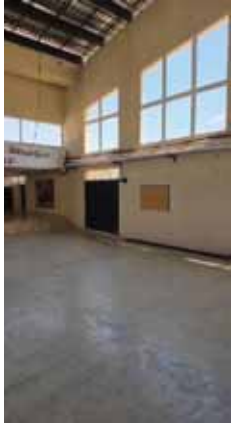
| Finishing | | | | | | |
|---|---|---|---|---|---|---|
| 1st | Open space playground and entrance | Paint | 220 | m2 | 9.5.1 | |

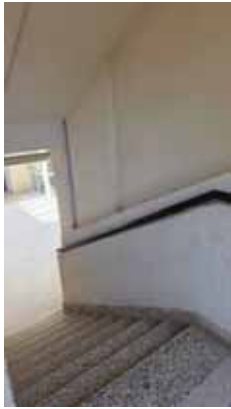
| Floor | Room / Area | Defect Description / Required Works | Qty | Unit | BOQ | Photo |
|---|---|---|---|---|---|---|
| 1st | Staircase | Paint walls of the staircase | 50 | m2 | 9.5.1 | |

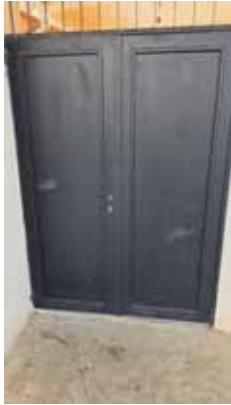
| Floor | Room / Area | Defect Description / Required Works | Qty | Unit | BOQ | Photo |
|---|---|---|---|---|---|---|
| 1st | | Paint metal doors | 15 | pcs | 5.2 | |

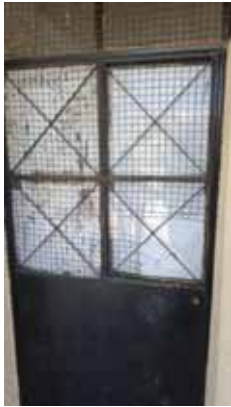
| Floor | Room / Area | Defect Description / Required Works | Qty | Unit | BOQ | Photo |
|---|---|---|---|---|---|---|
| 1st | | Door Glass | 1 | pcs | 5.2 | |

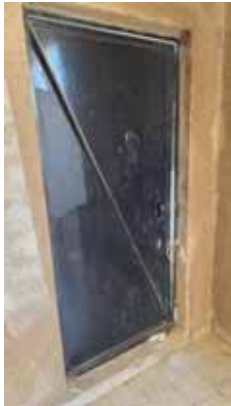
| Floor | Room / Area | Defect Description / Required Works | Qty | Unit | BOQ | Photo |
|---|---|---|---|---|---|---|
| 2nd | | Paint metal door | 1 | pcs | 5.2 | |

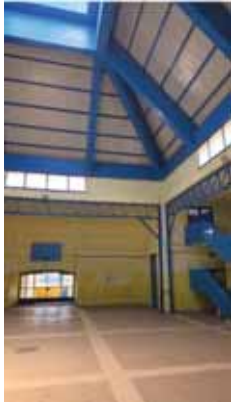
| Floor | Room / Area | Defect Description / Required Works | Qty | Unit | BOQ | Photo |
|---|---|---|---|---|---|---|
| | Open space playground + Hallways walls | Paint | 300 | m2 | 9.5.1 | |

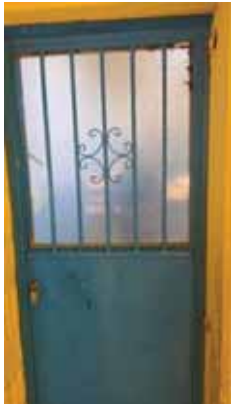
| Floor | Room / Area | Defect Description / Required Works | Qty | Unit | BOQ | Photo |
|---|---|---|---|---|---|---|
| 1st | Toilet | Door Glass | 1 | pcs | 5.2 | |

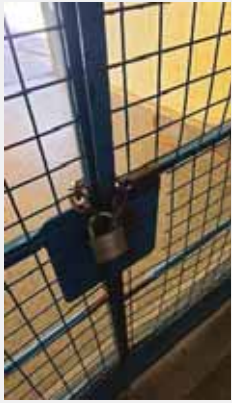
| Floor | Room / Area | Defect Description / Required Works | Qty | Unit | BOQ | Photo |
|---|---|---|---|---|---|---|
| 1st | Hallway | Lock | 2 | pcs | 5.2 | |

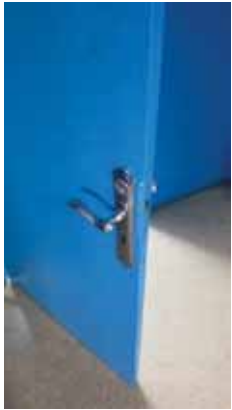
| Floor | Room / Area | Defect Description / Required Works | Qty | Unit | BOQ | Photo |
|---|---|---|---|---|---|---|
| 1st | 1-2-3-4-5-6-7-8-9-10-11-12 | Door Handles (2) | 24 | pcs | 8.1.3 | |

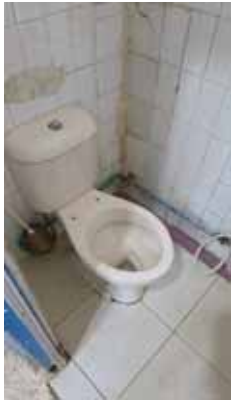
| Floor | Room / Area | Defect Description / Required Works | Qty | Unit | BOQ | Photo |
|---|---|---|---|---|---|---|
| 1st | Toilet | New Toilet seat Lid | 1 | pcs | 1.2.1 | |

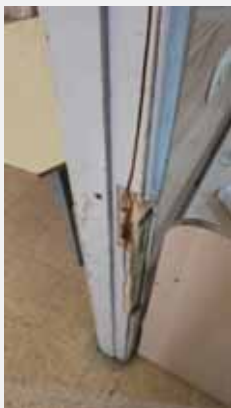
| Floor | Room / Area | Defect Description / Required Works | Qty | Unit | BOQ | Photo |
|---|---|---|---|---|---|---|
| 1st | 7 | Change the frame of wooden door | 1 | pcs | 8.1.3 | |

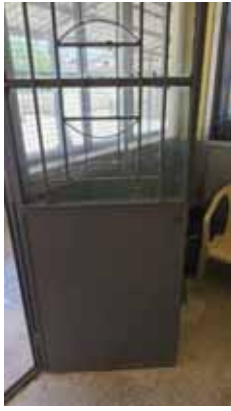
| Floor | Room / Area | Defect Description / Required Works | Qty | Unit | BOQ | Photo |
|---|---|---|---|---|---|---|
| 1st | Hallway | Lock for metal door | 1 | pcs | 8.1.3 | |

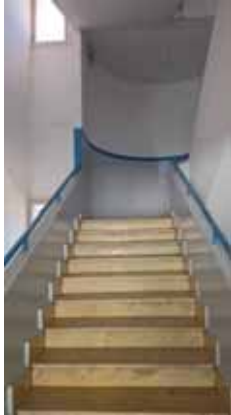
| Finishing | | | | | | |
|---|---|---|---|---|---|---|
| | Staircase | Paint walls | 45 | m2 | 9.5.1 | |

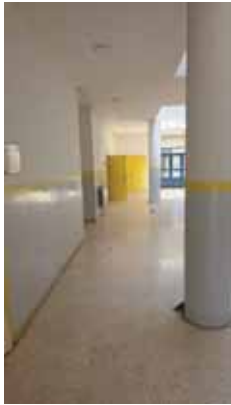
| Floor | Room / Area | Defect Description / Required Works | Qty | Unit | BOQ | Photo |
|---|---|---|---|---|---|---|
| 1st-Block D | Coridor | Paint | 150 | m2 | 9.5.1 | |

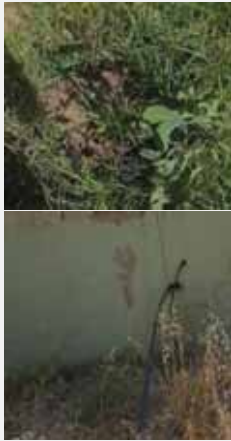
| Floor | Room / Area | Defect Description / Required Works | Qty | Unit | BOQ | Photo |
|---|---|---|---|---|---|---|
| Outdoor | Water Well and Submersible Pump System | Repair or Replace Submersible well pump (dysfunctional)<br>- غطاس البئر - | 1 | pcs | 1.2.1 | |

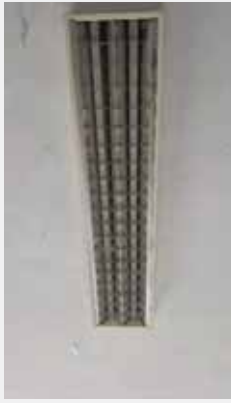
| Floor | Room / Area | Defect Description / Required Works | Qty | Unit | BOQ | Photo |
|---|---|---|---|---|---|---|
| 2nd | 1-2-3-4-5-6 | Neon Light | 24 | pcs | 1.1.1 | |

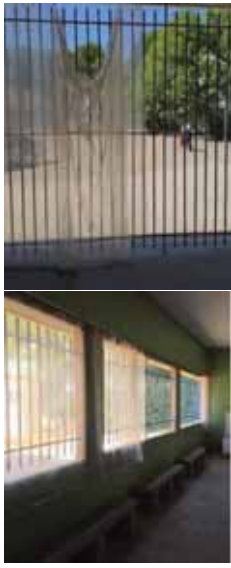
| Floor | Room / Area | Defect Description / Required Works | Qty | Unit | BOQ | Photo |
|---|---|---|---|---|---|---|
| 1st | Playground | Paint metal fences all around the playground | 6 | pcs | <b>2.4</b> | |

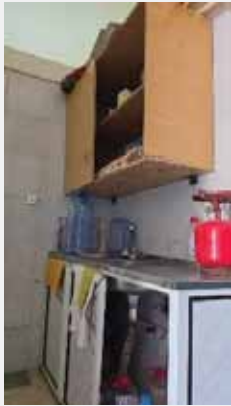
| Floor | Room / Area | Defect Description / Required Works | Qty | Unit | BOQ | Photo |
|---|---|---|---|---|---|---|
| 1st | Kitchen | Replace Kitchen cupboards doors | 5 | pcs | 6.1.1 | |

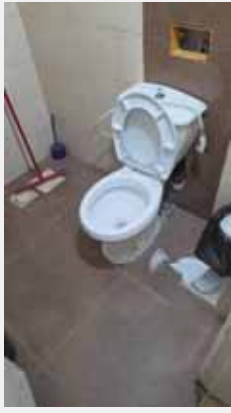
| Floor | Room / Area | Defect Description / Required Works | Qty | Unit | BOQ | Photo |
|---|---|---|---|---|---|---|
| 1st | Toilets | Toilet seat Flushing system | 3 | pcs | 1.2.1 | |
