# **Tender Preparation and Construction Supervision for Shelters**

## **Lebanon Emergency Assistance Project (LEAP)**

### **Detailed Assessment and Verification Report**

### **September 2026**

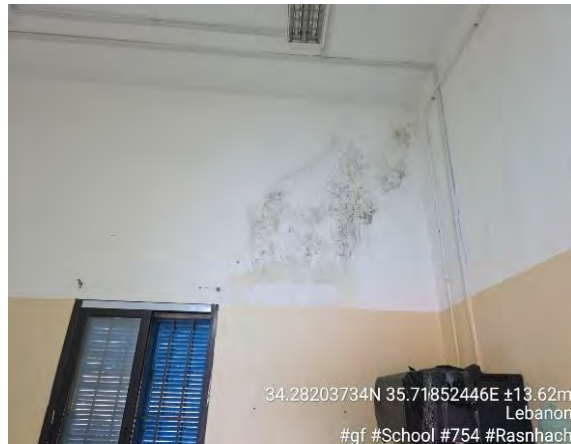
**Figure 5- Ceiling & walls in bad condition**

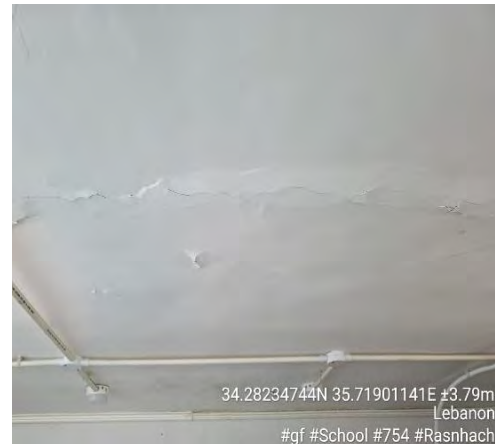
| Trade | Item | Damaged | Location, extent and quantity |
|---|---|---|---|
| | Toilet finishing | Yes | 10 m <sup>2</sup> plaster damaged due to water leakage |

**Figure 6- Damaged plaster due to water leakage**

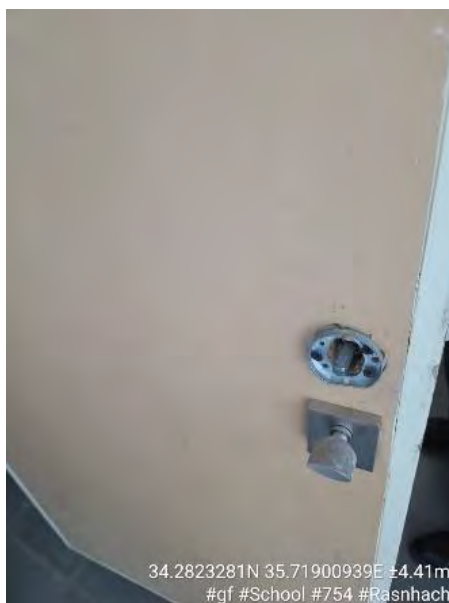
**Figure 7- Damaged Door accessories**

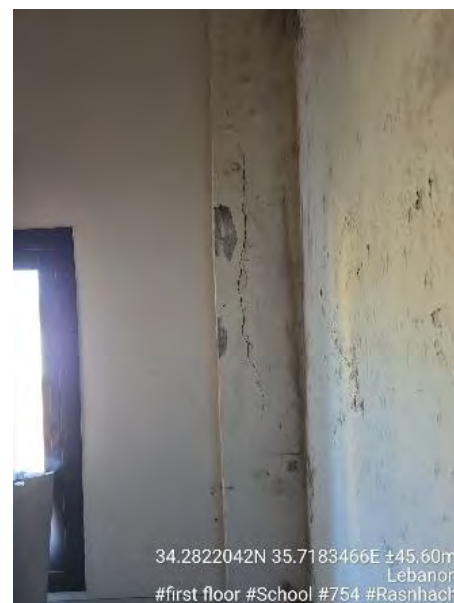
| No. | Element | Yes | No | Location and description |
|---|---|---|---|---|
| 4 | Column cracks | X | | |

**Figure 8- Column crack**

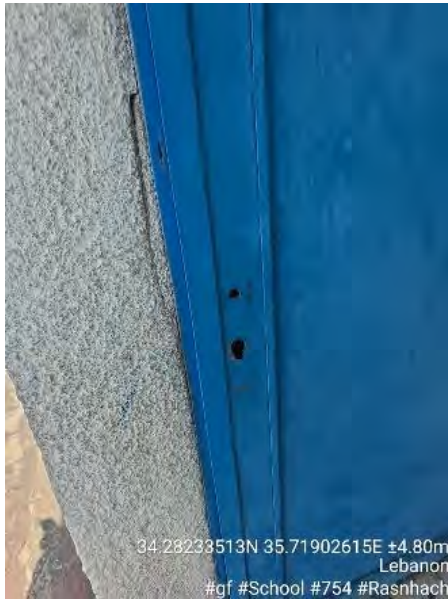
| Trade | Item | Damaged | Location, extent and quantity |
|---|---|---|---|
| | Metal doors | Yes | 6 doors to be repaired |

***Figure 9- Steel door accessories damaged***

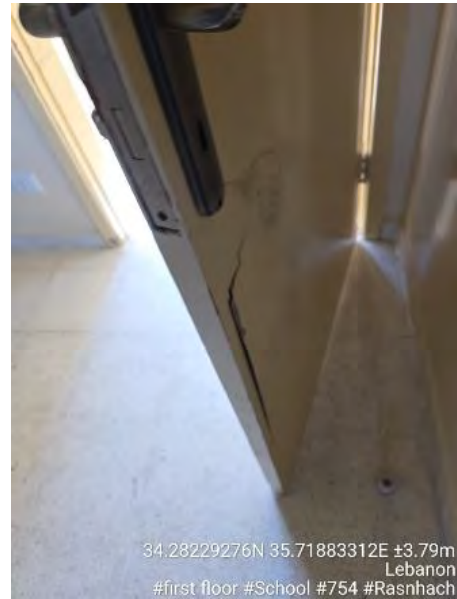
| Trade | Item | Damaged | Location, extent and quantity |
|---|---|---|---|
| Doors | Timber doors | Yes | 12 doors to be repaired |

***Figure 10- Damaged Wooden Door***

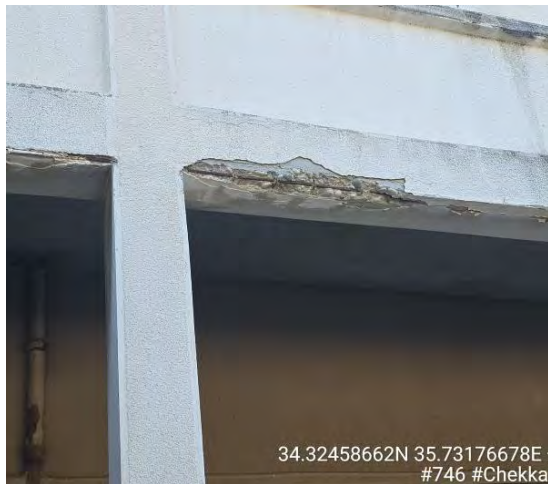
| No. | Element | Yes | No | Location and description |
|---|---|---|---|---|
| 8 | Spalled concrete with exposed reinforcement | X | | |

**Figure 5- Concrete spalling**

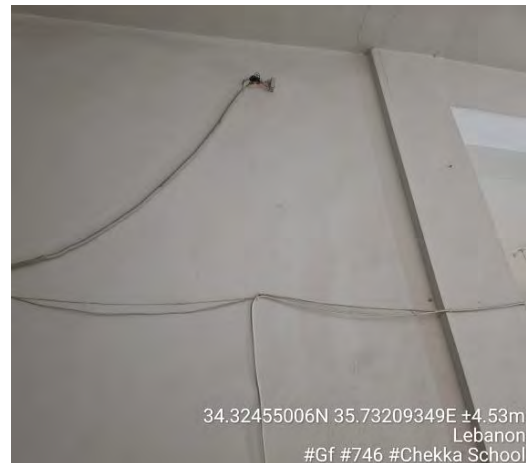
**Figure 6- Electrical wires to be properly installed**

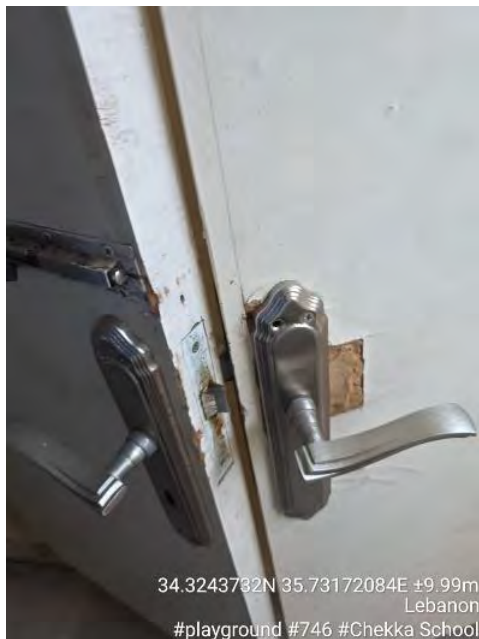
**Figure 7- Damaged Door accessories**

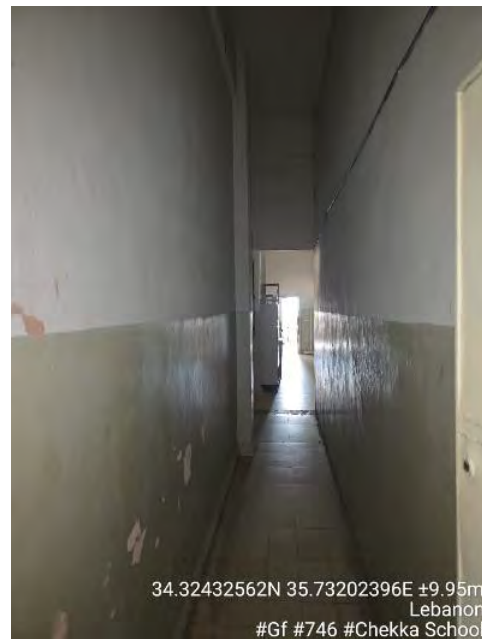
**Figure 8- Damaged wall and ceiling needs paints**

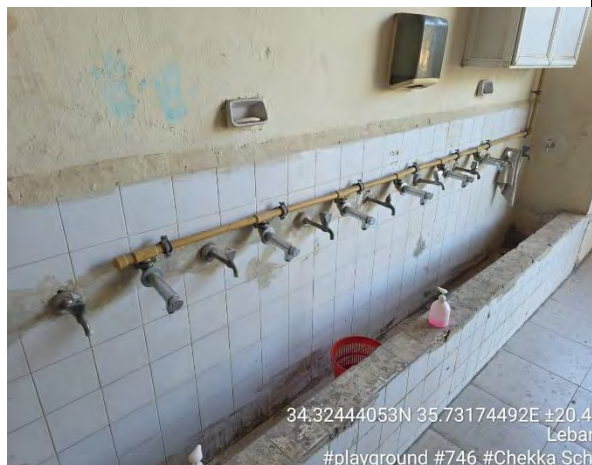
| Trade | Item | Damaged | Location, extent and quantity |
|---|---|---|---|
| | Mixers and taps | Yes | 3 taps to be replaced |

**Figure 9- Damaged taps**

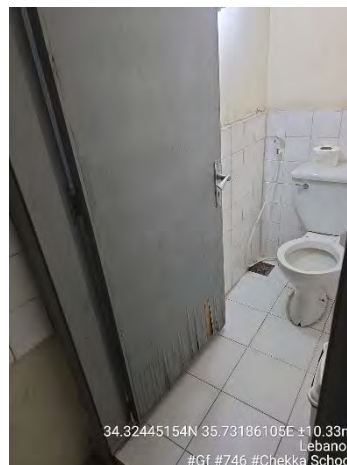
| Trade | Item | Damaged | Location, extent and quantity |
|---|---|---|---|
| Doors | Timber doors | Yes | 10 doors to be repaired |

**Figure 10- Damaged Wooden Door**

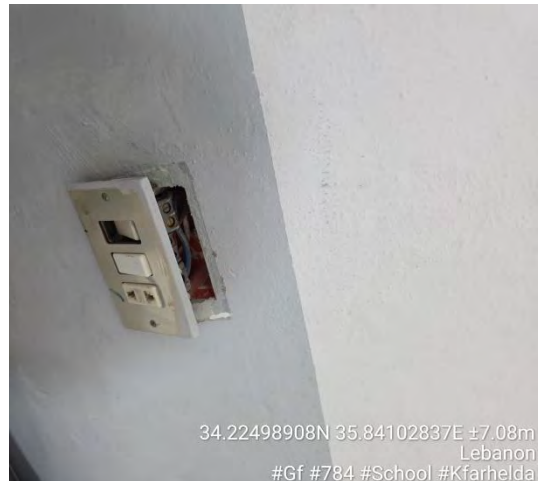
| Trade | Item | Damaged | Location, extent and quantity |
|---|---|---|---|
| Electrical | Sockets and switches | Yes | 4 sockets and switches box needs to be replaced |

**Figure 6- Electrical switch damaged**

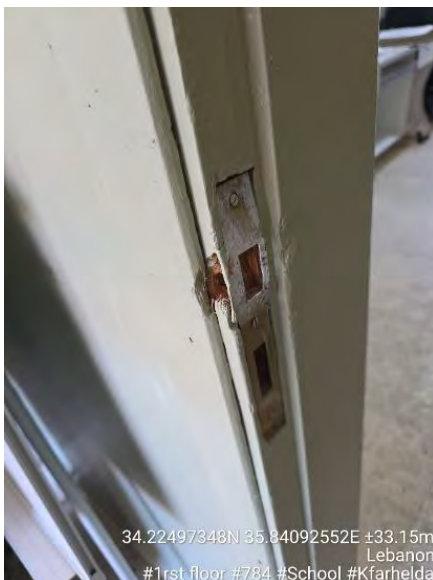
**Figure 7- Damaged Door accessories**

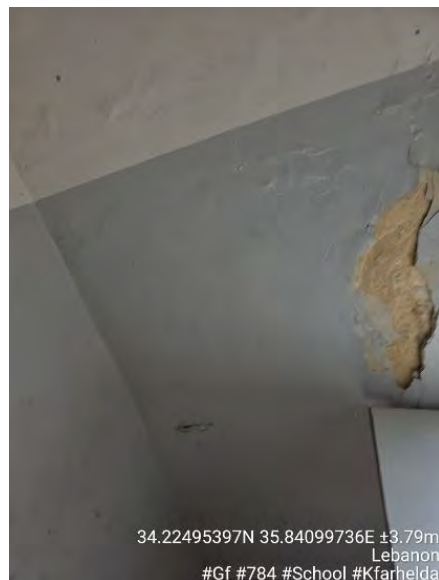
**Figure 8- Damaged plaster due to water leakage**

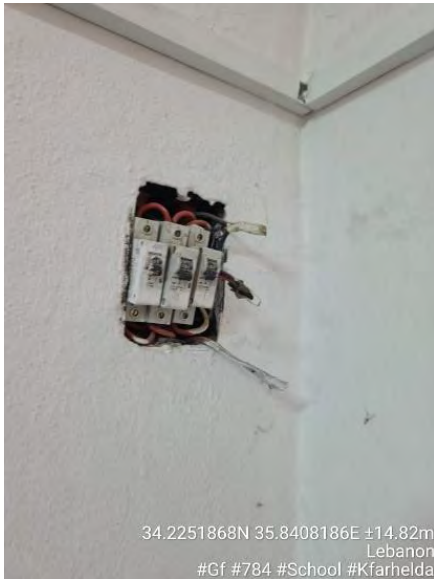
**Figure 9- Electrical panel damaged**

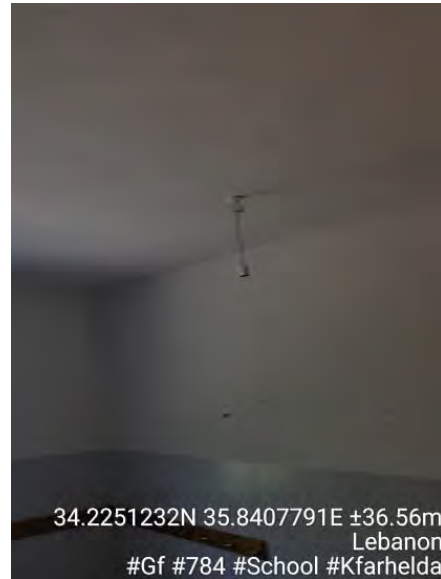
**Figure 10 - Lighting fixtures missing**

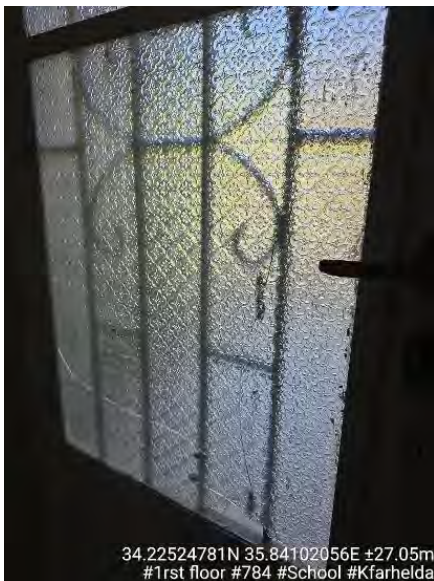
**Figure 11 - Broken glass**

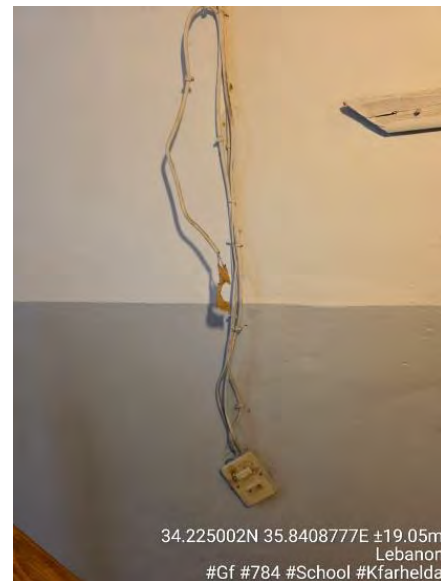
**Figure 12 - Electrical wires to be properly installed**

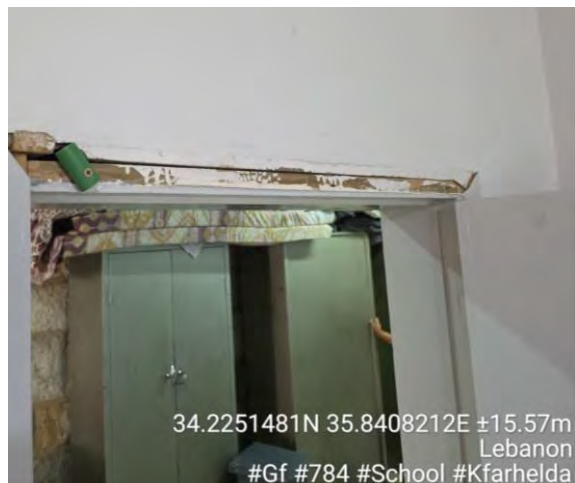
| Trade | Item | Damaged | Location, extent and quantity |
|---|---|---|---|
| Doors | Timber doors | Yes | 7 doors to be repaired |

**Figure 13- Damaged wooden door**

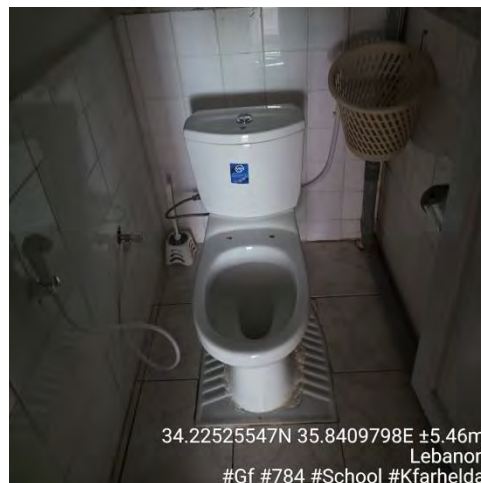
**Figure 14 - Toilet seat cover missing**

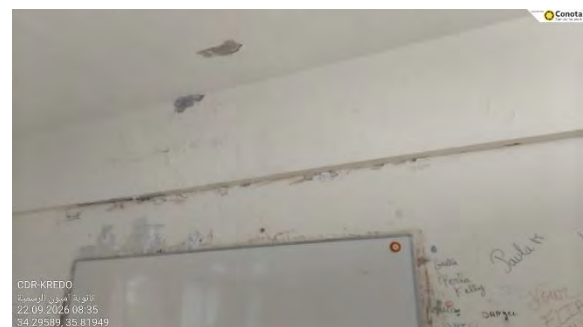
| Item | Condition found |
|---|---|
| Humidity | Exist in some walls |

**Figure 8 - Humidity in Wall**

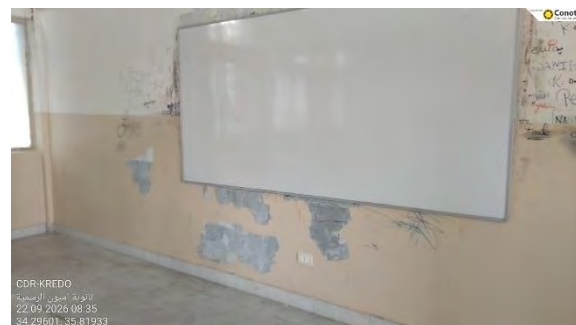
**Figure 9 - Damaged Wall Paint**

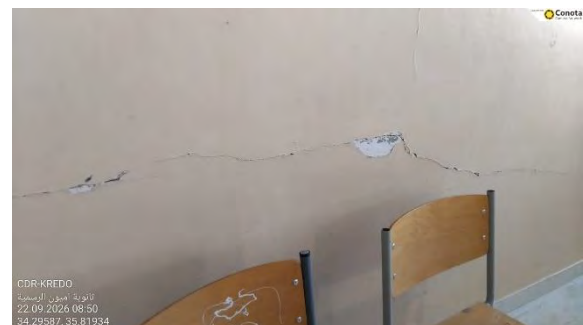
| No. | Element | Yes | No | Location and description |
|---|---|---|---|---|
| 3 | Wall cracks | X | | In different walls |

**Figure 10 - Crack in Wall**

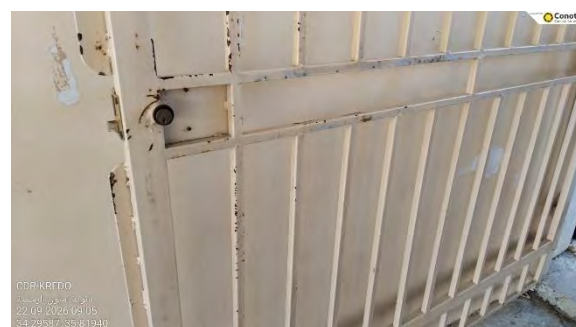
**Figure 11 - Damaged Steel Gate Paint**

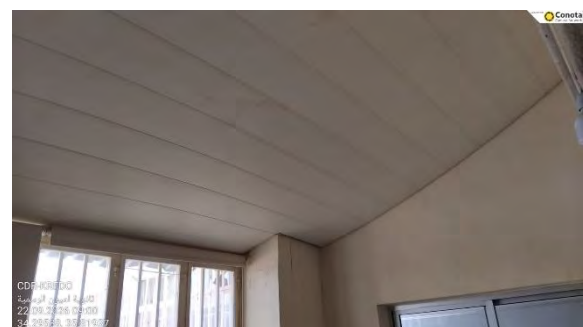
**Figure 12 – Damaged False Ceiling Leveling**

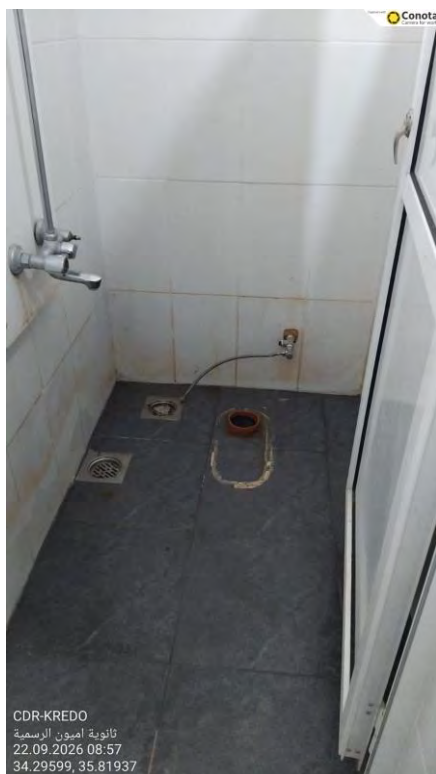
**Figure 13 - Missing Toilet Seat**

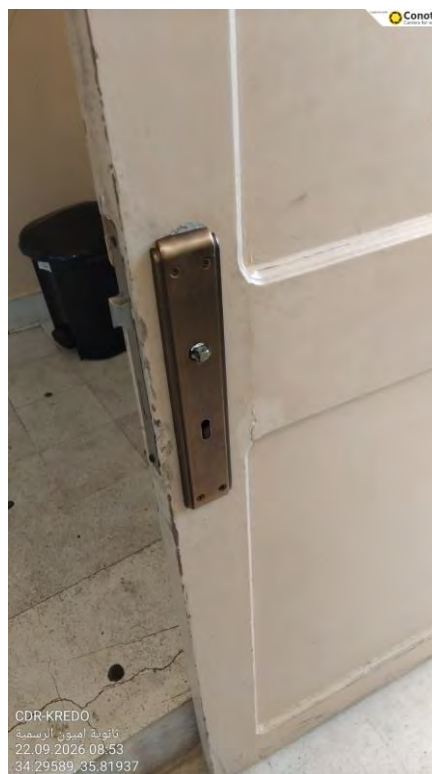
**Figure 14 - Missing Door Handle**

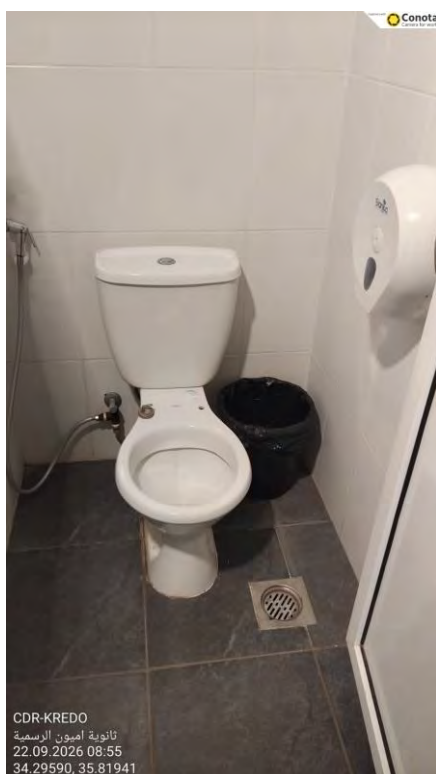
**Figure 15 - Missing Toilet Seat Cover**

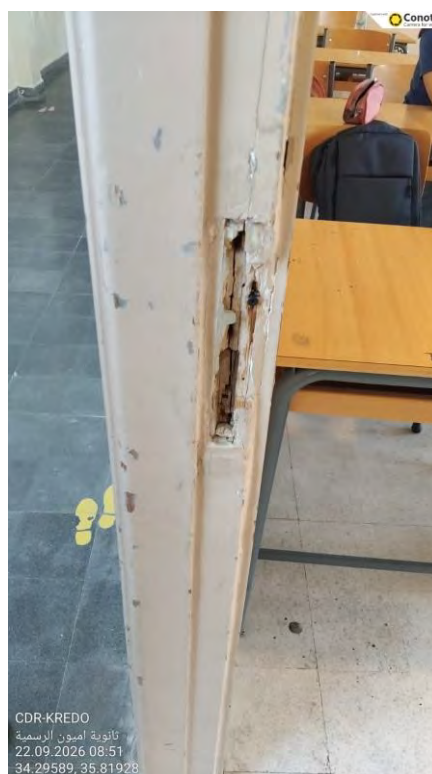
**Figure 16 - Missing Door Accessories**

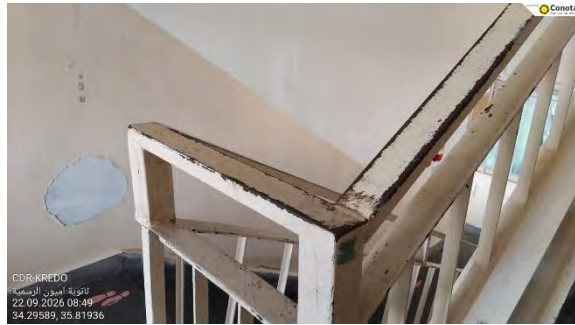
**Figure 17 - Rusted Handrail**

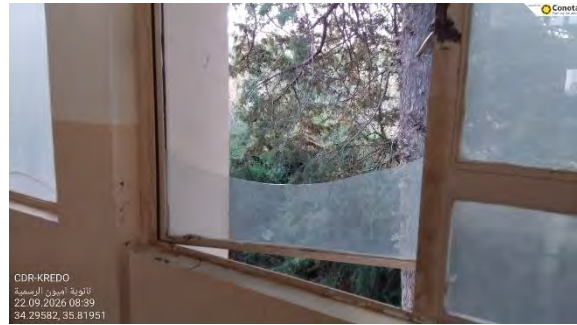
**Figure 18 - Broken Glazing**

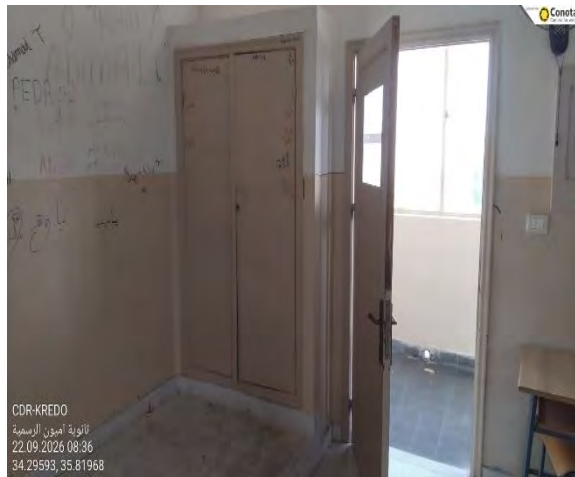
**Figure 19 - Damaged Paint**

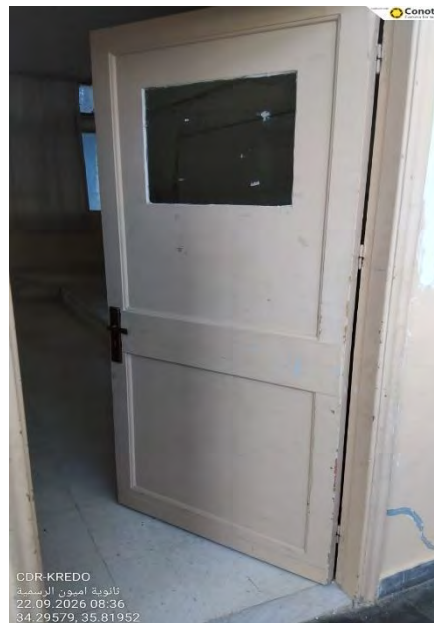
**Figure 20 - Damaged Door Paint**

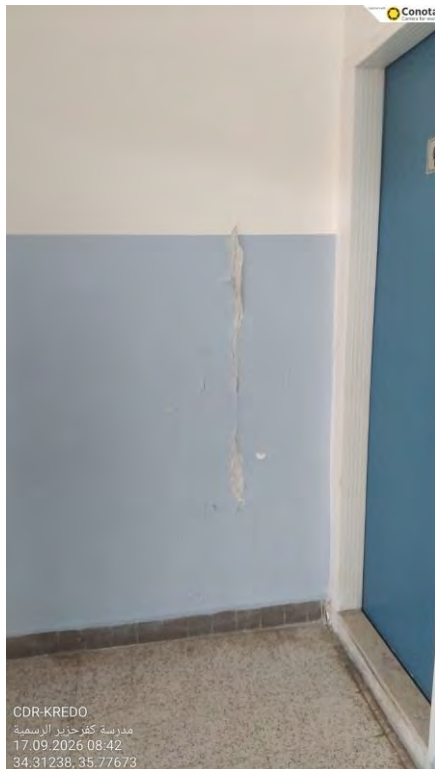
| No. | Element | Yes | No | Location and description |
|---|---|---|---|---|
| 3 | Wall cracks | X | | In limited spots |

**Figure 7 - Crack in Wall**

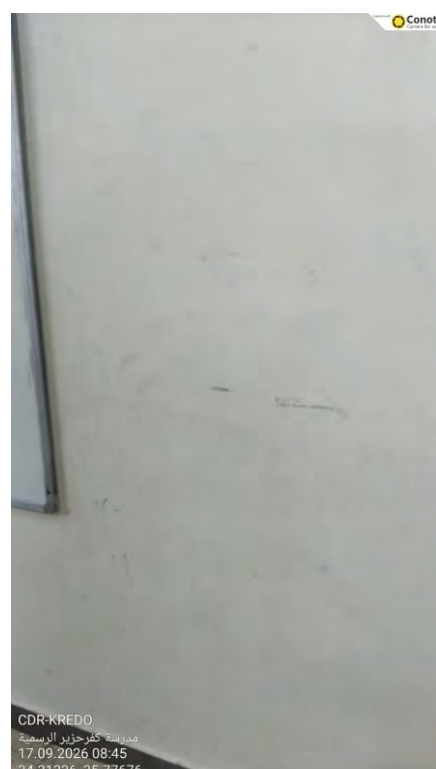
**Figure 8 - Damaged Wall Paint**

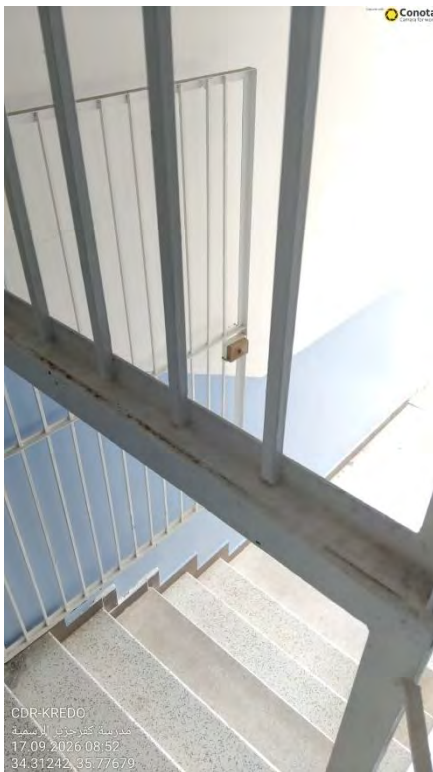
**Figure 9 - Rusty Steel Gate**

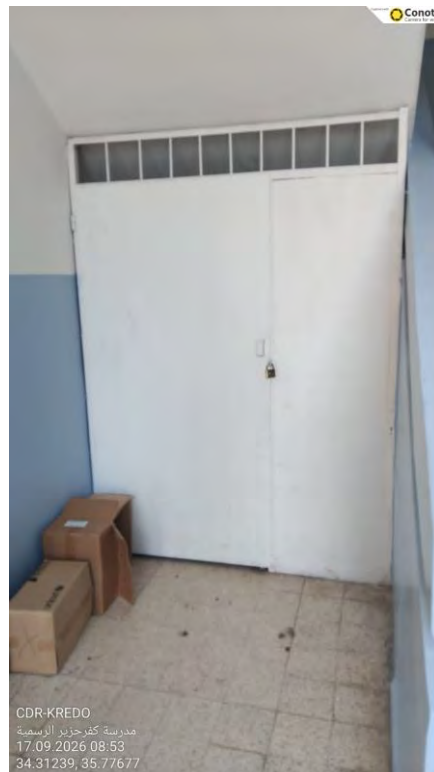
**Figure 10 - Damaged Steel Door Paint**

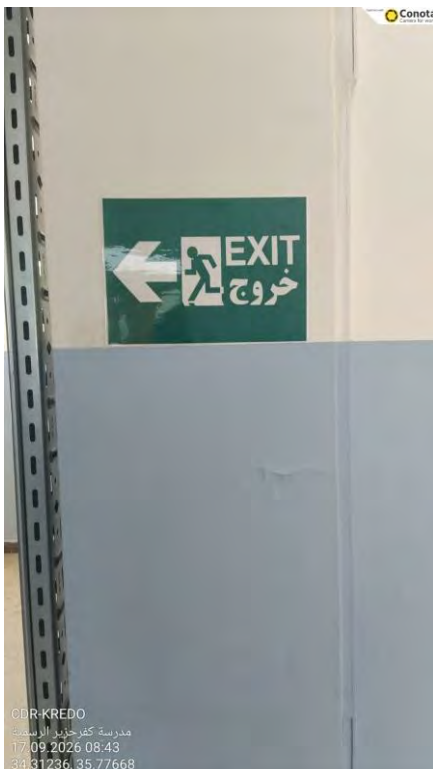
**Figure 11 - Damaged Wall Paint**

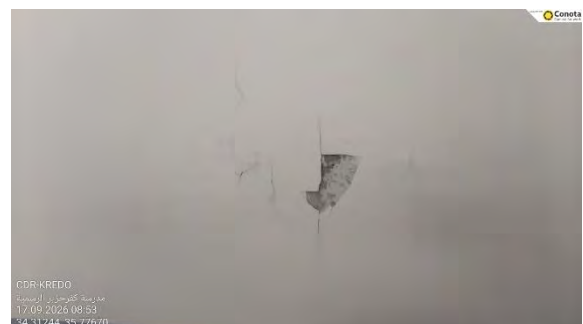
**Figure 12 - Damaged Wall**

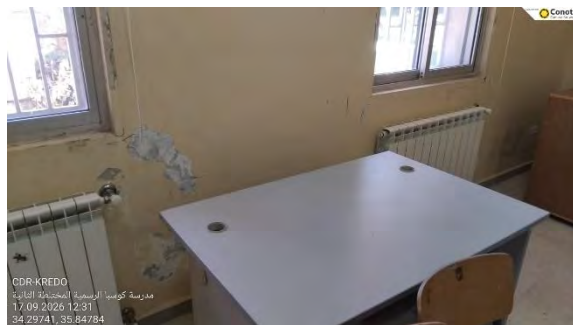
**Figure 6 - Damaged Wall Paint**

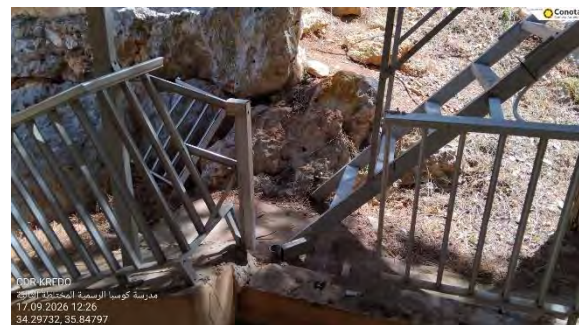
**Figure 7 - Broken Aluminum Gate**

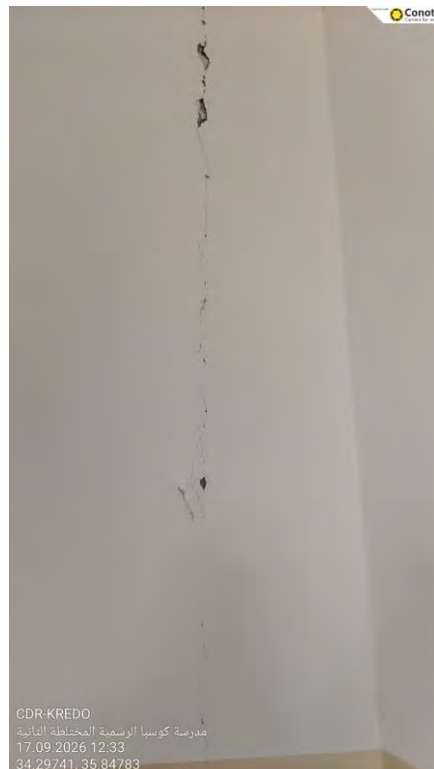
| No. | Element | Yes | No | Location and description |
|---|---|---|---|---|
| 3 | Wall cracks | X | | In several spots |

**Figure 9 - Crack in Wall**

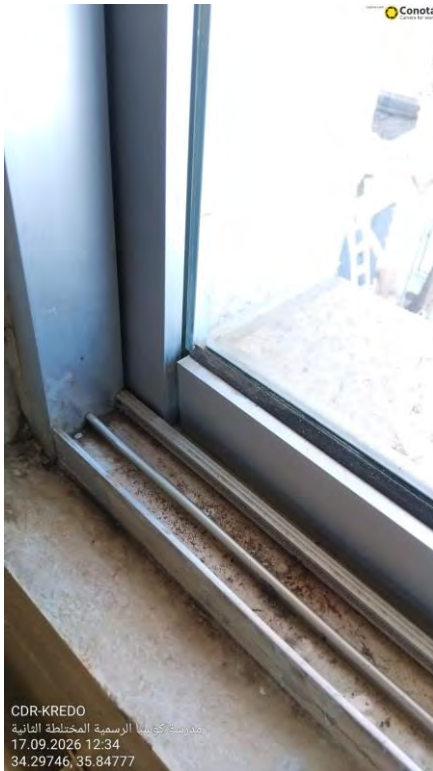
**Figure 10 - Broken Aluminum Window**

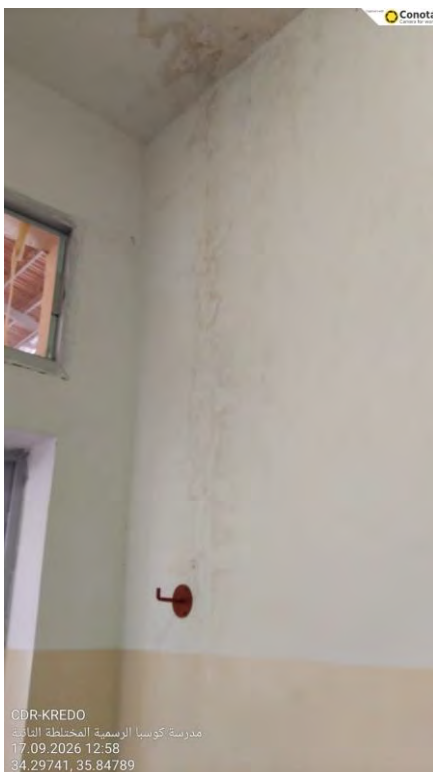
| No. | Element | Yes | No | Location and description |
|---|---|---|---|---|
| 2 | Facade water leak | X | | Visible on the inside of the building |

**Figure 12 - Humidity in Wall & Ceiling**

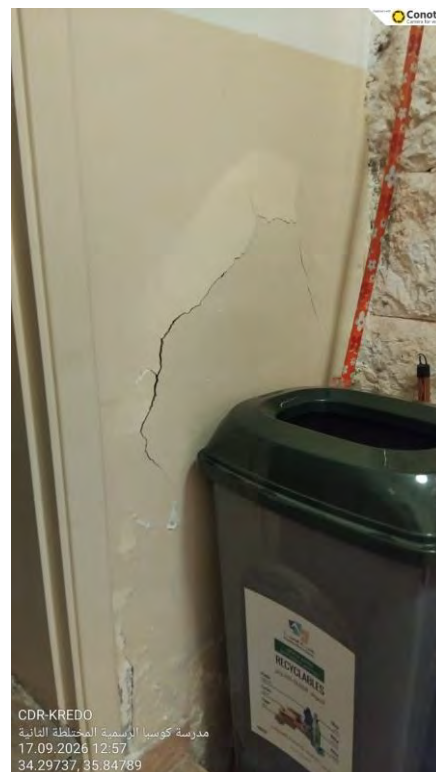
**Figure 13 - Damaged Plaster**

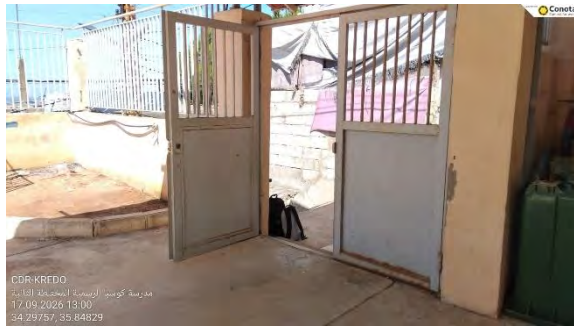
**Figure 14 - Rusty Main Gate**

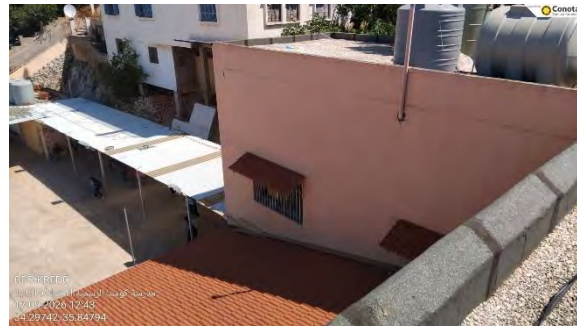
| No. | Element | Yes | No | Location and description |
|---|---|---|---|---|
| 1 | Facade cracks | X | | At roof slab |

**Figure 15 - Crack in Elevation**

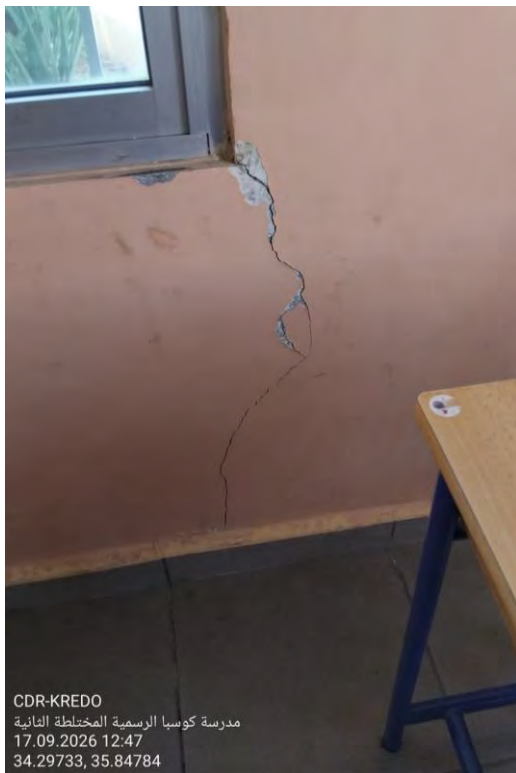
**Figure 16 - Crack in Wall**

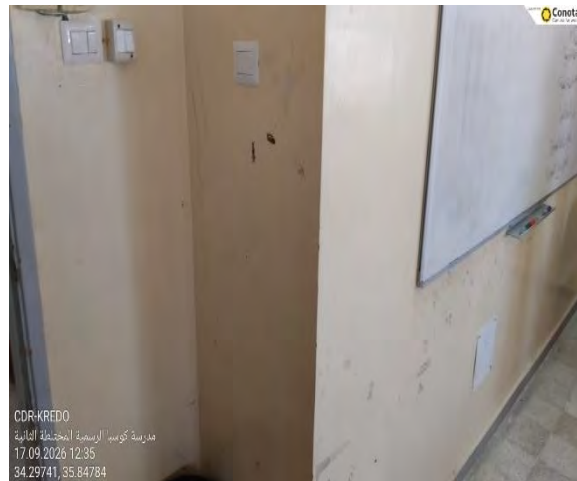
**Figure 17 - Damaged Wall**
