Consultancy Services for  
Tender Preparation and Construction Supervision Consultant for  
Shelters  
Lebanon Emergency Assistance Project (LEAP)

**ASSESSMENT REPORT**

**BATCH 2 - LOT 3**

**BATCH 2 - LOT 3**  
**MOUNT LEBANON SCHOOLS**  
**GENERAL INDEX**

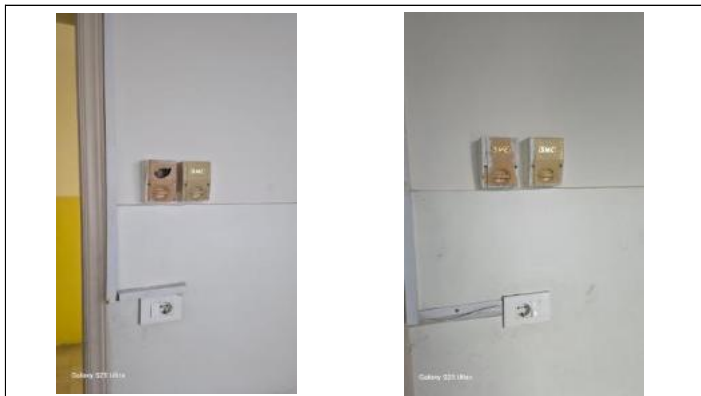
Pic showing the bad condition of the fan socket

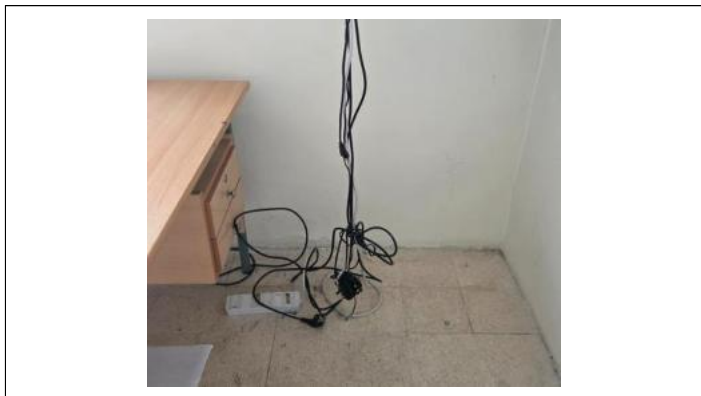
Pic showing the bad conditions of electrical socket

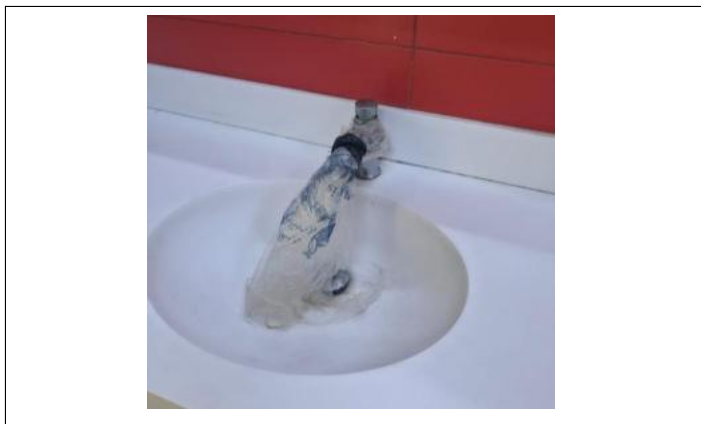
Pics showing the mixer off the wash bain to be changed

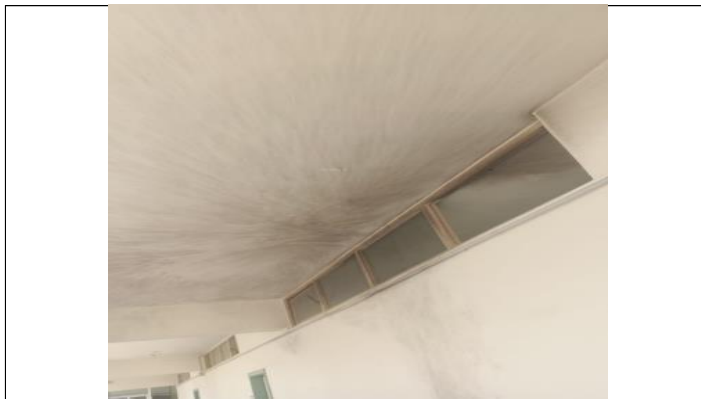
Wall need repair

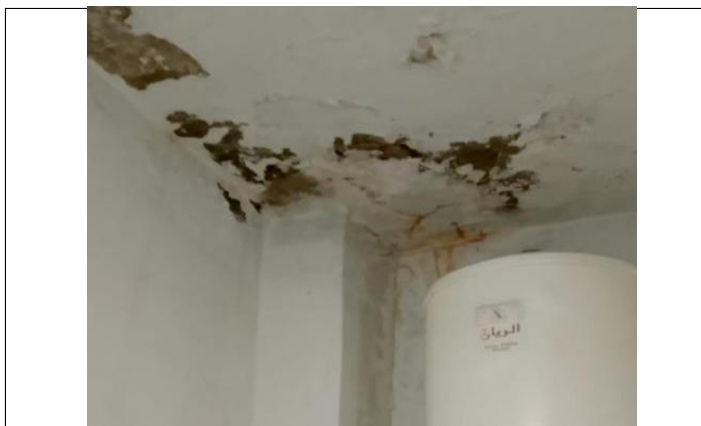
Water leak thru slab

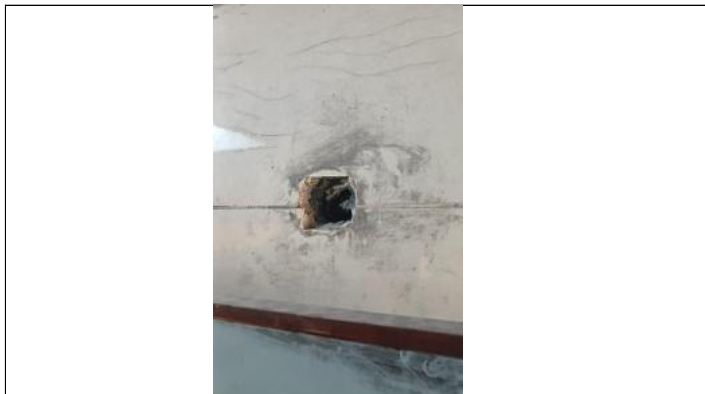
Electrical socket to be repaired

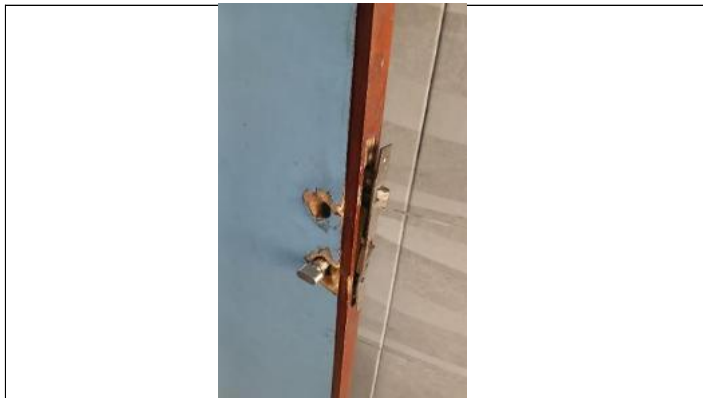
Broken wooden door need to be repaired

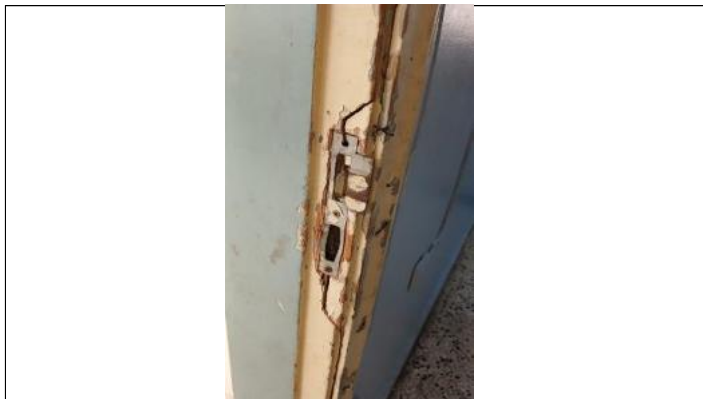
Broken wooden door need to be repaired

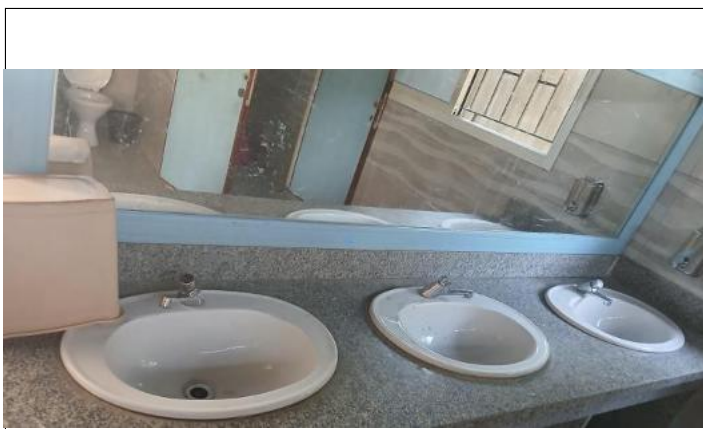
status of the washing basin

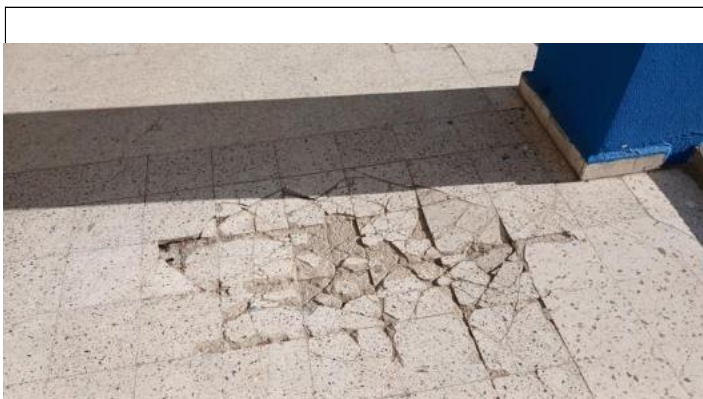
tiles need repair and its slippery

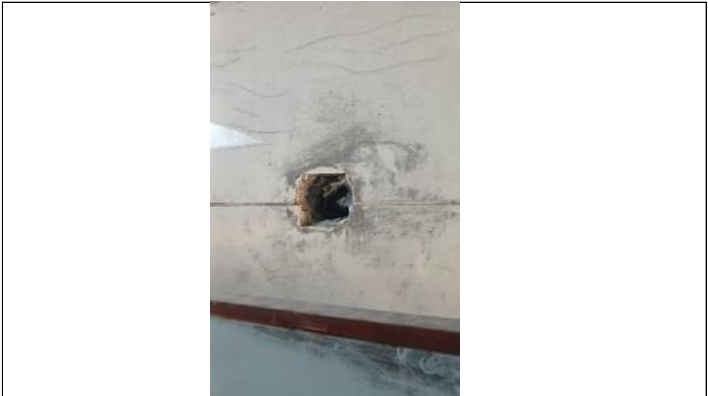
Electrical socket to be repaired

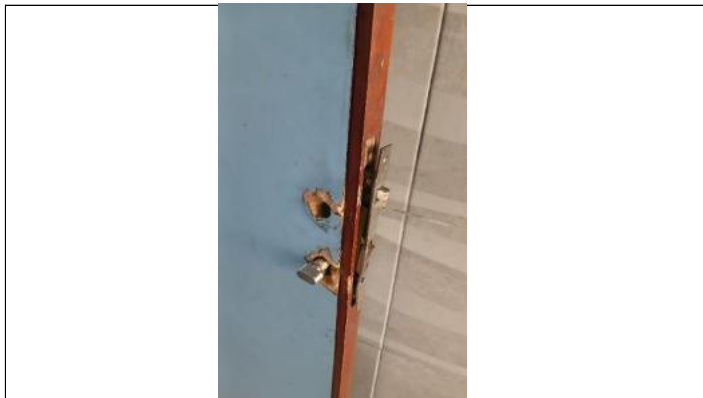
Broken wooden door need to be repaired

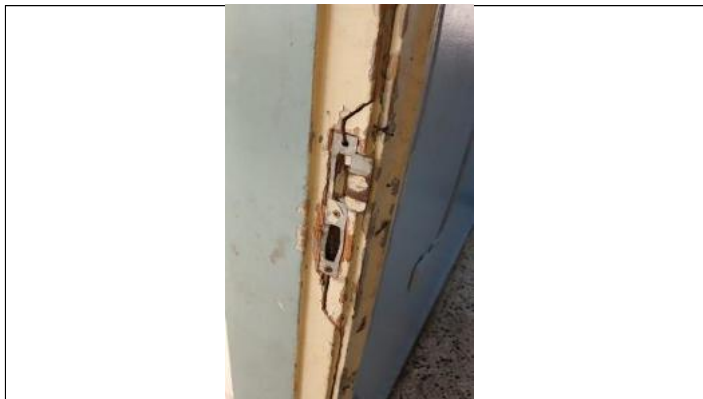
Broken wooden door need to be repaired

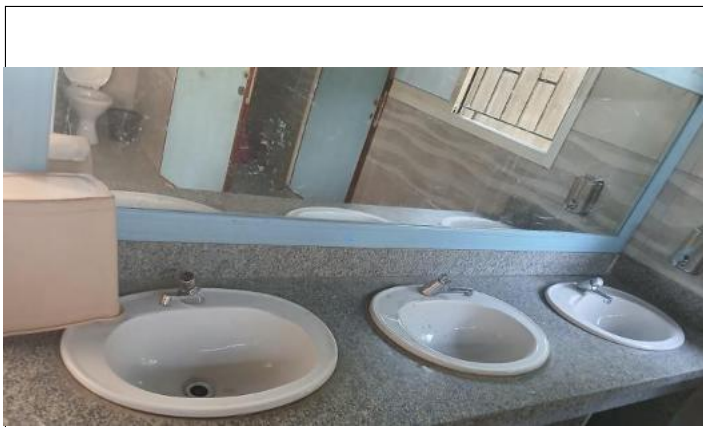
status of the washing basin

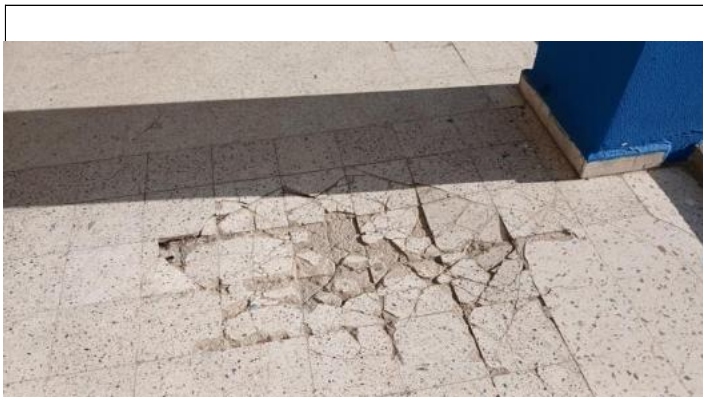
tiles need repair and its slippery

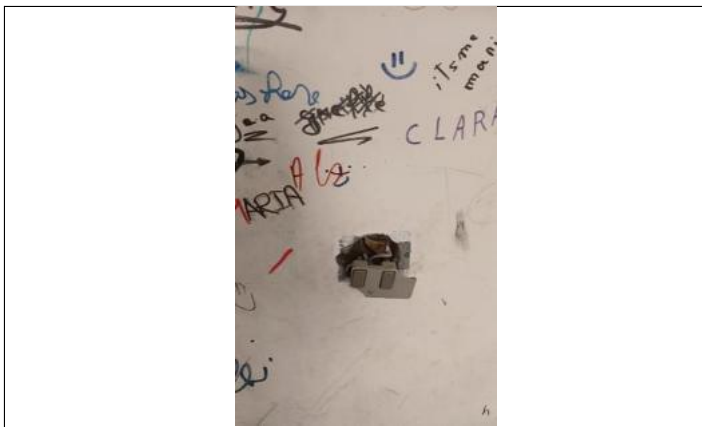
Electrical socket to be repaired

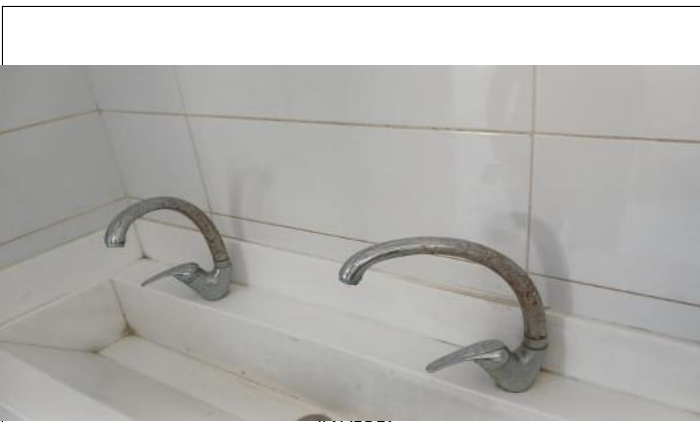
status of the washing basin

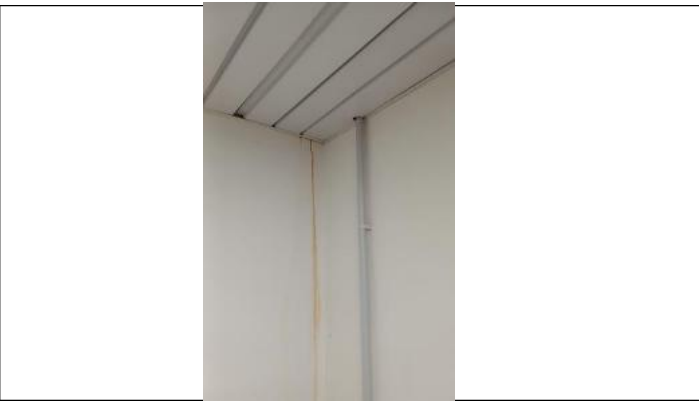
Humidity and water leak from the  
roof and elevations shown inside  
the building

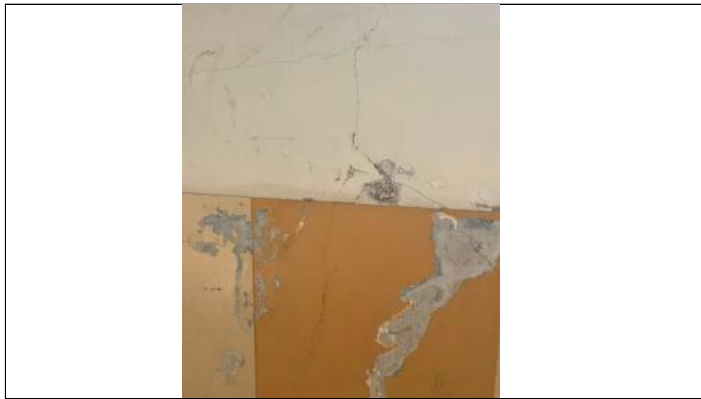
Pic showing damage in the walls

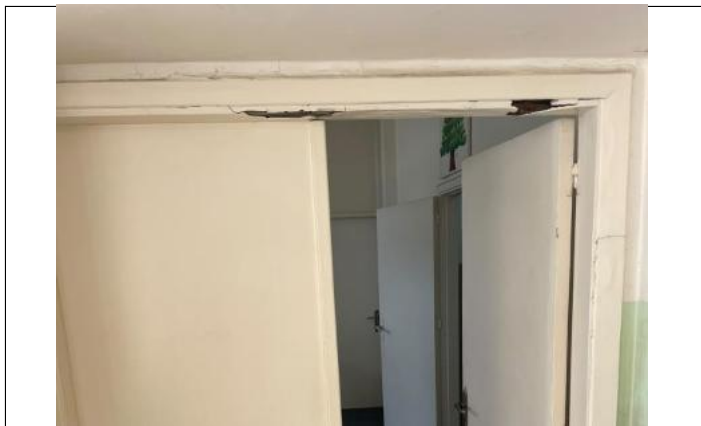
Lever handle and lock to door to be replaced and door to be painted

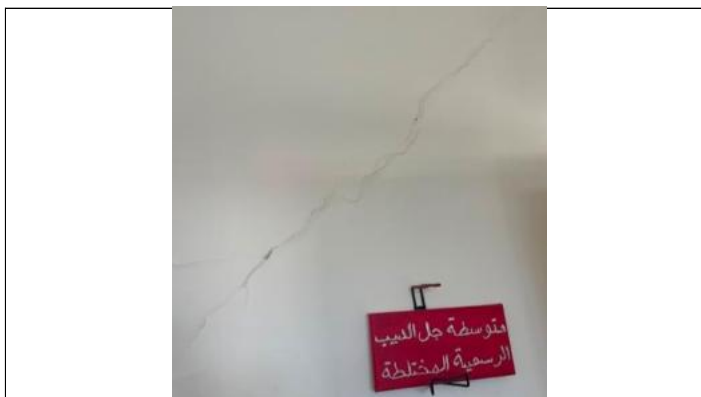
damage needs t be rehabilitated

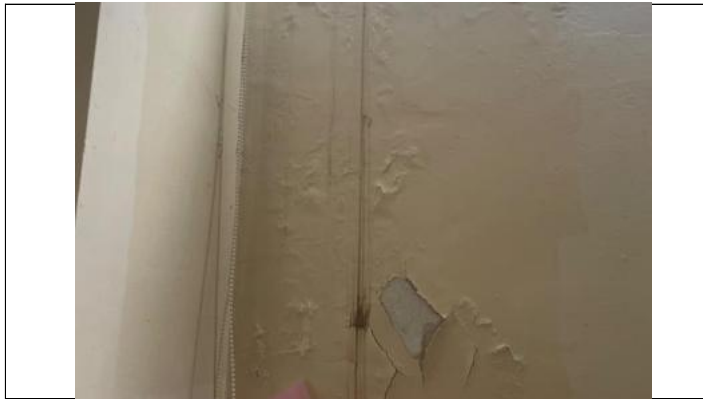
pic showing the humidity inside  
the wall

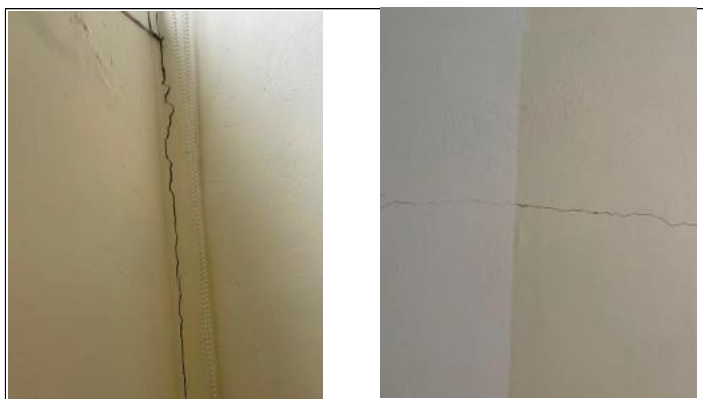
crack in the walls

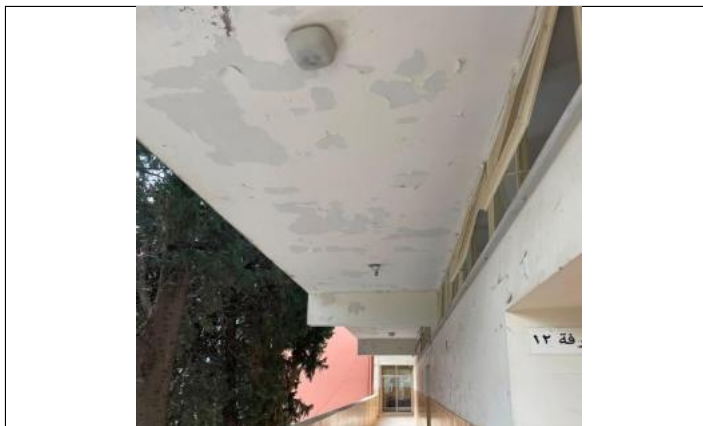
walls need to be painted

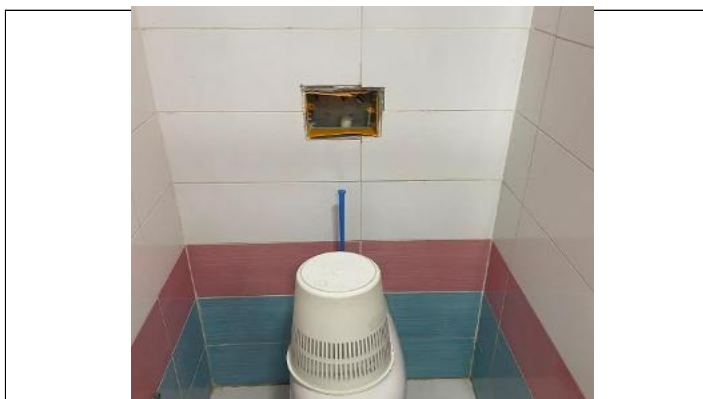
toilet damages

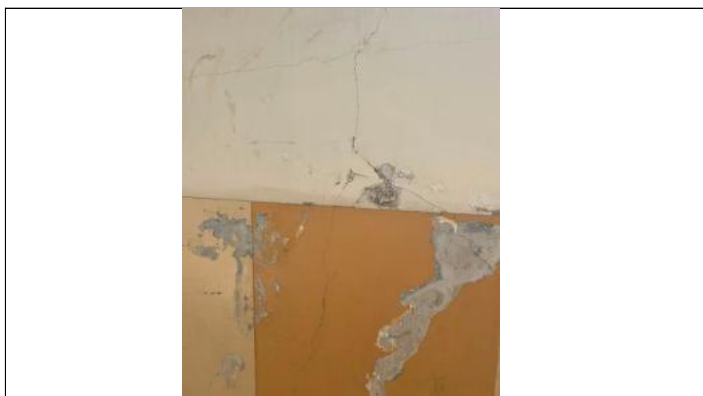
Pic showing damage in the walls

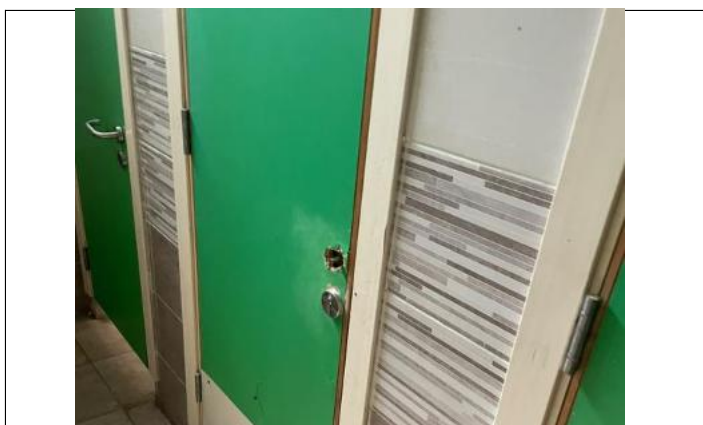
Lever handle and lock to door to be replaced and door to be painted

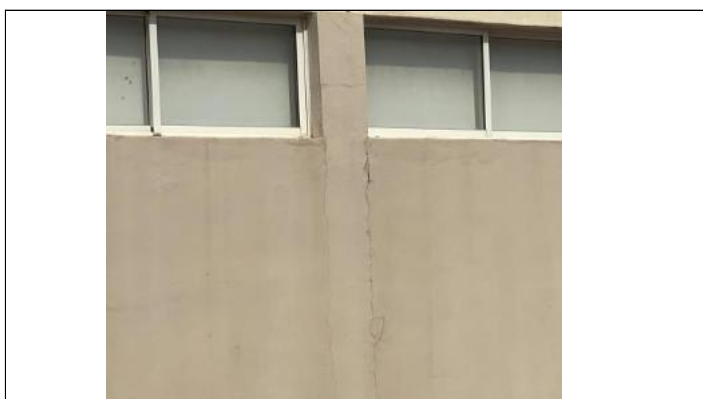
damage needs t be rehabilitated

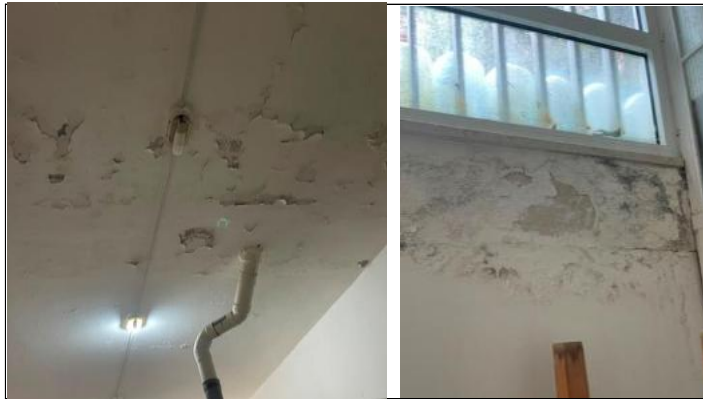
pic showing the humidity inside  
the wall

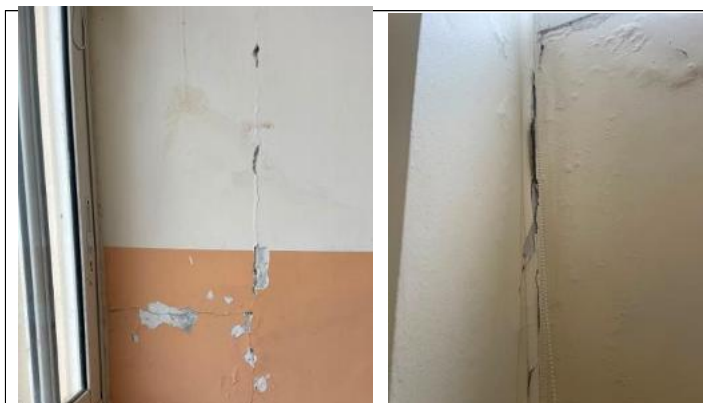
crack in the walls

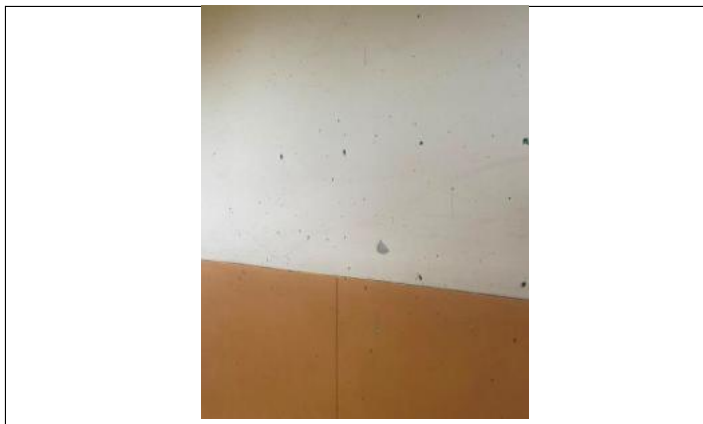
walls need to be painted

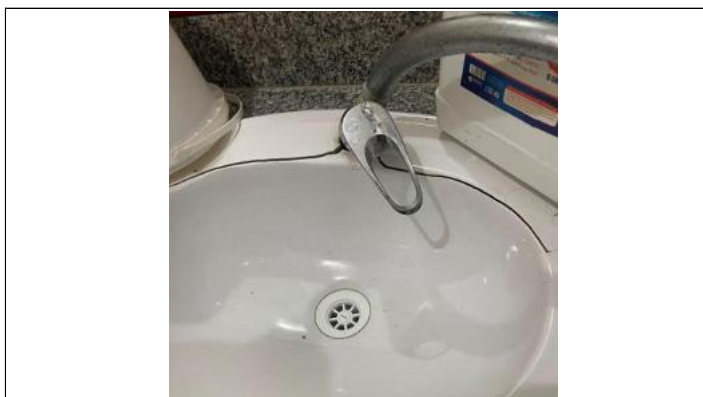
toilet damages

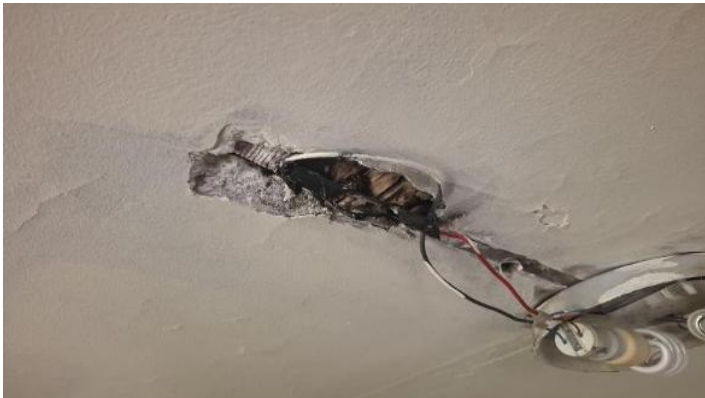
Bad condition of lighting and  
electric wiring

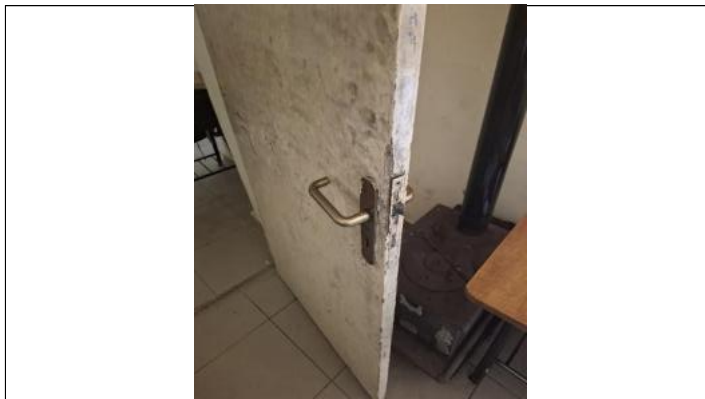
Bad condition of wooden doors

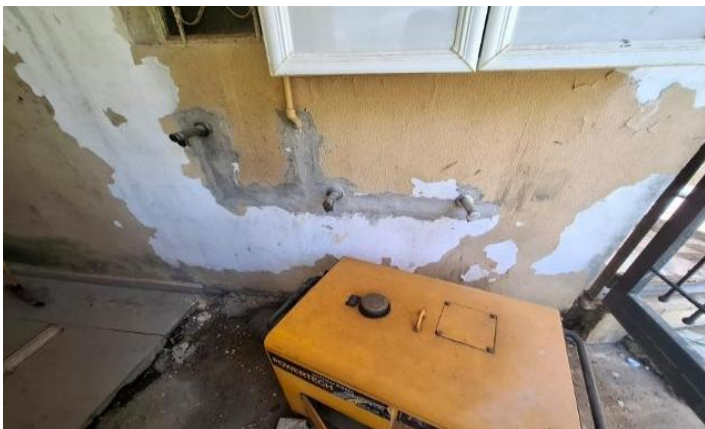
The drinking basin was  
demolished and removed

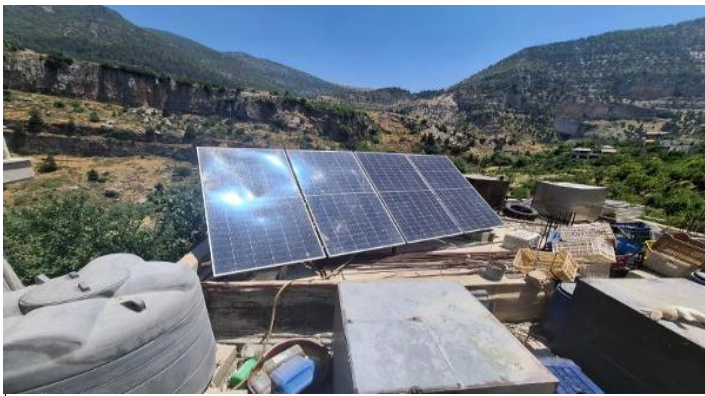
Solar Panels are broken

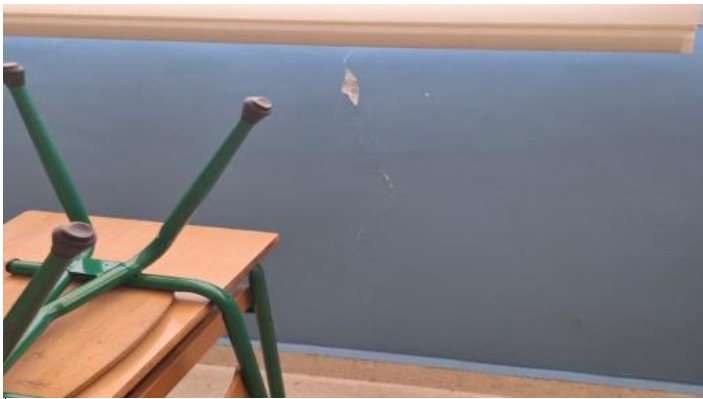
Watre leak thru elevation

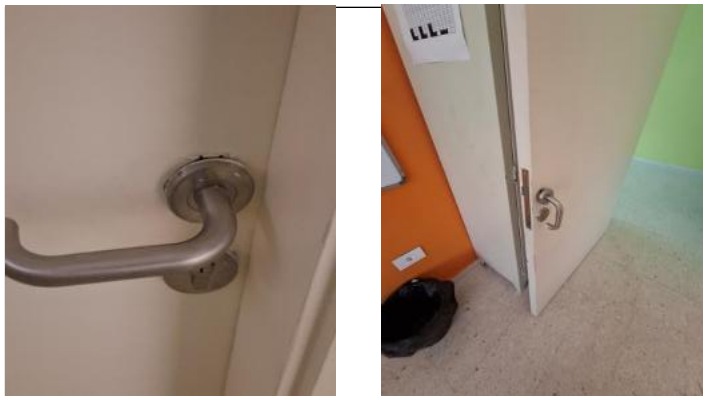
Door handles need to be replaced

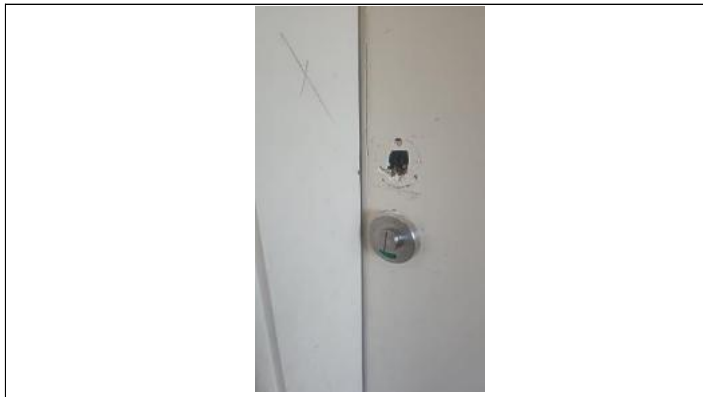
wooden door accessories

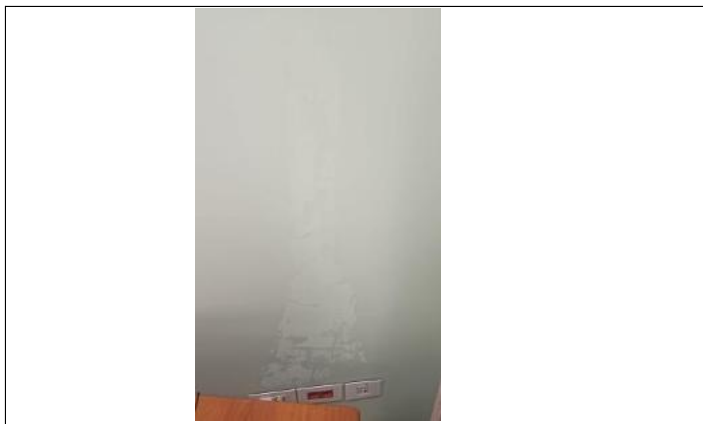
humidity around electrical  
sockets

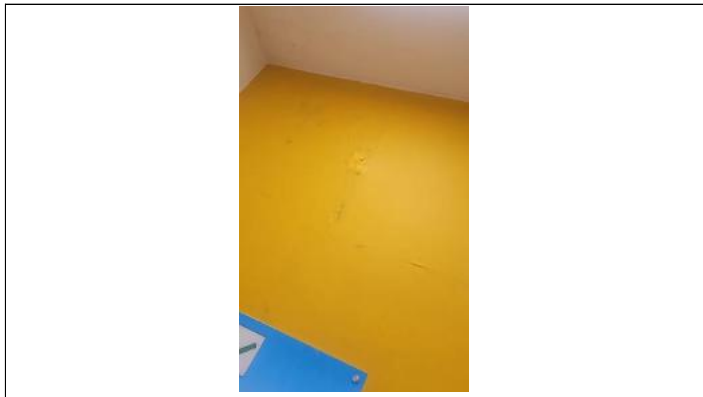
humidity in walls

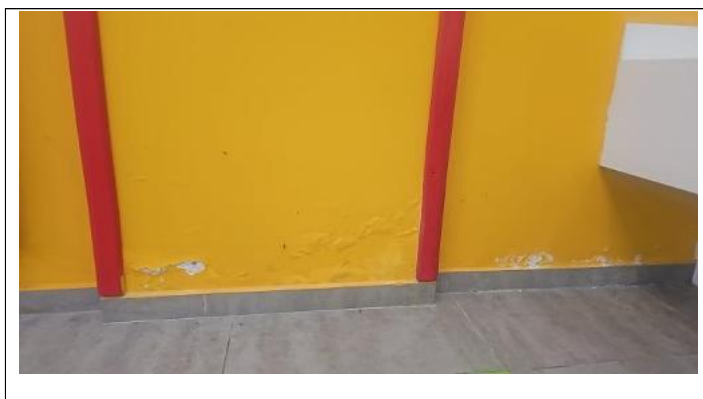
humidity

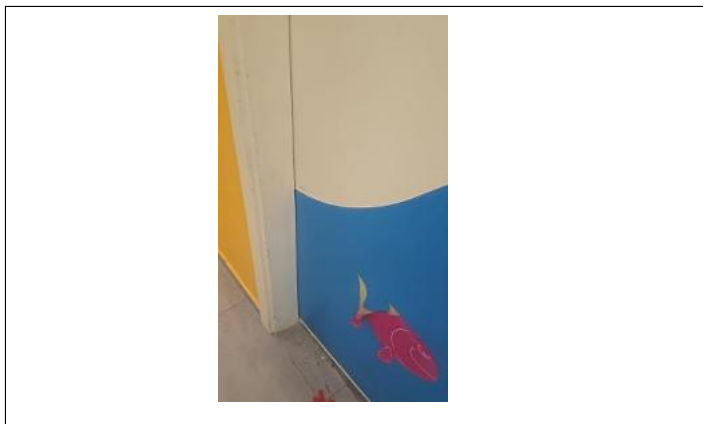
wooden doors repair

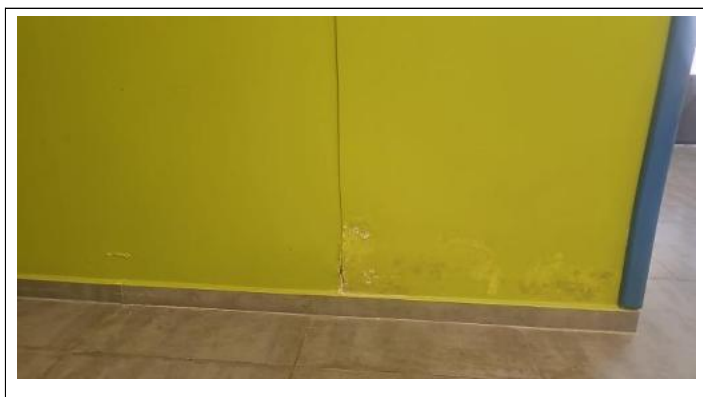
cracks in walls

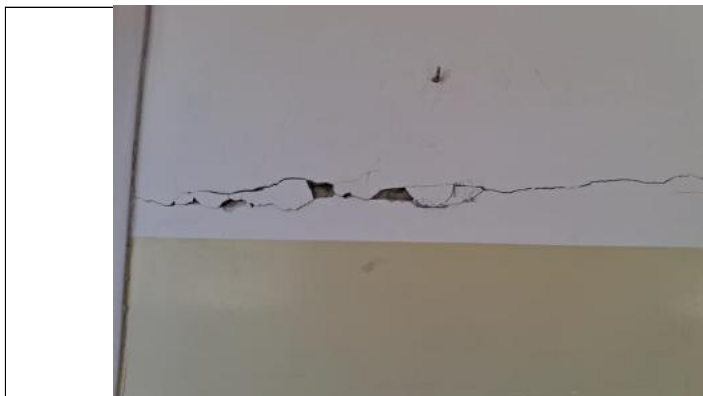
Cracks in walls need repair

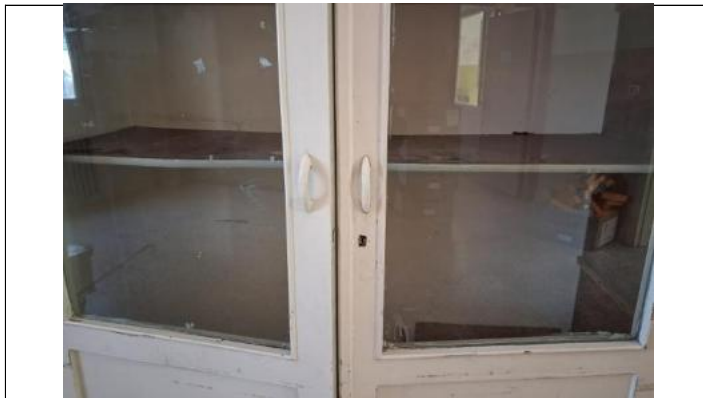
Doors need repair

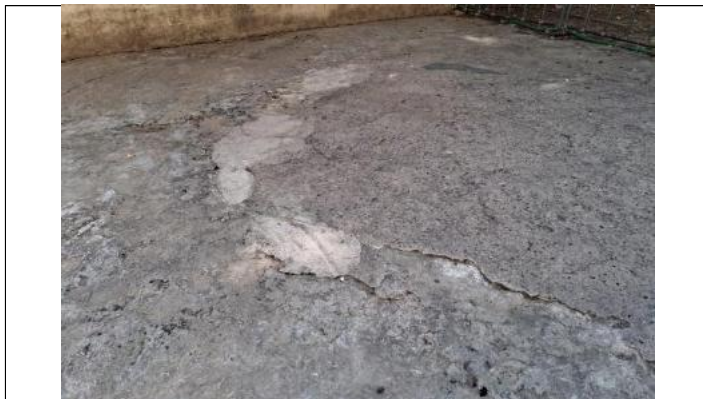
Floor cracks need repair in  
playground

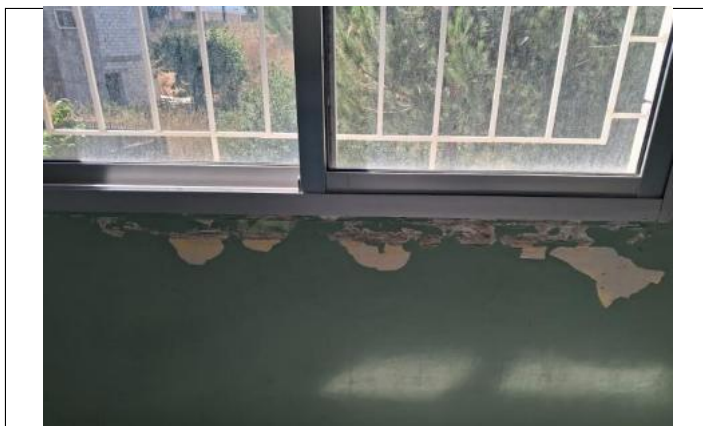
Humidity

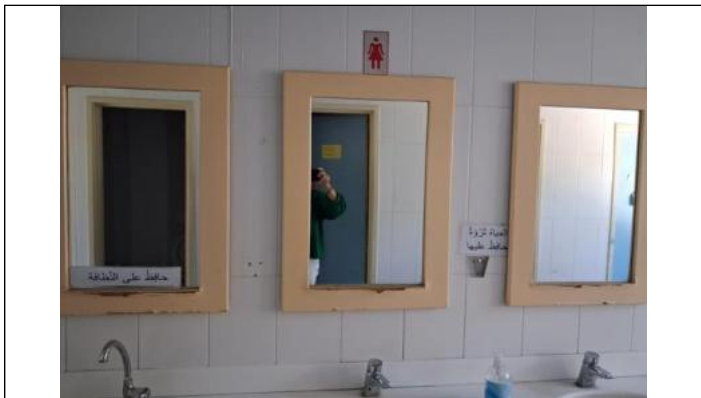
WC need repair

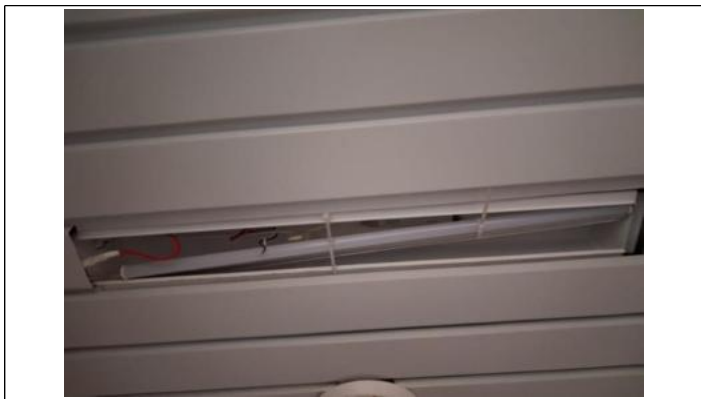
False ceiling need repair

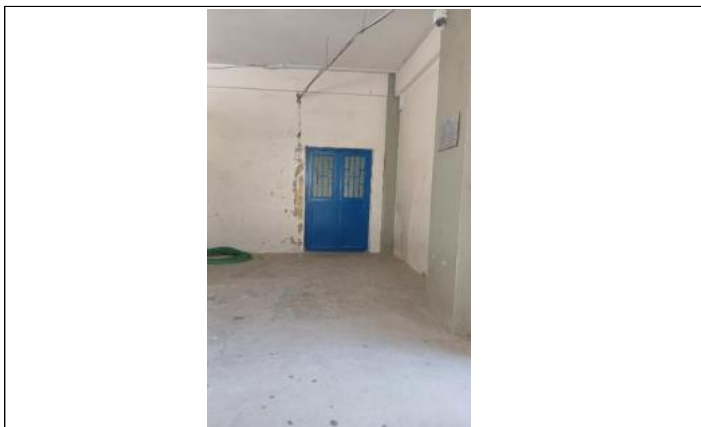
Exterior walls need repair

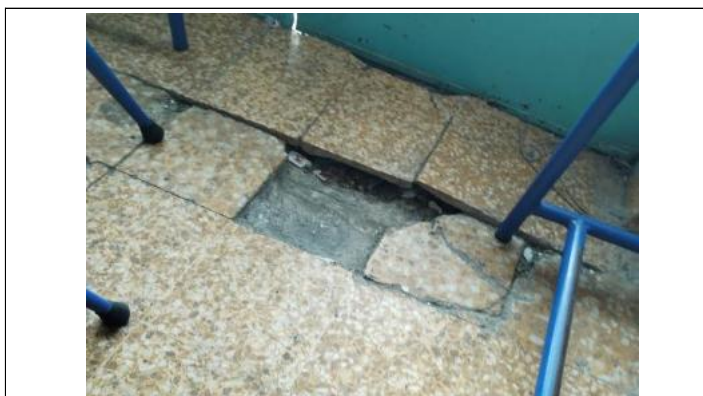
Tile cracks due to settlement

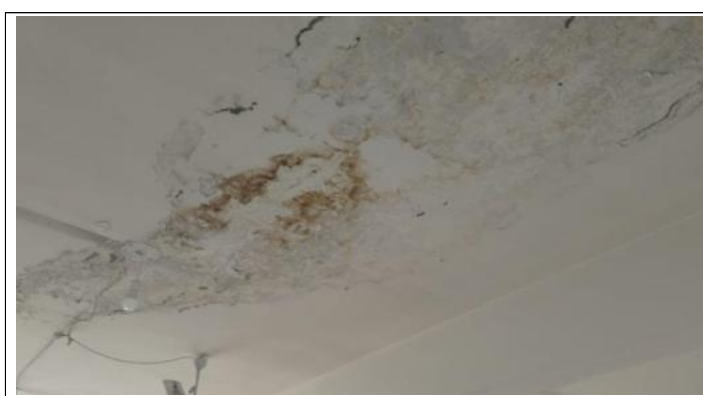
water leak inside the school

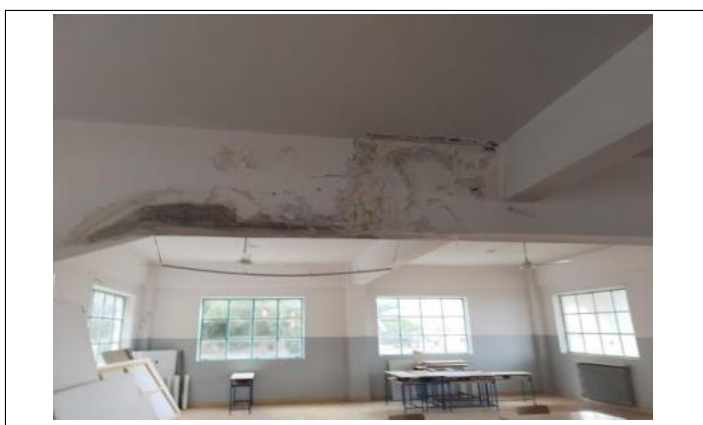
crack in beams

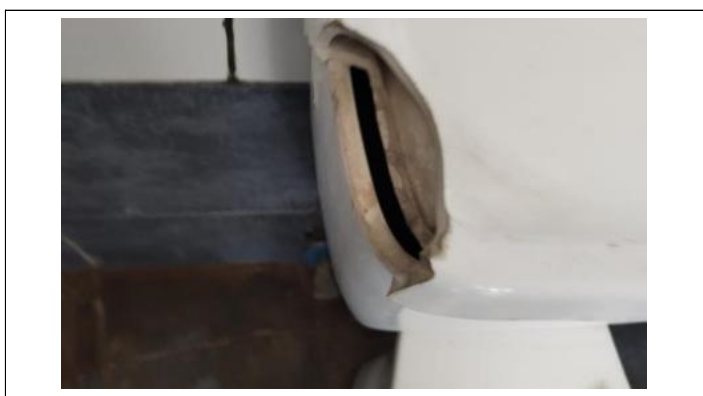
WC seat need to be changed
