**CERD 515 - Tall Bire Mixed Public School**

Batch 4 - Lot 1 - Akkar

Lebanon Emergency Assistance Project (LEAP)

## Detailed Assessment and Verification Report

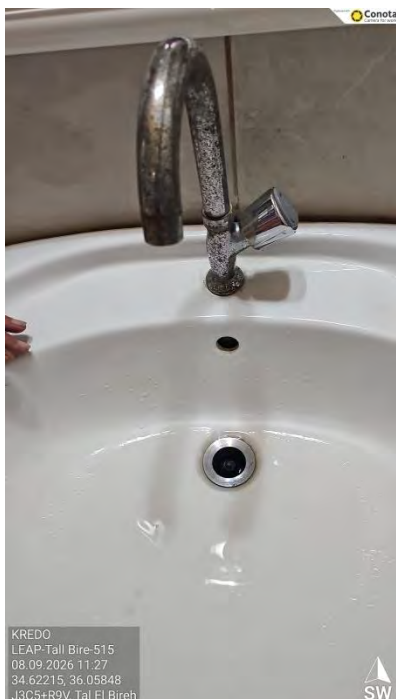
| Trade | Item | Damaged | Location, extent and quantity |
|---|---|---|---|
| | Mixers and taps | Yes | 6 mixers, 4 water taps |

**Figure 4 – Mixers in bad condition**

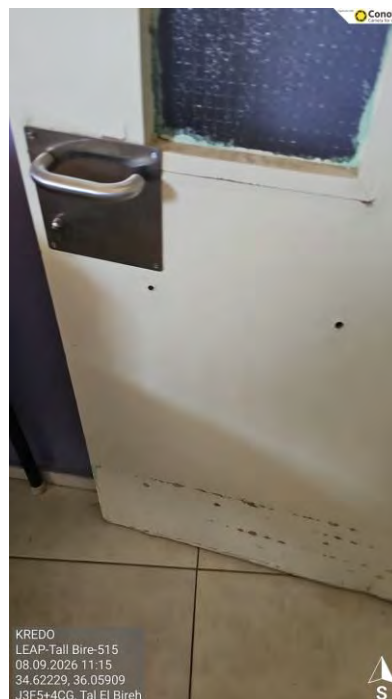
| Trade | Item | Damaged | Location, extent and quantity |
|---|---|---|---|
| | Door paint | Yes | 7 doors paint with Frames and architraves |

**Figure 5 - Damaged door paint**

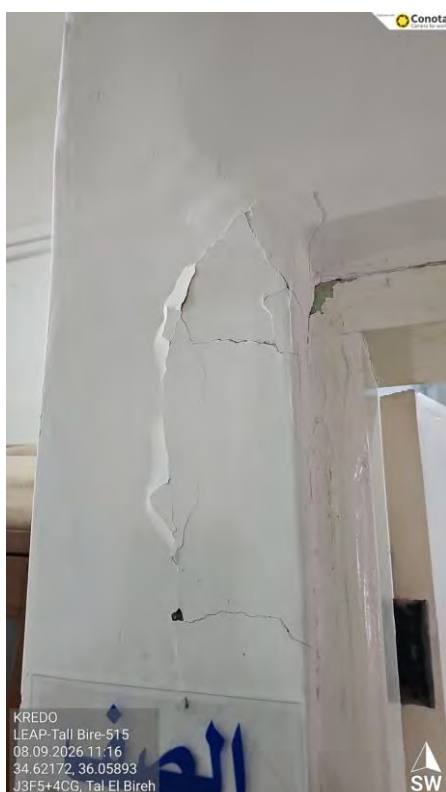
| No. | Element | Yes | No | Location and description |
|---|---|---|---|---|
| 3 | Wall cracks | X | | |

**Figure 6 - Wall cracks**

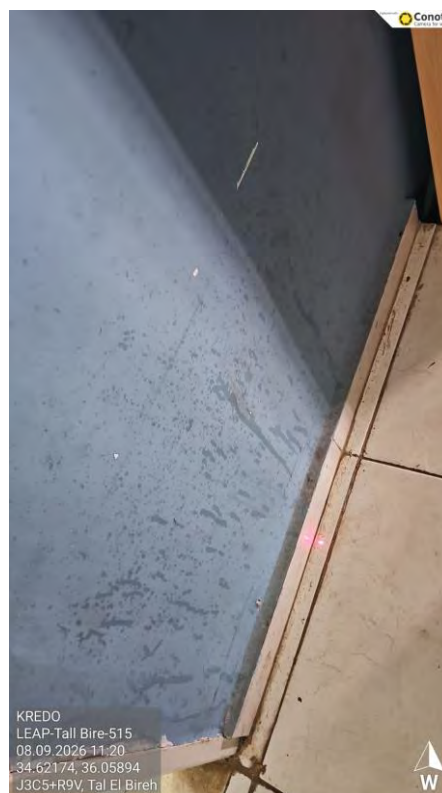
| Trade | Item | Damaged | Location, extent and quantity |
|---|---|---|---|
| Finishes | Paint - walls and ceilings - plasters | Yes | 800 m <sup>2</sup> paint |

**Figure 7 - Damaged paint**

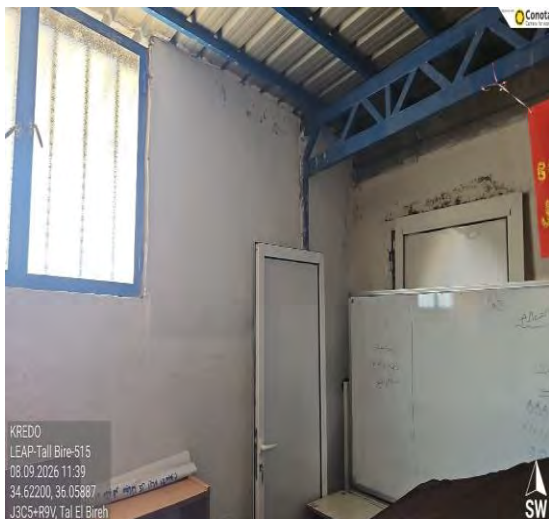
| Trade | Item | Damaged | Location, extent and quantity |
|---|---|---|---|
| | Water tanks and pumps | Yes | Water tank leakage |

**Figure 8 - Water leakage**

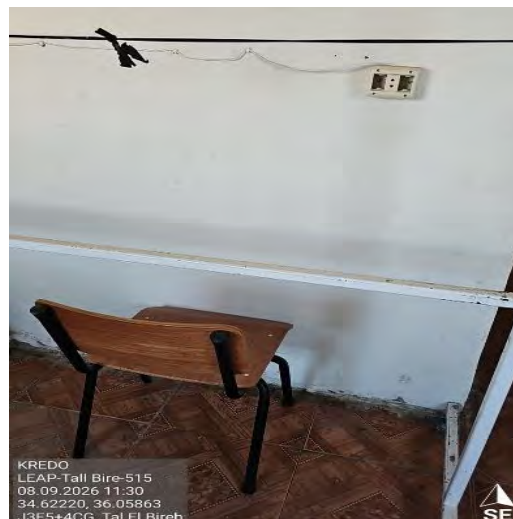
| Trade | Item | Damaged | Location, extent and quantity |
|---|---|---|---|
| Electrical | Sockets and switches | Yes | 5 covers for sockets<br>5 switches |

**Figure 9 - Damaged socket**

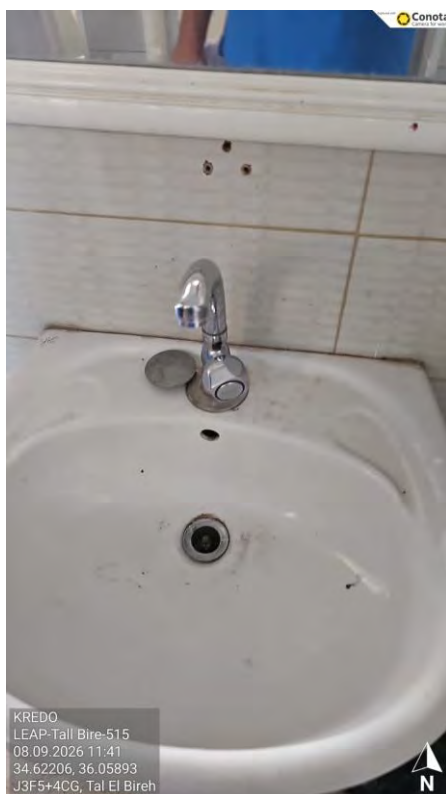
| Trade | Item | Damaged | Location, extent and quantity |
|---|---|---|---|
| Sanitary and plumbing | Wash basins | Yes | 4 wash basins |

**Figure 10 – Wash basins**

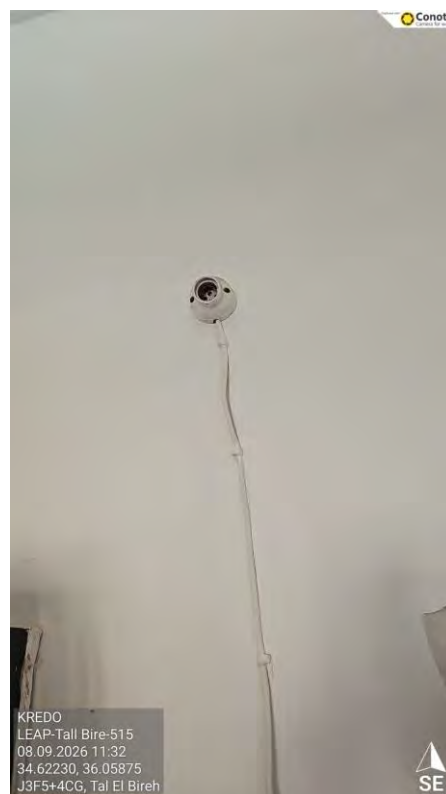
| Trade | Item | Damaged | Location, extent and quantity |
|---|---|---|---|
| | Lighting fixtures | Yes | 5 light fixtures with wires adjustments |

**Figure 11 - Damaged lighting fixtures**

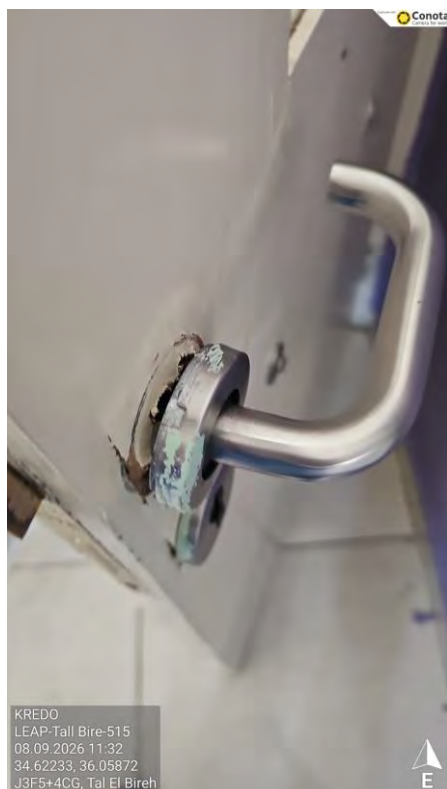
| Trade | Item | Damaged | Location, extent and quantity |
|---|---|---|---|
| | Door accessories and ironmongery | Yes | 10 sets for doors handles<br>5 sets of door accessories and ironmongery<br>4 doors locks |

**Figure 12 - Damaged door handle**

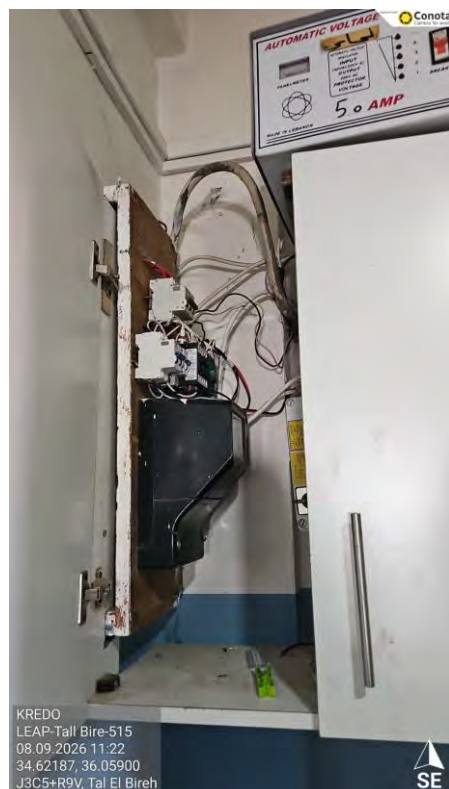
| Item | Condition found |
|---|---|
| Protection of electrical installations | Not Available |

**Figure 13 - Unprotected electrical installation**

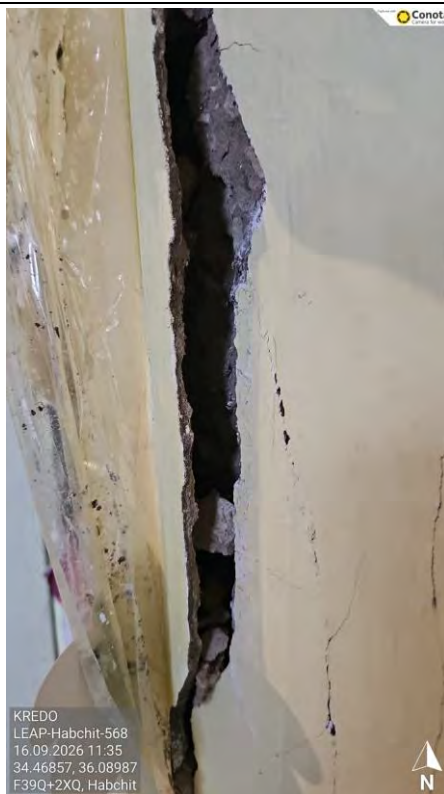
| No. | Element | Yes | No | Location and description |
|---|---|---|---|---|
| 4 | Column cracks | X | | |

**Figure 7- Column Cracks (1)**

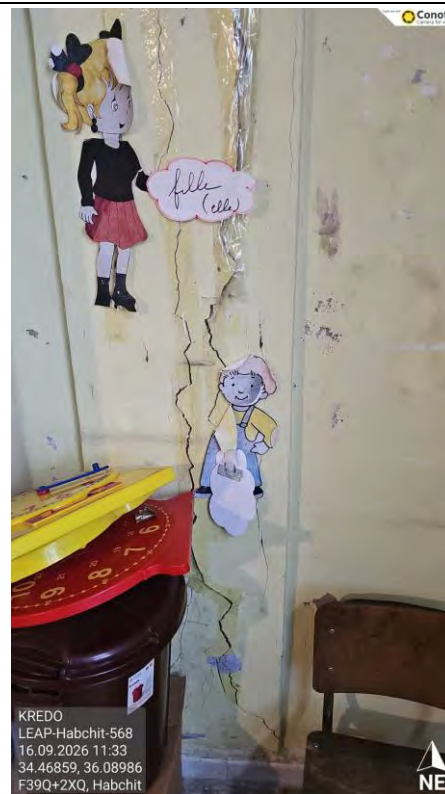
**Figure 8- Column Cracks (2)**

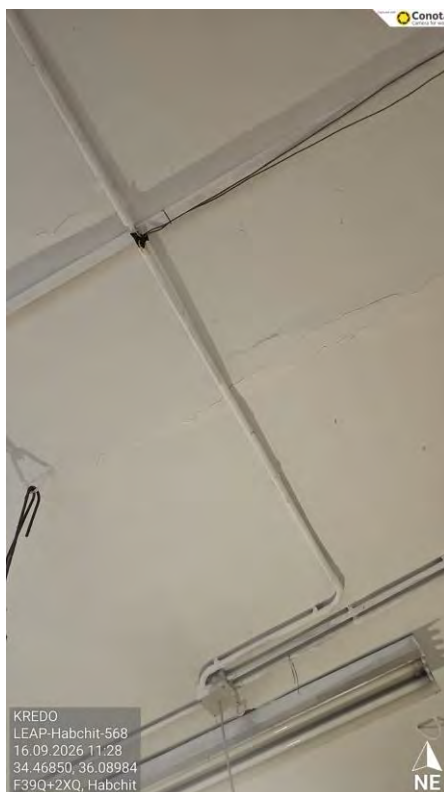
| No. | Element | Yes | No | Location and description |
|---|---|---|---|---|
| 6 | Roof slab cracks | X | | |

**Figure 9 - Roof Slab Cracks (1)**

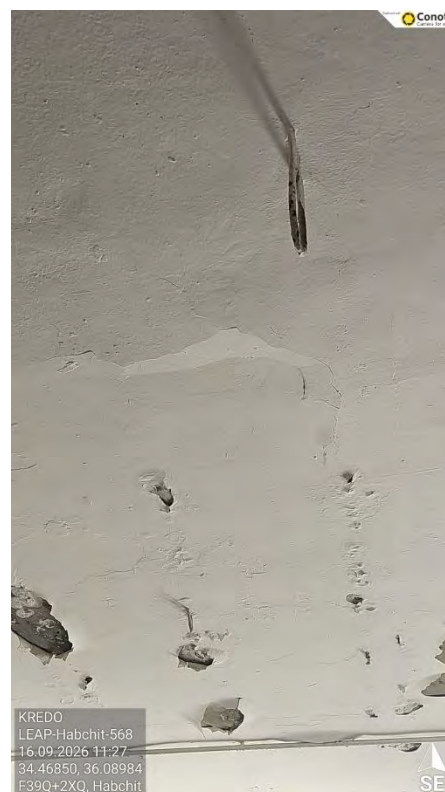
**Figure 10 - Roof Slab Cracks (2)**

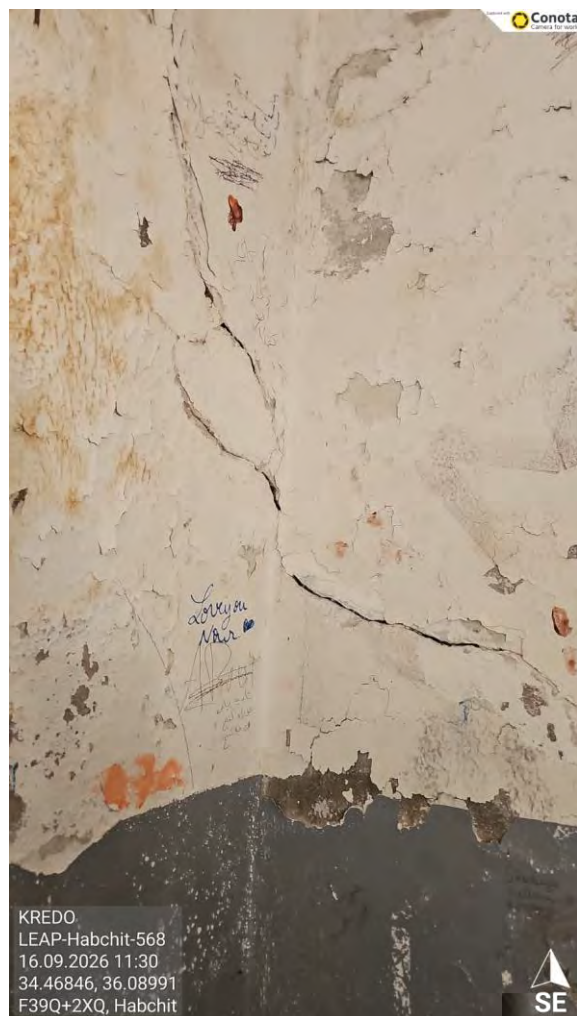
| No. | Element | Yes | No | Location and description |
|---|---|---|---|---|
| 3 | Wall cracks | X | | |

**Figure 11 - Wall Cracks (1)**

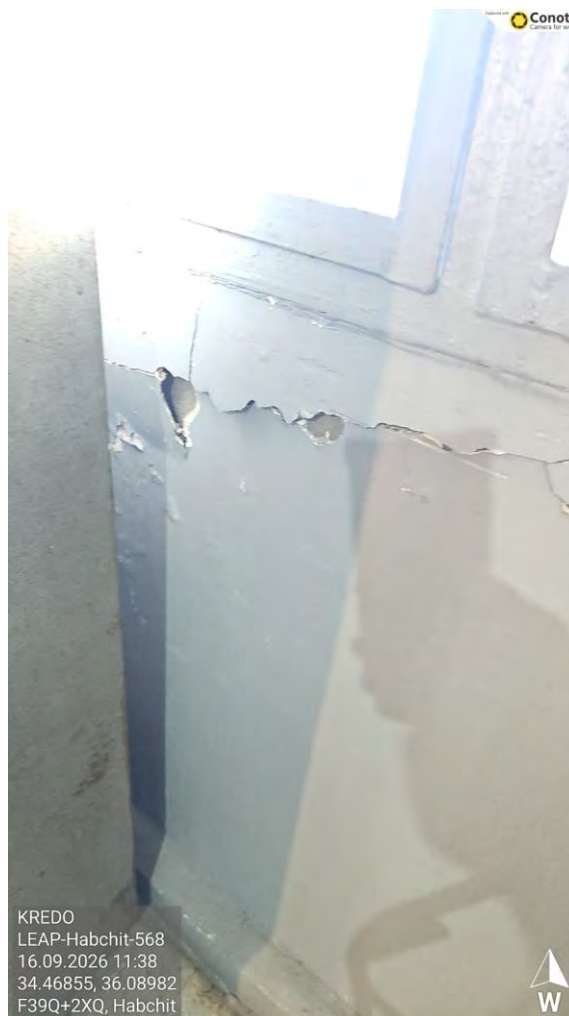
**Figure 12 - Wall Cracks (2)**

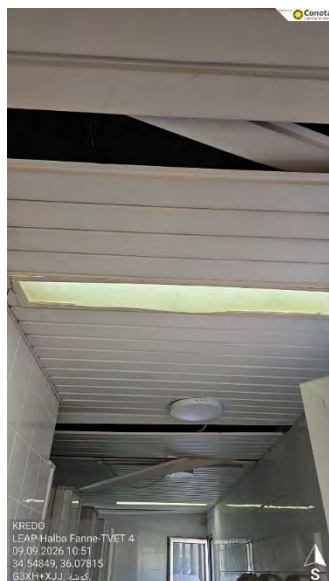
**Figure 7 – Damaged False Ceiling**

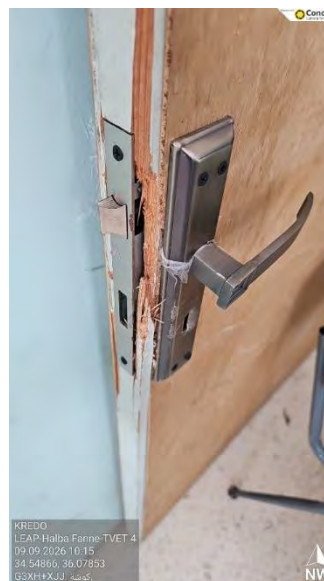
| Trade | Item | Damaged | Location, extent and quantity |
|---|---|---|---|
| Doors | Timber doors | Yes | 32 doors with frames architraves shall be changed, 14 shall be repaired, and 1 double door shall be changed |

**Figure 8 – Damaged Door**

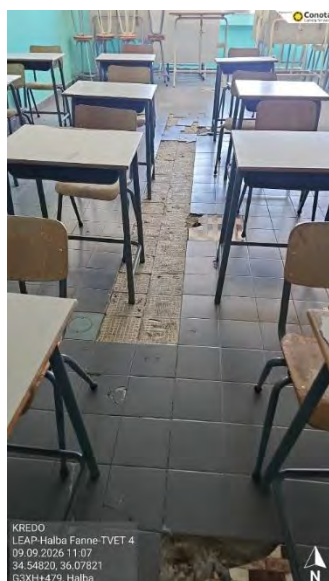
**Figure 9 – Damaged Floor Tiles**

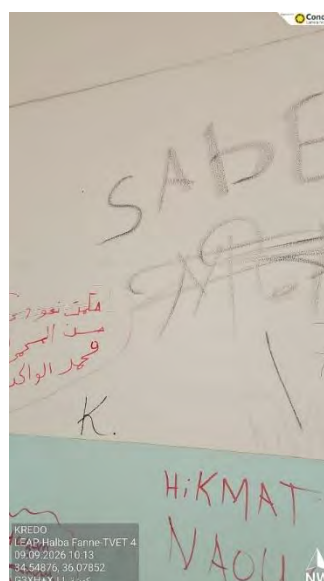
**Figure 10 – Damaged Wall Paint**

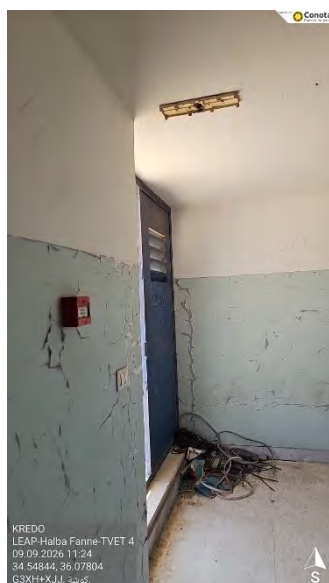
**Figure 11- Water Leakage**

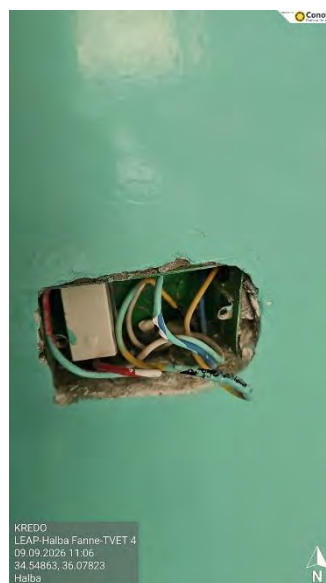
**Figure 12 – Damaged Socket**

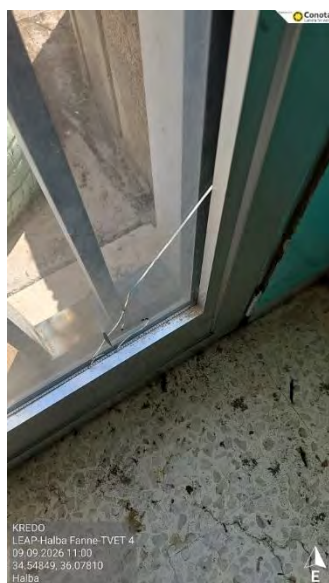
**Figure 13 – Damaged Door Glazing**

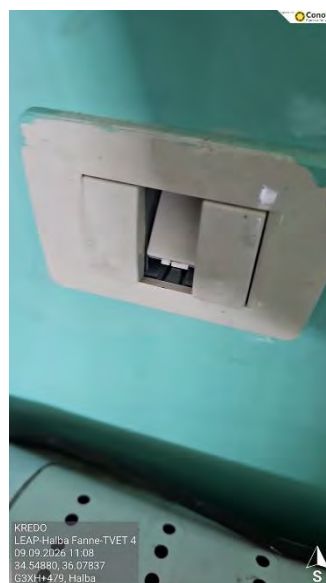
**Figure 14 – Damaged Switches**

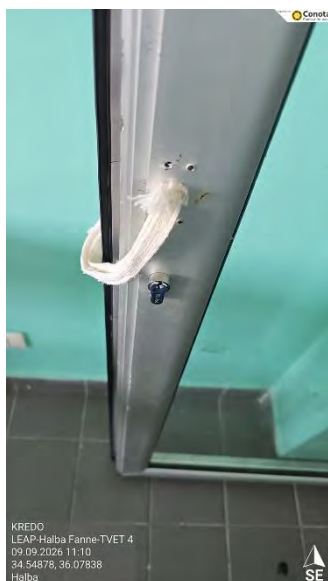
**Figure 15 - Damaged Door Handle**

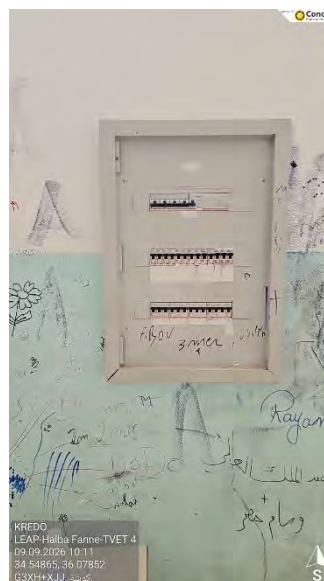
**Figure 16 - Unprotected Electrical Installation**

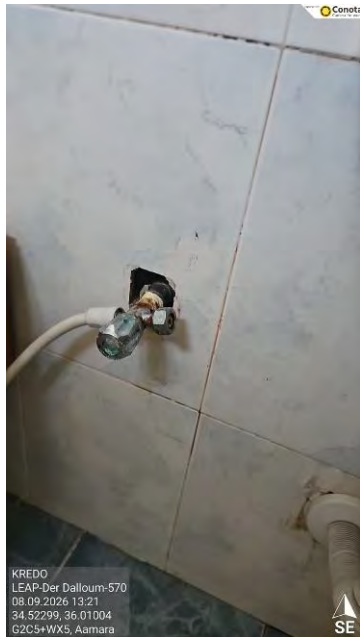
**Figure 4 – Damaged Angle Valve**

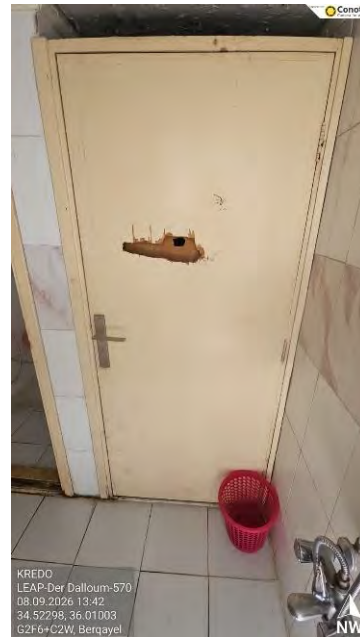
| Trade | Item | Damaged | Location, extent and quantity |
|---|---|---|---|
| Doors | Timber doors | Yes | 8 doors with frames architraves shall be changed, 6 doors shall be repaired |

**Figure 5 - Damaged Door**

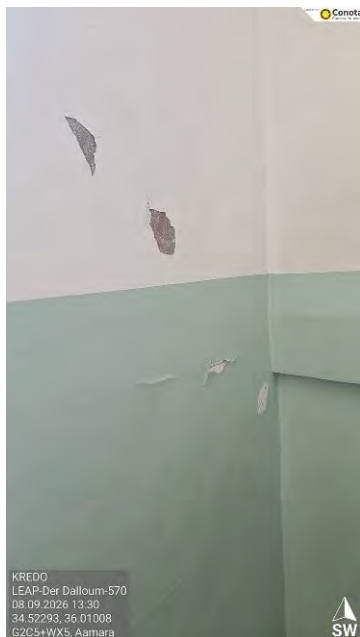
**Figure 6 – Wall Cracks**

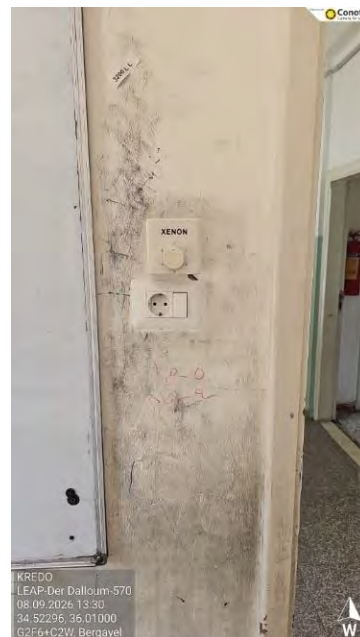
**Figure 7 - Damaged Paint**

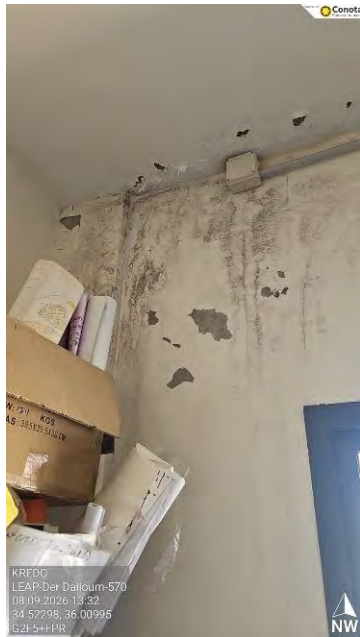
**Figure 8 – Water Leakage**

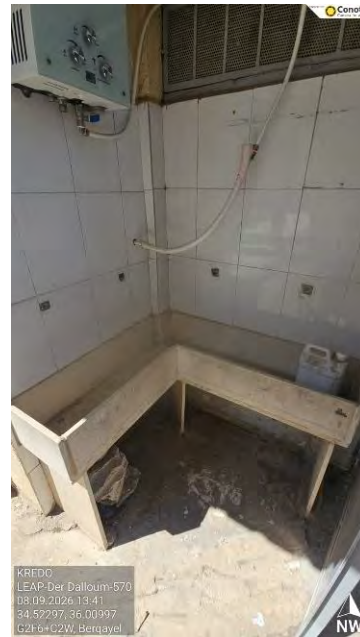
**Figure 9 – Damaged Taps**

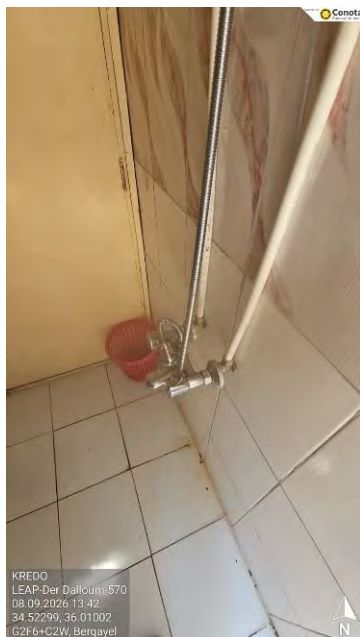
**Figure 10 – Damaged Mixers**

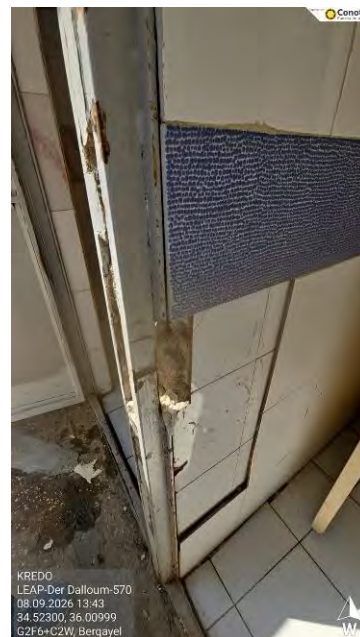
**Figure 11 - Damaged Tiles**

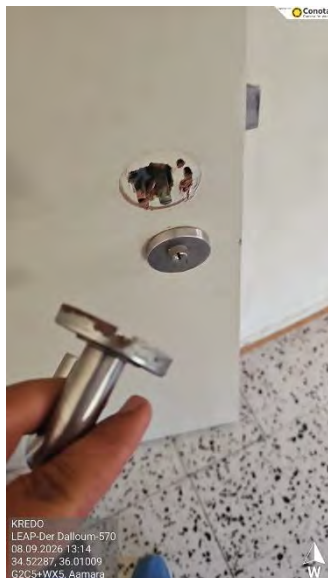
**Figure 12 - Broken Door Handle**

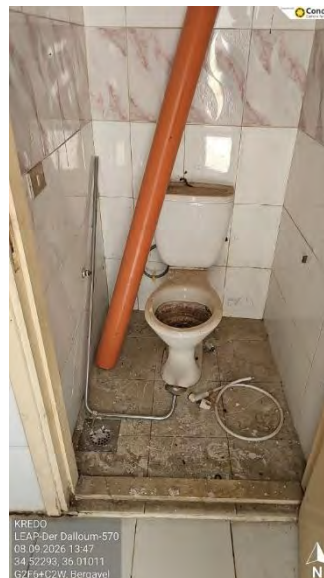
**Figure 13 – Damaged Toilet Seat**

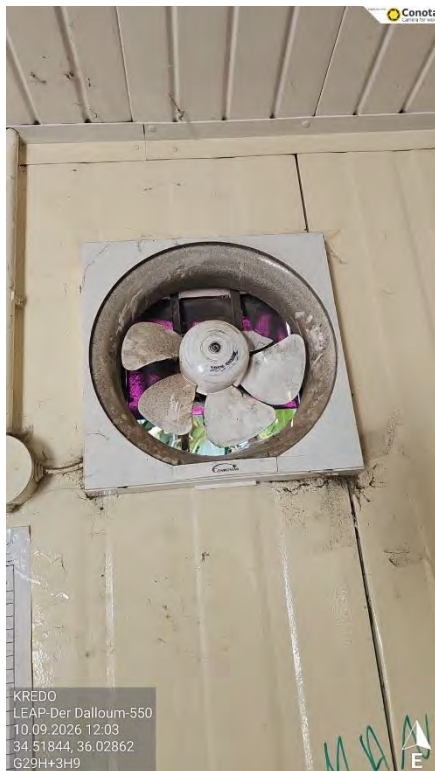
**Figure 4 – Damaged fan**

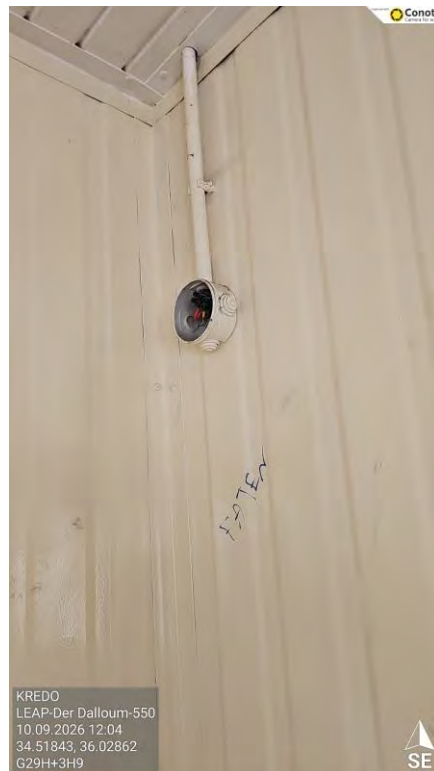
**Figure 5 - Damaged socket**

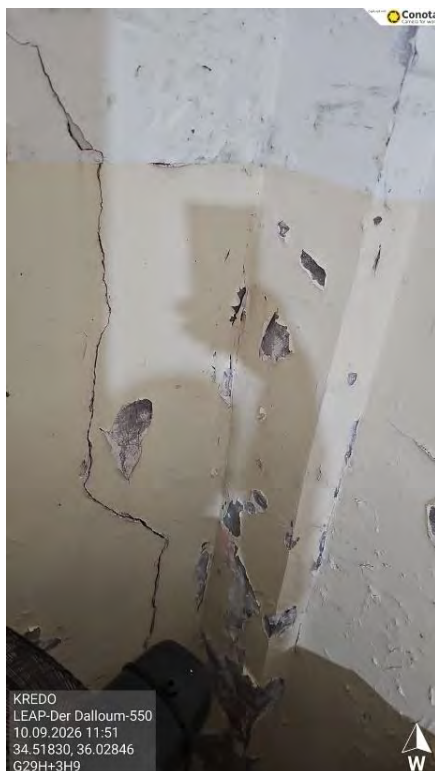
**Figure 6 – Wall cracks**

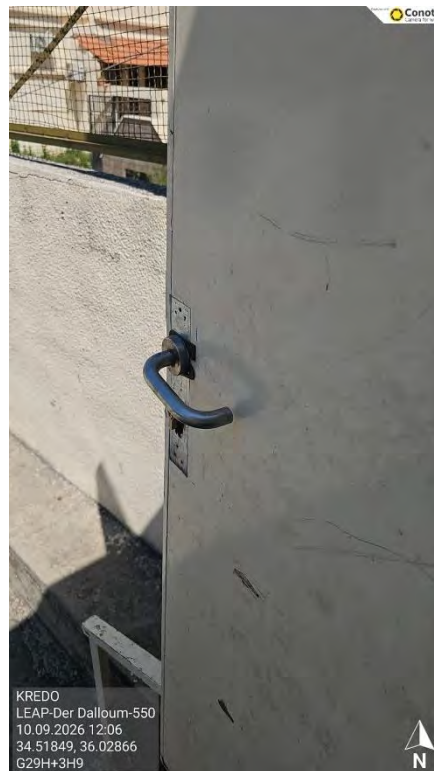
**Figure 7 – Damaged door handle**

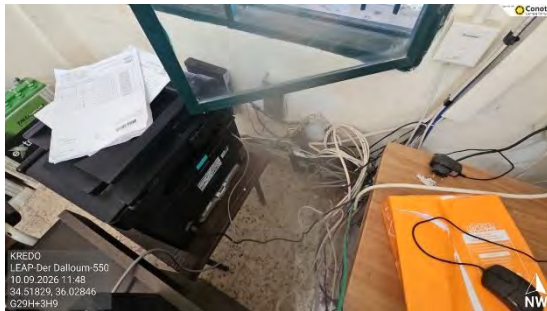
**Figure 8 – Unprotected electrical installation**

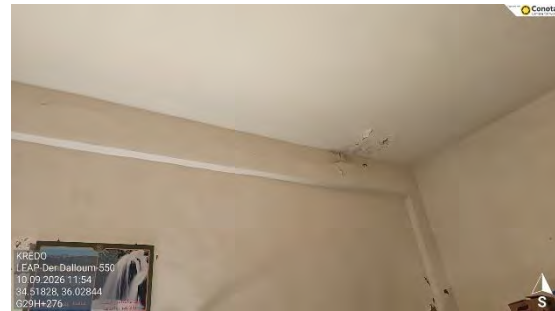
**Figure 9 – Water leakage**

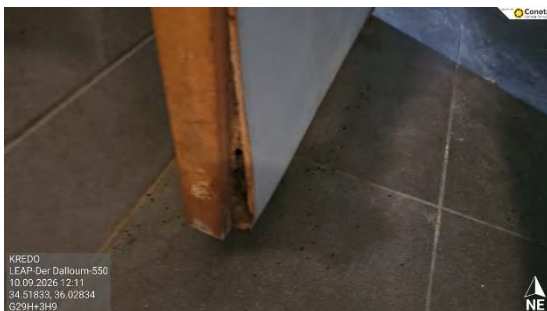
| Trade | Item | Damaged | Location, extent and quantity |
|---|---|---|---|
| Doors | Timber doors | Yes | 12 doors with frames architraves shall be changed,<br>4 doors shall be repaired |

**Figure 10 – Damaged door**

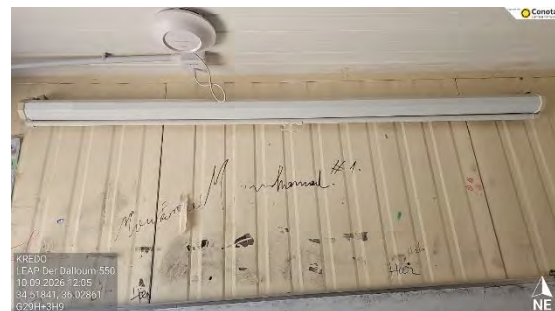
**Figure 11 - Damaged paint**

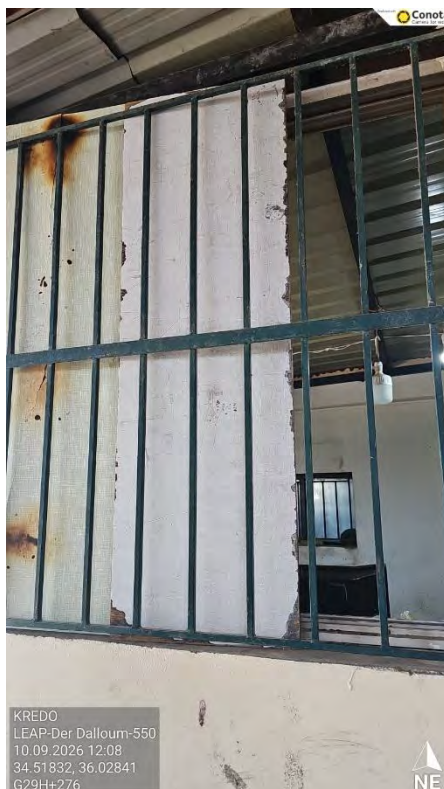
**Figure 12 -Window glazing in bad condition**

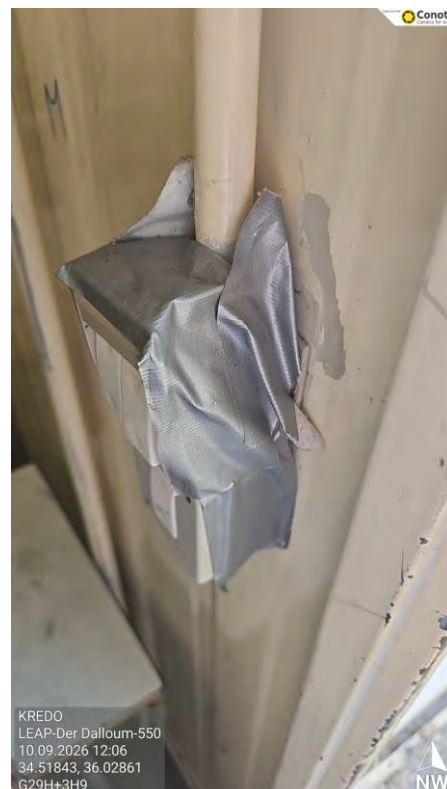
**Figure 13 – Damaged switches**

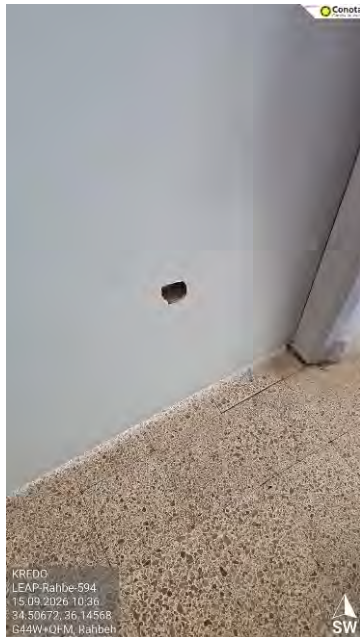
| Trade | Item | Damaged | Location, extent and quantity |
|---|---|---|---|
| Doors | Timber doors | Yes | 15 single doors with frames architraves shall be changed, 3 doors shall be repaired |

**Figure 7 - Doors in bad condition**

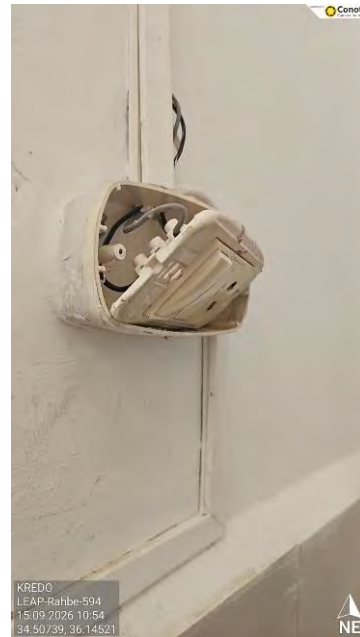
**Figure 8 – Damaged socket**

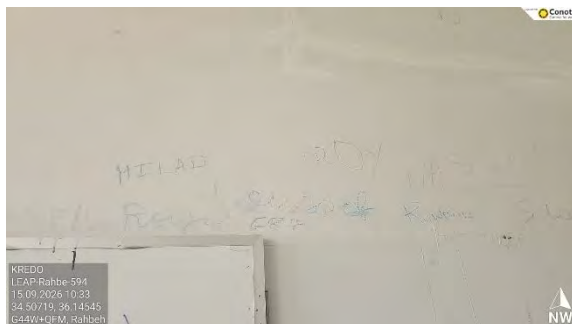
**Figure 9 - Paint in bad condition**

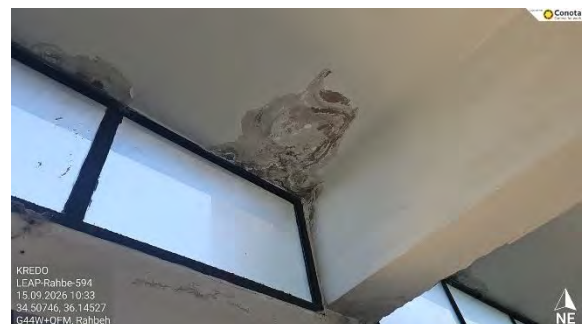
**Figure 10 - Water leakage**

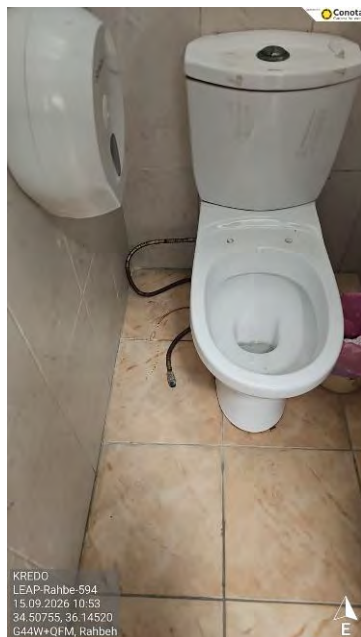
**Figure 11 - Damaged toilet seat**

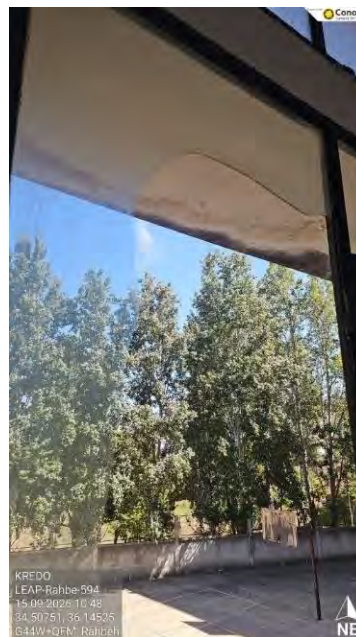
**Figure 12 - Cracked Glazing**

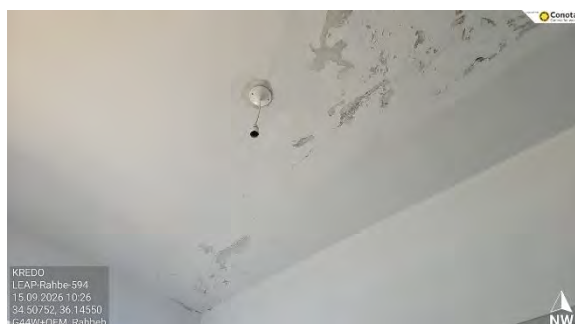
**Figure 13 - Damaged fixtures**

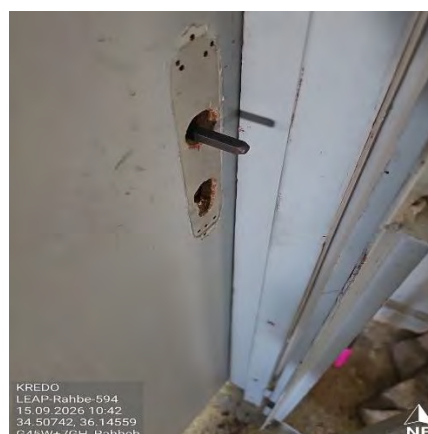
**Figure 14 - Door Handles in bad condition**

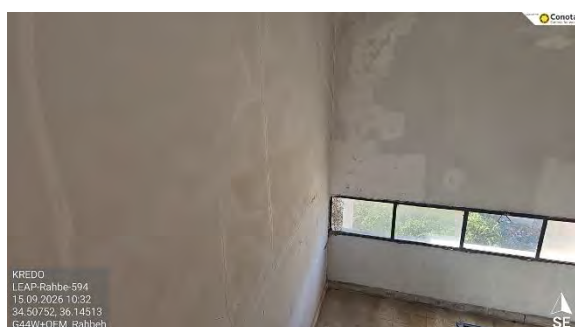
**Figure 15 - Wall cracks**

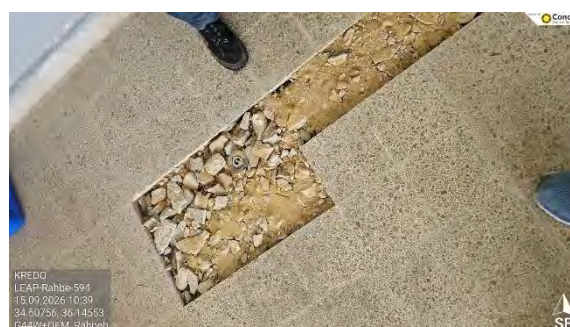
**Figure 16 - Damaged tiles**
