# **Annex A**

## **Assessment Report**

The location of the Ministry of Agriculture's Phyto-Pharmacy Laboratory building in Kfarshima. is shown in Figure 1 on Satellite imagery.

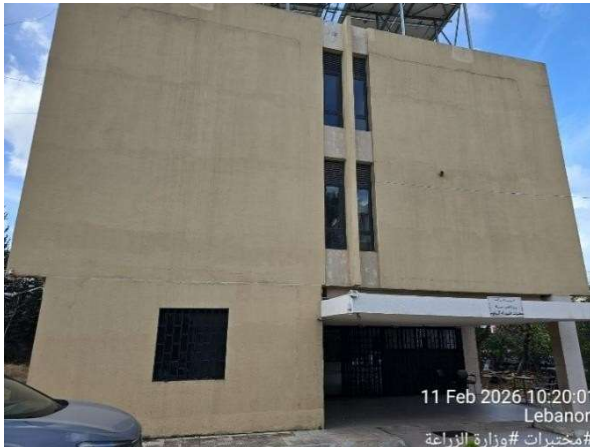
Facades to be Rehabilitated

- The building facades require repainting using weatherproof acrylic exterior paint.
- Roof drainage pipes are deteriorated and should be replaced.
- Several AC outdoor units should be relocated closer to their corresponding indoor units to reduce the length of exposed pipes and wiring on the facades.
- Minor leakages were observed at some aluminum window frames; this should be addressed during facade rehabilitation works.

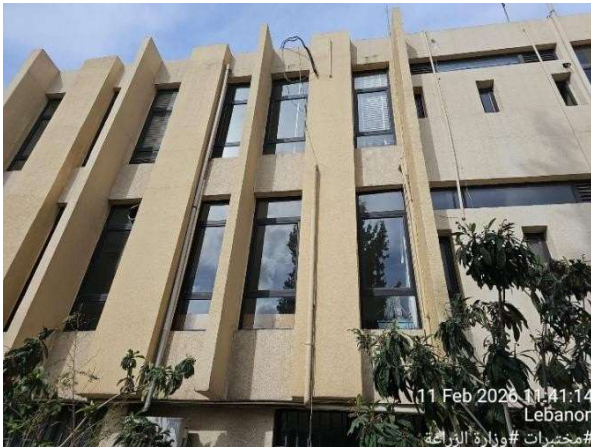
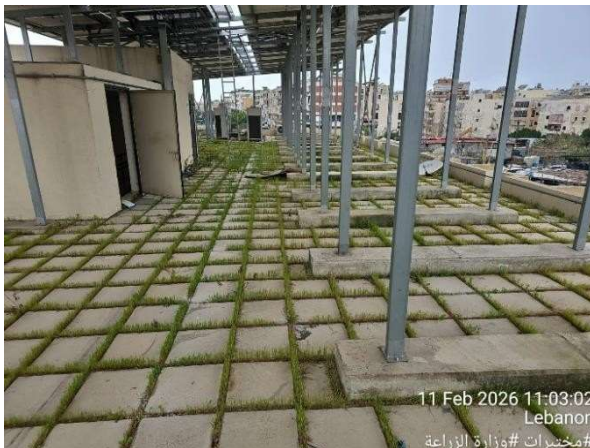
Roof

- The roof is waterproofed using bitumen membrane protected with gravel and tiles.
- One localized water leakage was identified above the elevator shaft. This issue should be repaired locally without replacing the entire waterproofing system.
- Two plastic water tanks located on the roof are in poor condition and require replacement.

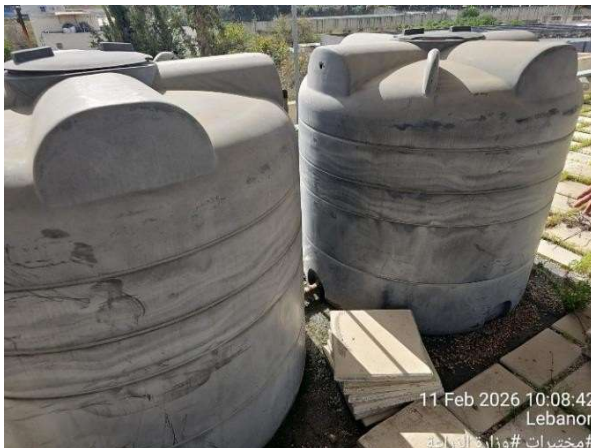
Water tanks to be replaced

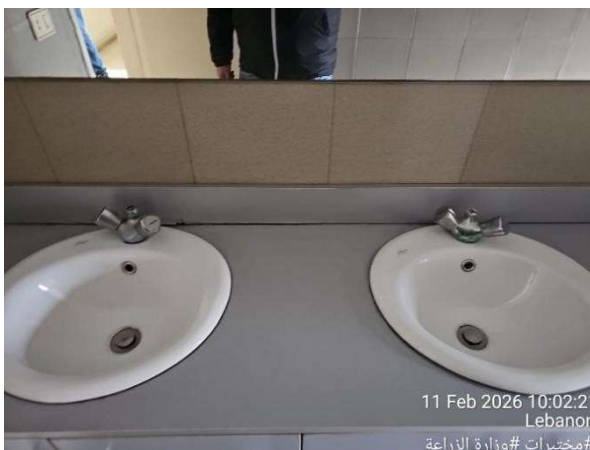
Wash basins & faucets to be replaced

- Replacement of toilet seats.
- Replacement of wash basins.
- Replacement of faucets, flexible pipes, and drainage accessories.

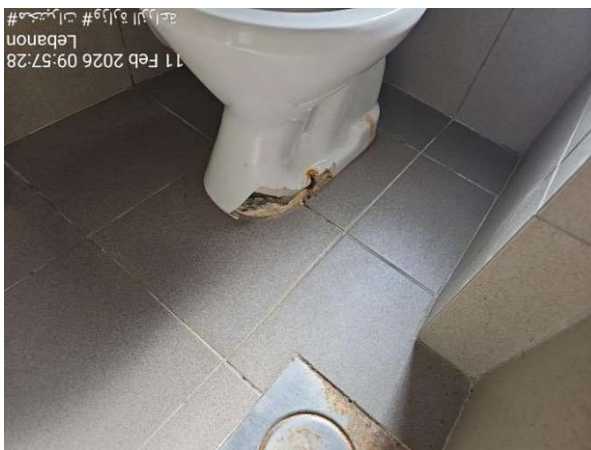
Toilet seats to be replaced

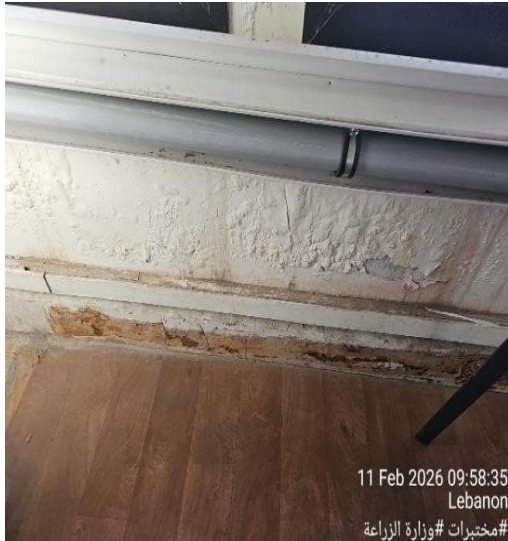
**Water leakage from aluminum opening**

- Repainting of all internal walls.
- Aluminum windows are in good condition; minor leakages to be treated during facade works.
- Some offices with vinyl flooring require replacement.
- False ceilings are in good condition.
- Floor tiles are generally in good condition.

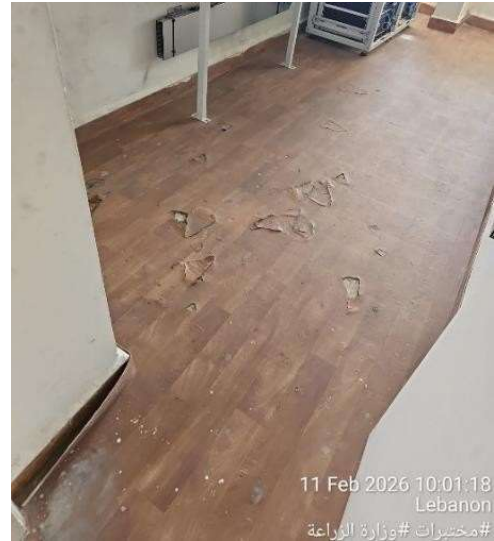
**Vinyl flooring to be replaced**

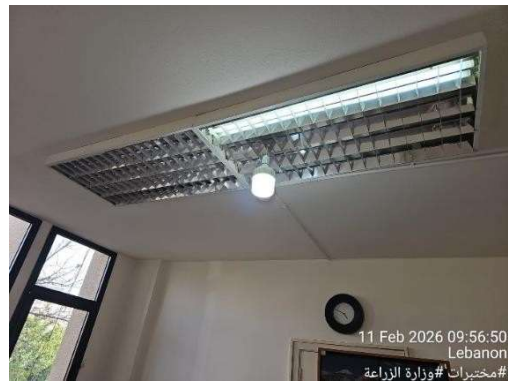
**Lighting to be rehabilitated**

- Some offices require lighting system replacements.

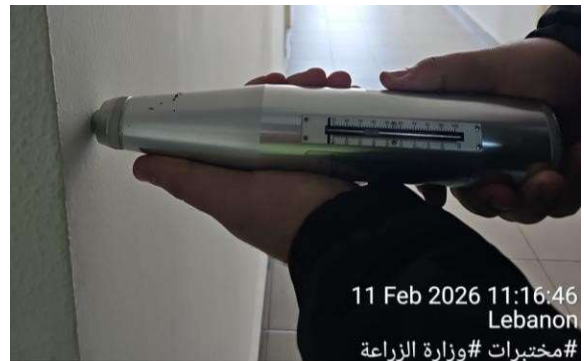
| <b>Location</b> | <b>Reading 1</b> | <b>Reading 2</b> | <b>Reading 3</b> | <b>Average f'c (MPa)</b> |
|---|---|---|---|---|
| Column 1 - Entrance of GF | 33 | 32 | 34 | 33 |

**Schmidt hammer test on RC Columns**

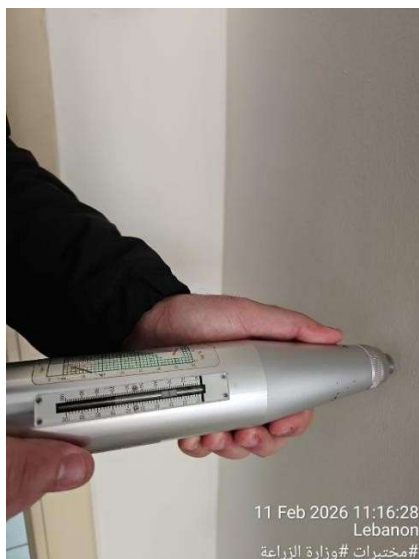
| <b>Location</b> | <b>Reading 1</b> | <b>Reading 2</b> | <b>Reading 3</b> | <b>Average f'c (MPa)</b> |
|---|---|---|---|---|
| Column 2 - Inside of GF Hallway | 36 | 35 | 36 | 35.67 |

**Schmidt hammer test on RC Columns**

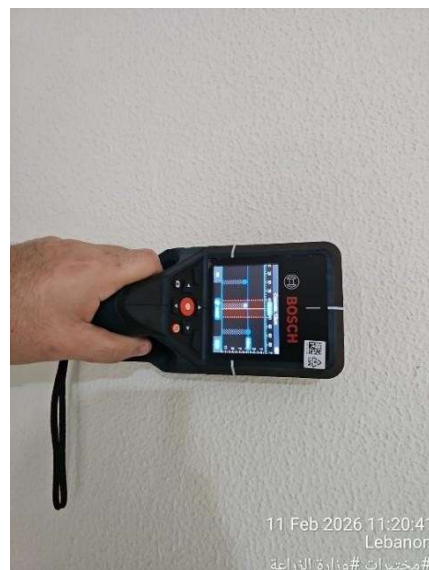
A ferrosan survey was undertaken in accordance with ACI228.2R using a rebar locator, in order to detect reinforcement in concrete elements.

**Wall scanner to check Steel Reinforcement**
