**CERD 423 - Ebn Rashed Public School for Girls**

Batch 4 - Lot 2 – Tripoli

### Lebanon Emergency Assistance Project (LEAP)

## Detailed Assessment and Verification Report

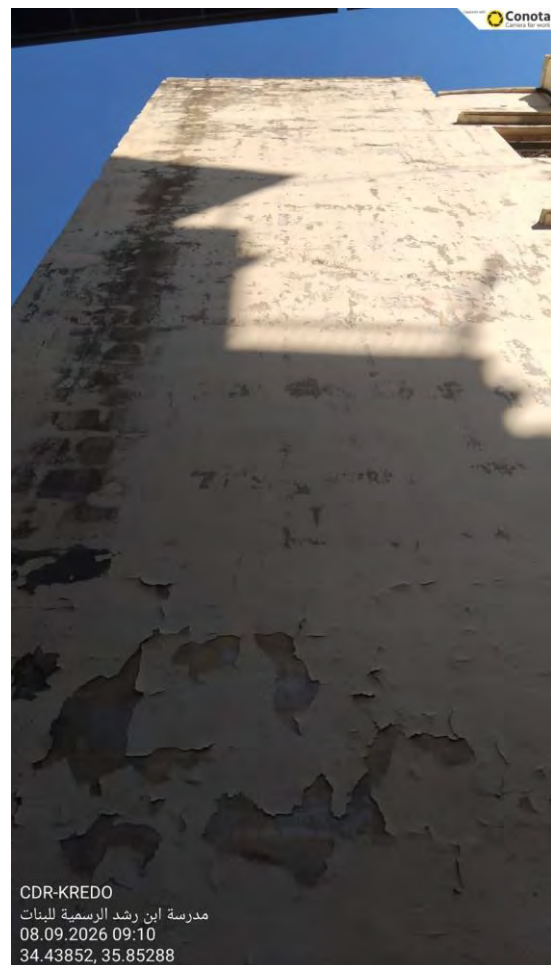
| No. | Element | Yes | No | Location and description |
|---|---|---|---|---|
| 3 | Wall cracks | X | | In staircase wall |

**Figure 7 – Damaged Exterior Wall**

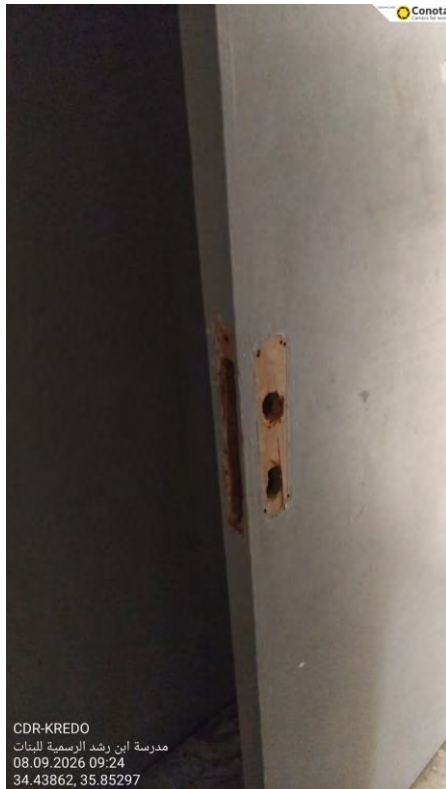
| Trade | Item | Damaged | Location, extent and quantity |
|---|---|---|---|
| | Door accessories and ironmongery | Yes | 1 wooden door handle & lock needed |

**Figure 8 – Missing Door Handle & Lock**

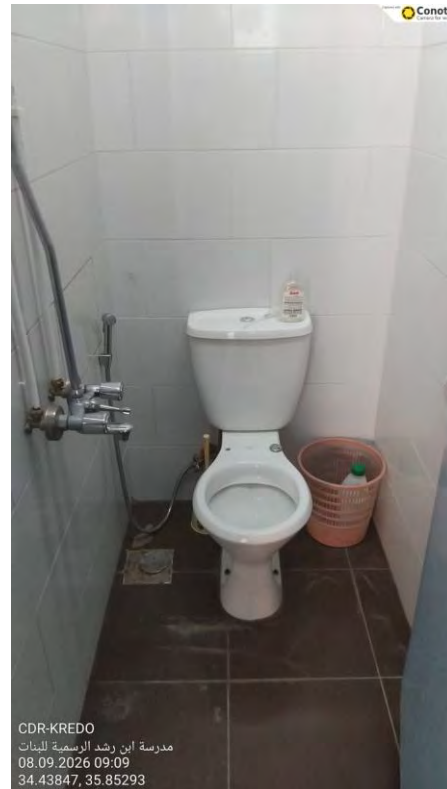
**Figure 9 – Missing Toilet Seat Cover**

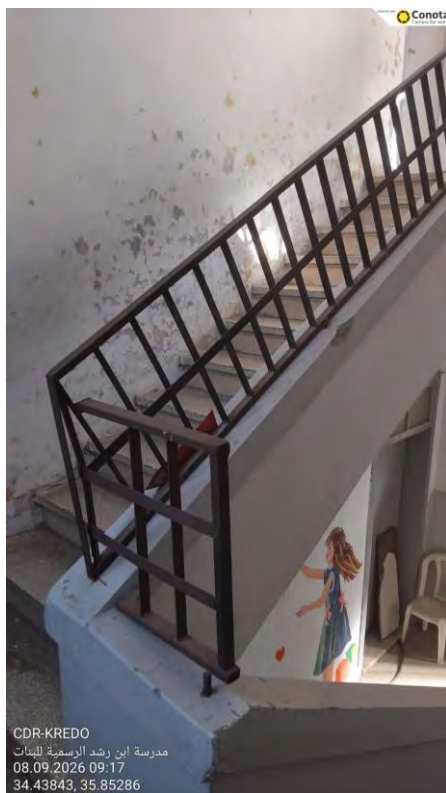
| Item | Condition found |
|---|---|
| Handrails | Available but need painting (rusted) |

**Figure 10 – Rusted Stair Handrail**

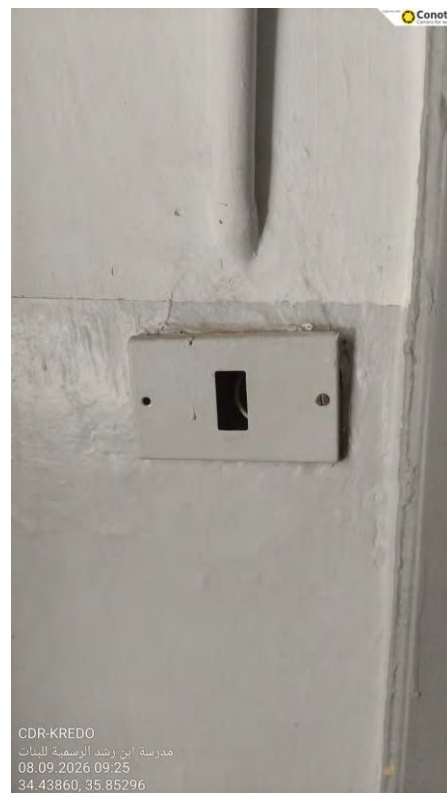
| Trade | Item | Damaged | Location, extent and quantity |
|---|---|---|---|
| Electrical | Sockets and switches | Yes | In 3 points<br>General maintenance |

**Figure 11 – Damaged Switch**

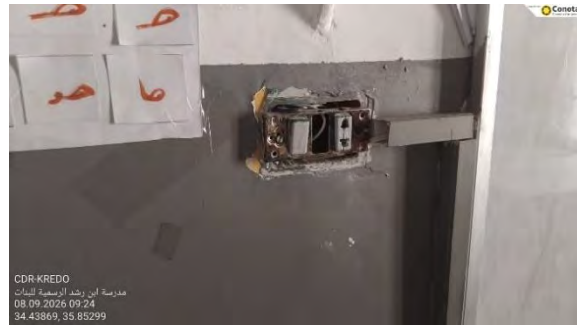
**Figure 12 – Damaged Switch**

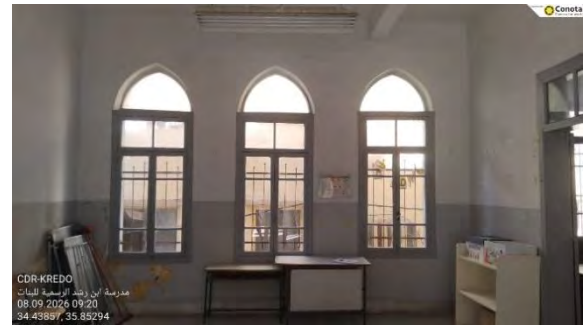
| Trade | Item | Damaged | Location, extent and quantity |
|---|---|---|---|
| Finishes | Paint - walls and ceilings - plasters | Yes | 1,125 m <sup>2</sup> for walls<br>28 wood windows, 4 steel doors shall be painted<br>25 m <sup>2</sup> for steel Balustrade |

**Figure 13 – Damaged Wall Paint**

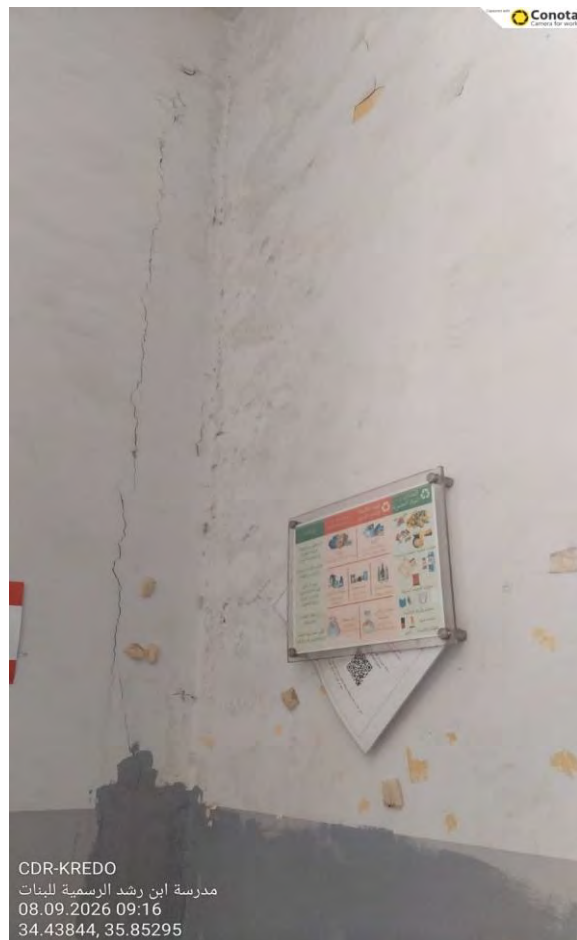
**Figure 14 – Crack in Wall**

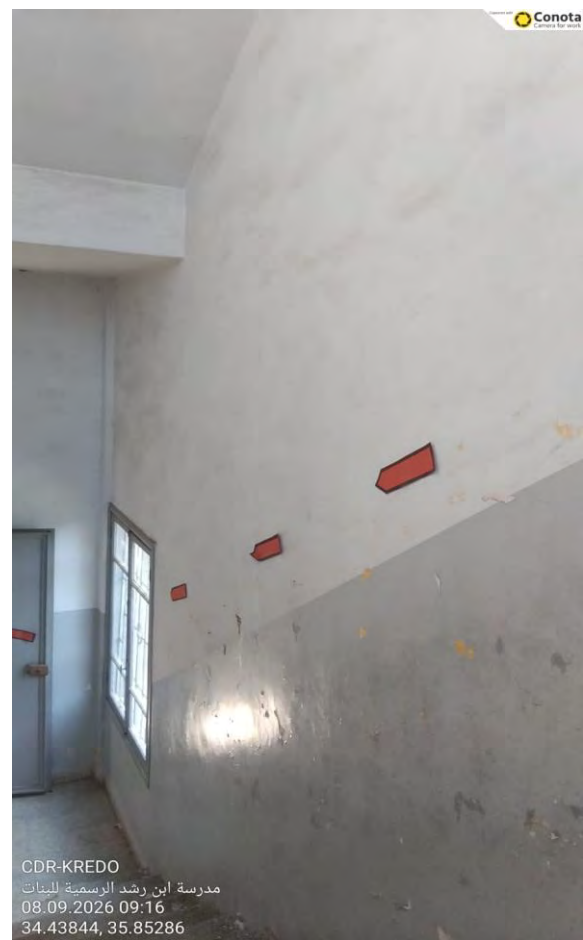
**Figure 15 – Damaged Wall Paint**

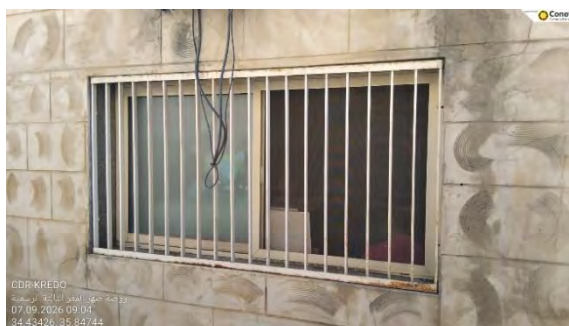
**Figure 8 – Rusty Steel Protection**

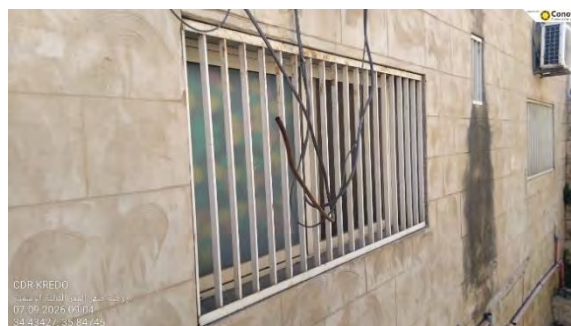
**Figure 9 – Rusty Steel Protection**

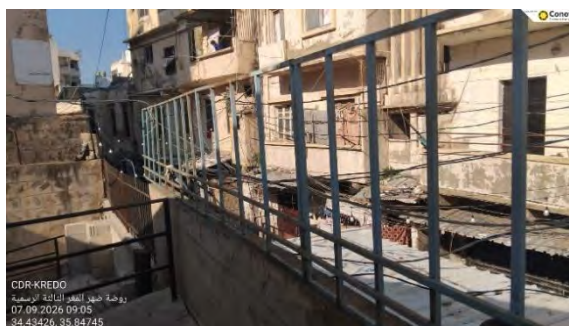
**Figure 10 – Rusty Steel Fence**

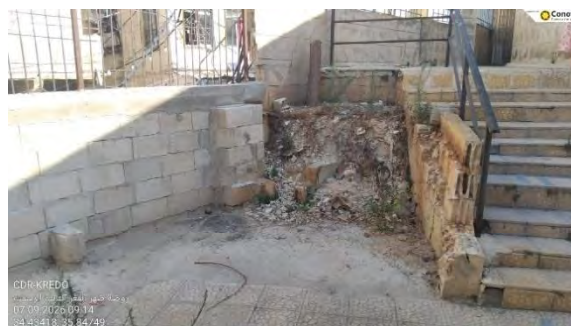
**Figure 11 – Risky Zone in Kids Playground (1)**

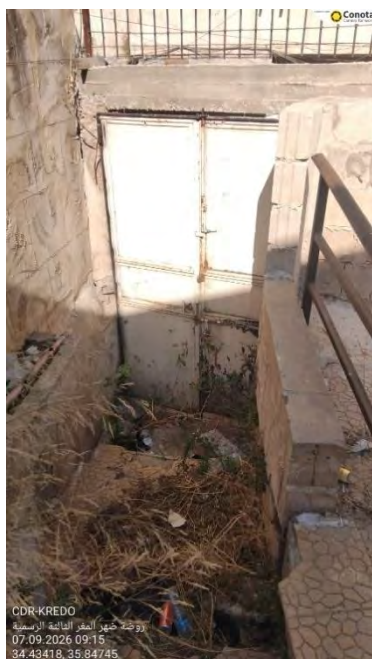
**Figure 12 – Rusted Gate in Kids Playground**

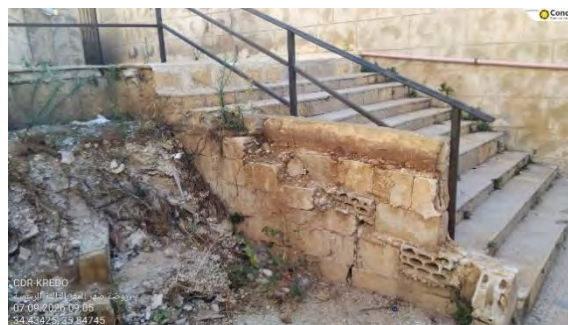
**Figure 13 – Risky Zone in Kids Playground (2)**

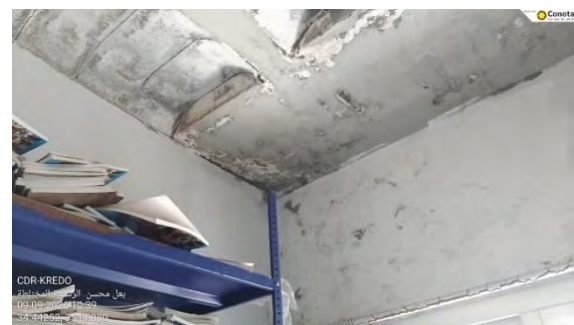
**Figure 18 - Humidity in Staircase**

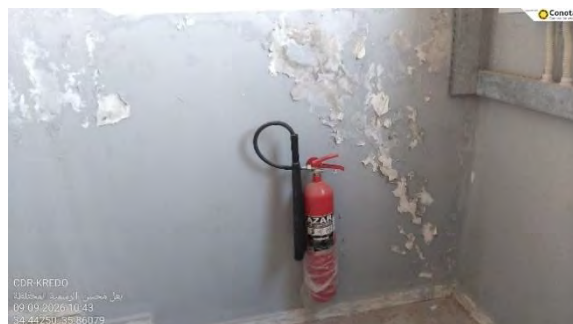
**Figure 19 - Humidity in Wall**

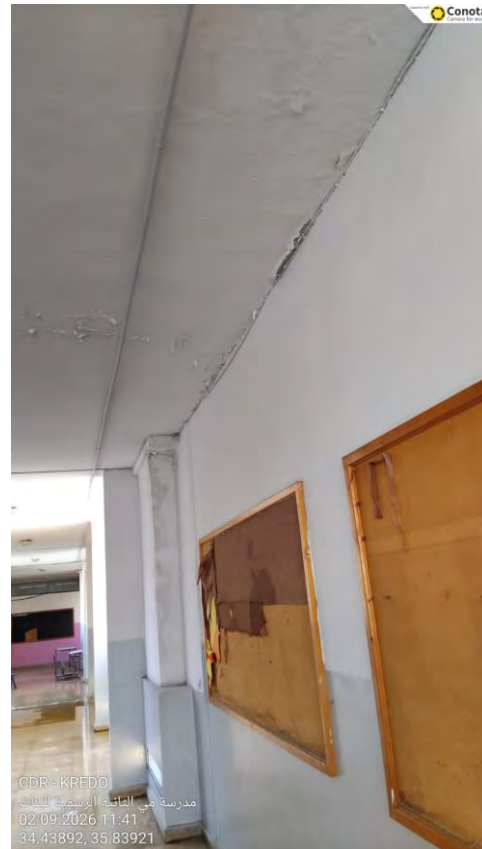
**Figure 17 - Humidity in Wall**

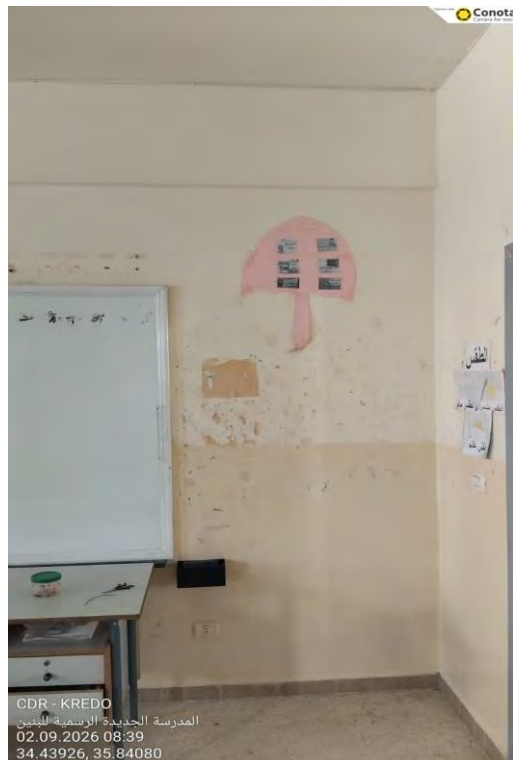
**Figure 8 – Damaged Wall Paint**

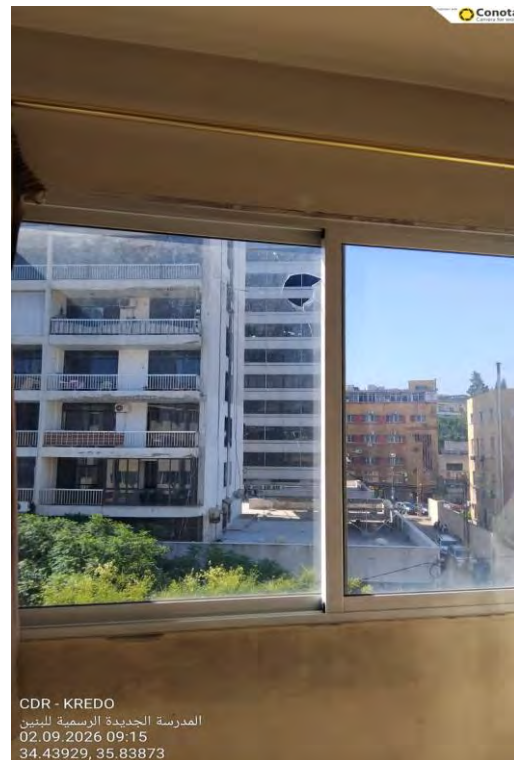
**Figure 9 – Broken Window Glass**

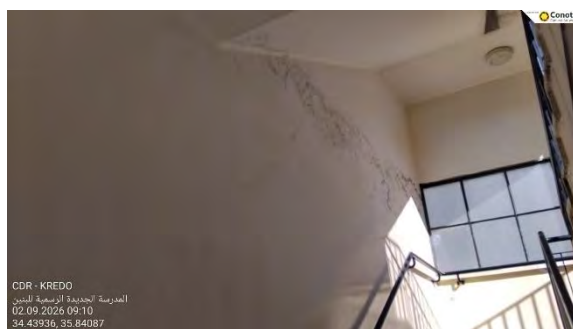
**Figure 10 – Humidity in Wall**

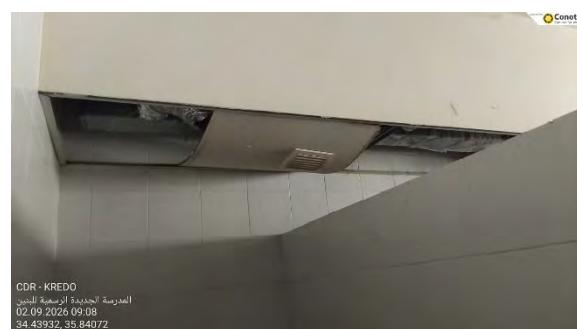
**Figure 11- Damaged False Ceiling**

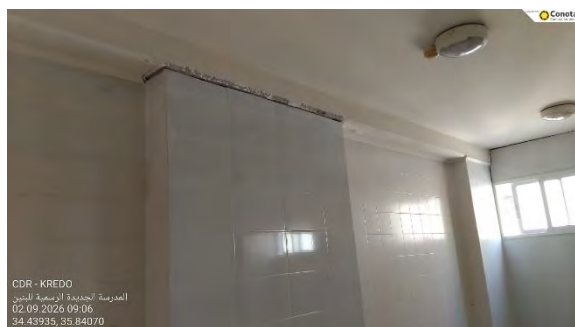
**Figure 12 – Damaged Paint**

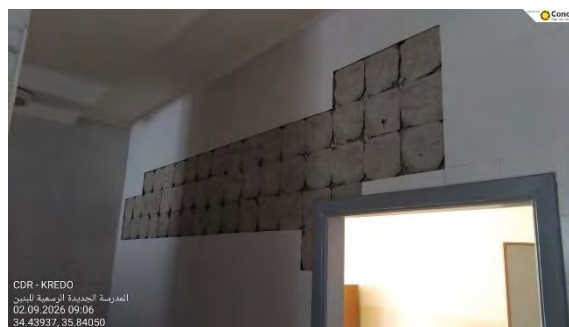
**Figure 13 – Missing Tiles**

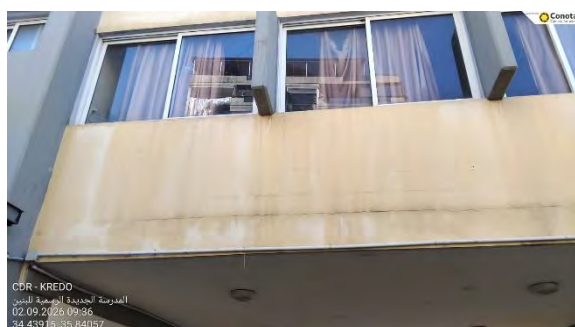
**Figure 14 – Humidity in External Wall**

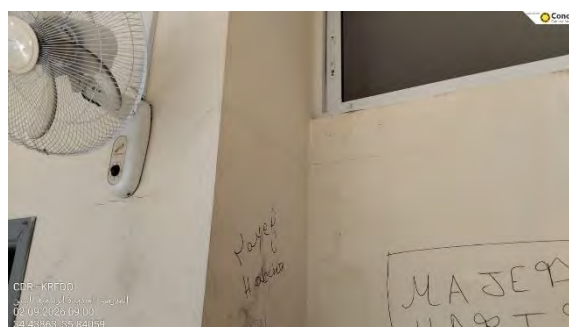
**Figure 15 – Crack in Wall**

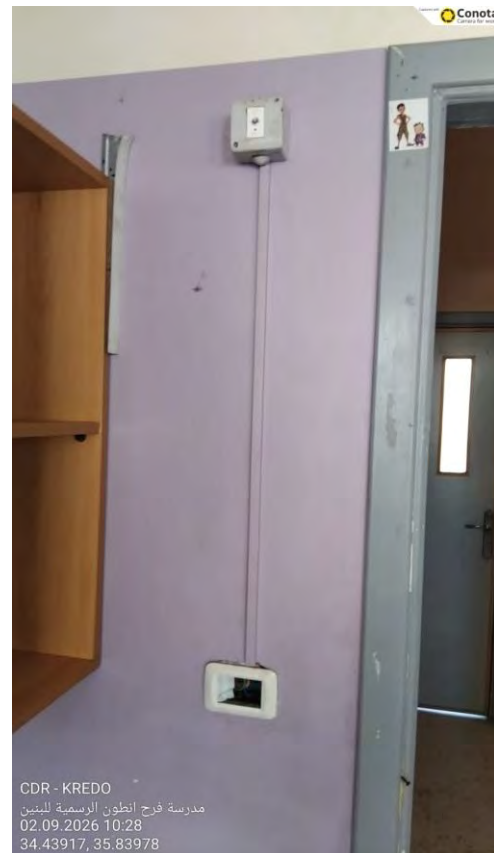
**Figure 7 – Damaged Switches**

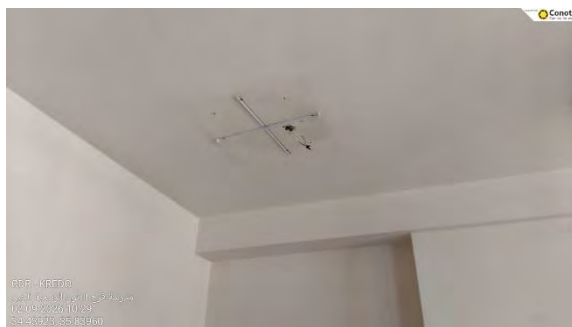
**Figure 8 – Missing Light Fixture**

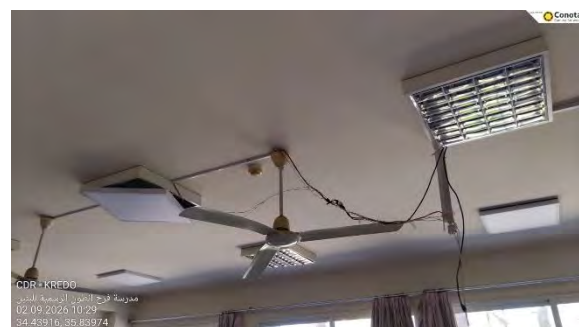
| Trade | Item | Damaged | Location, extent and quantity |
|---|---|---|---|
| | Distribution boards and wiring | Yes | Wiring needs repair in one room |

**Figure 9 – Damaged Electrical Wiring**

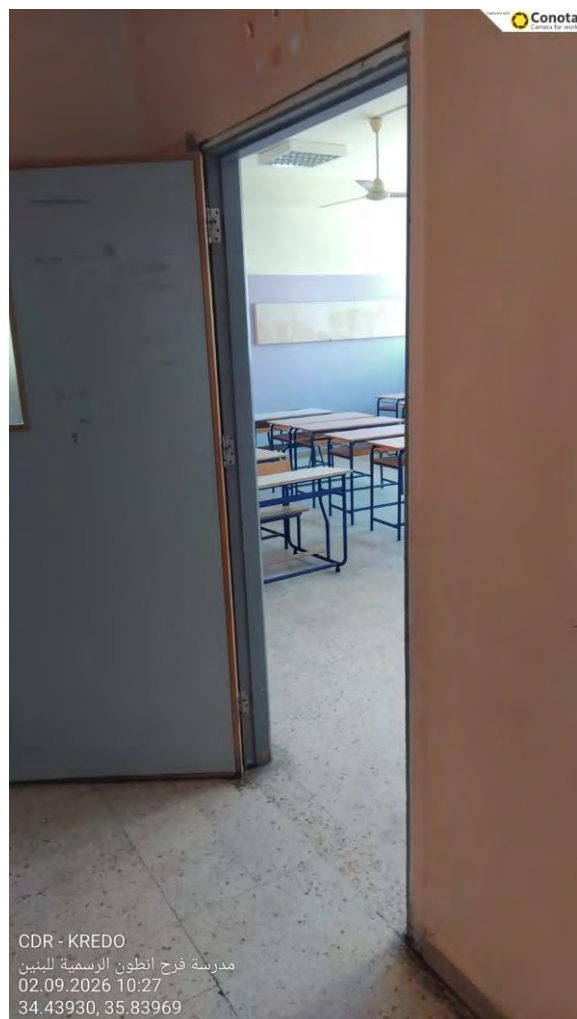
**Figure 10 – Damaged Door Frame**

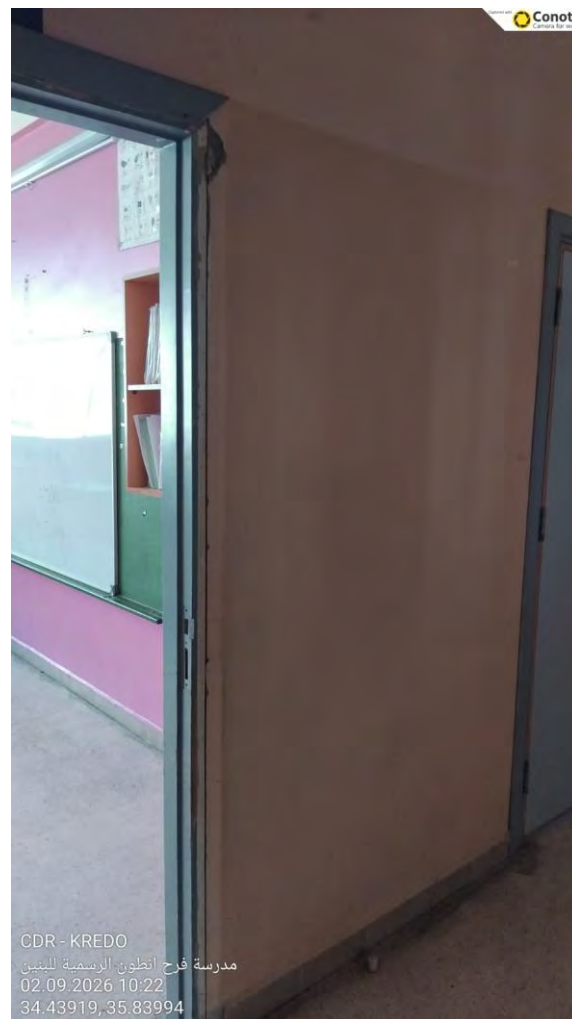
**Figure 11 - Damaged Door Frame**

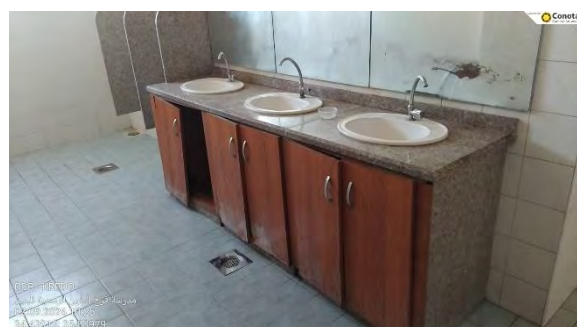
**Figure 12 – Damaged Wash Basins**

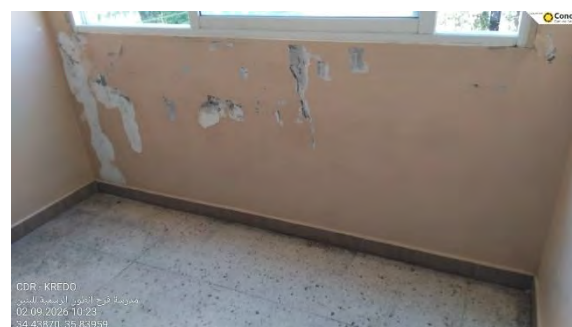
**Figure 13 – Humidity in Wall**

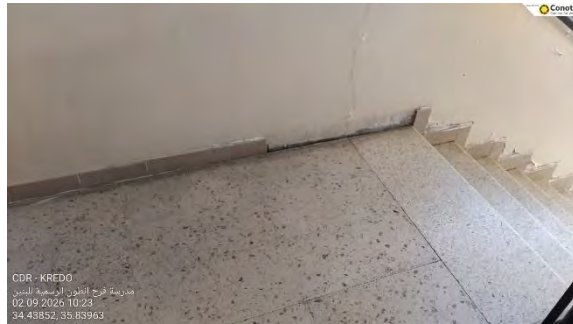
**Figure 14 – Crack in Wall**

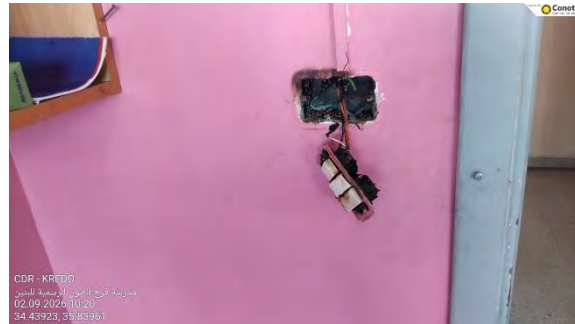
**Figure 15 – Damaged Switch**

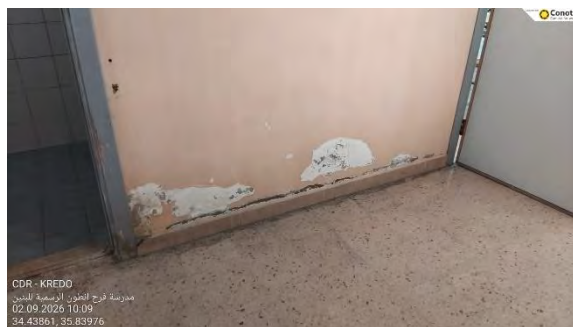
**Figure 16 - Humidity in Wall**

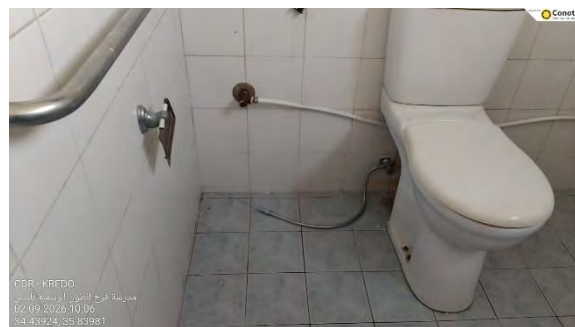
| Trade | Item | Damaged | Location, extent and quantity |
|---|---|---|---|
| | Water closets | Yes | 1 bidet sprayer to replace |

**Figure 17 - Damaged Toilet Accessories**

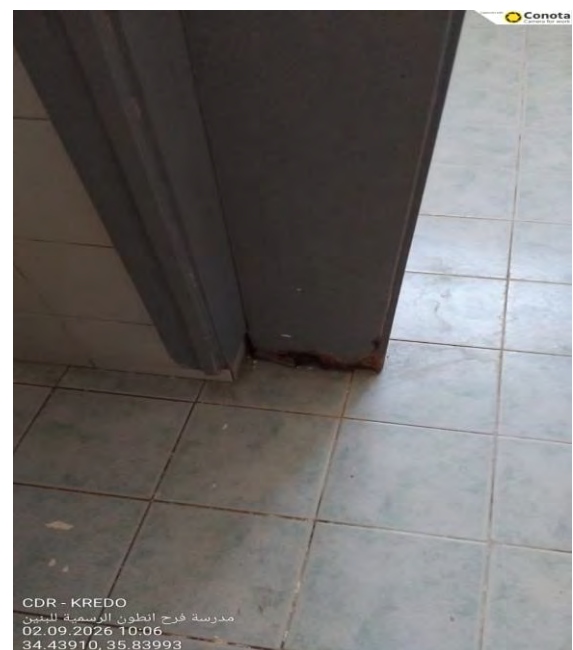
**Figure 18 - Damaged Door Frame**

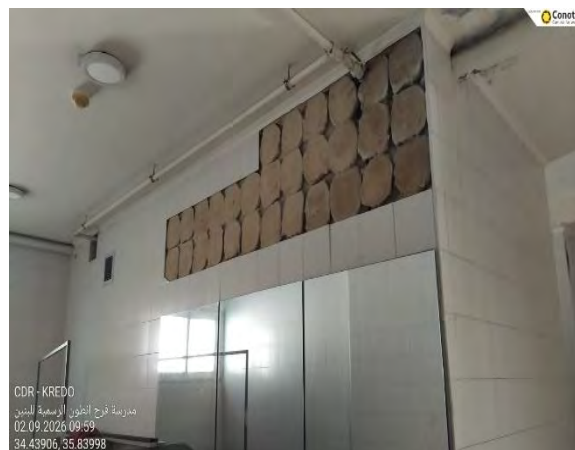
**Figure 19 - Missing Tiles**

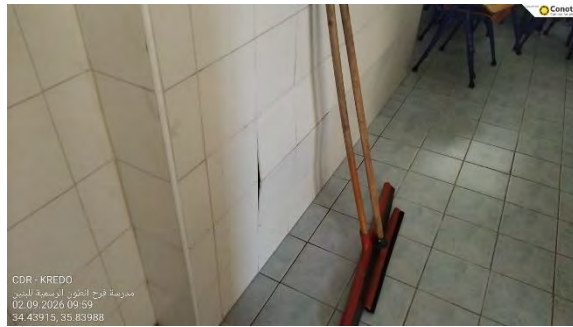
**Figure 20 - Damaged Tiles**

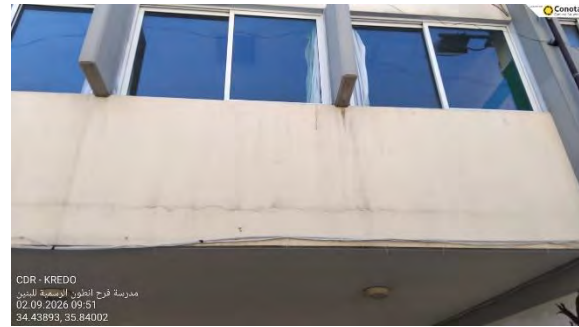
**Figure 21 - Humidity in External Wall**

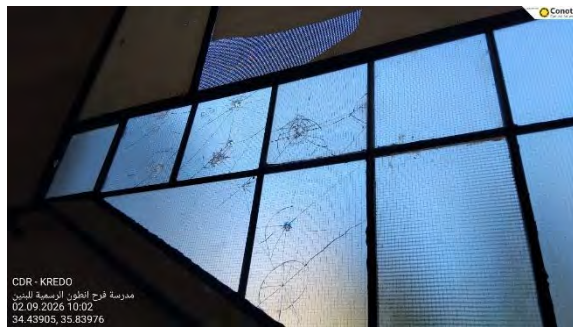
**Figure 22 - Broken Window Glazing**

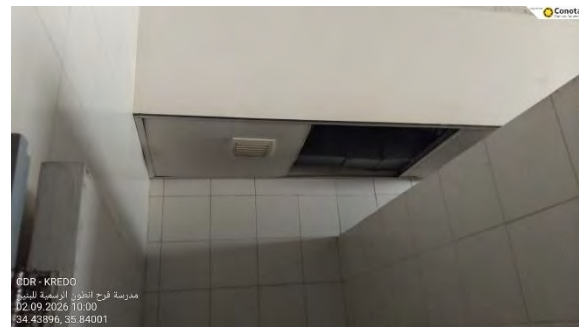
**Figure 23 - Damaged False Ceiling**
