# **Tender Preparation and Construction Supervision for Shelters**

## **Lebanon Emergency Assistance Project (LEAP)**

### **Detailed Assessment and Verification Report**

### **September 2026**

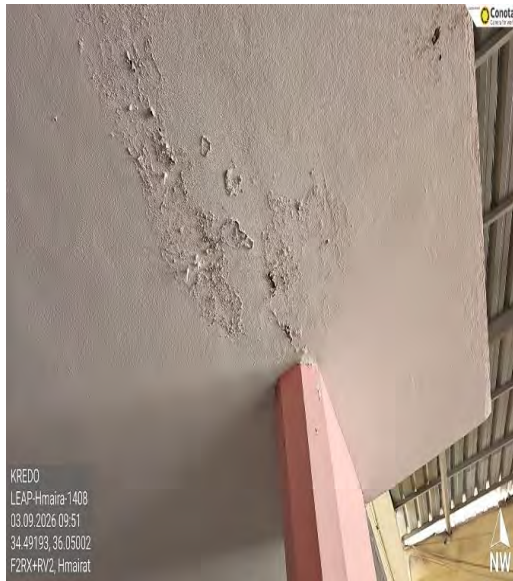
**Figure 4 – Water leakage**

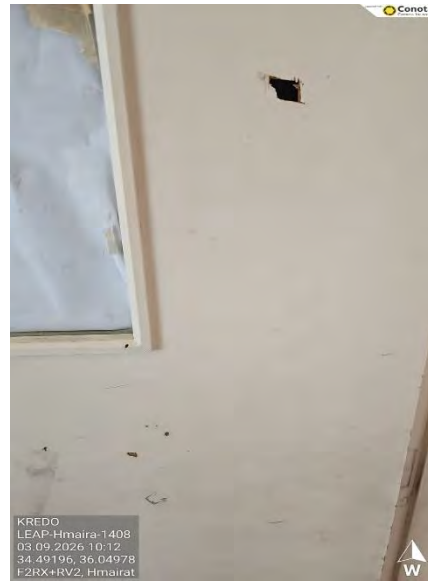
| Trade | Item | Damaged | Location, extent and quantity |
|---|---|---|---|
| | Metal doors | Yes | 1 aluminum door needs repair<br>14 m <sup>2</sup> paint |

**Figure 5 – Damaged door**

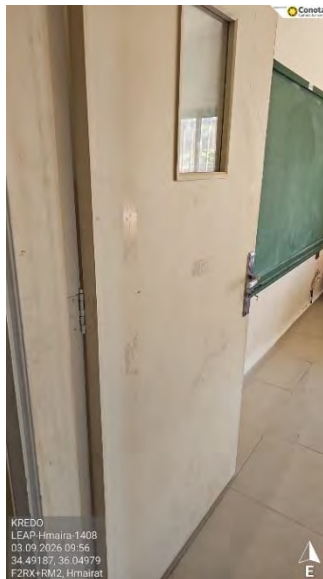
**Figure 6 – Damaged door paint**

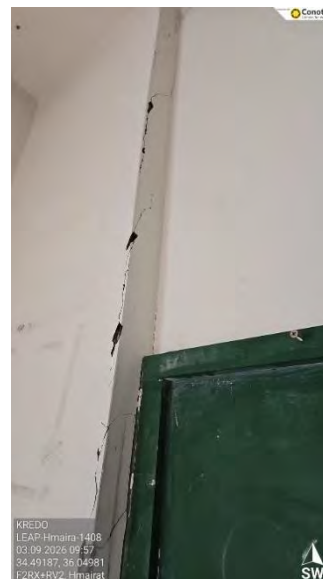
| No. | Element | Yes | No | Location and description |
|---|---|---|---|---|
| 3 | Wall cracks | X | | |

**Figure 7 – Wall cracks**

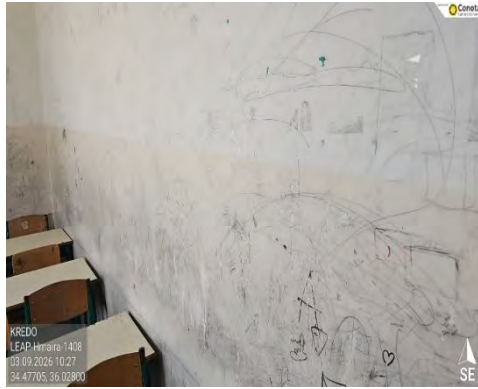
**Figure 8 – Damaged wall paint**

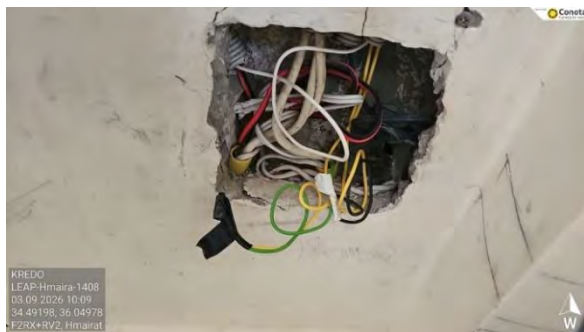
| Trade | Item | Damaged | Location, extent and quantity |
|---|---|---|---|
| Electrical | Sockets and switches | Yes | 5 socket repairs<br>4 new sockets<br>6 socket covers |

**Figure 10 – Missing socket**

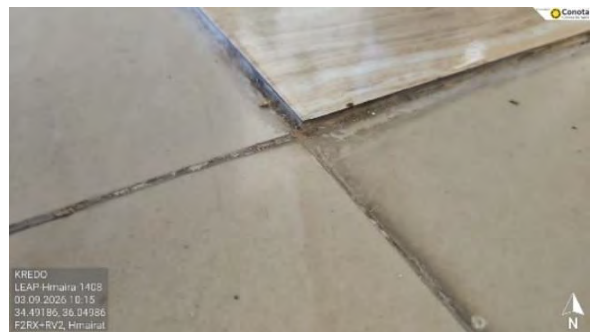
**Figure 11 – Damaged tiles**

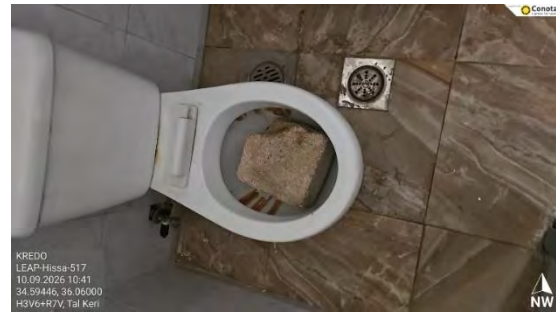
**Figure 5 - Damaged Toilet Seat**

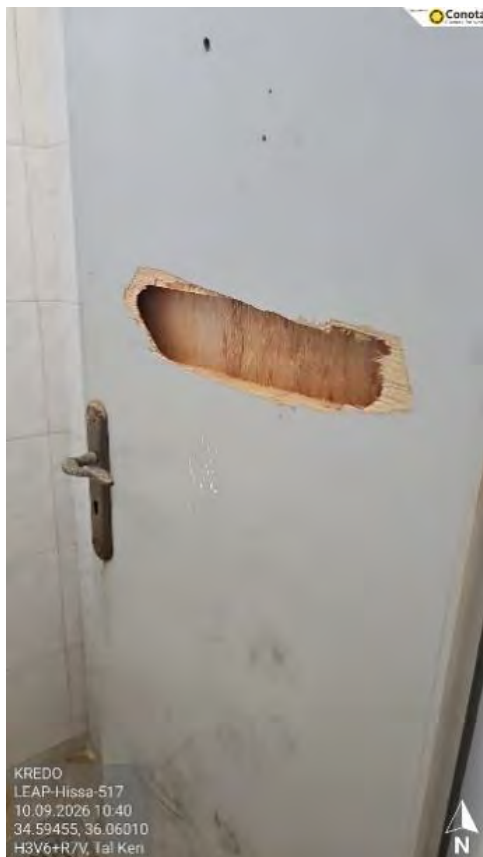
| Trade | Item | Damaged | Location, extent and quantity |
|---|---|---|---|
| Doors | Timber doors | Yes | 20 doors with frames architraves shall be changed, 5 need repairing |

**Figure 6 – Damaged Door**

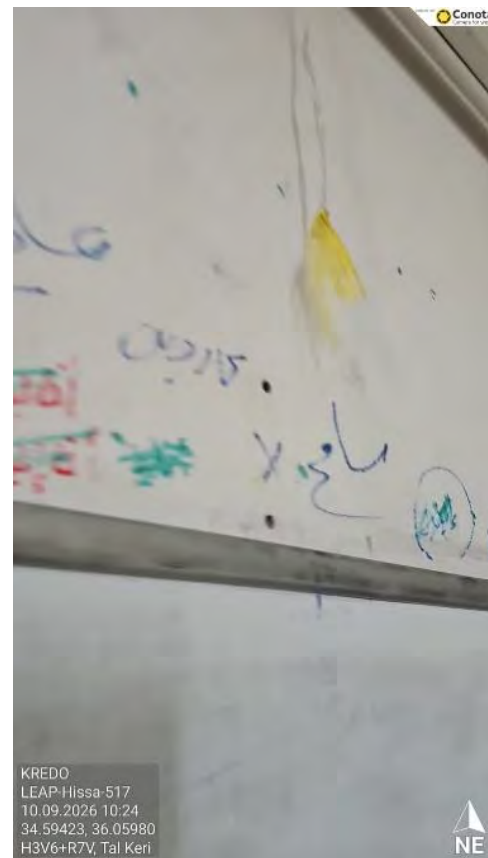
**Figure 7 - Damaged Paint**

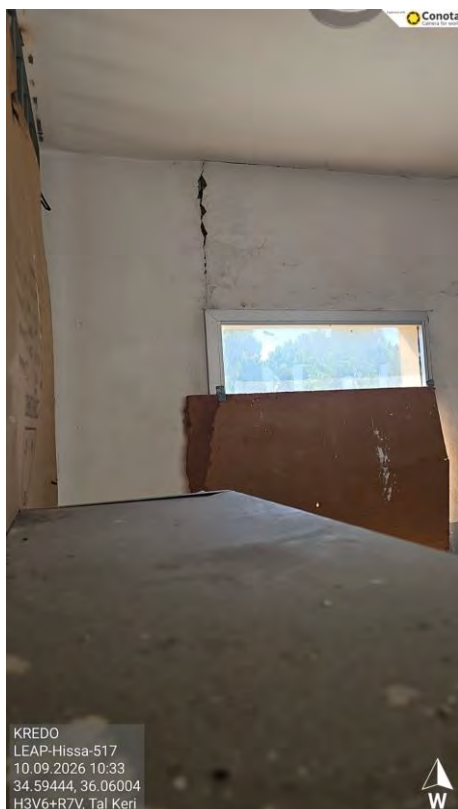
**Figure 8 - Water Leakage**

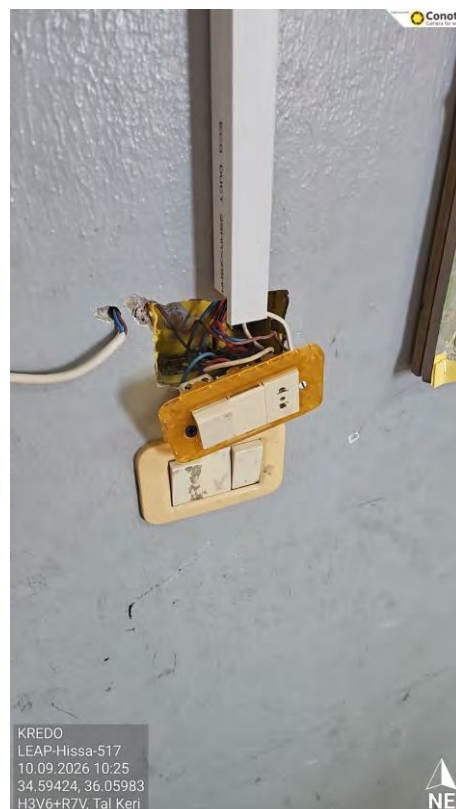
**Figure 9 – Broken Socket**

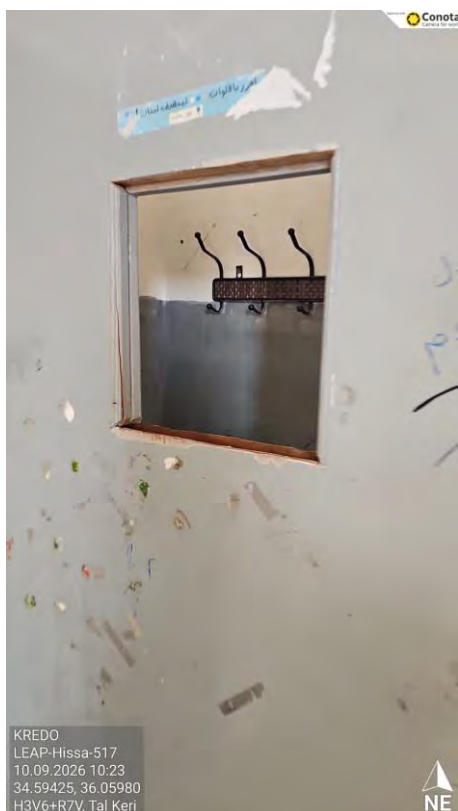
**Figure 10 – Damaged Door Glazing**

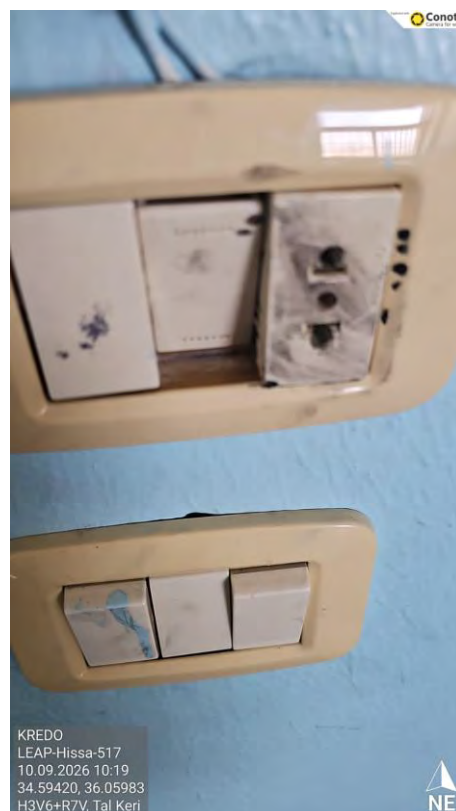
**Figure 11 - Damaged Switches**

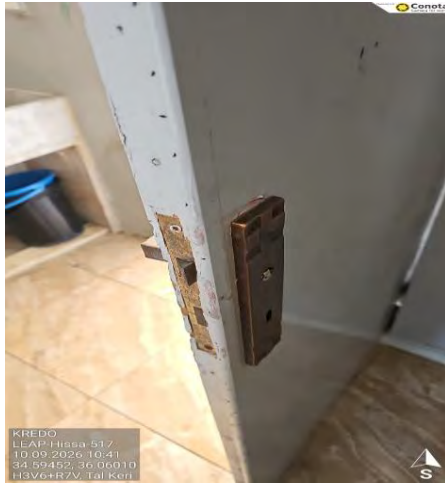
**Figure 12 - Damaged Door Handle**

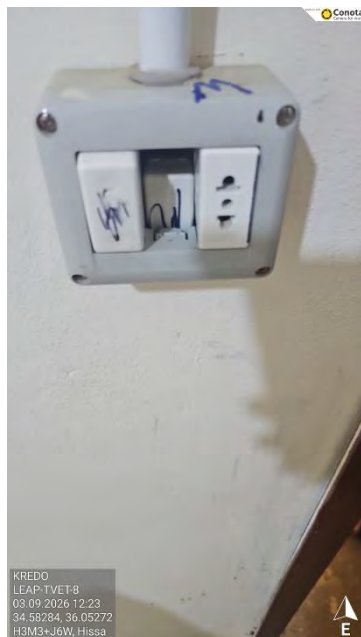
| Trade | Item | Damaged | Location, extent and quantity |
|---|---|---|---|
| Electrical | Sockets and switches | Yes | 8 sockets shall be repaired<br>8 new sockets |

**Figure 12- Damaged Switches**

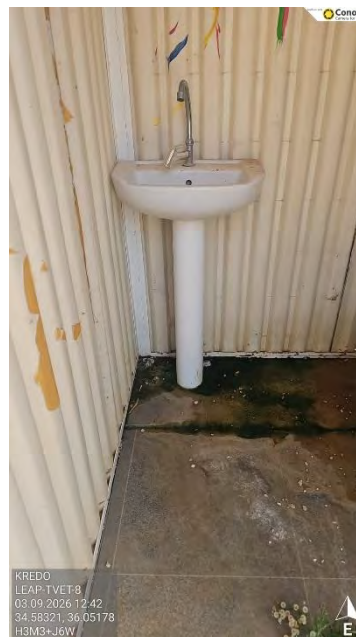
**Figure 13 – Wash Basin**

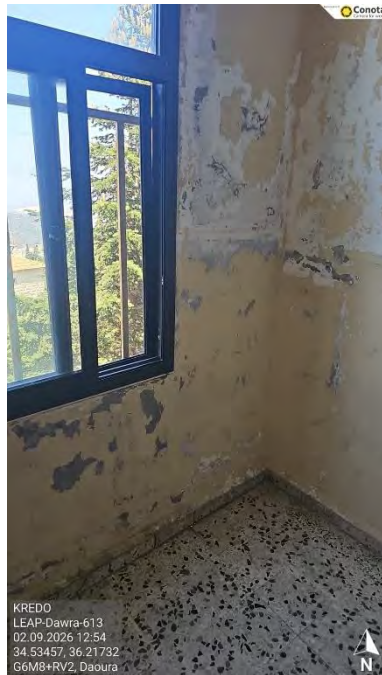
| No. | Element | Yes | No | Location and description |
|---|---|---|---|---|
| 2 | Facade water leak | X | | Roof |

**Figure 4 – Water Leakage**

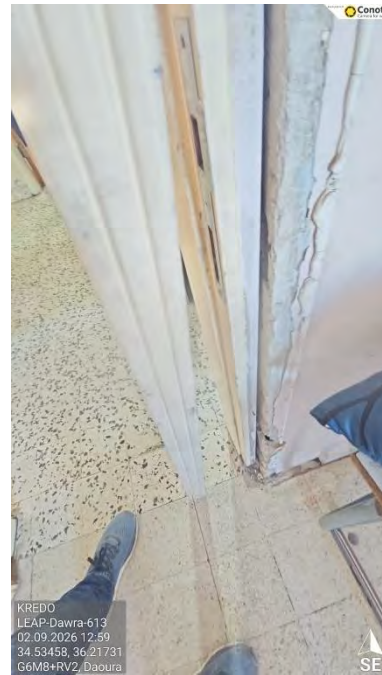
**Figure 5 – Damaged Door Frames**

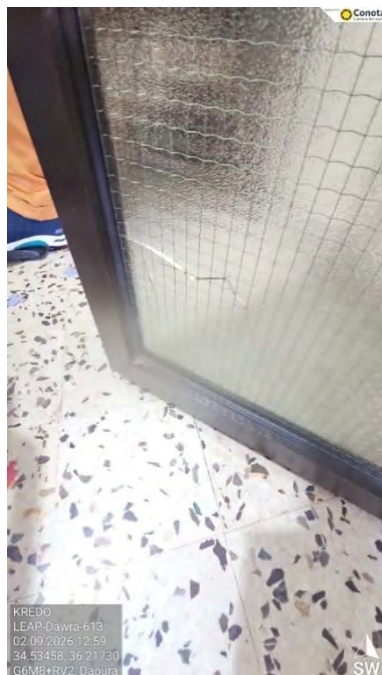
**Figure 6 – Damaged Glazed Panel**

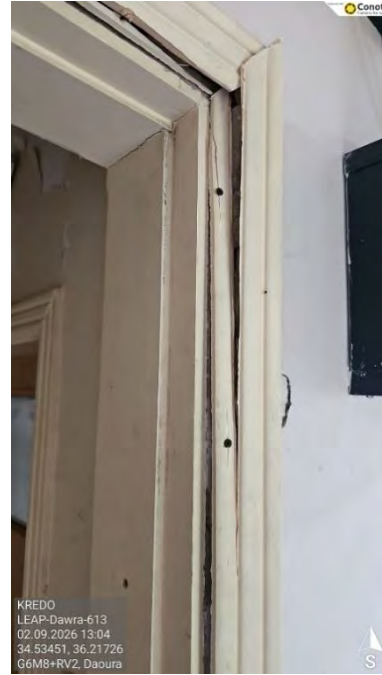
**Figure 7 – Damaged Door Frames**

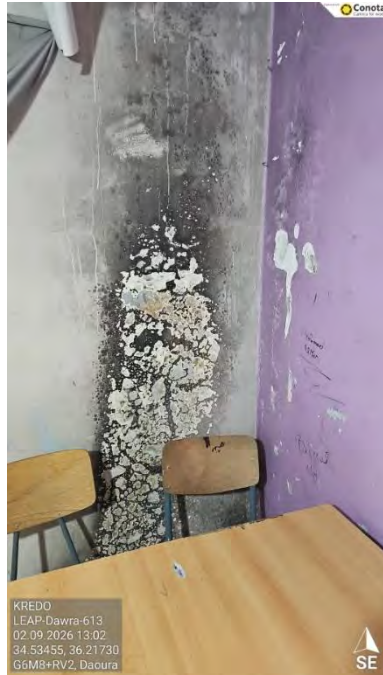
**Figure 8 – Damaged Wall Paint**

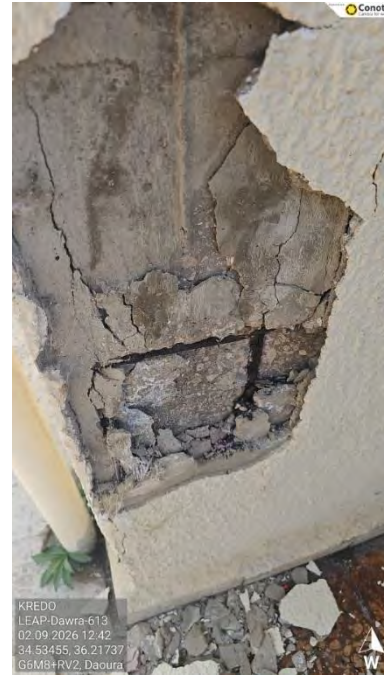
| No. | Element | Yes | No | Location and description |
|---|---|---|---|---|
| 8 | Spalled concrete with exposed reinforcement | X | | |

**Figure 9 – Spalled Concrete with Exposed Reinforcement**

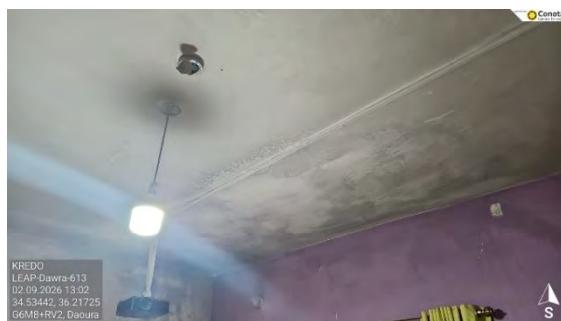
**Figure 10 – Damaged Roof Paint**

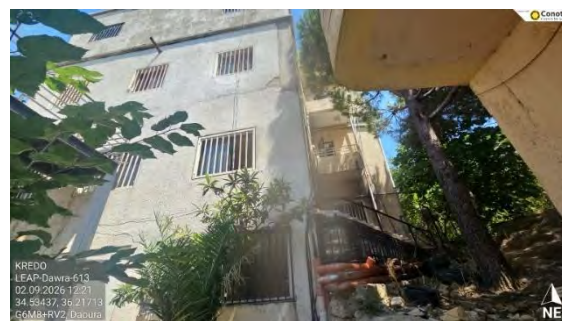
**Figure 11 – Spalled Concrete with Exposed Reinforcement**

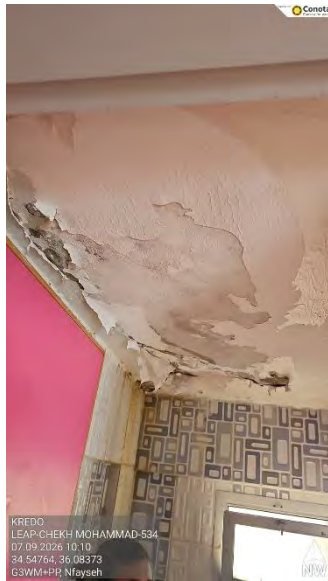
**Figure 4 - Water Leakage**

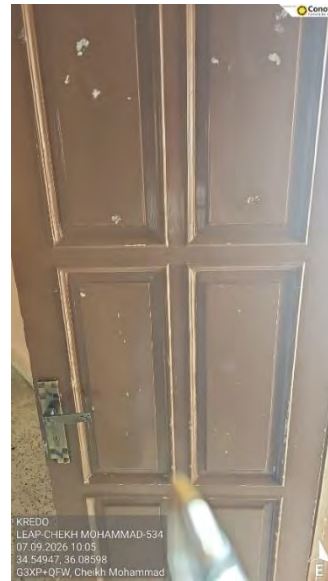
**Figure 5 - Damaged Door Paint**

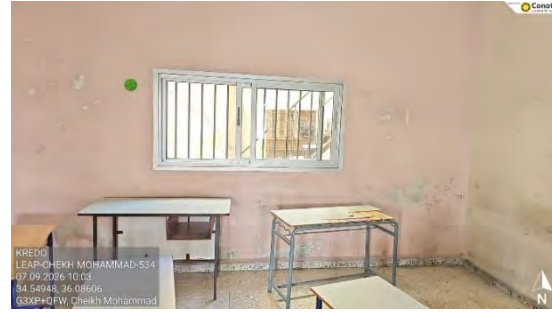
**Figure 7 - Damaged Paint**

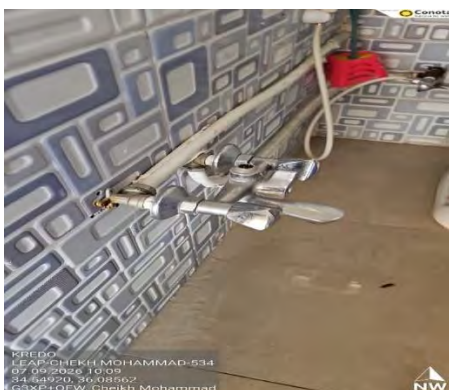
**Figure 8 - Broken Mixers**

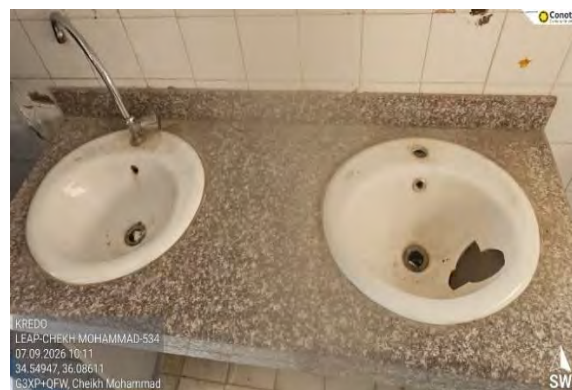
**Figure 9 - Damaged Wash Basin**

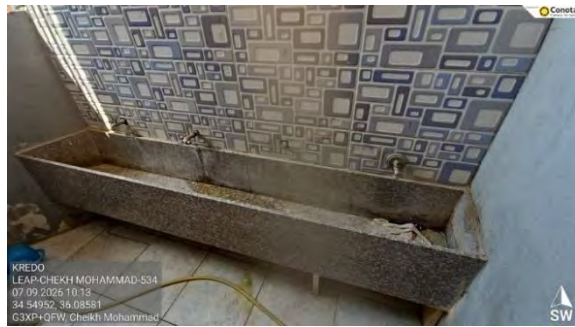
**Figure 10 – Damaged Water Taps**

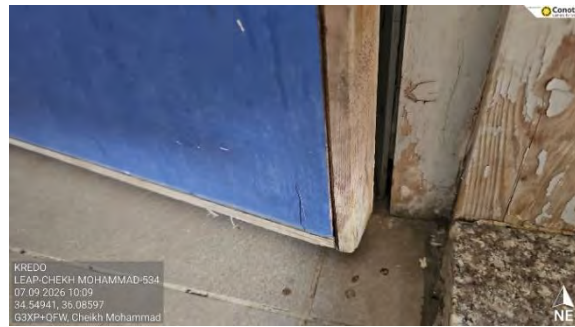
| Trade | Item | Damaged | Location, extent and quantity |
|---|---|---|---|
| Doors | Timber doors | Yes | 7 doors with frames architraves shall be changed, and 4 shall be repaired |

**Figure 11 - Damaged Door**

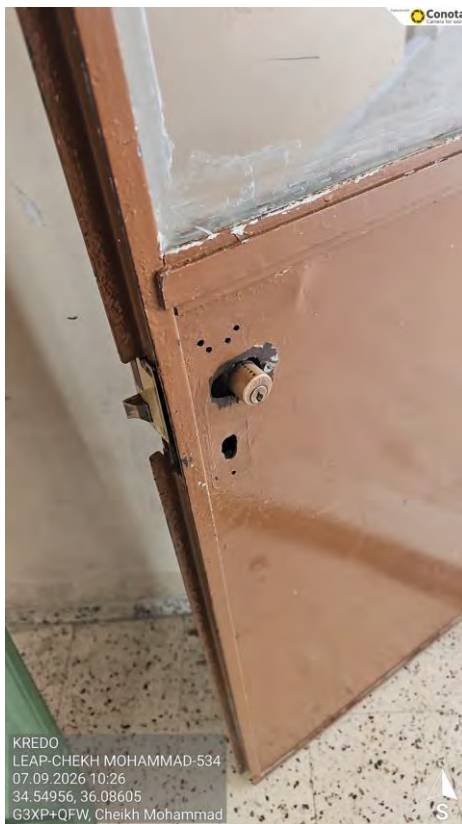
**Figure 12 - Missing Door Handle**

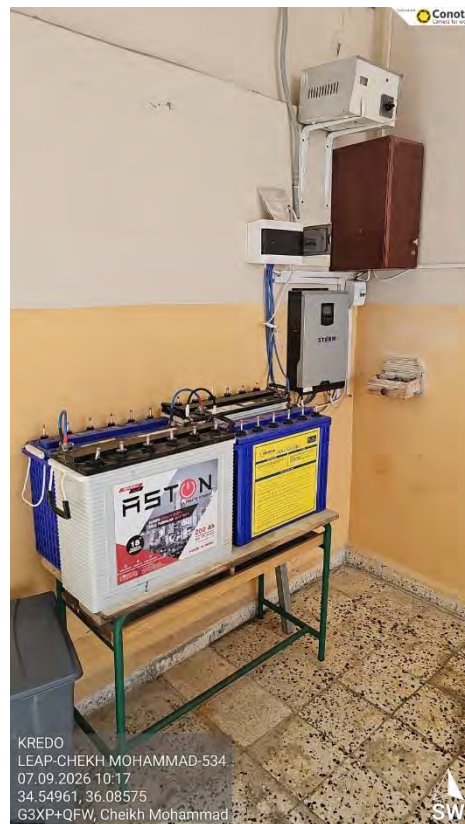
**Figure 13 - Unprotected Electrical Installation**

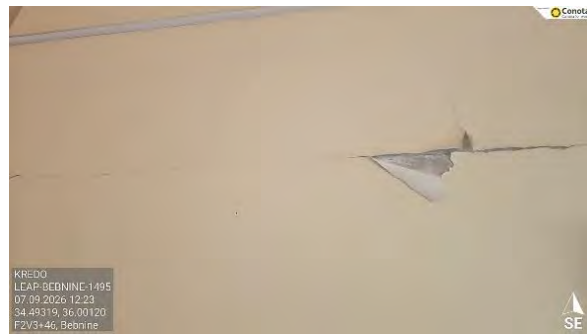
**Figure 4 – Water leakage**

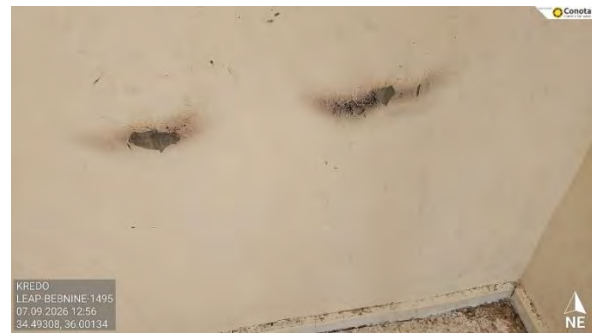
**Figure 5 – Damaged paint**

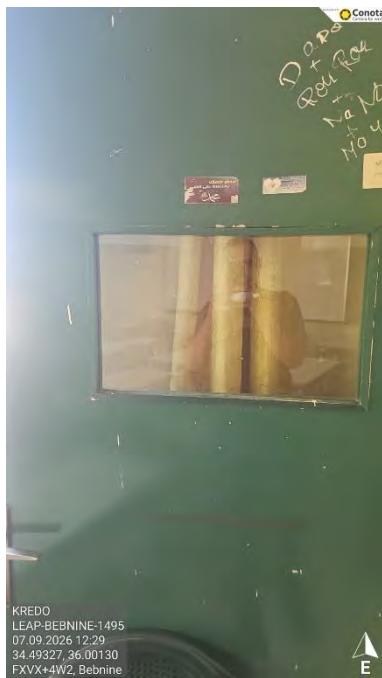
**Figure 6 – Damaged door paint**

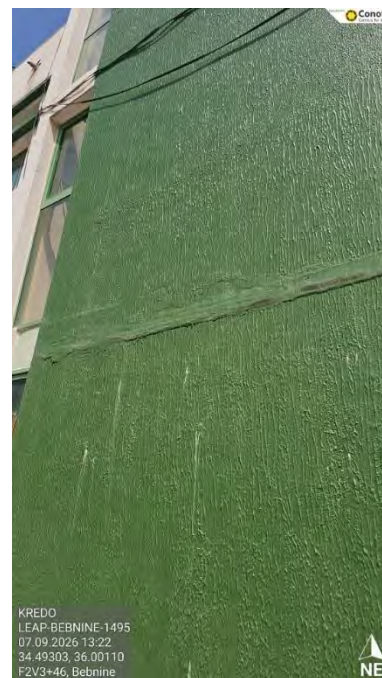
**Figure 7 – Facade cracks**

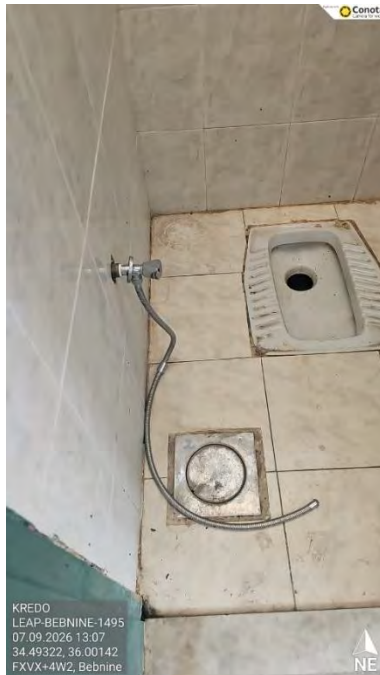
**Figure 8 – Damaged mixers**

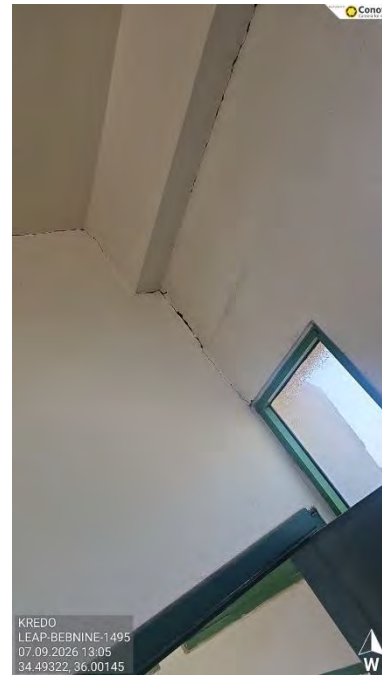
**Figure 9 – Internal wall cracks**

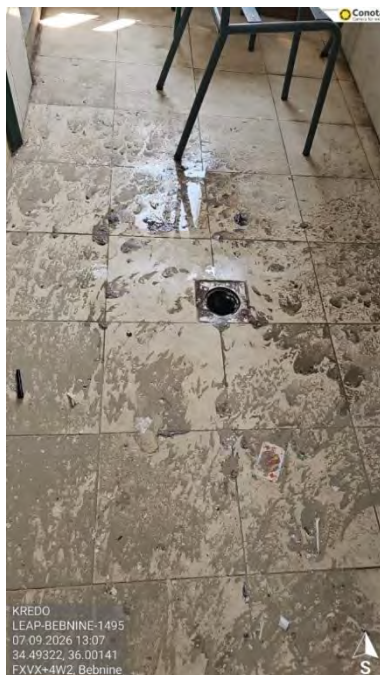
**Figure 10 – Damaged floor drain**

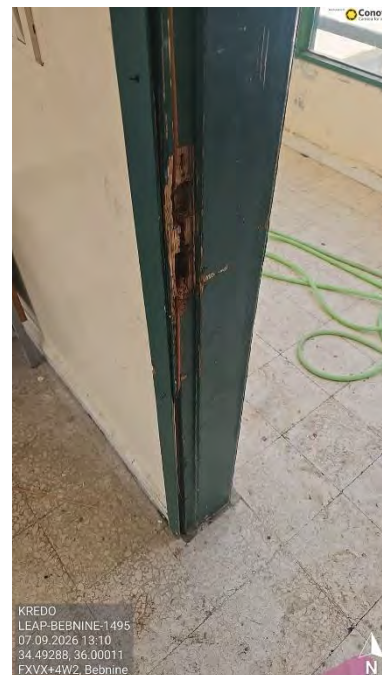
| Trade | Item | Damaged | Location, extent and quantity |
|---|---|---|---|
| Doors | Timber doors | Yes | 1 double and 8 single doors with frames architraves shall be changed,<br>6 doors shall be repaired, and 2 frames and 2 architraves shall be changed |

**Figure 11 – Damaged door frame**

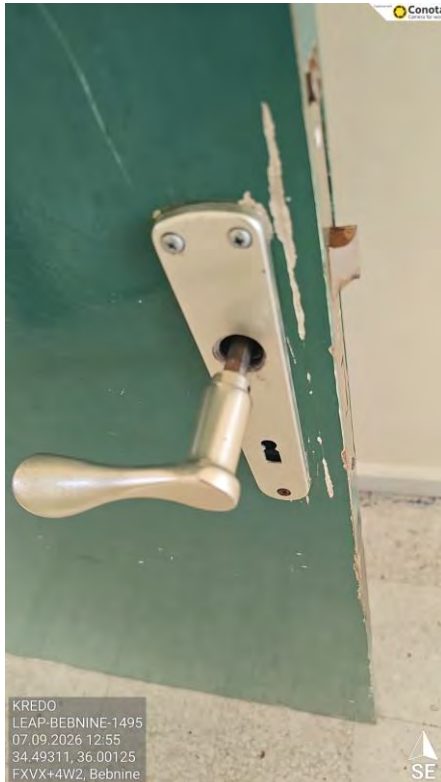
**Figure 12 - Damaged door handle**

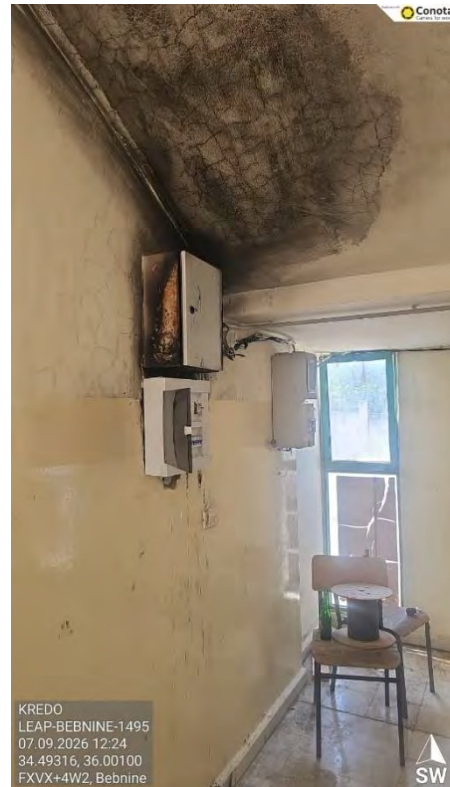
**Figure 13 - Unprotected electrical installations and ceiling in poor condition**

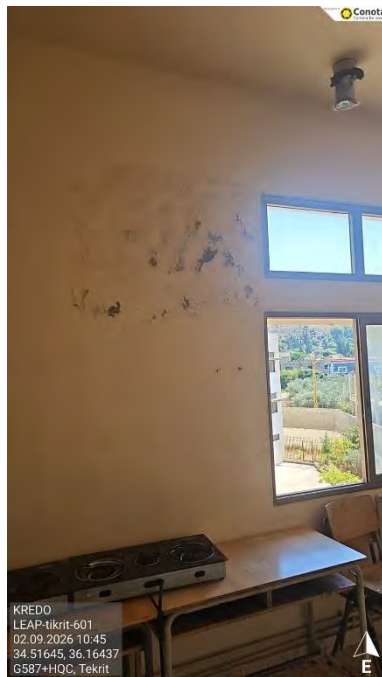
**Figure 4 – Water Leakage**

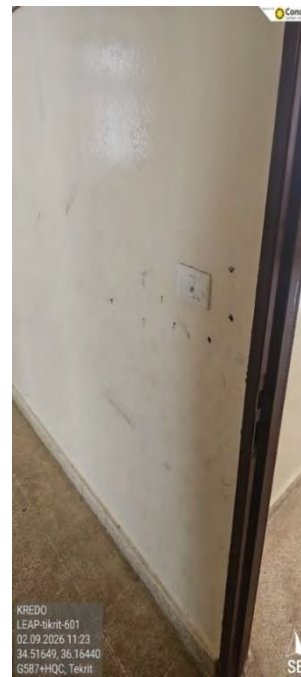
**Figure 5 – Damaged Door Frames**

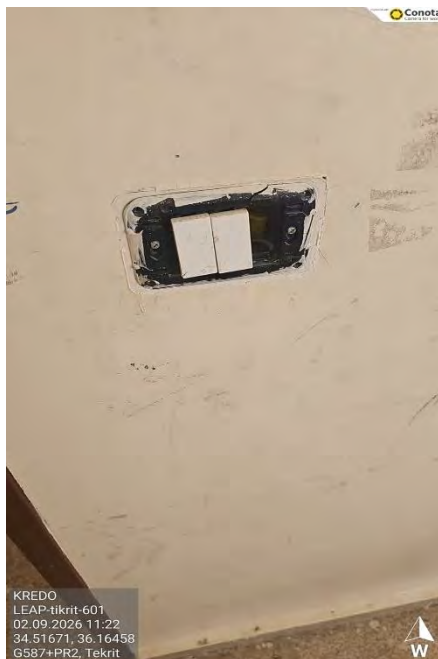
**Figure 6 – Damaged Lighting Switches**

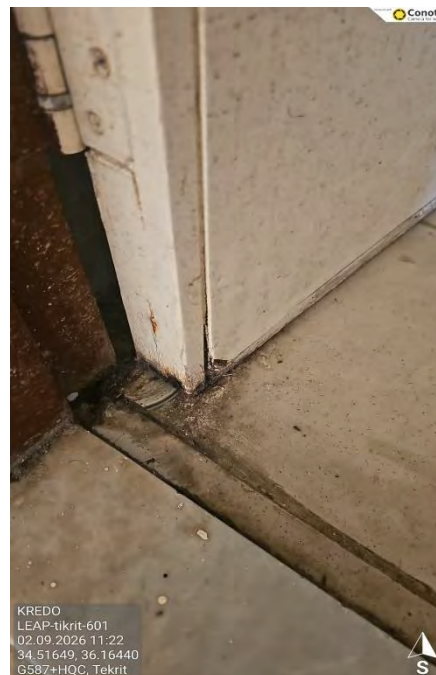
| Trade | Item | Damaged | Location, extent and quantity |
|---|---|---|---|
| | Door accessories and ironmongery | Yes | 3 double and 3 single doors shall be repaired with accessories<br>1 door handle |

**Figure 7 – Damaged Wooden Doors**

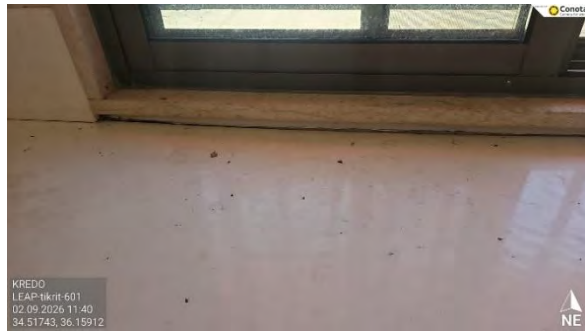
**Figure 8 – Damaged Tiles**

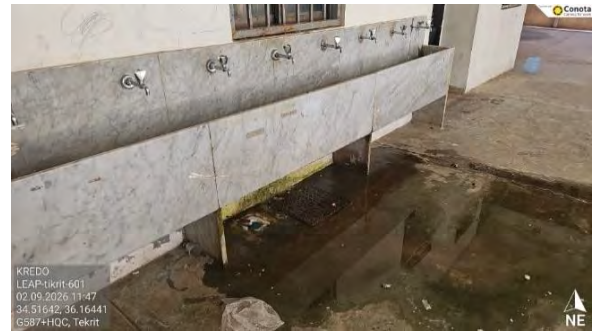
| Trade | Item | Damaged | Location, extent and quantity |
|---|---|---|---|
| Sanitary and plumbing | Wash basins | Yes | Outdoor water basins shall be repaired |

**Figure 9 - Damaged Basins**

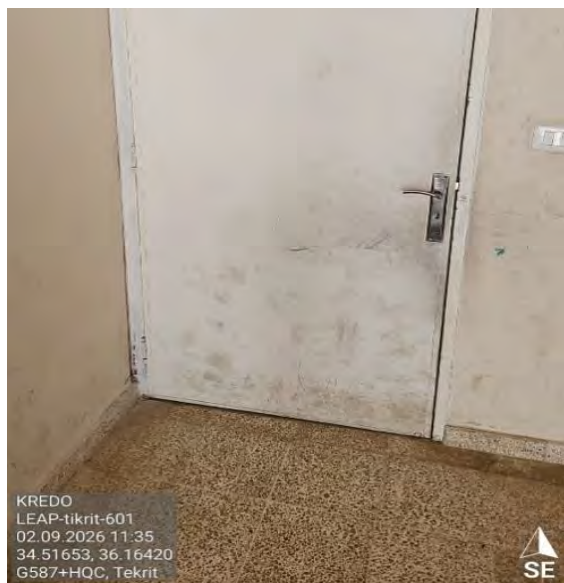
**Figure 10 – Damaged Door Paint**

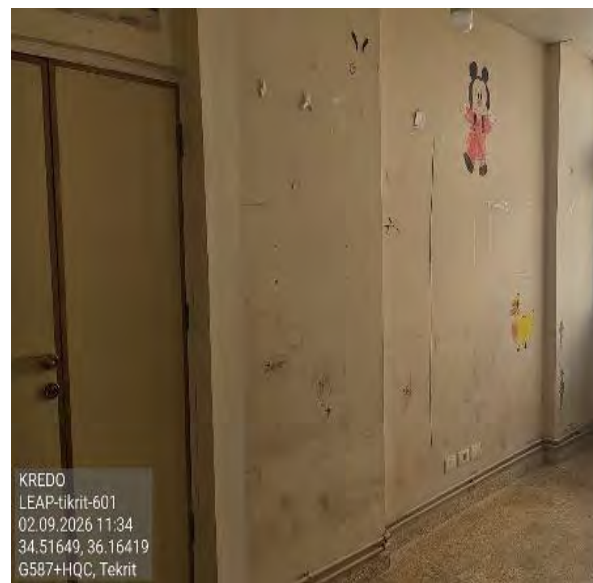
**Figure 11 – Damaged Paint**

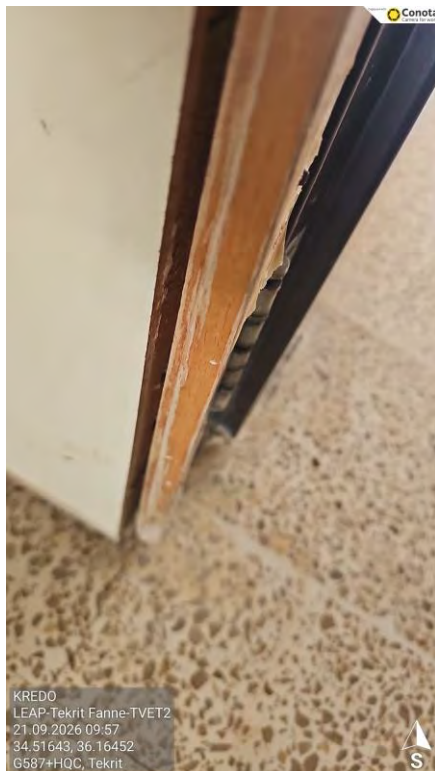
**Figure 7 - Damaged Door**

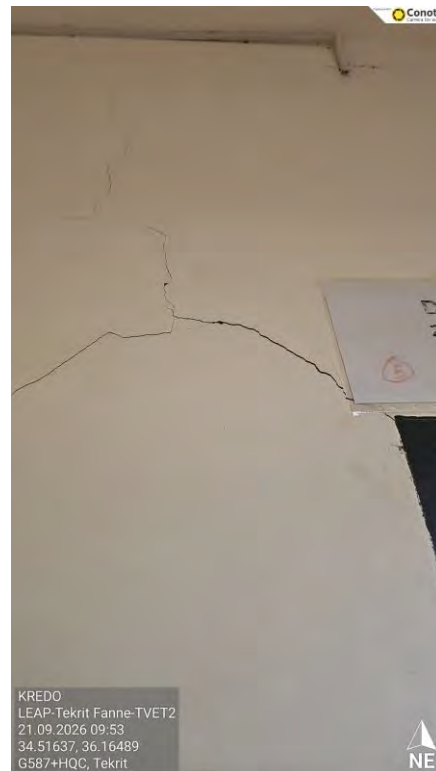
**Figure 8 - Wall Cracks**

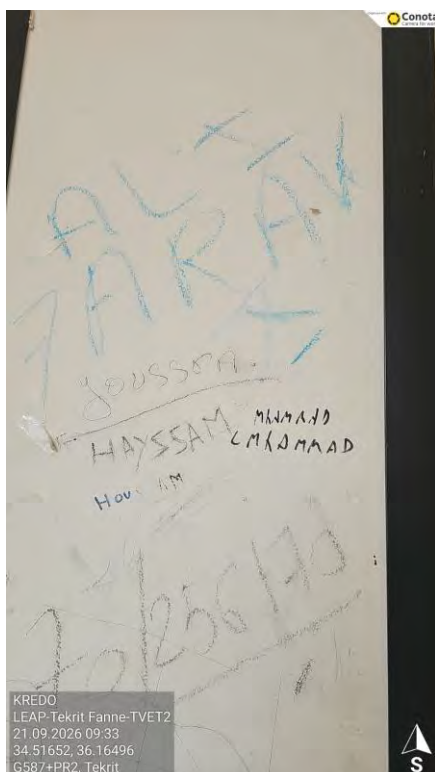
**Figure 9 - Damaged Paint**

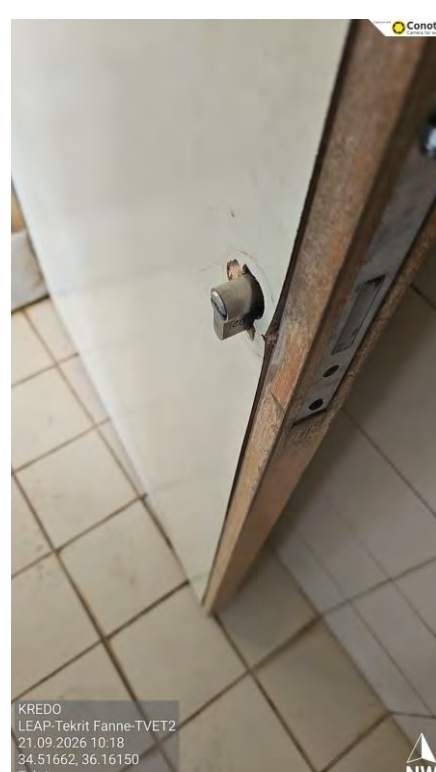
**Figure 10 – Damaged Door Handle**

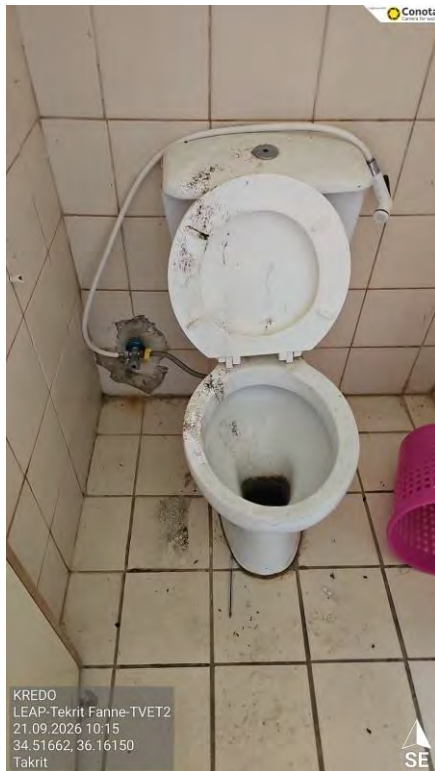
**Figure 11 - Damaged Toilet Seat**

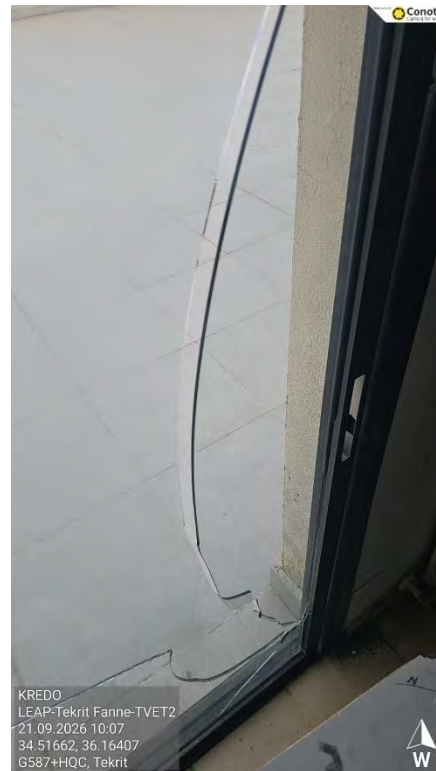
**Figure 12 - Cracked Glazing**

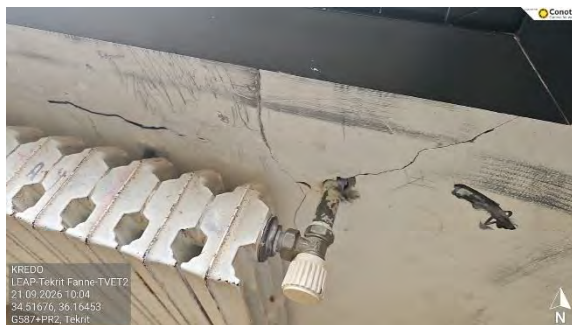
**Figure 13 - Damaged Plastering**

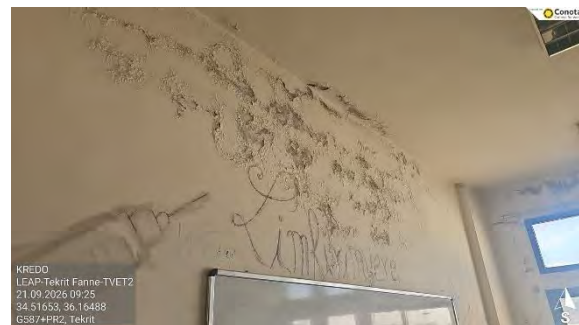
**Figure 14 - Water Leakage**

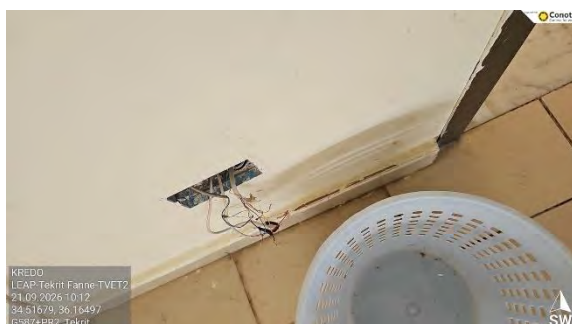
**Figure 15 - Damaged Sockets**

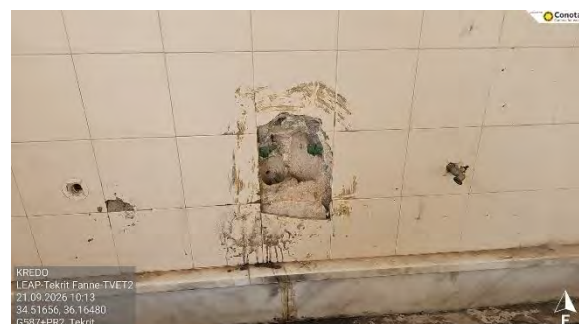
**Figure 16 - Damaged Tiles**

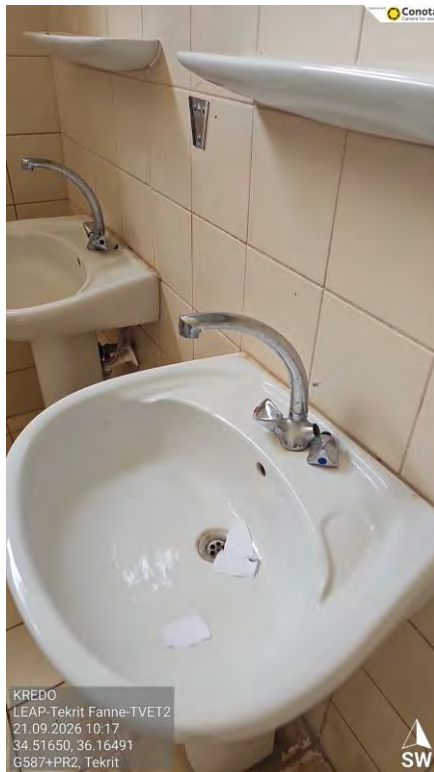
**Figure 17 - Damaged Mixers**

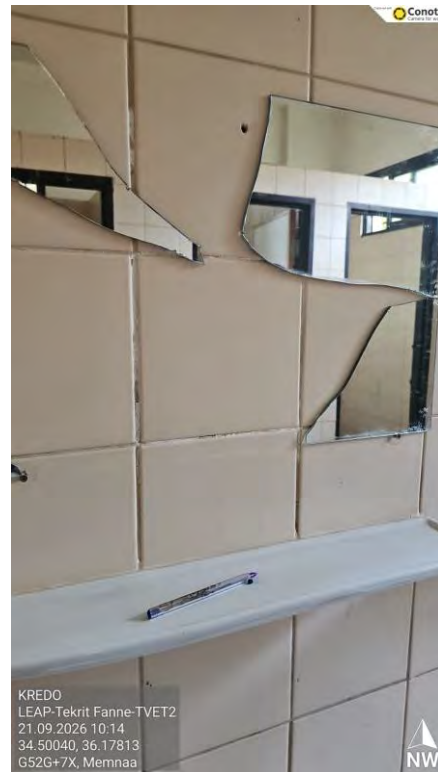
**Figure 18 - Broken Mirrors**

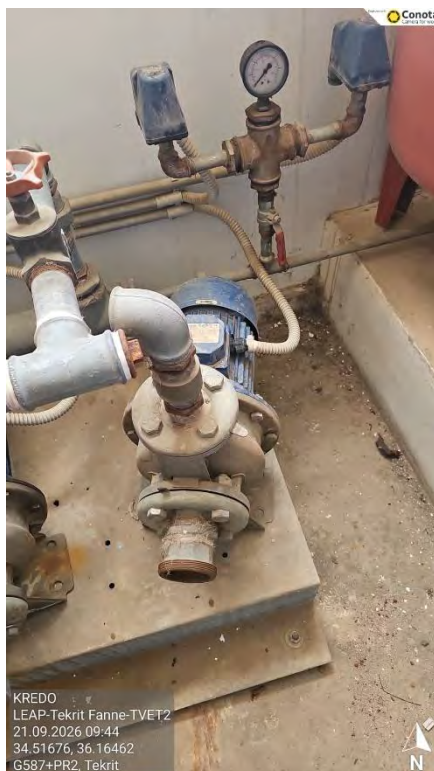
**Figure 19 - Damaged Pump**

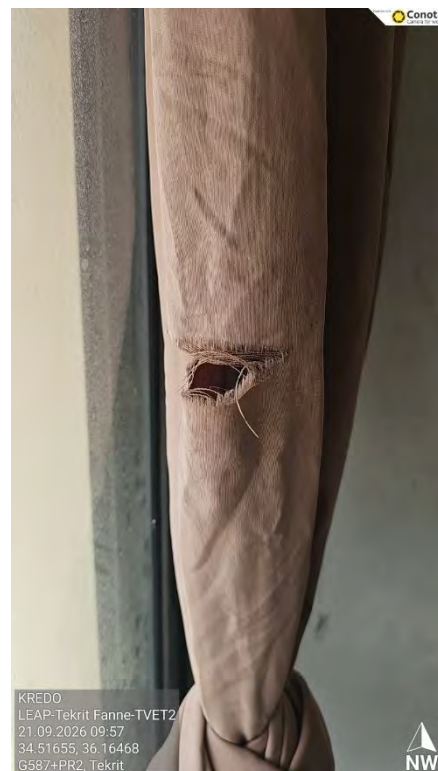
**Figure 20 - Damaged Curtains**

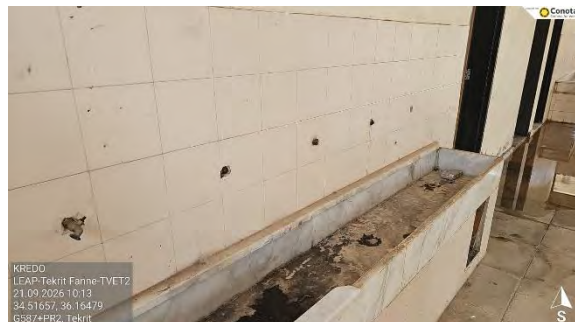
***Figure 21 – Damaged Basins and Taps***

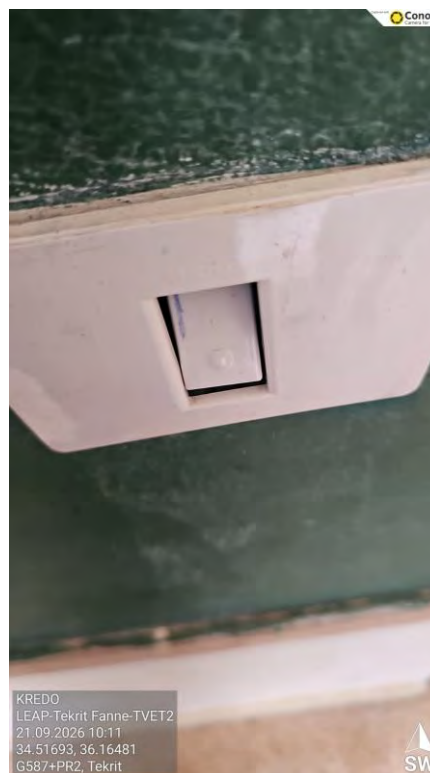
***Figure 22 – Damaged Switch***
