Consultancy Services for  
Tender Preparation and Construction Supervision Consultant for  
Shelters  
Lebanon Emergency Assistance Project (LEAP)

**ASSESSMENT REPORT  
BATCH 2- LOT 1**

July 2026

**BATCH 2 - LOT 1**  
**MINYEH SCHOOLS**  
**GENERAL INDEX**

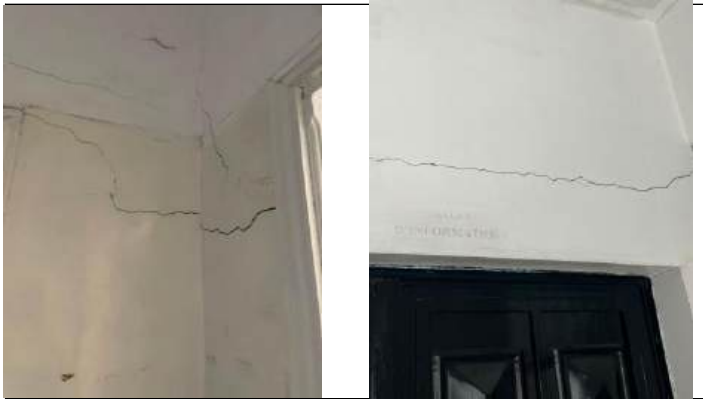
Pic showing crackin the walls

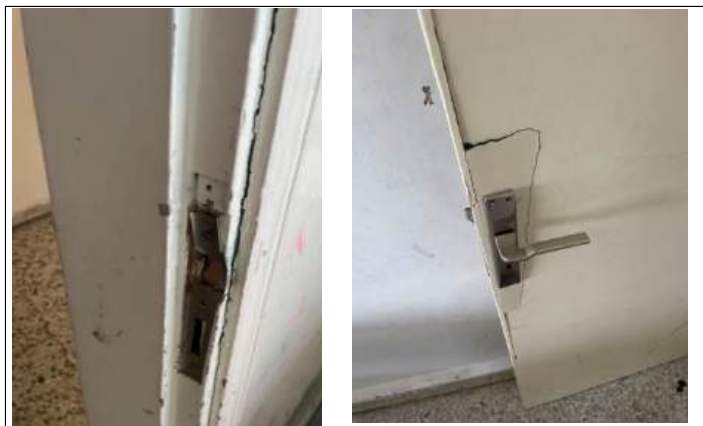
Lever handle and lock to door to be replaced and door to be painted

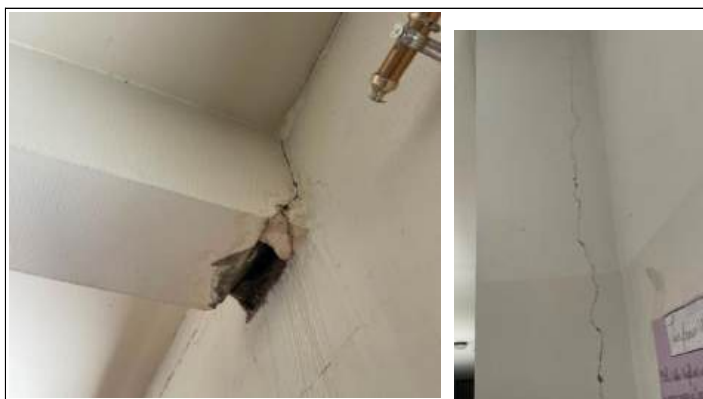
damage needs t be rehabilitated

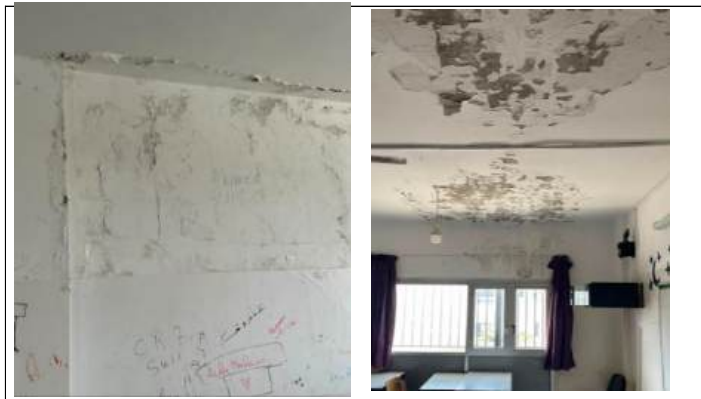
pic showing the humidity inside the wall

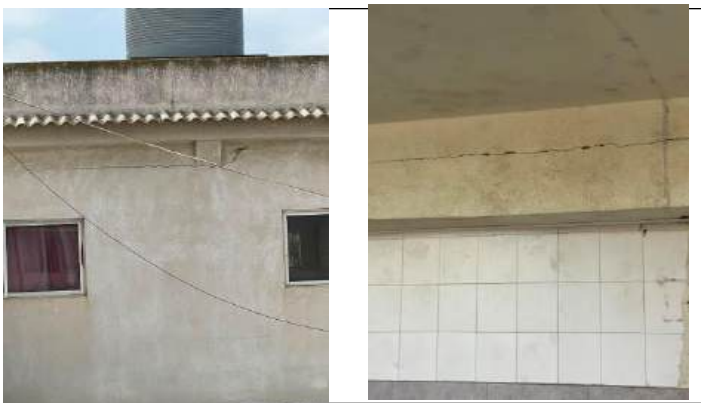
crack showing from outside

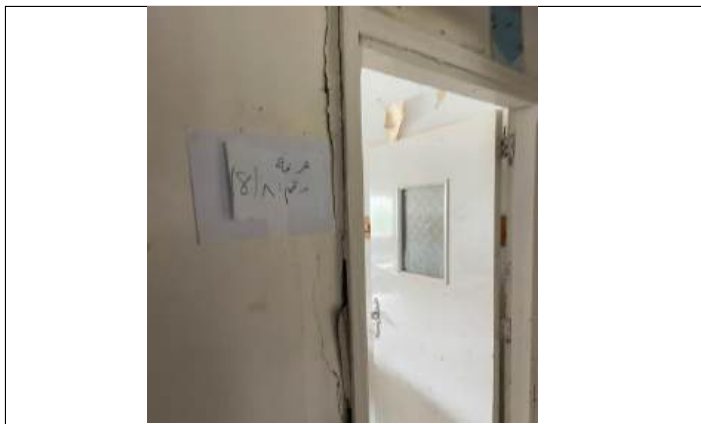
Door damage

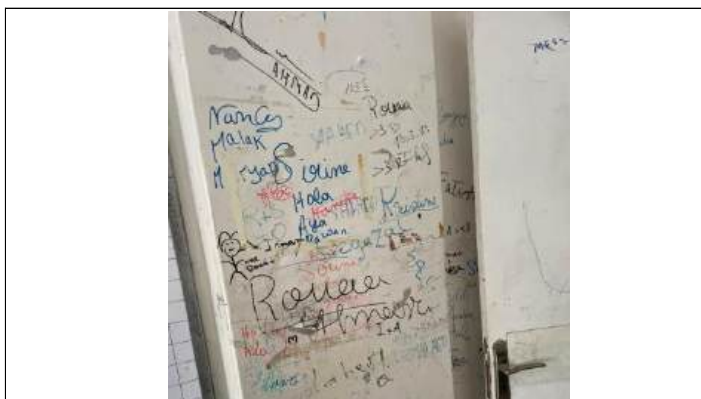
pic showing walls need to be painted

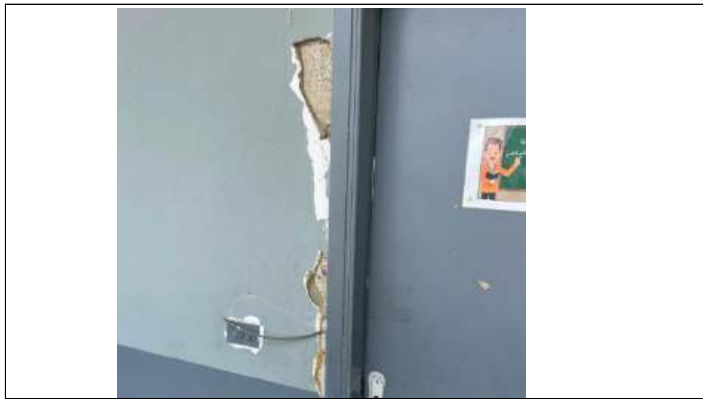
Pic showing damage in the walls

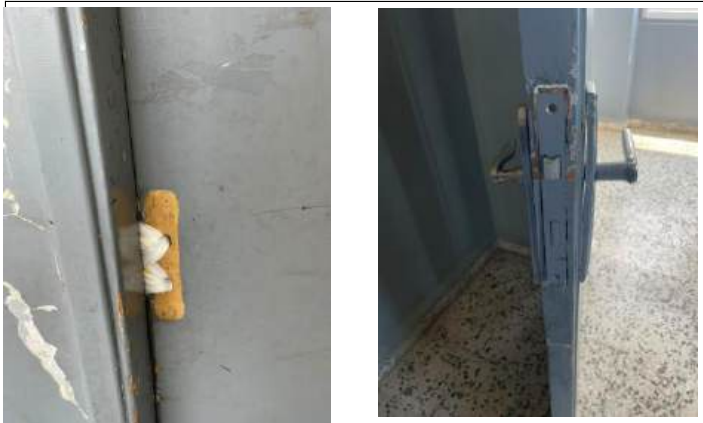
Lever handle and lock to door to be replaced and door to be painted

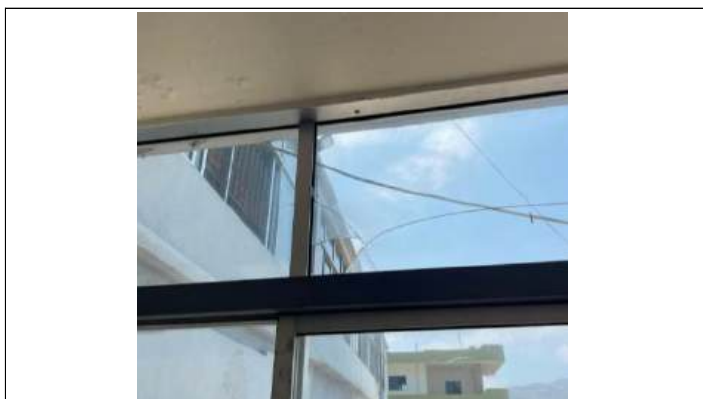
damage needs to be rehabilitated

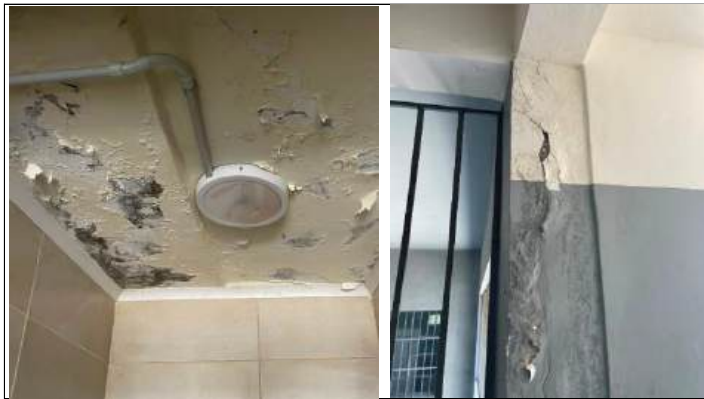
pic showing the humidity inside the wall

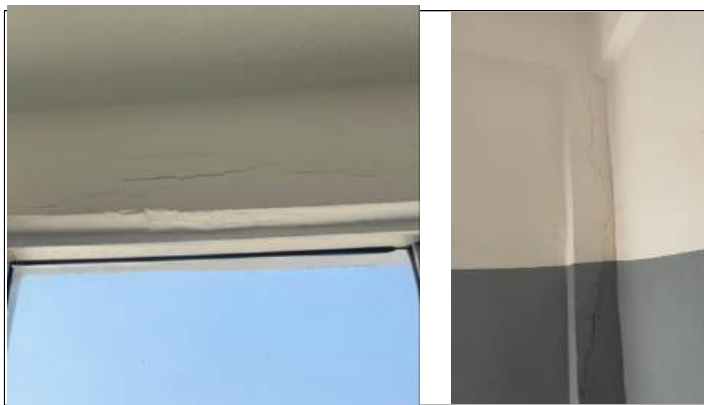
crack in the walls

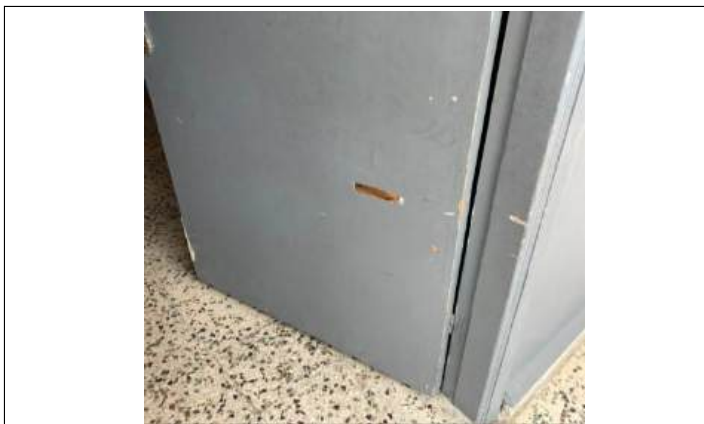
Door damage

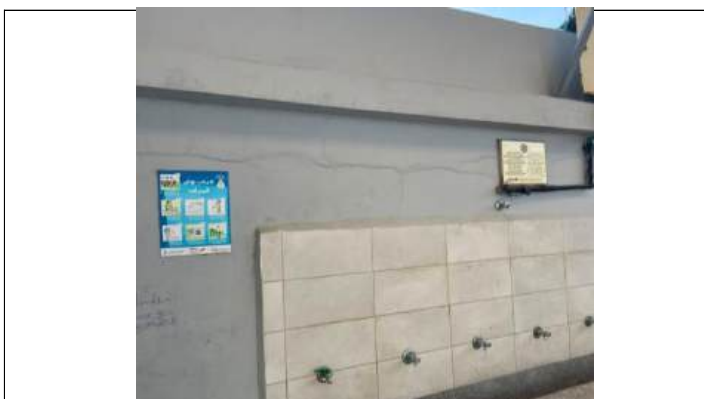
Drinking basin damages

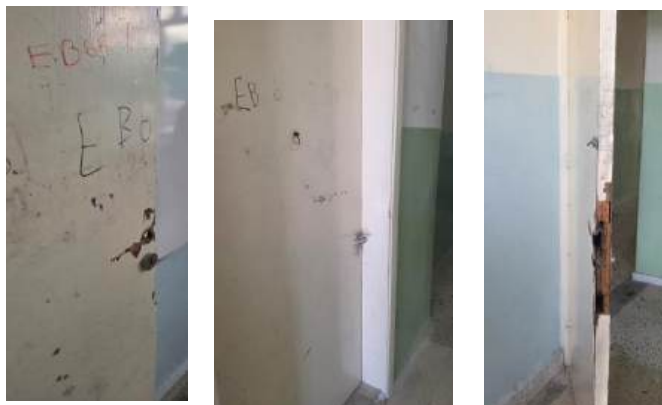
Lever handle and lock to door to  
be replaced and door to be  
painted

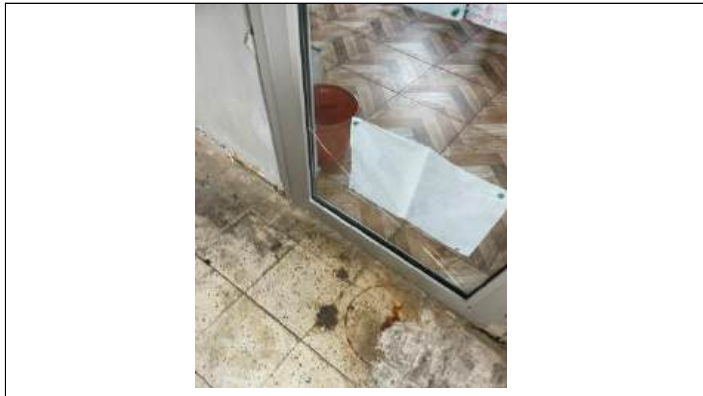
broken glass

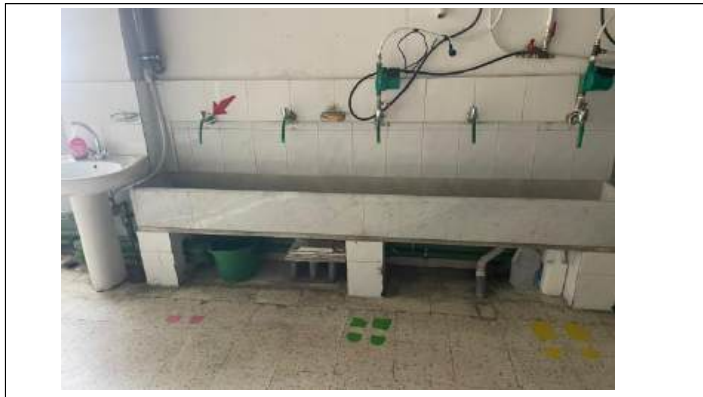
drinking basin situation

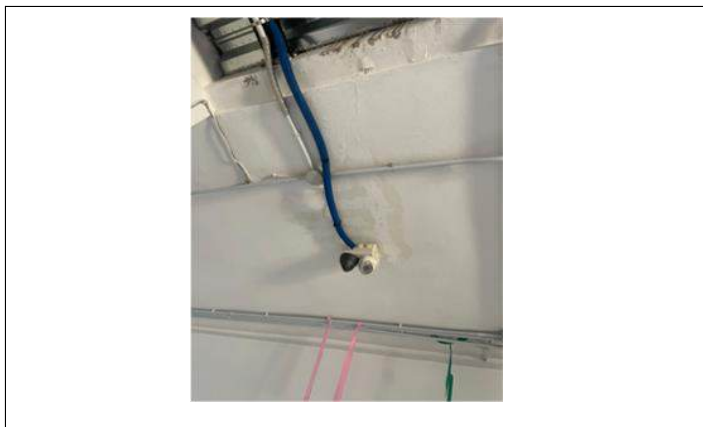
humidity in slab

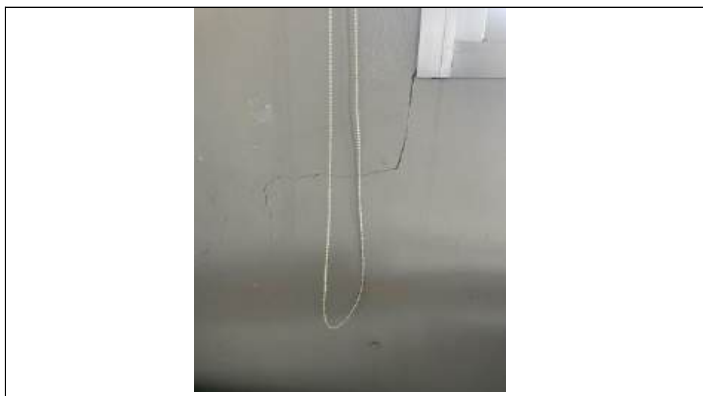
cracks in wall

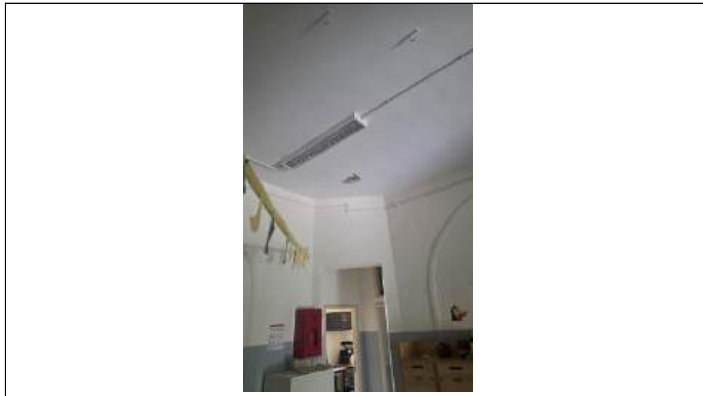
corroded steel at slab

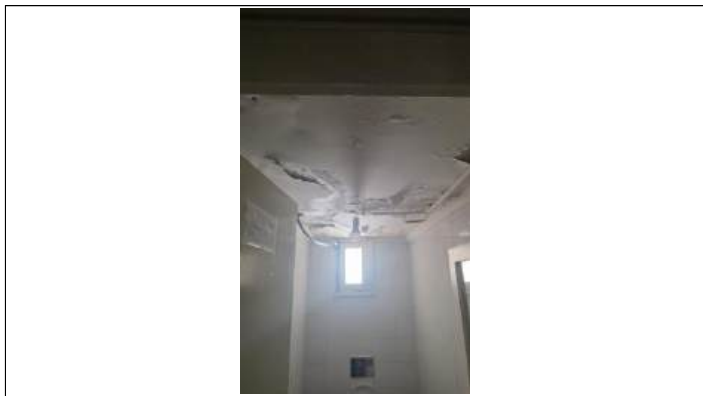
humidity at wc slab

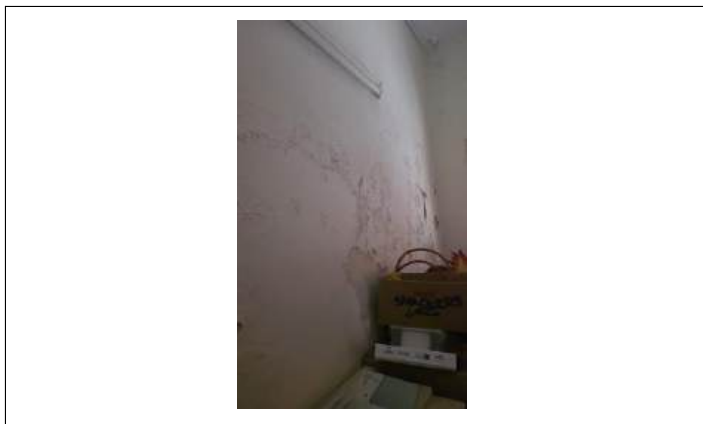
humidity at classes

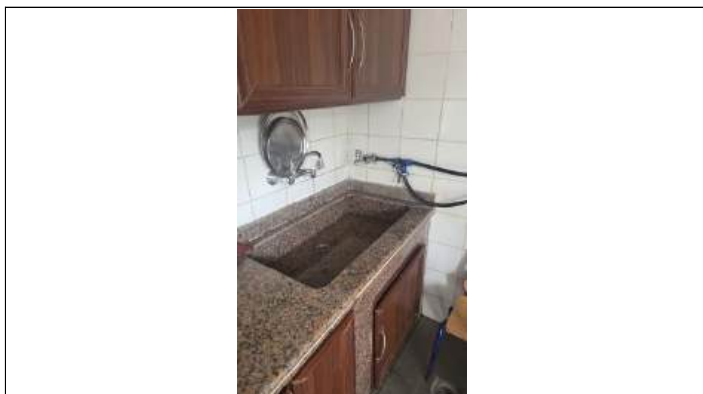
kitchen mixer need replacement

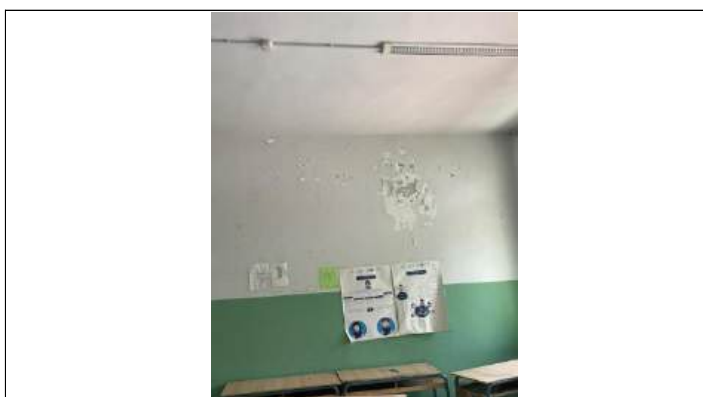
classes need painting

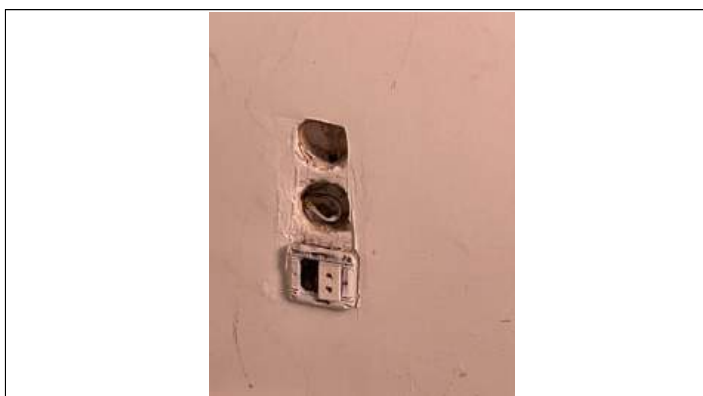
bad condition of electrical sockets

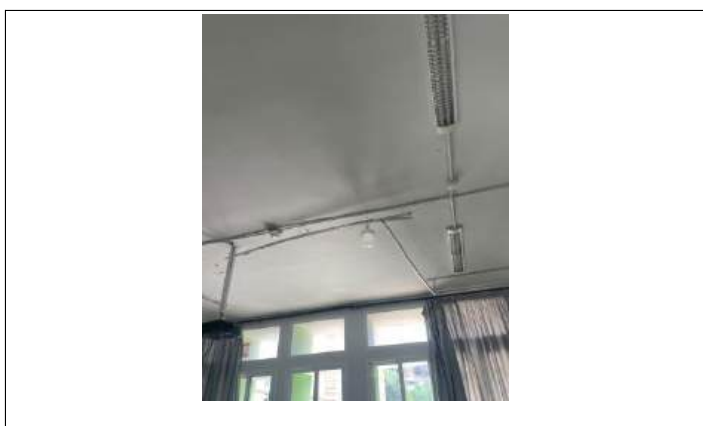
bad condition of electrical  
installations

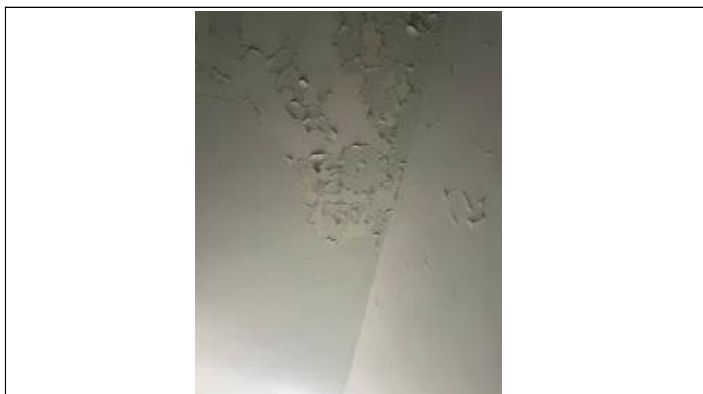
humidity in classes

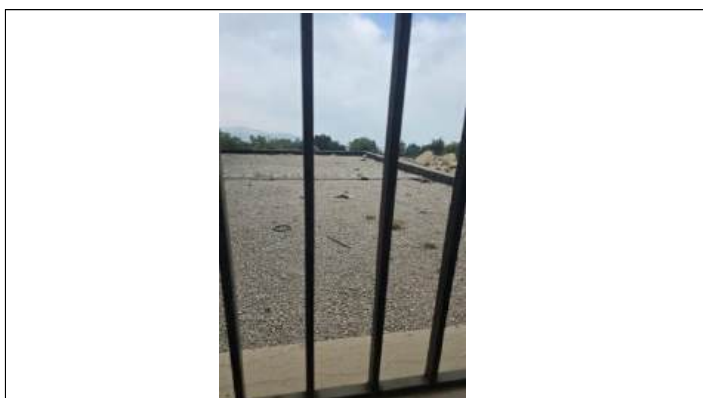
waterproofing membrane needs repair in some place on the roof

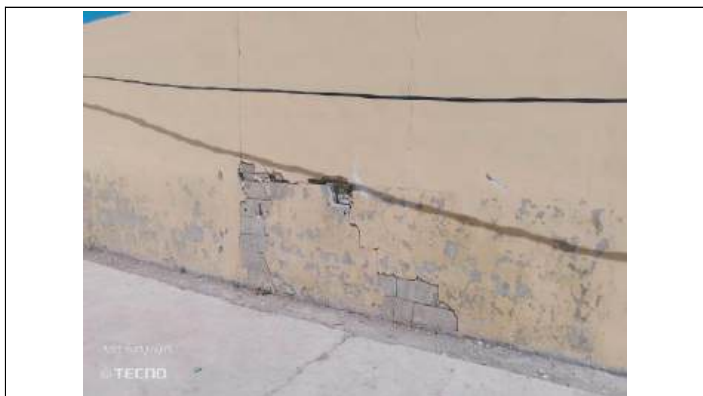
the fence needs rehabilitation

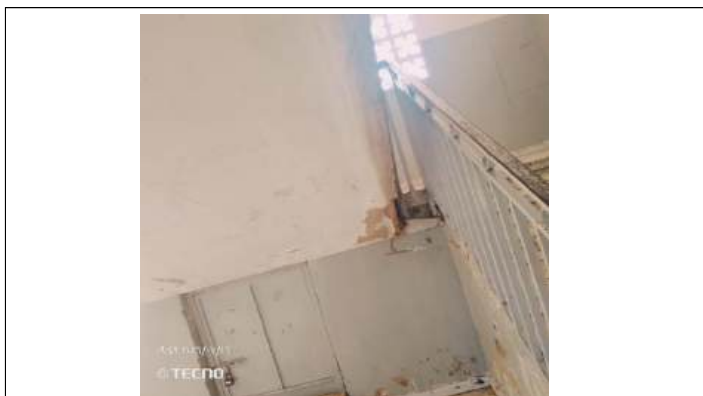
stair needs some repair for safety issues

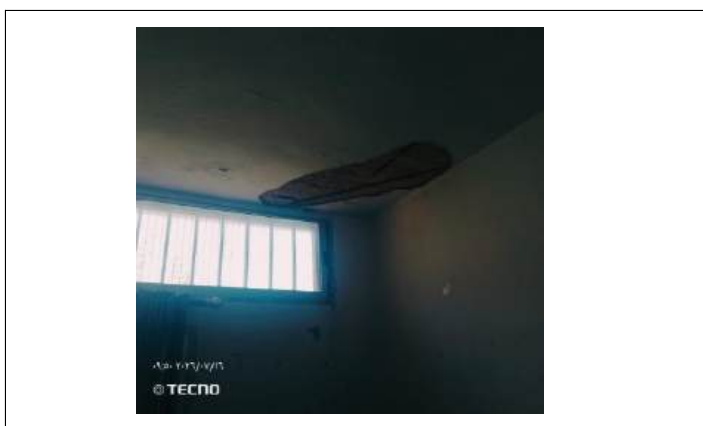
steel corroded in slabs

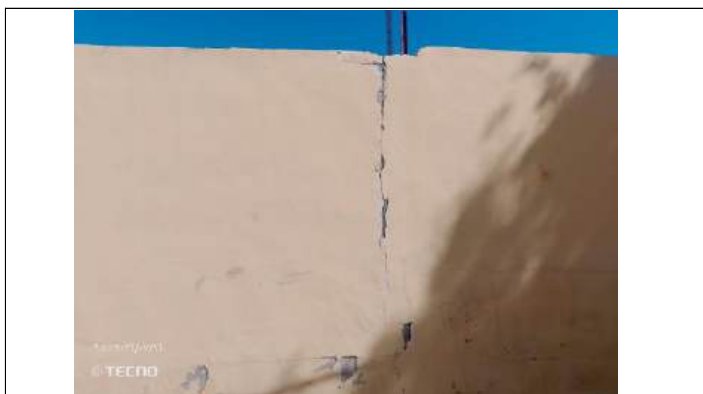
cracks in fence

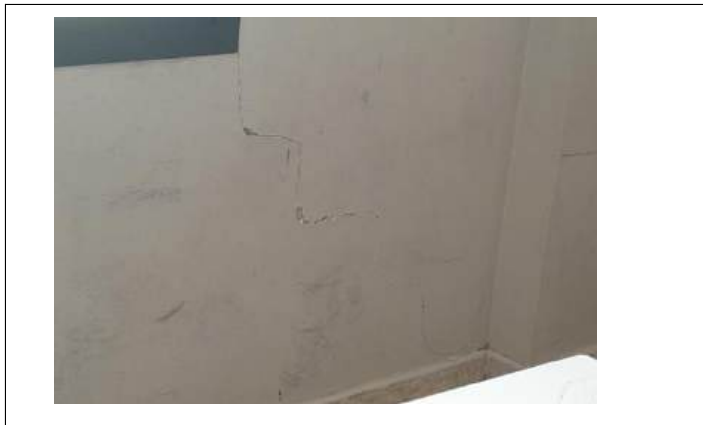
inclined cracks

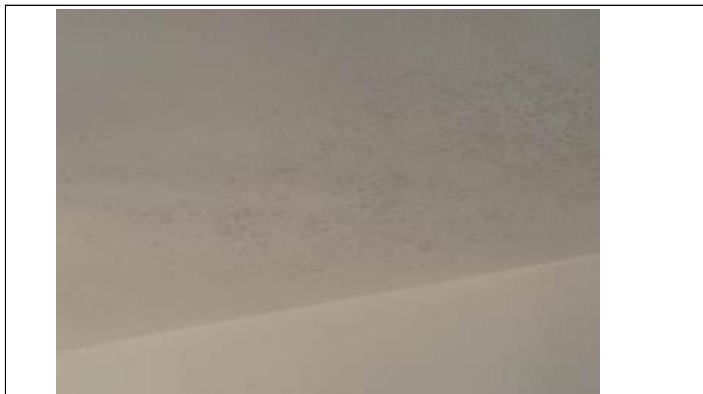
humidity in slab

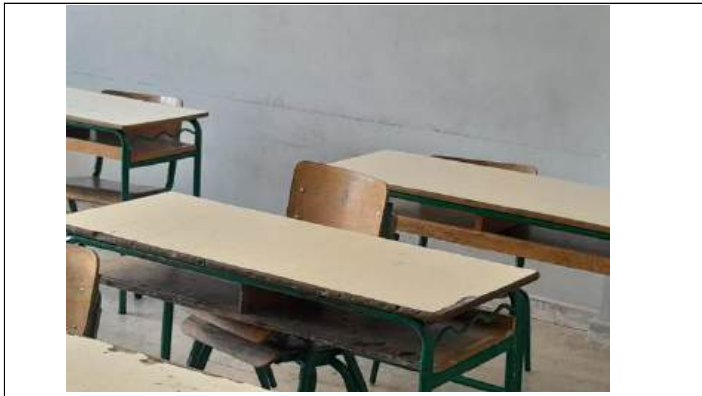
needs paint

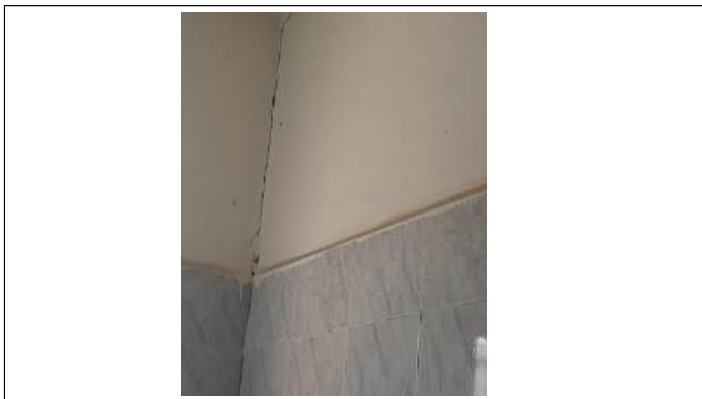
cracks between walls

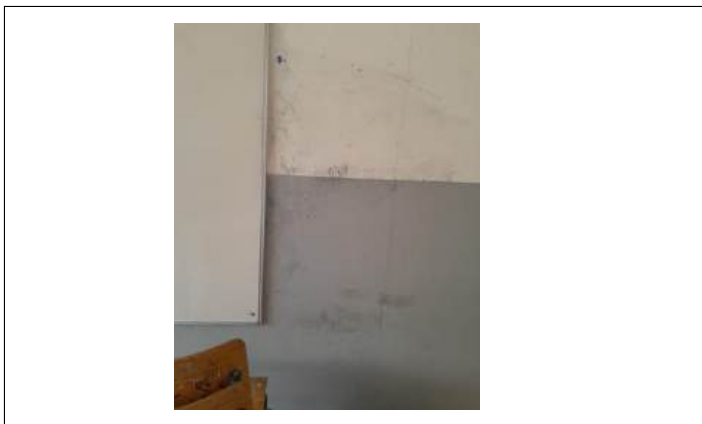
needs paint

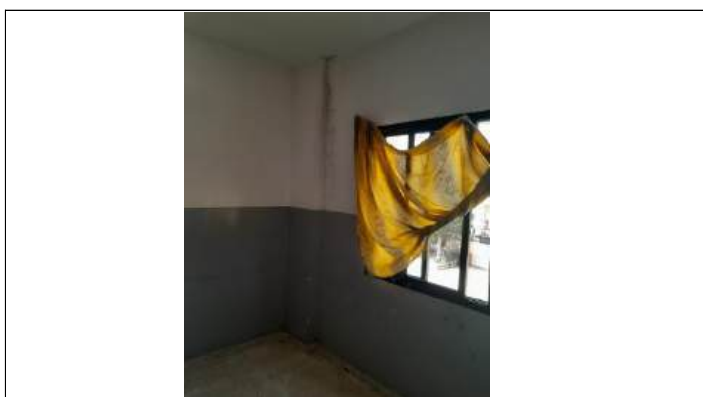
humidity from façade

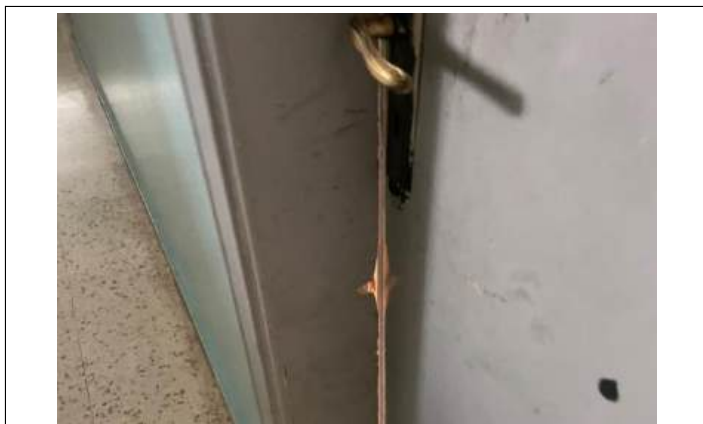
bad condition of wooden doors  
to be rehabilitated

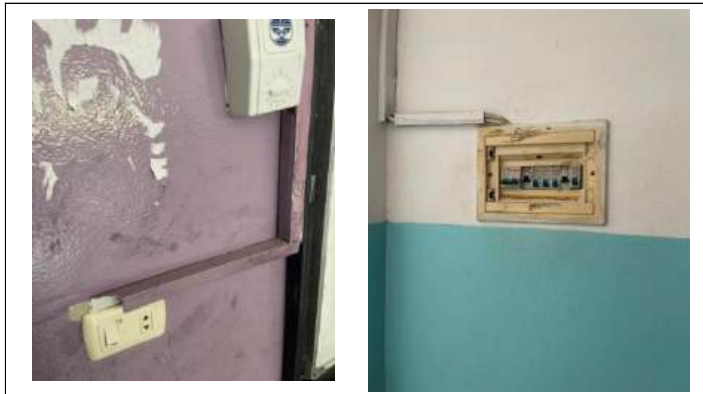
Pic showing the electrical DB in a very bad condition and not safe at all

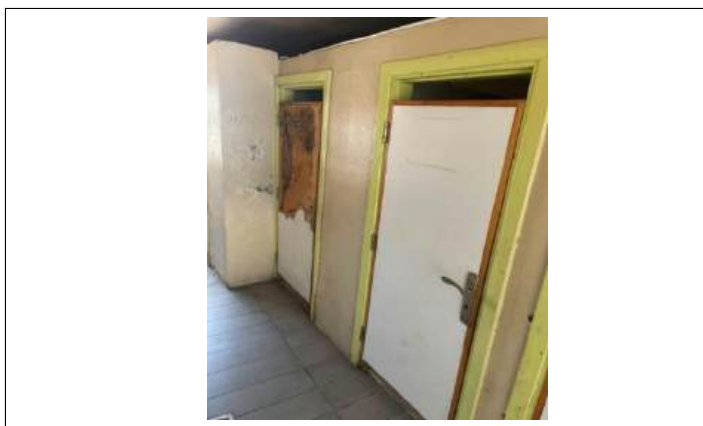
WC in a bad condition

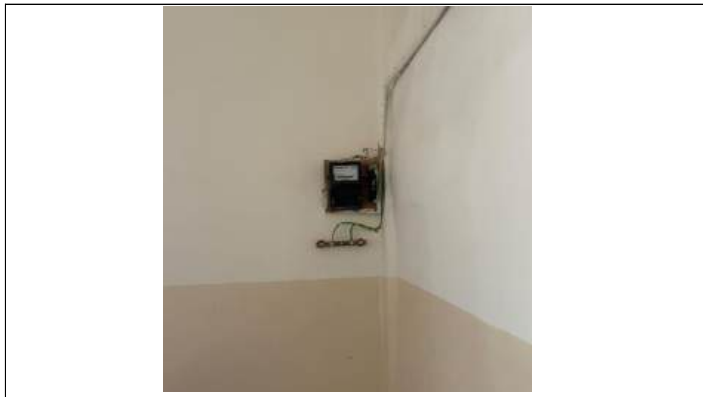
pic showing exposed electrical work

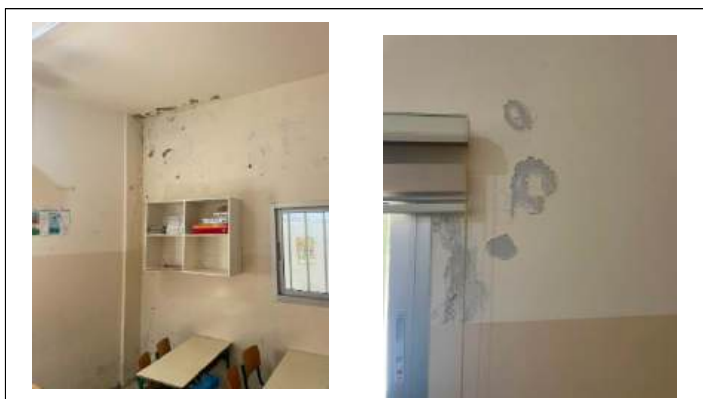
humidity in the classes

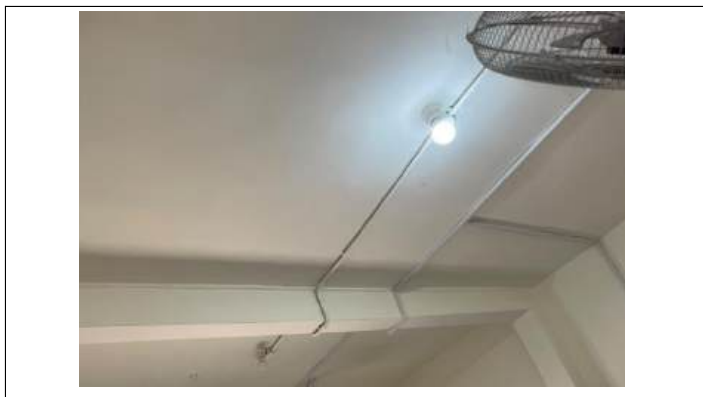
damage in the lamps

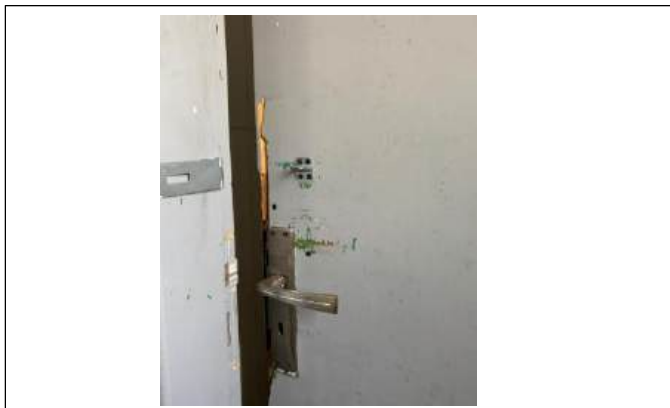
Lever handle and lock to door to be replaced and door to be painted

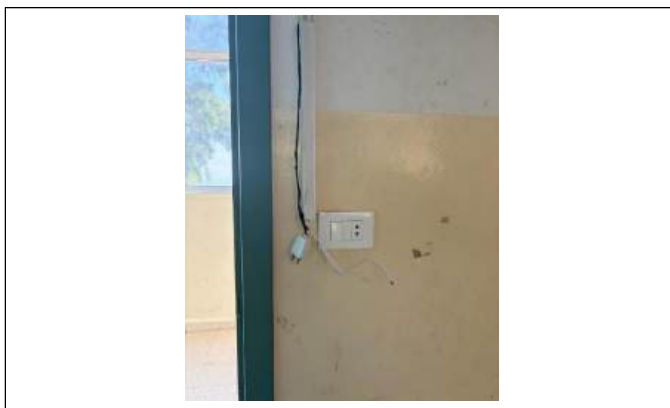
exposed electrical work

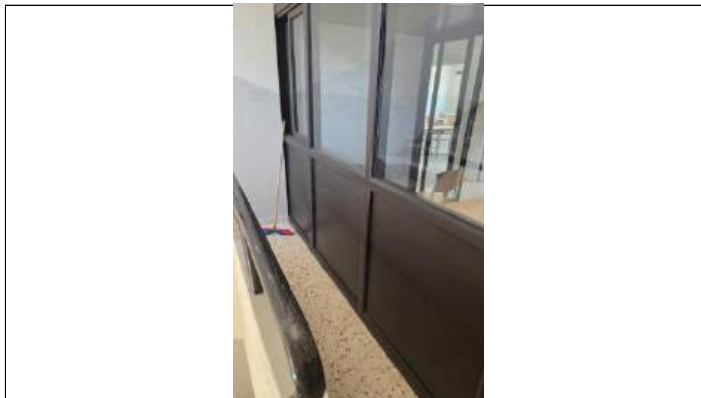
Aluminum Partition need some repair

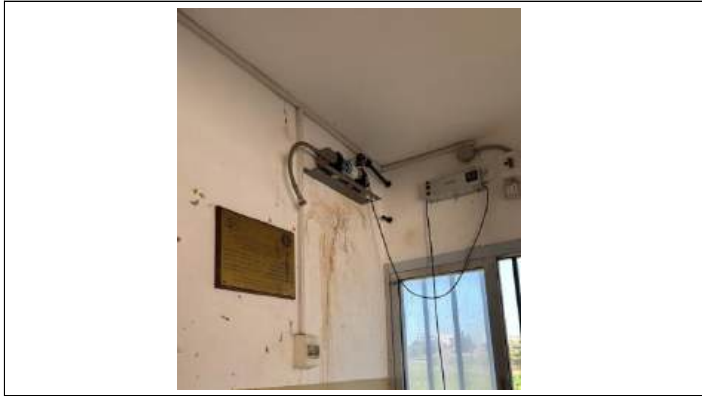
pic showing exposed electrical work

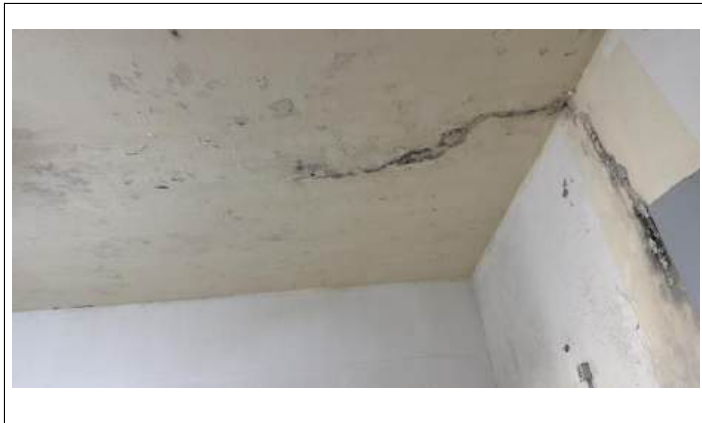
pic showing damage in the ceiling

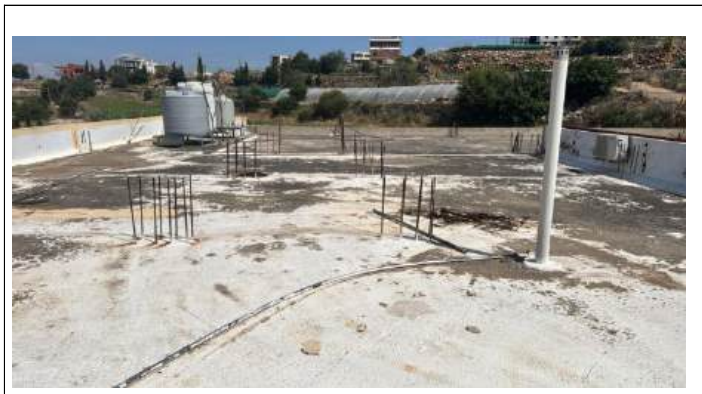
roof need to be rehabilitated

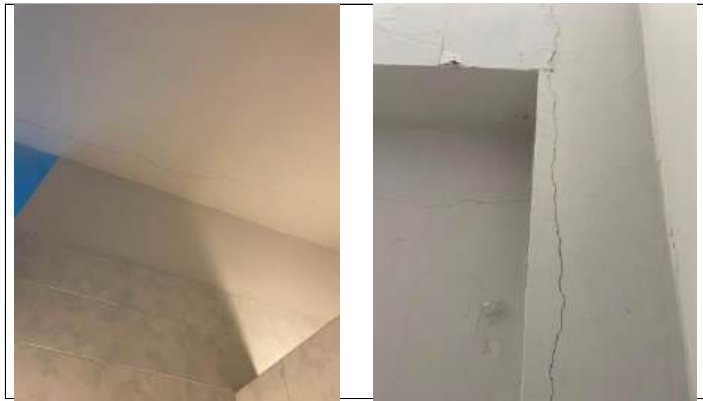
Pic showing crackin the walls

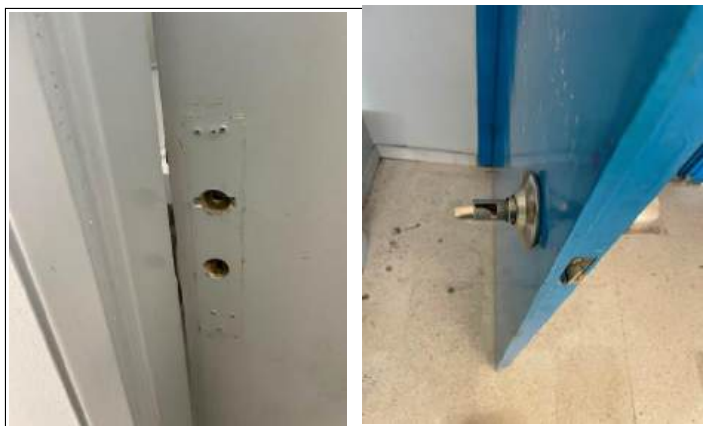
Lever handle and lock to door to be replaced and door to be painted

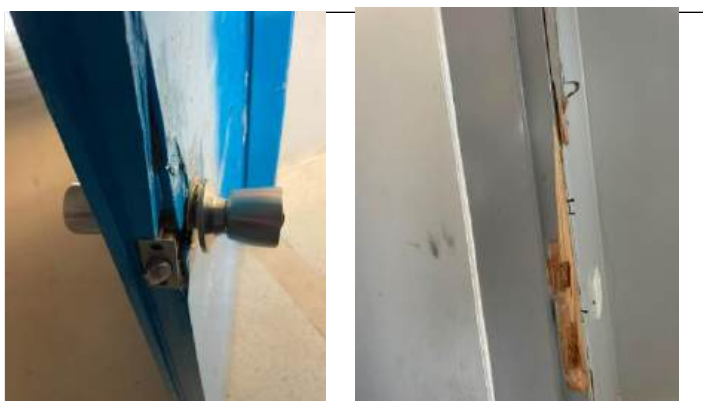
damage needs to be rehabilitated

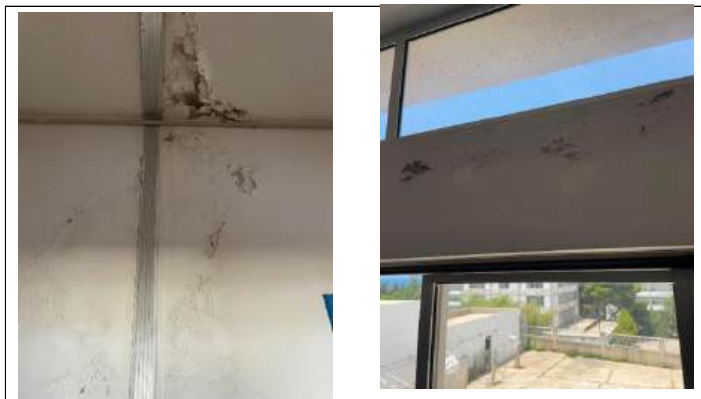
pic showing the humidity inside the wall

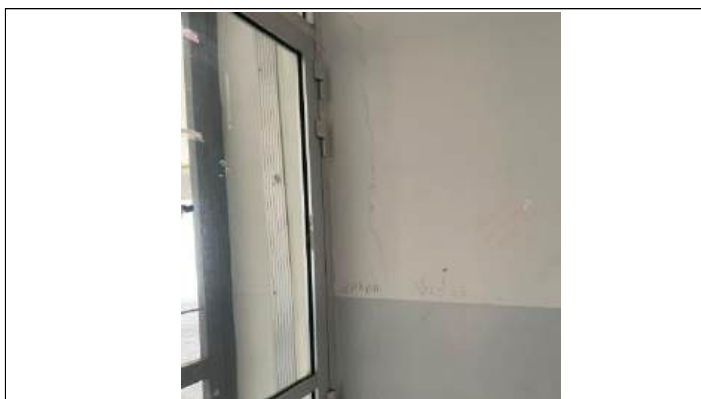
more cracks

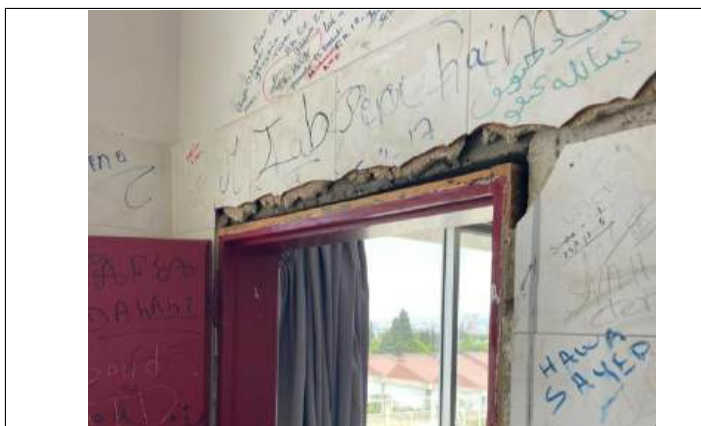
Door damage

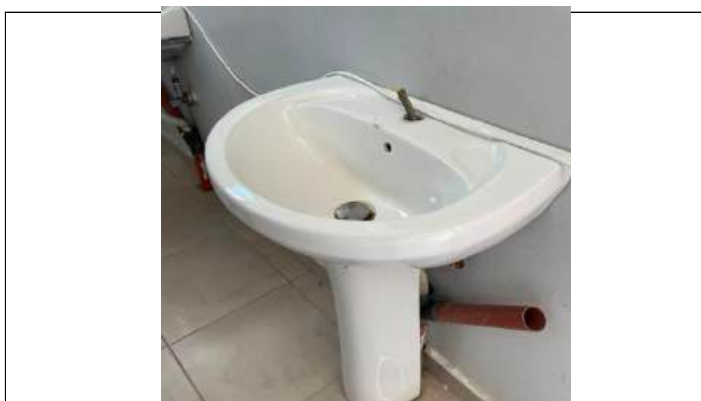
pic showing damage in the toilet
