**CERD 1629 - El Zahriye - El Tabbaneh Public School for Girls**

Batch 4 - Lot 2 – Tripoli

Lebanon Emergency Assistance Project (LEAP)

### Detailed Assessment and Verification Report

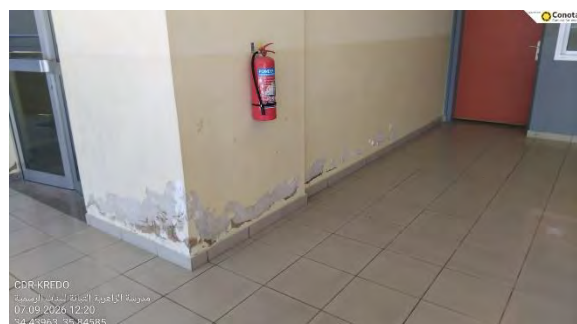
| Item | Condition found |
|---|---|
| Humidity | High Humidity |

**Figure 7 – Humidity in Wall**

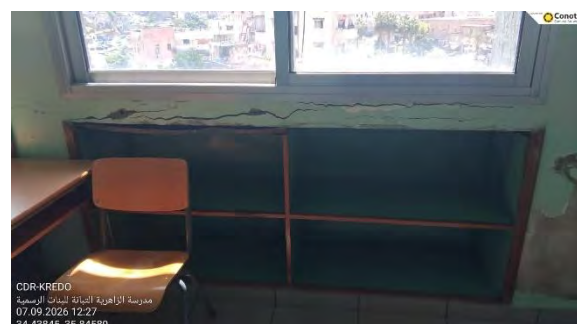
| No. | Element | Yes | No | Location and description |
|---|---|---|---|---|
| 3 | Wall cracks | X | | All floors |

**Figure 8 – Crack in Wall**

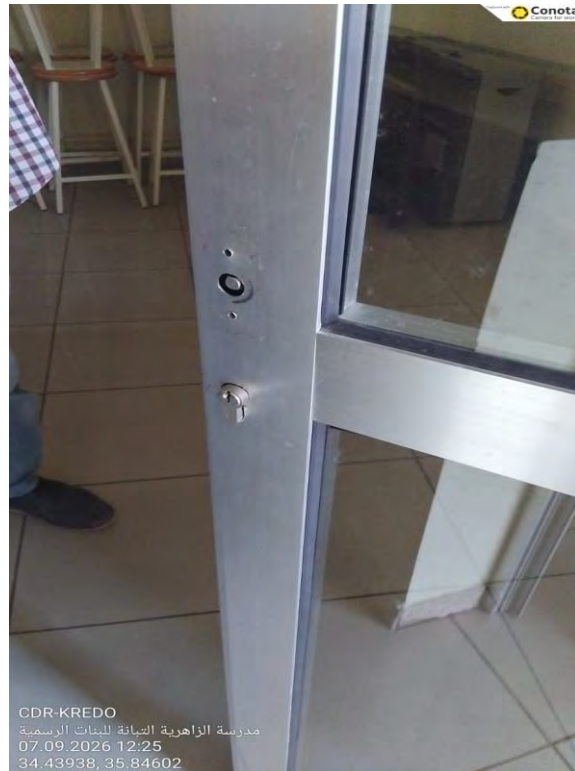
| Trade | Item | Damaged | Location, extent and quantity |
|---|---|---|---|
| | Door accessories and ironmongery | Yes | 8 wooden door handles<br>8 wooden door locks |

**Figure 9 – Missing Door Handle**

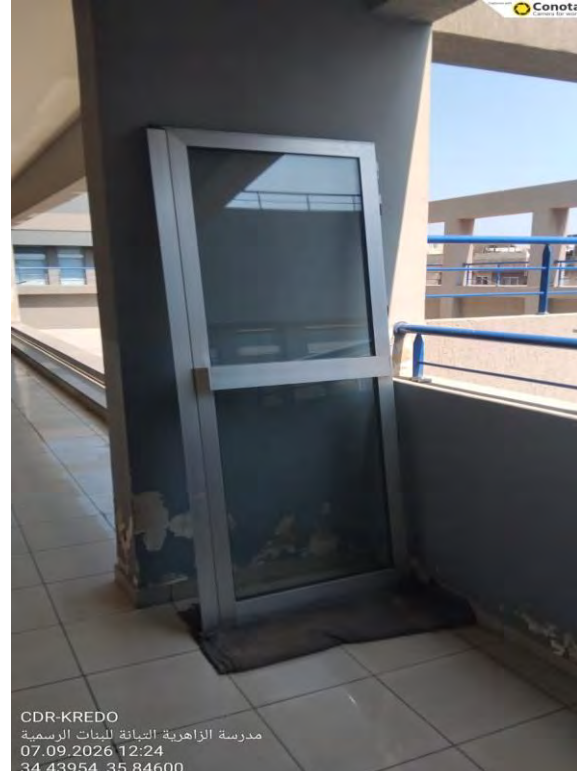
**Figure 10 – Aluminum Door to be Installed**

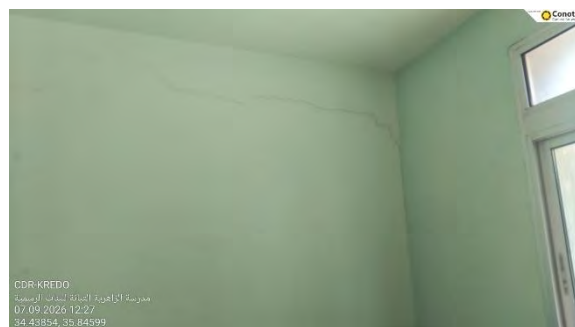
**Figure 11 – Crack in Wall**

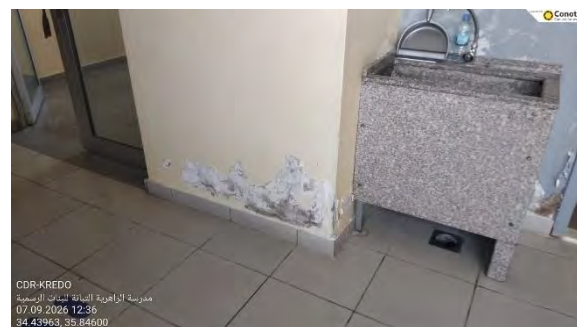
**Figure 12 – Humidity in Wall**

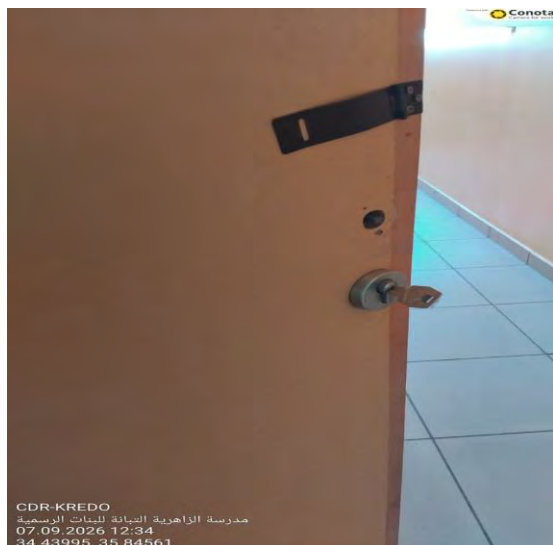
**Figure 13 – Missing Door Handle**

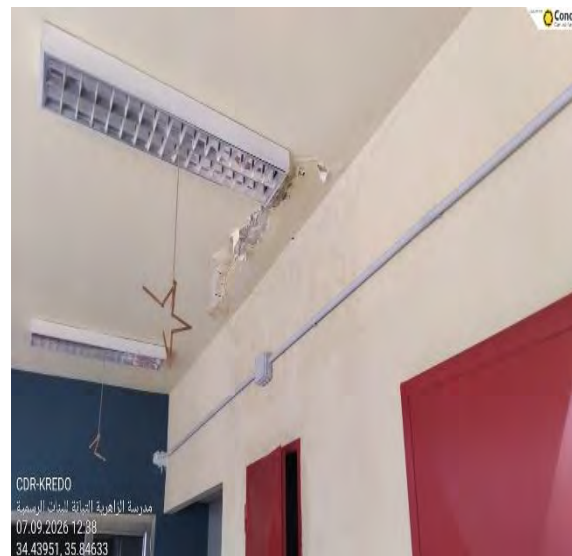
**Figure 14 – Humidity in Ceiling**

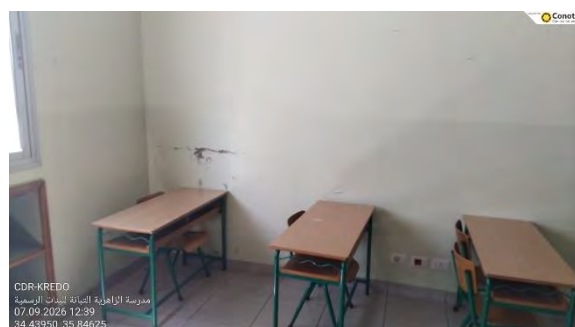
| Trade | Item | Damaged | Location, extent and quantity |
|---|---|---|---|
| Finishes | Paint - walls and ceilings - plasters | Yes | 3,250 m <sup>2</sup> painting<br>2 m <sup>2</sup> plastering |

**Figure 15 - Damaged Wall Paint**

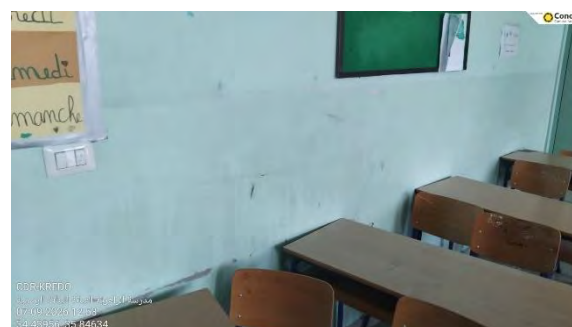
**Figure 16 - Damaged Wall Paint**

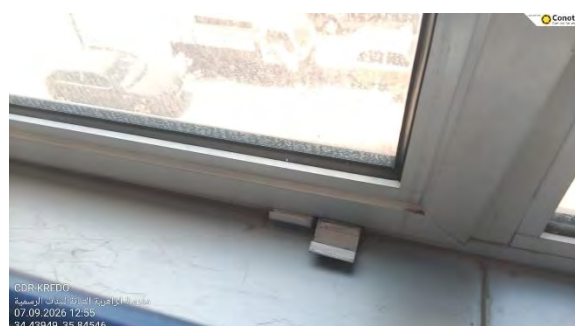
**Figure 17 - Damaged Window**

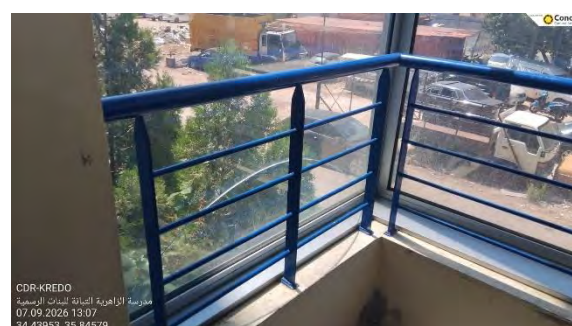
| Trade | Item | Damaged | Location, extent and quantity |
|---|---|---|---|
| Aluminum and glazing | Aluminum glazing | Yes | 4.5 m <sup>2</sup> |

**Figure 18 - Broken Glazing**

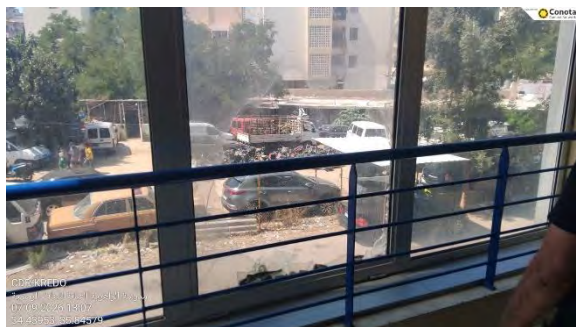
**Figure 19 - Broken Window Glazing**

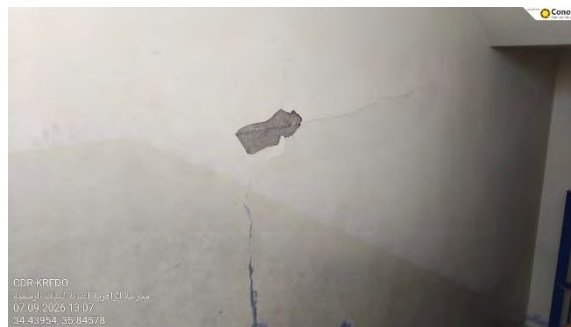
**Figure 20 - Crack in Wall**

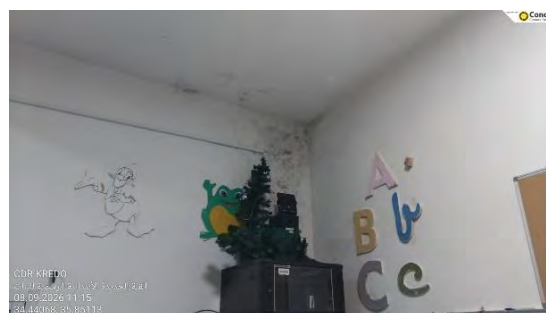
| Trade | Item | Damaged | Location, extent and quantity |
|---|---|---|---|
| Roofing | Roof waterproofing | Yes | Detected humidity in all the ceilings and walls of the rooms |

**Figure 5- Walls & ceiling in bad condition**

| Item | Assessment |
|---|---|
| Other risks noted on site | Should eliminate leakage causing humidity in walls & ceiling |

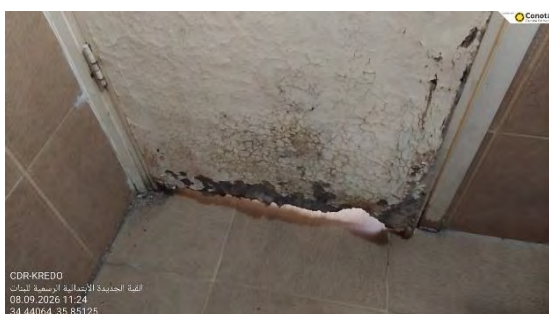
**Figure 6- Damaged Toilet doors**

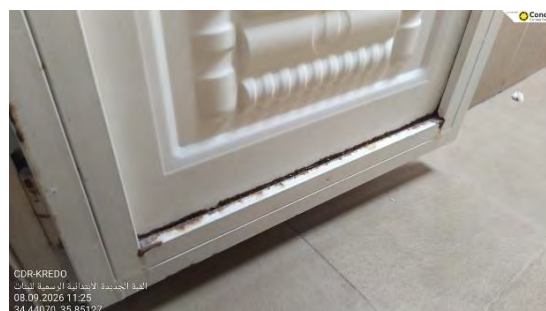
**Figure 7- Corrosion and deterioration at the bottom of the steel door**

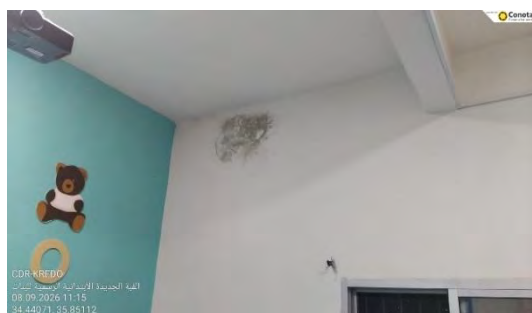
**Figure 8- Walls in bad condition**

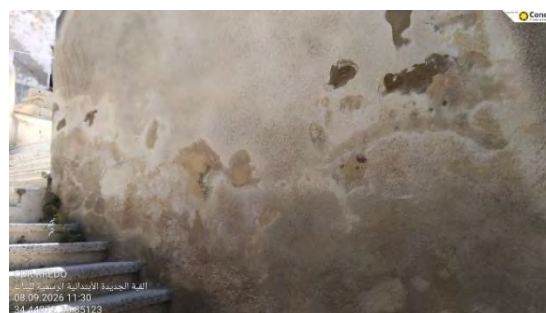
**Figure 9- Playground walls in bad condition**

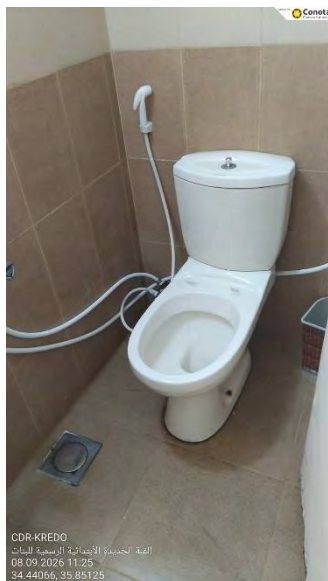
| Trade | Item | Damaged | Location, extent and quantity |
|---|---|---|---|
| | Water closets | Yes | 2 toilet seat covers are missing |

**Figure 10- WC cover missing**

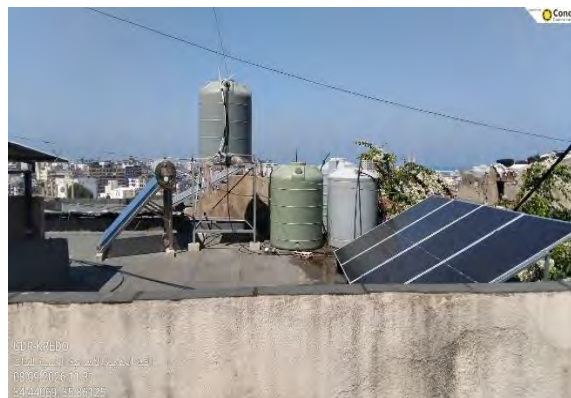
| Trade | Item | Damaged | Location, extent and quantity |
|---|---|---|---|
| | Water tanks and pumps | Yes | Roof Tanks are leaking |

**Figure 11- Roof Water tanks leaking**

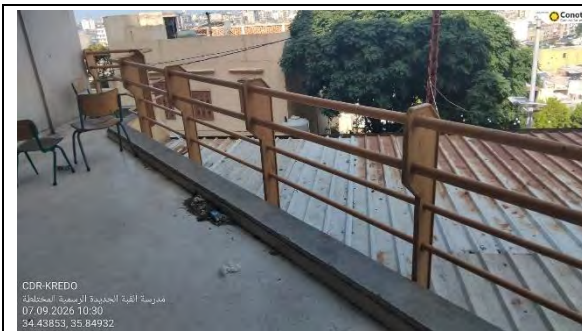
**Figure 7 – Rusted Fence**

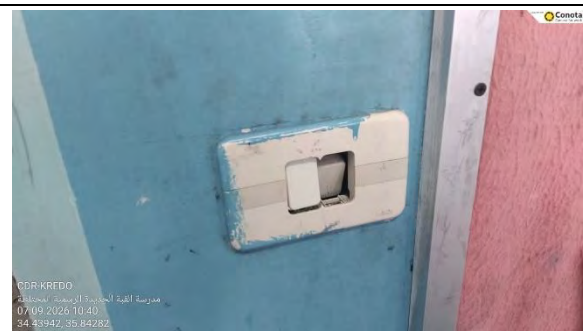
| Trade | Item | Damaged | Location, extent and quantity |
|---|---|---|---|
| Electrical | Sockets and switches | Yes | 7 points to be repaired |

**Figure 8 – Damaged Switch**

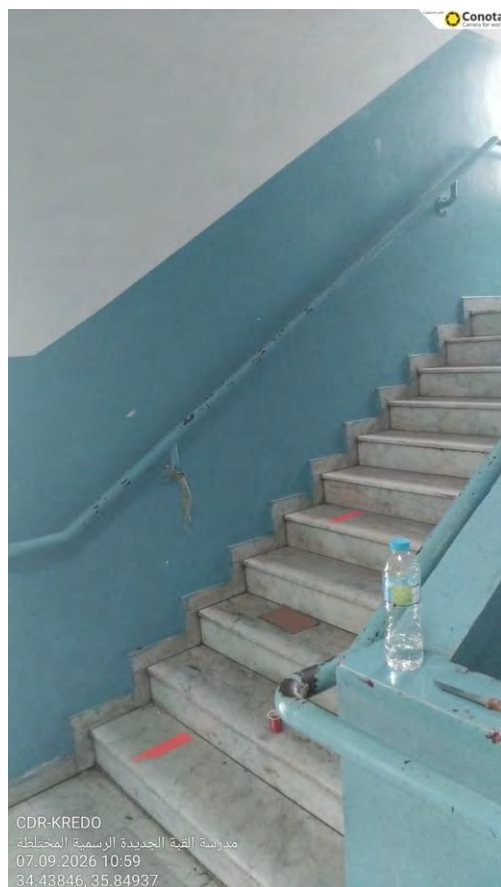
**Figure 9 – Damaged Handrail Paint**

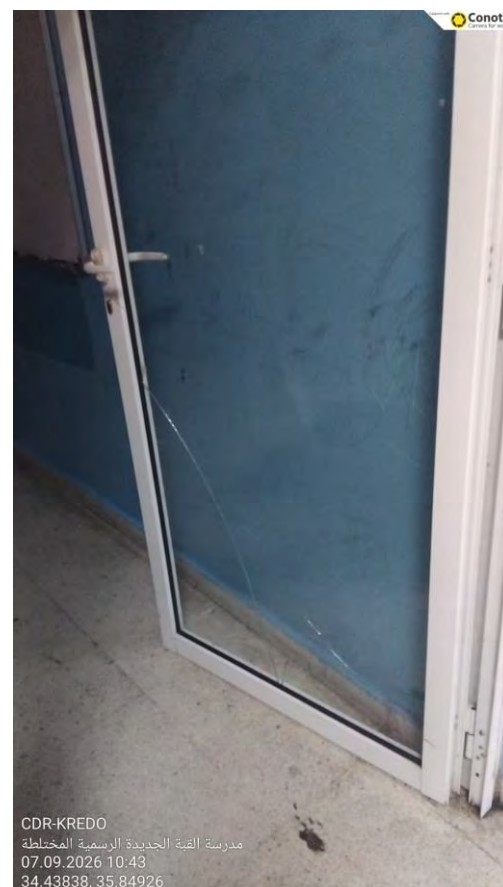
**Figure 10 – Broken Door Glazing**

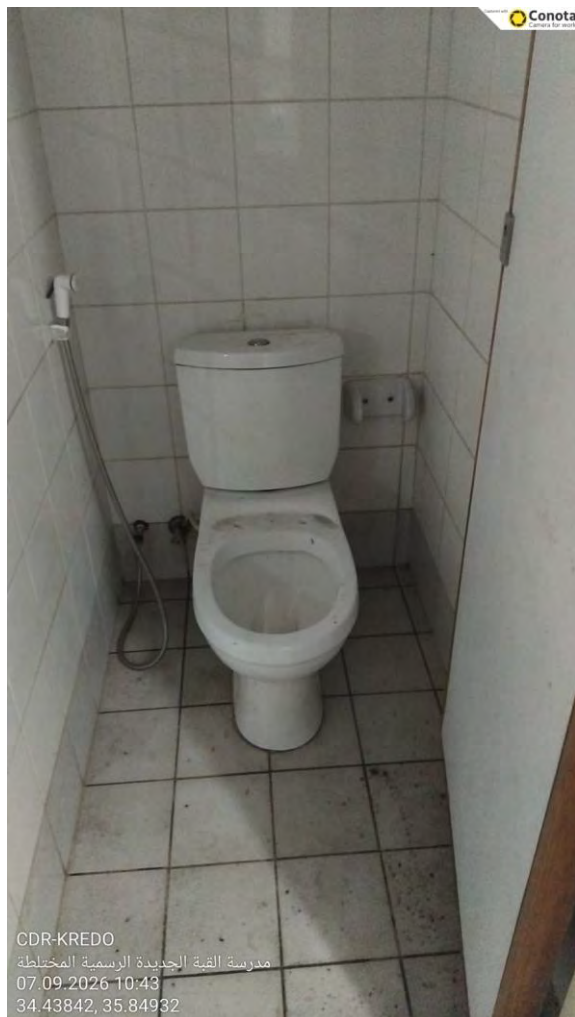
**Figure 11 – Missing Toilet Seat Cover**

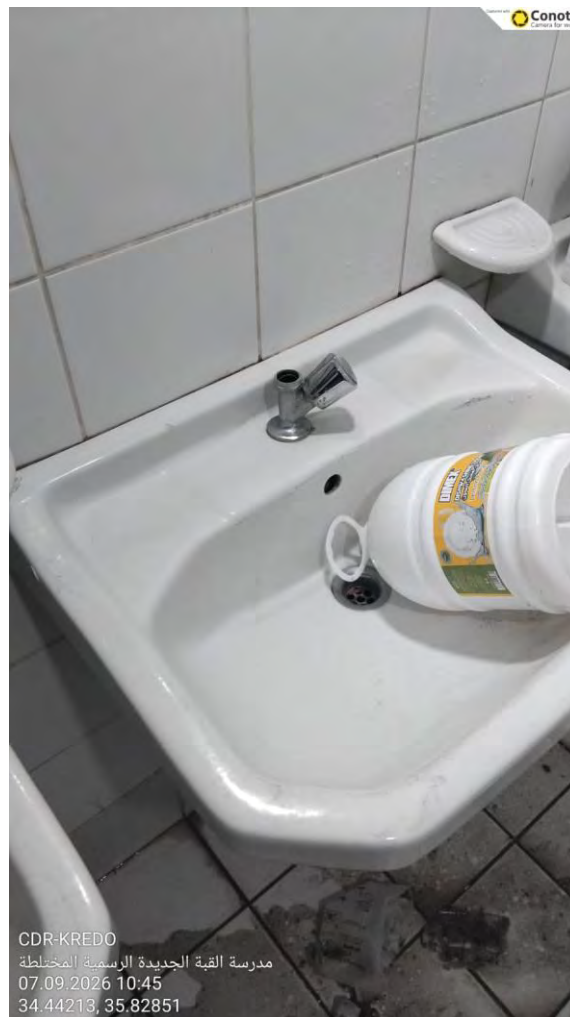
**Figure 12 – Missing Wash Basin Accessories**

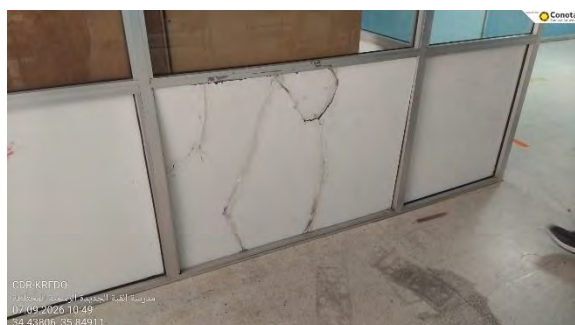
**Figure 13 – Broken Partition Panel**

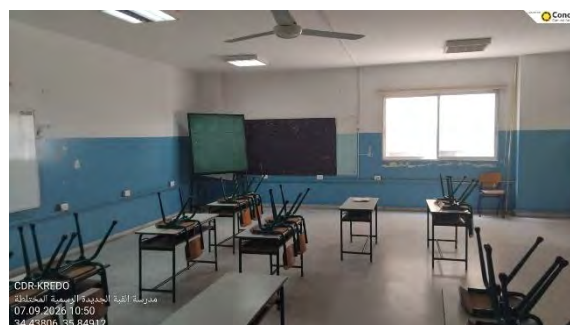
**Figure 14 – Damaged Wall Paint**

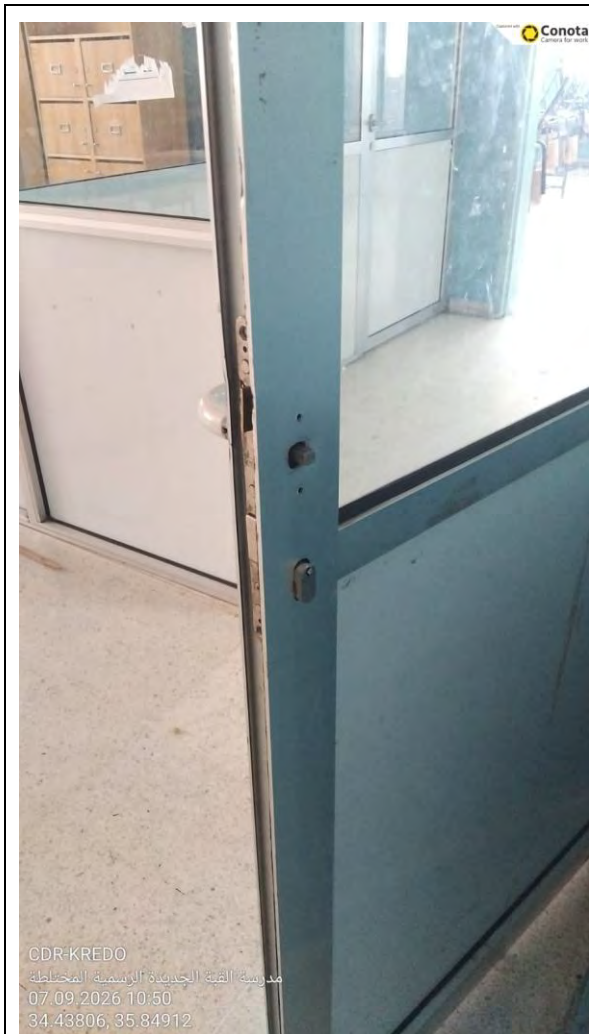
**Figure 15 – Missing Door Handle**

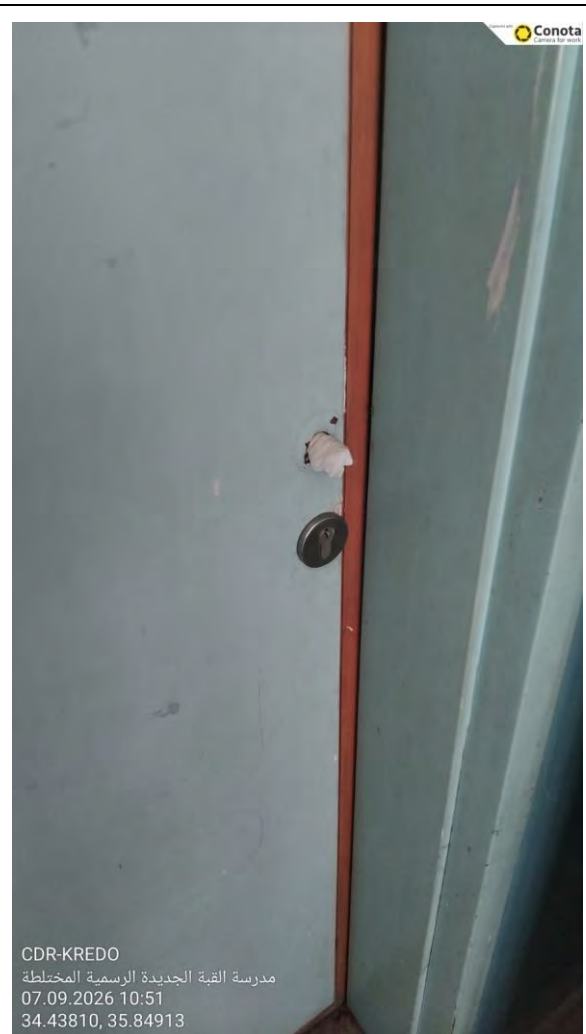
**Figure 16 – Missing Door Handle**

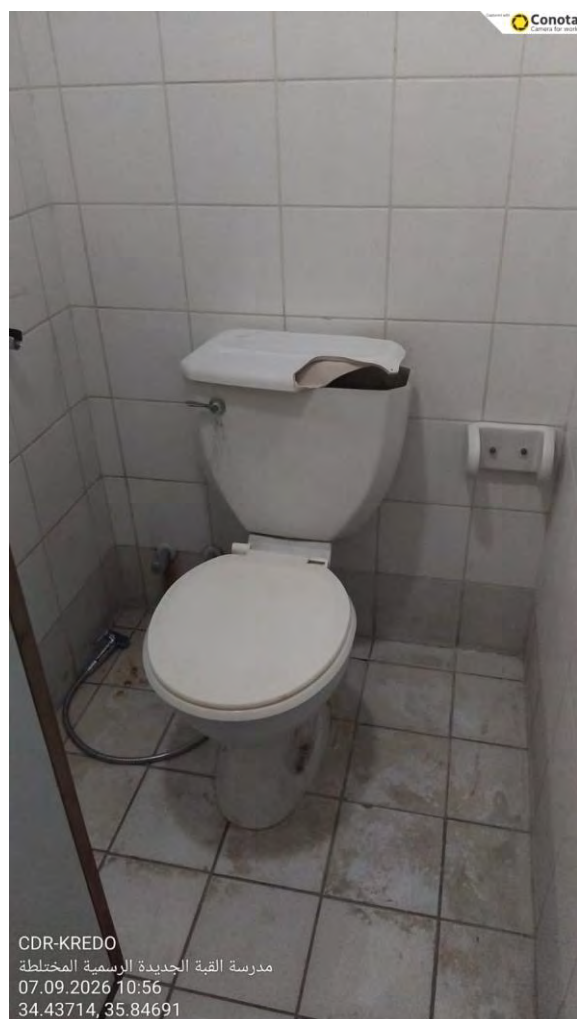
**Figure 17 - Broken Toilet Seat**

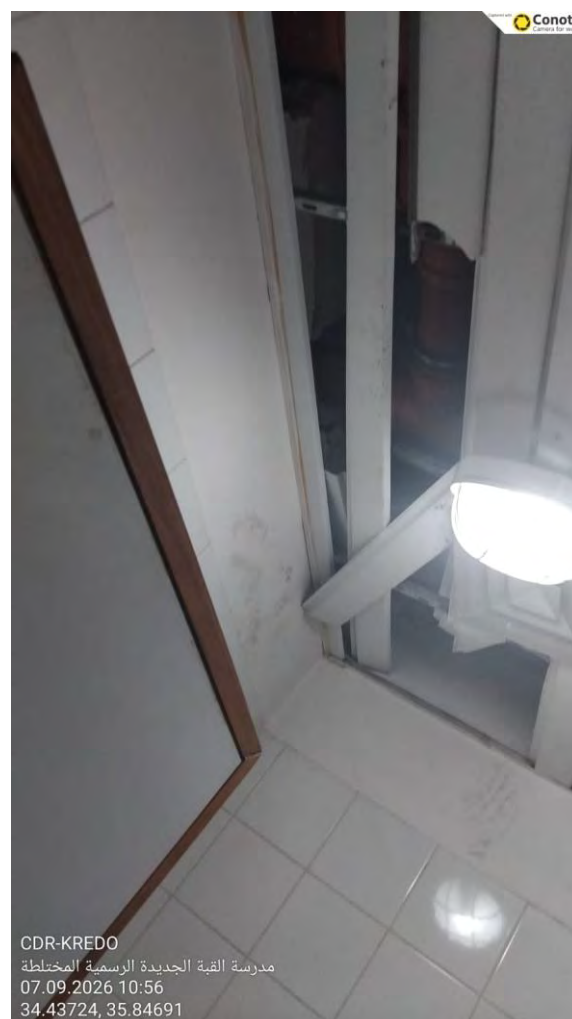
**Figure 18 - Damaged False Ceiling**

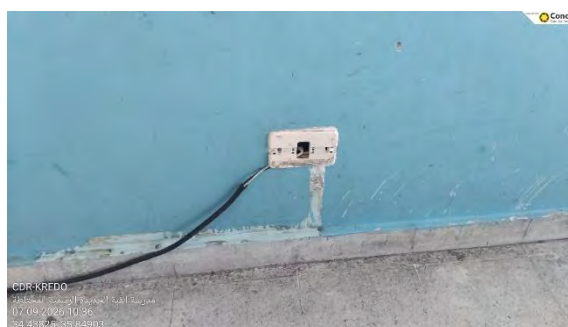
**Figure 19 - Damaged Socket**

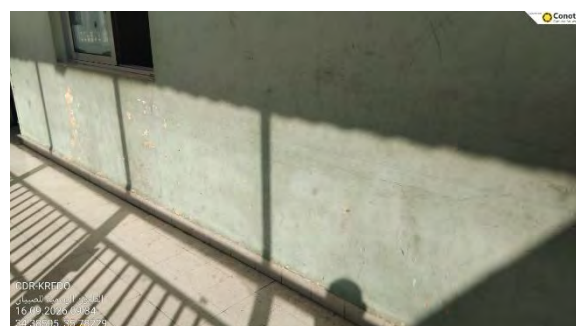
**Figure 11 - Damaged Wall Paint**

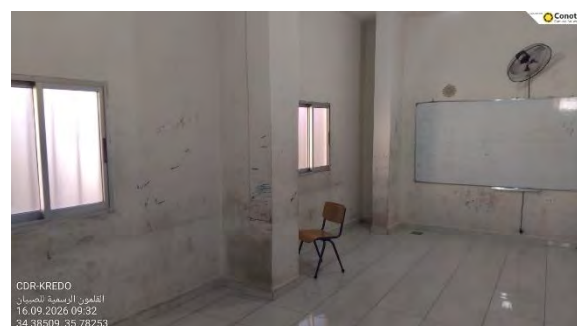
**Figure 12 - Damaged Wall Paint**

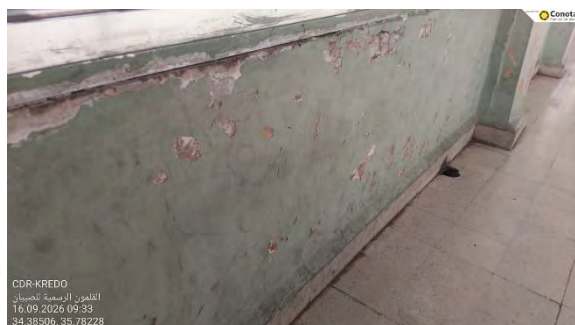
**Figure 13 – Damaged Wall**

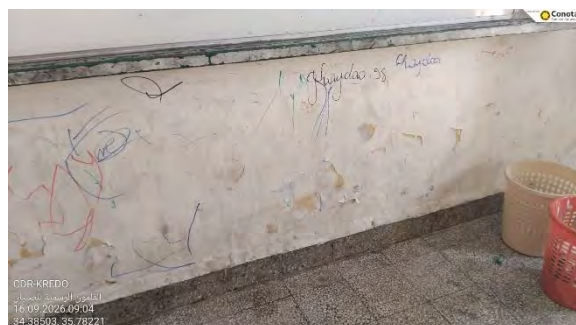
**Figure 14 – Damaged Wall Paint**

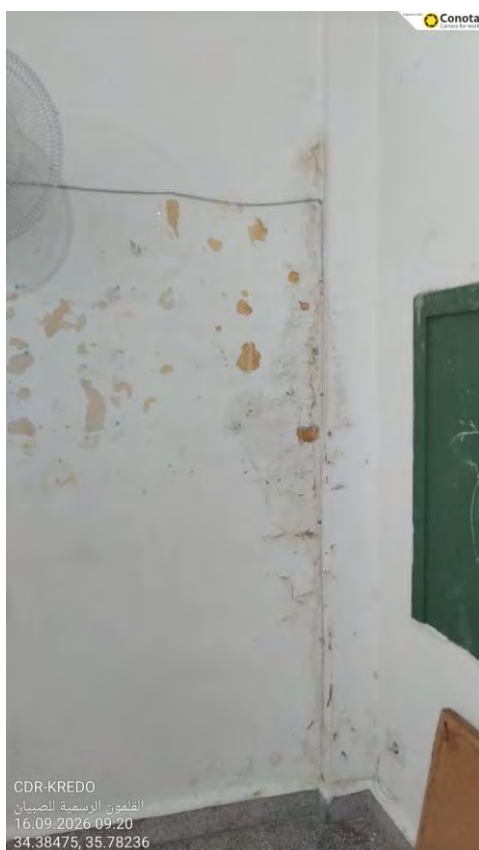
**Figure 15 – Damaged Wall**

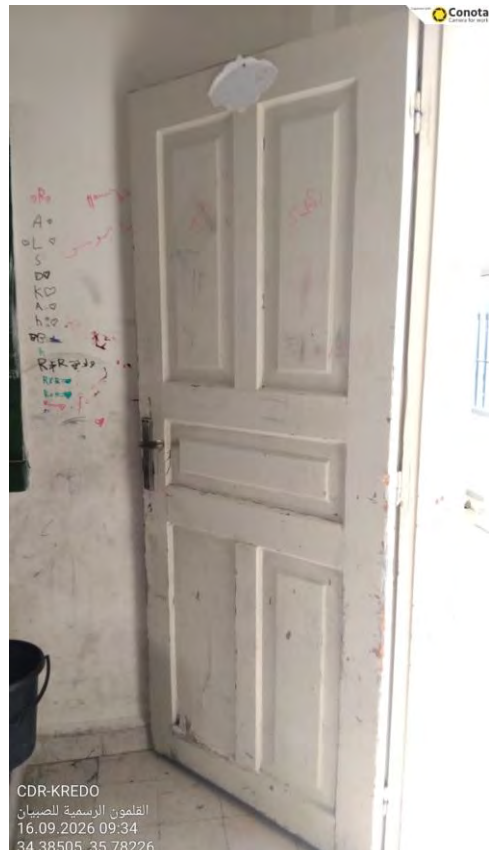
**Figure 16 – Damaged Door Paint**

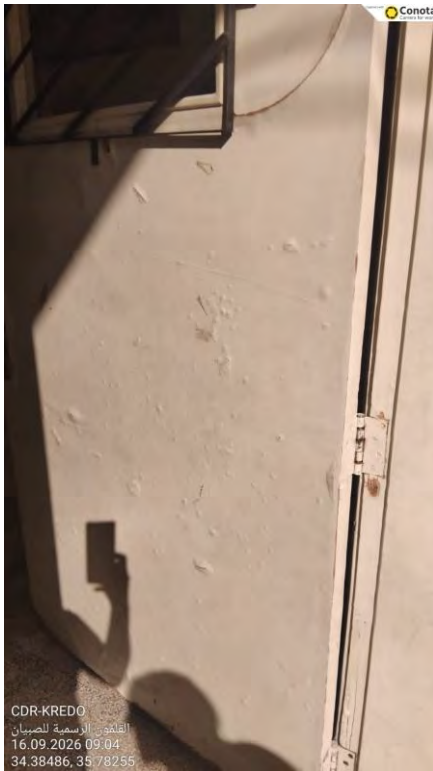
**Figure 17 – Damaged Door Paint**

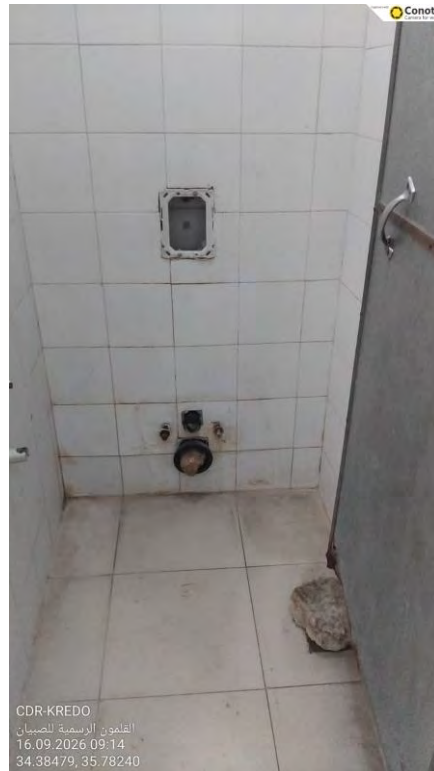
| Trade | Item | Damaged | Location, extent and quantity |
|---|---|---|---|
| | Water closets | Yes | 2 wall mounted water closets are missing |

**Figure 18 – Missing Toilet Seat**

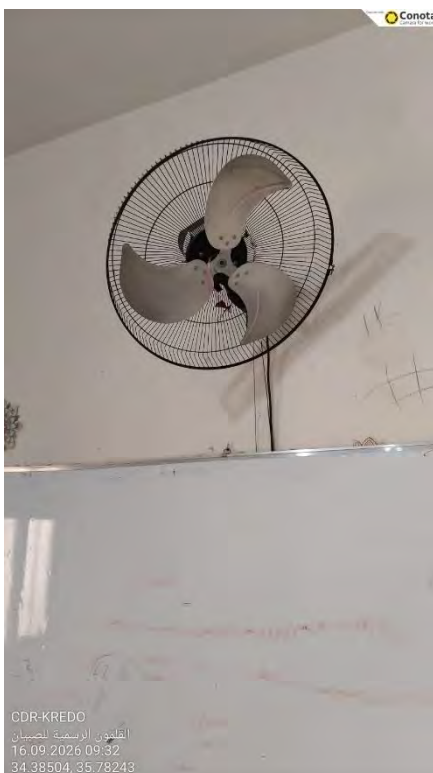
**Figure 19 – Spoiled Fan**

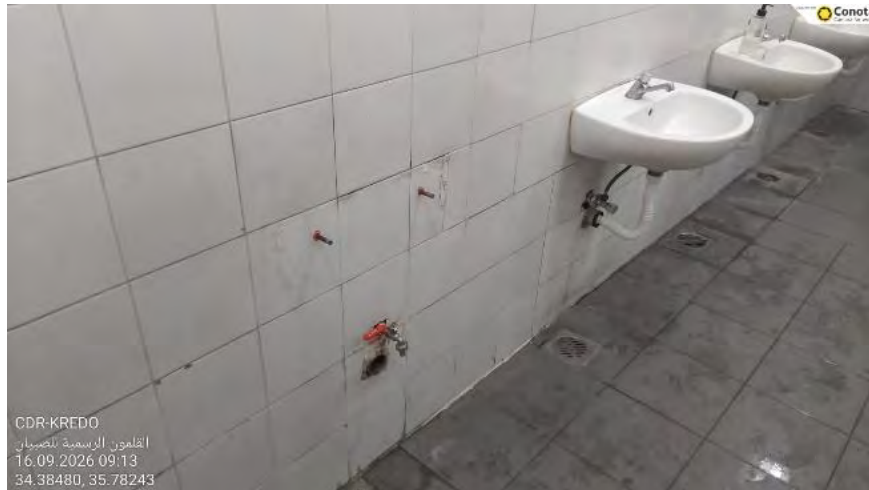
| Trade | Item | Damaged | Location, extent and quantity |
|---|---|---|---|
| Sanitary and plumbing | Wash basins | Yes | 1 wash basin is missing |

***Figure 21 - Missing Wash Basin***

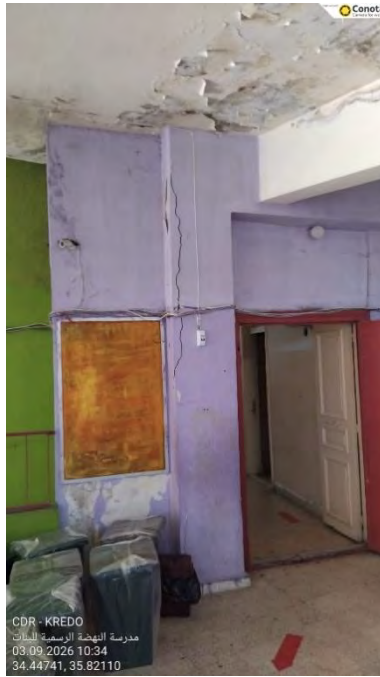
| No. | Element | Yes | No | Location and description |
|---|---|---|---|---|
| 4 | Column cracks | X | | Only in 1 column in the elevation |

**Figure 8 – Column Crack in Playground**

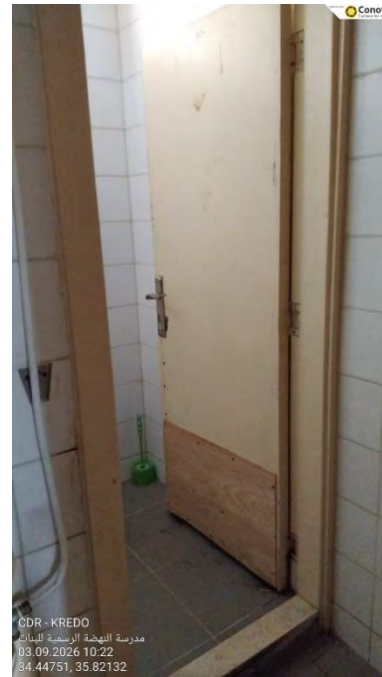
**Figure 9 – Damaged Door**

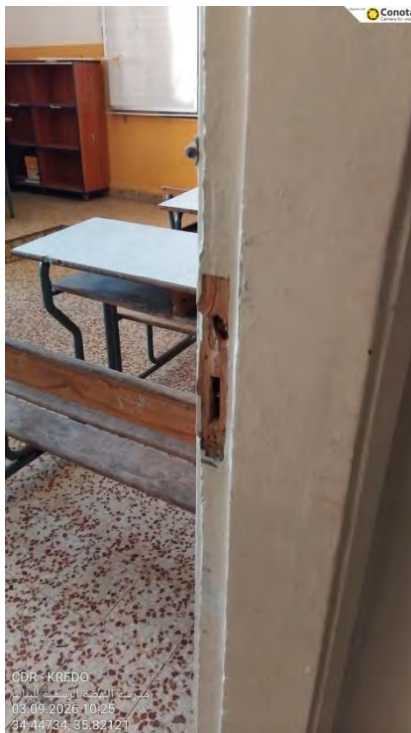
**Figure 10 – Missing Door Accessories**

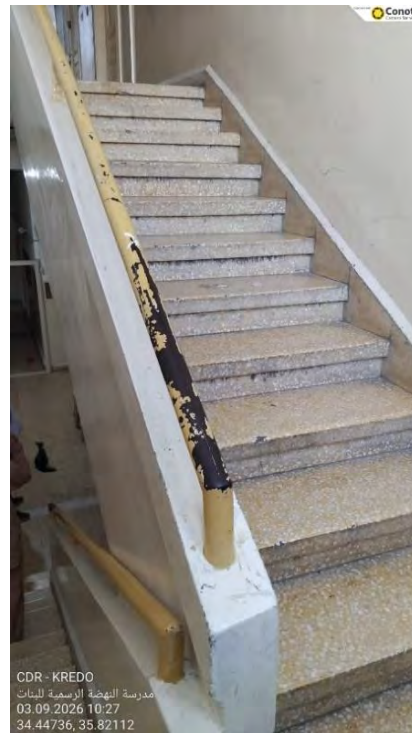
**Figure 11 - Damaged Handrail Paint**

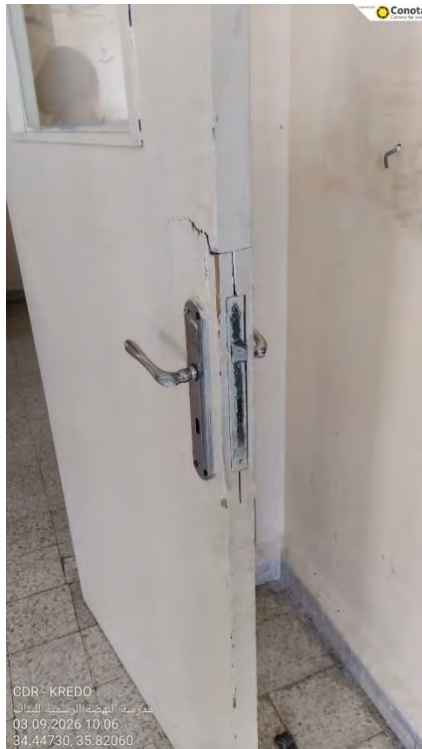
**Figure 12 - Broken Door**

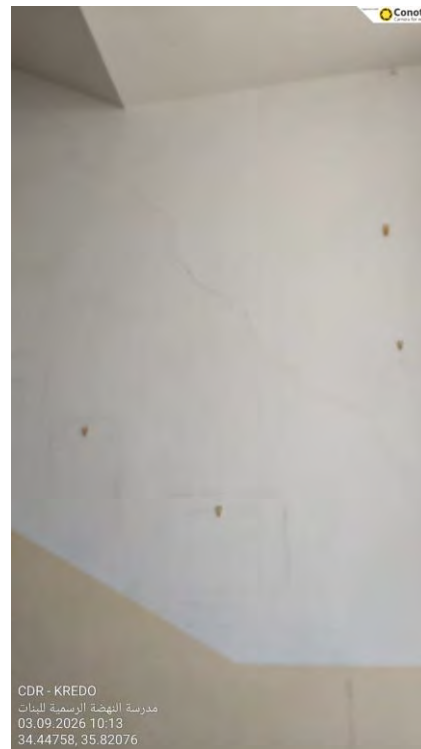
| No. | Element | Yes | No | Location and description |
|---|---|---|---|---|
| 3 | Wall cracks | X | | In the staircase |

**Figure 13 - Wall Cracks**

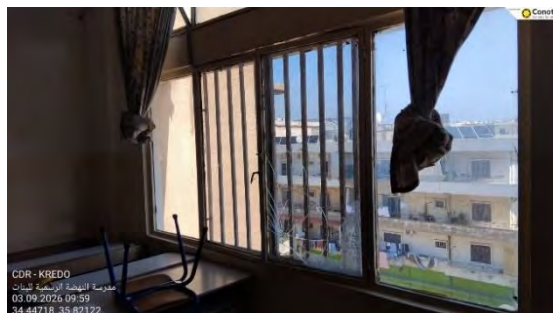
**Figure 14 - Broken Window Glass**

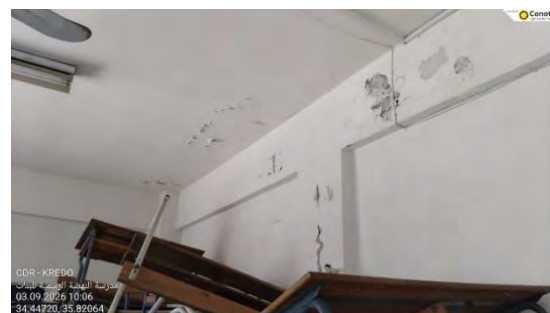
| No. | Element | Yes | No | Location and description |
|---|---|---|---|---|
| 2 | Facade water leak | X | | Showing in different spots |

**Figure 15 - Water Leakage**

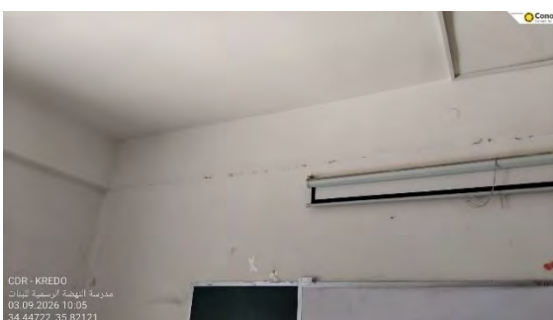
**Figure 16 - Crack Between Beam & Wall**

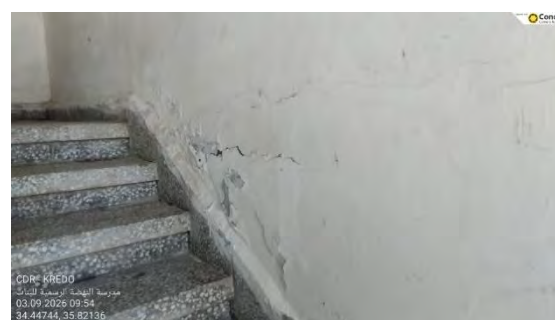
**Figure 17 - Humidity in Wall**

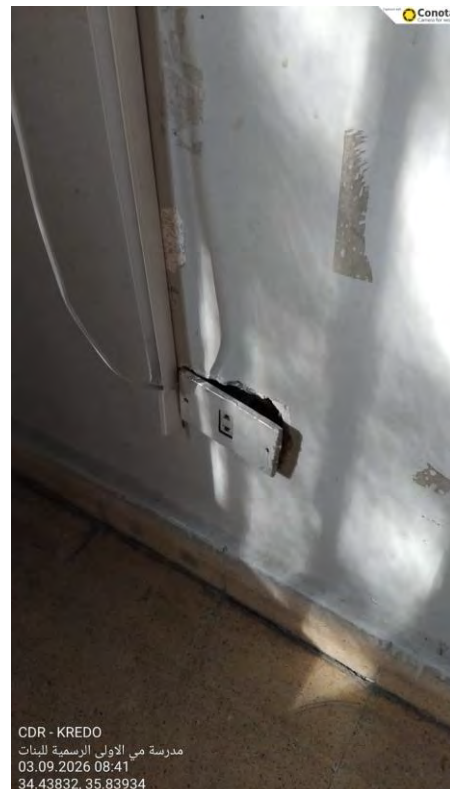
**Figure 7 – Damaged Socket**

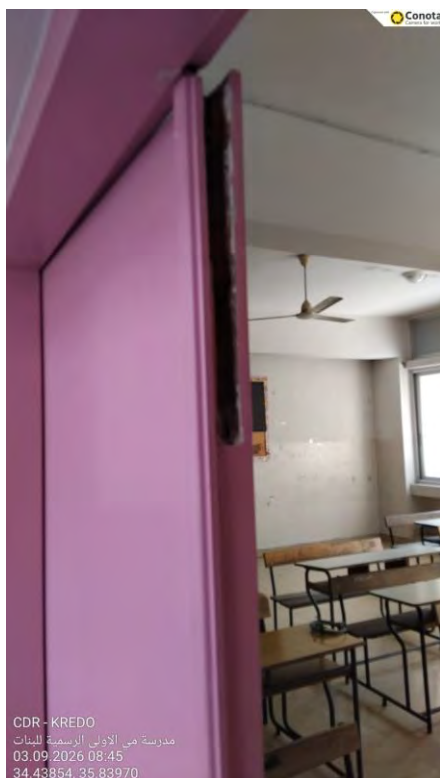
**Figure 8 – Missing Door Accessories**

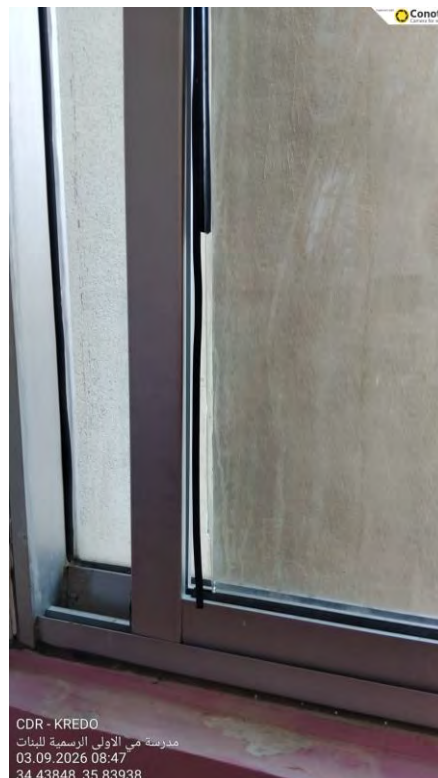
**Figure 9 – Broken Glazing**

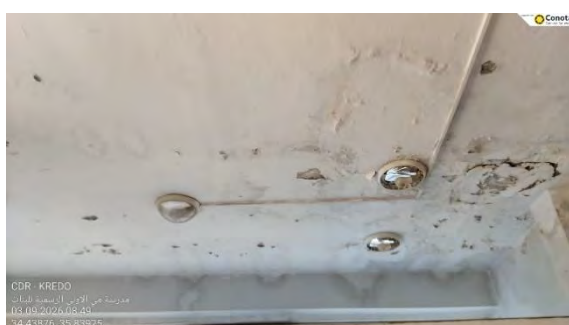
**Figure 10 – Humidity in Ceiling**

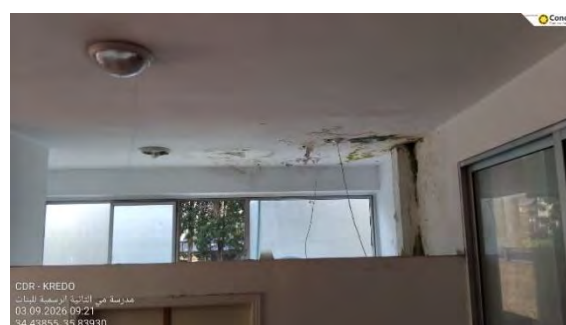
**Figure 11 – Humidity in Ceiling**

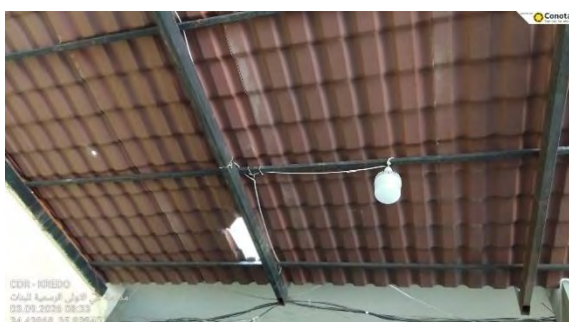
| Item | Condition found |
|---|---|
| Playground | Available but requires cover sheets replacement (75 m <sup>2</sup> ) |

**Figure 12 – Broken Playground Cover**

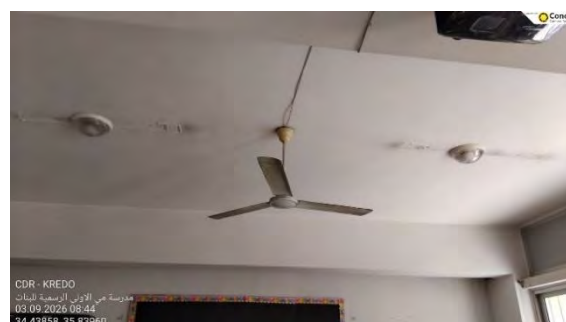
**Figure 13 – Damaged Ceiling Paint**

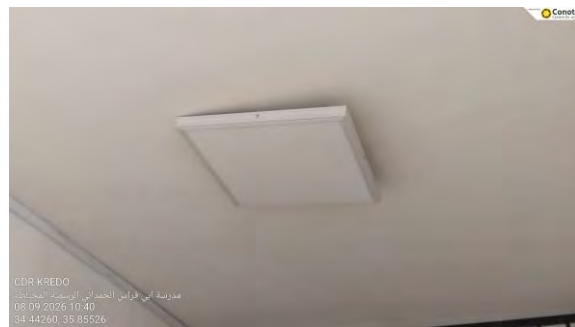
**Figure 12 – Damaged Light Fixture**

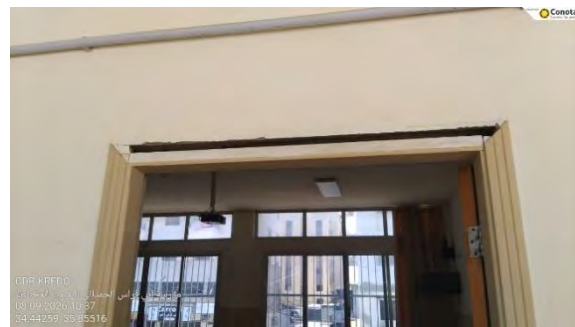
| Trade | Item | Damaged | Location, extent and quantity |
|---|---|---|---|
| Doors | Timber doors | Yes | Some architraves are missing & need paint |

**Figure 13 – Missing Architrave**

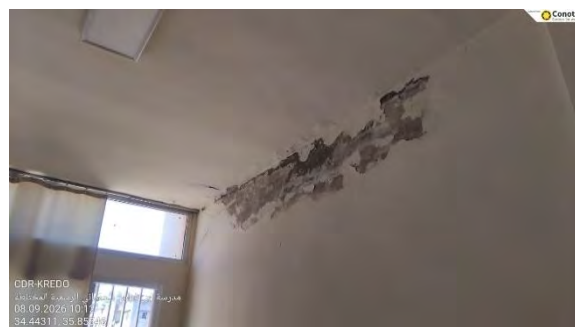
**Figure 14 – Humidity in Walls**

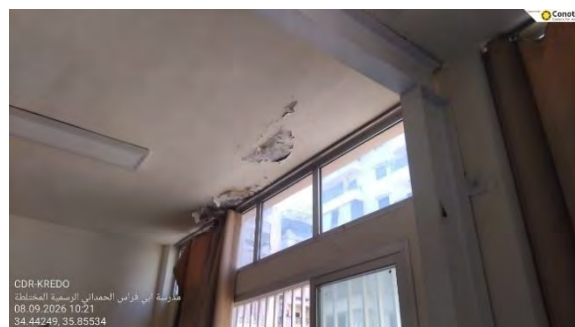
**Figure 15 – Humidity in Ceiling**

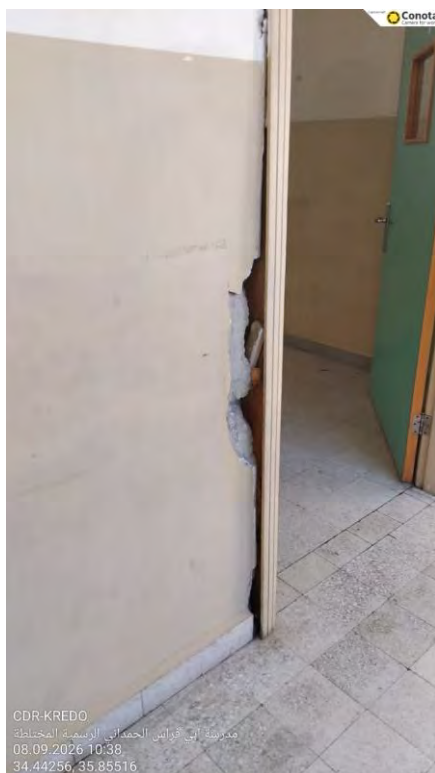
**Figure 16 – Damaged Door Fixation**

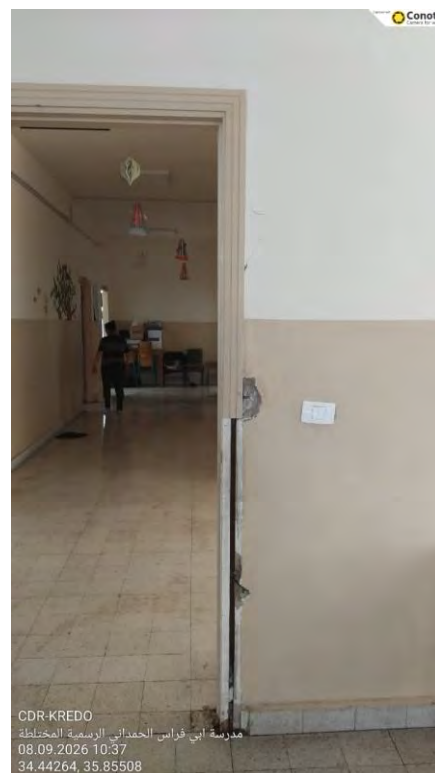
**Figure 17 – Damaged Door Frame**

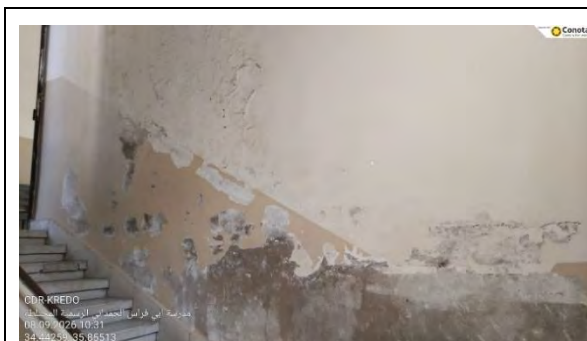
**Figure 18 - Humidity in Wall**

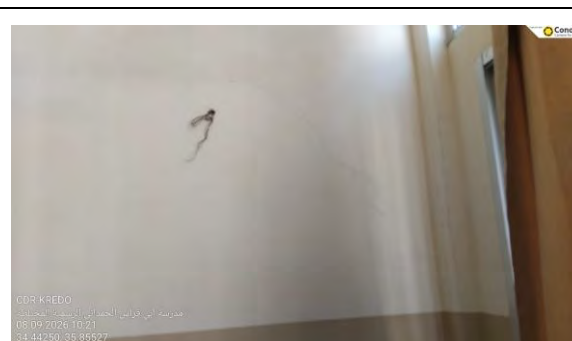
| No. | Element | Yes | No | Location and description |
|---|---|---|---|---|
| 3 | Wall cracks | X | | In different spots |

**Figure 19 - Cracks in Wall**
