**CERD 66 - Borj Hammoud Third Mixed Intermediate Public School**

Lebanon Emergency Assistance Project (LEAP)

## Detailed Assessment and Verification Report

September 2026

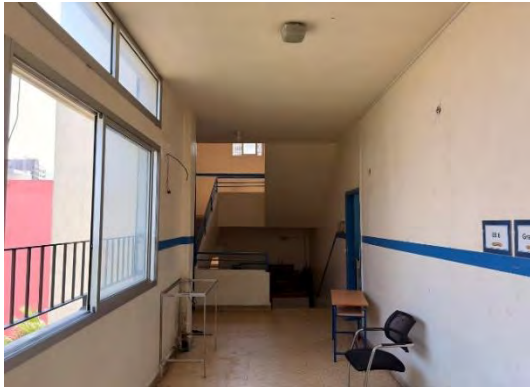
**Figure 4- Paint in bad condition**

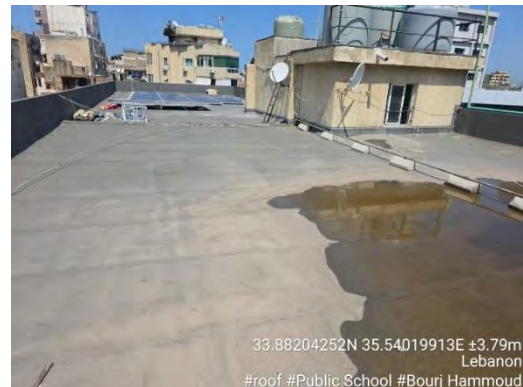
**Figure 5- Roof leakage**

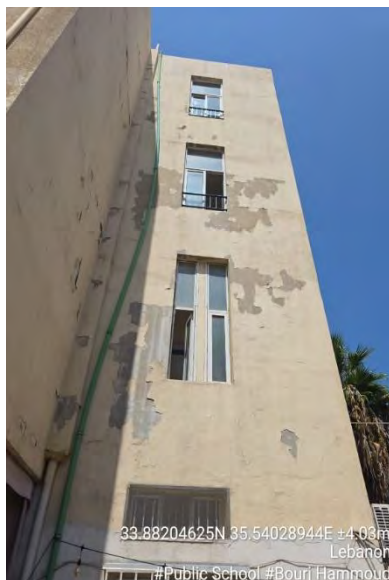
**Figure 6- Façade in bad condition**

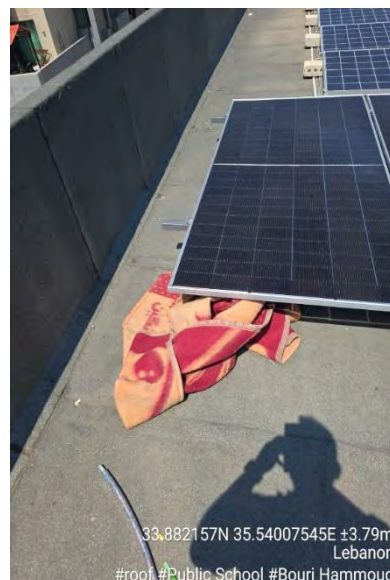
**Figure 7- Solar Panels in bad condition**

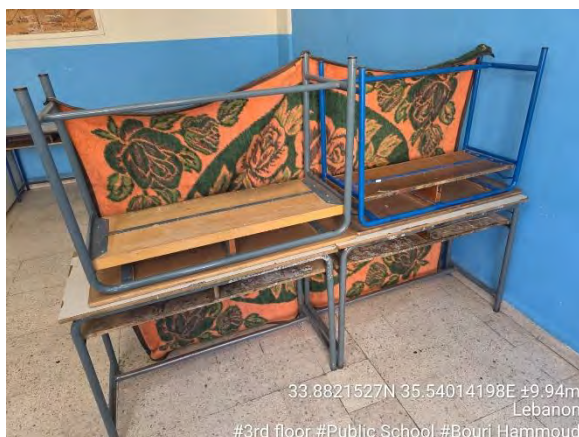
**Figure 8- Damaged wall paint**

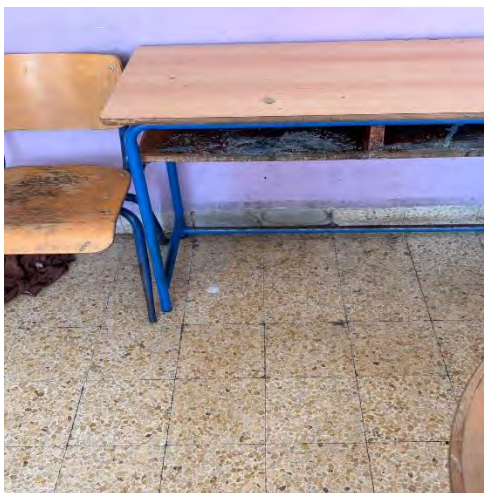
| Trade | Item | Damaged | Location, extent and quantity |
|---|---|---|---|
| | Floor tiles | Yes | Minor repairs are required in several rooms |

***Figure 10- Damaged tiles***

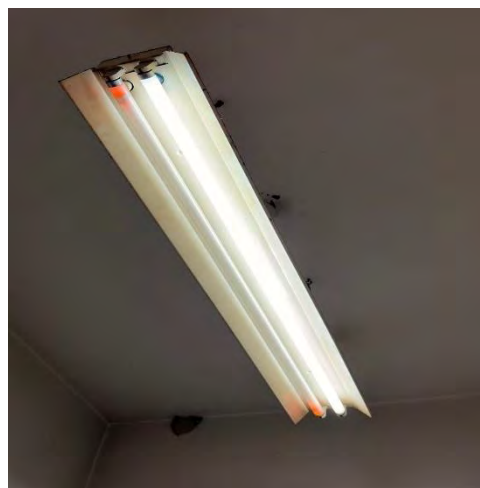
***Figure 11- Damaged Lighting Fixture***

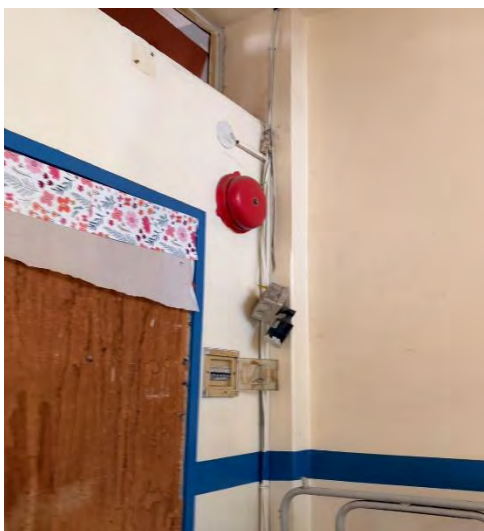
| Trade | Item | Damaged | Location, extent and quantity |
|---|---|---|---|
| Doors | Timber doors | Yes | - 2 new doors are required for the GF toilets<br>- 1 new door is required for the main entrance of the 2nd floor<br>- Minor repairs with painting are required for 26 doors |

***Figure 12- Damaged door***

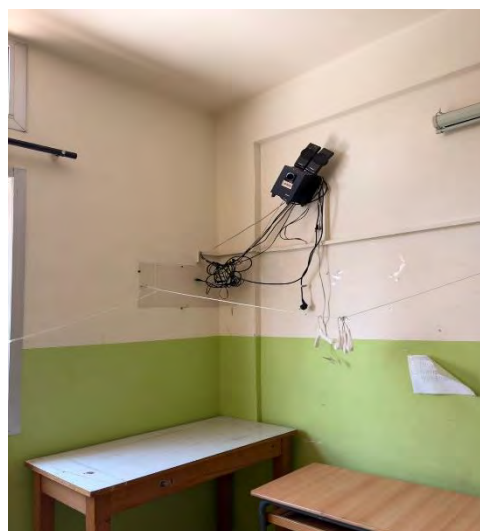
***Figure 13- Electrical Reservation Damaged***

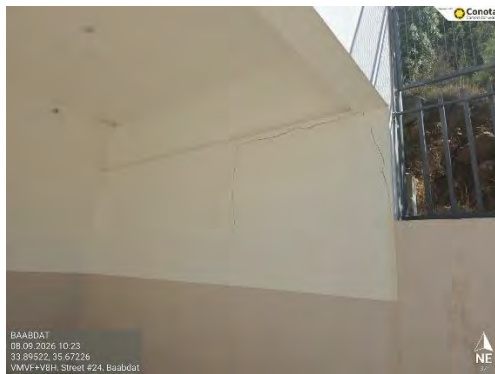
**Figure 4 - Humidity in walls**

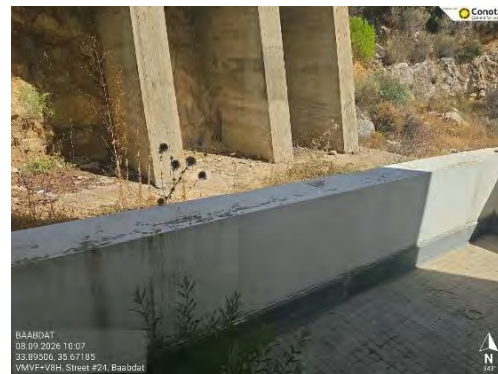
**Figure 5 - Damaged paint**

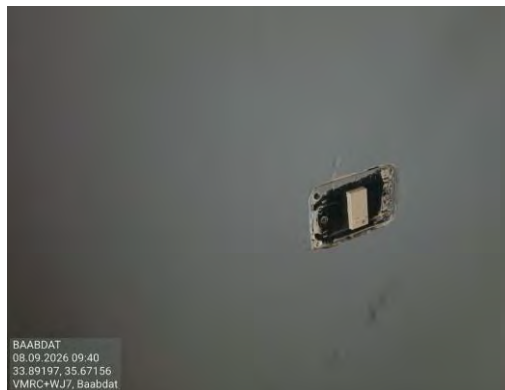
| Trade | Item | Damaged | Location, extent and quantity |
|---|---|---|---|
| Electrical | Sockets and switches | Yes | Minor repairs are required in several rooms. |

**Figure 6 - Damaged electrical sockets**

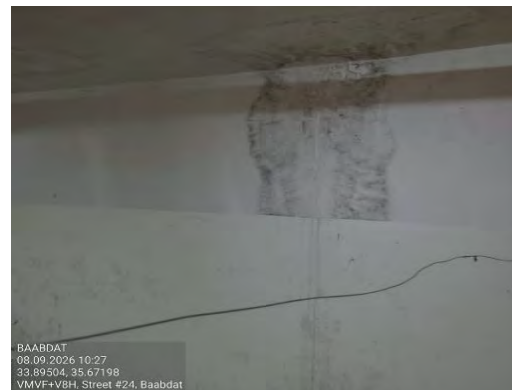
| No. | Element | Yes | No | Location and description |
|---|---|---|---|---|
| 3 | Wall cracks | X | | Finishing cracks |

**Figure 7 - Wall crack**

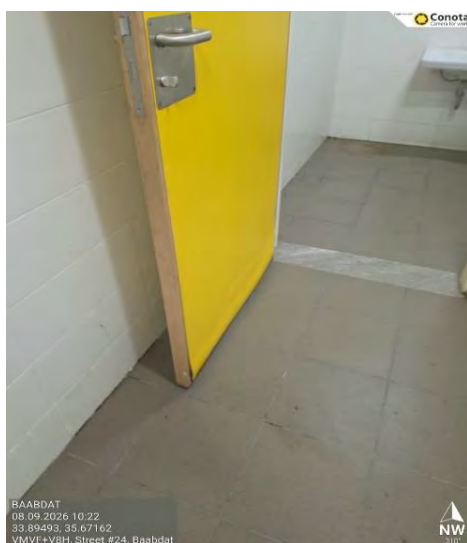
**Figure 8 - Damaged handicap toilet door**

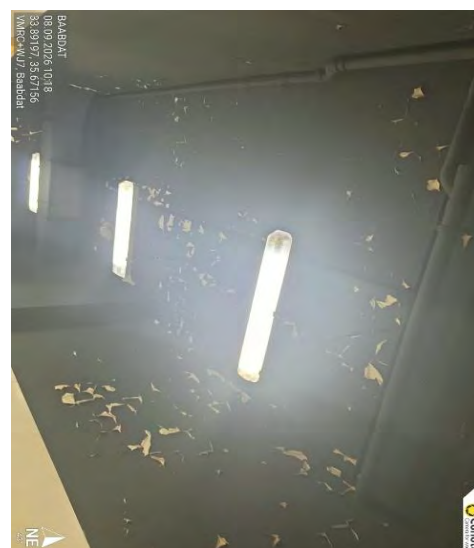
**Figure 9 - Damaged roof paint**

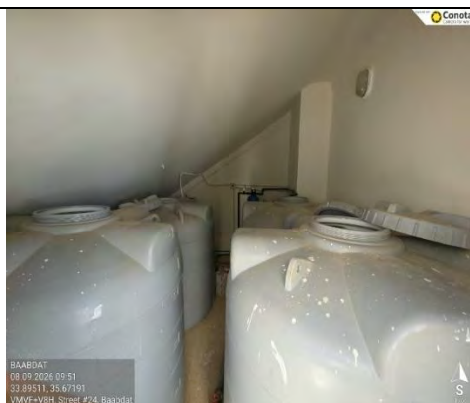
| Trade | Item | Damaged | Location, extent and quantity |
|---|---|---|---|
| | Water tanks and pumps | Yes | Need repair |

**Figure 10 - Water tanks**

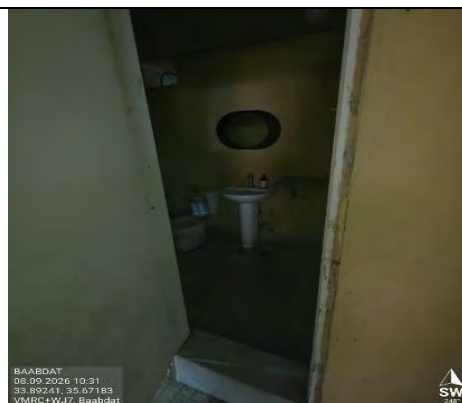
**Figure 11 - Damaged toilet**

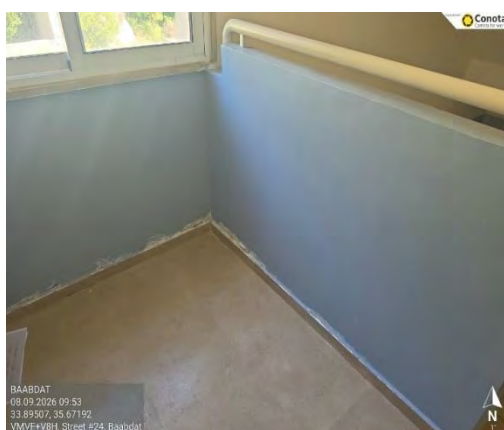
**Figure 12 - Damaged Staircase paint**

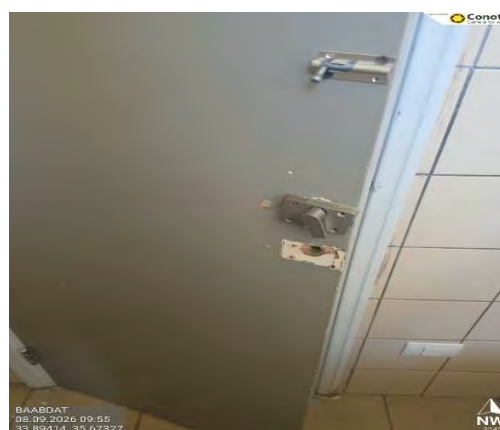
| Trade | Item | Damaged | Location, extent and quantity |
|---|---|---|---|
| | Door accessories and ironmongery | Yes | Several door accessories and ironmongery need fixation and repair. |

**Figure 13 - Damaged Door handle**

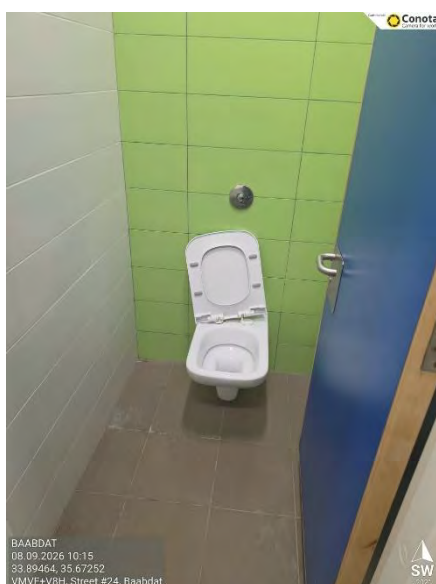
| Trade | Item | Damaged | Location, extent and quantity |
|---|---|---|---|
| | Toilet finishing | Yes | Several toilets have missing or damaged accessories |

**Figure 14 - Damaged toilet accessories**

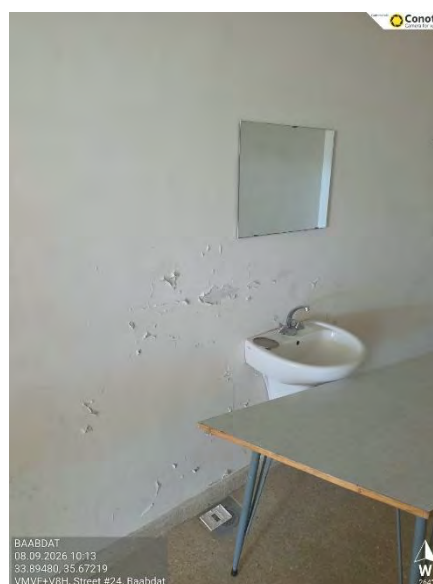
**Figure 15 - Damaged wall paint**

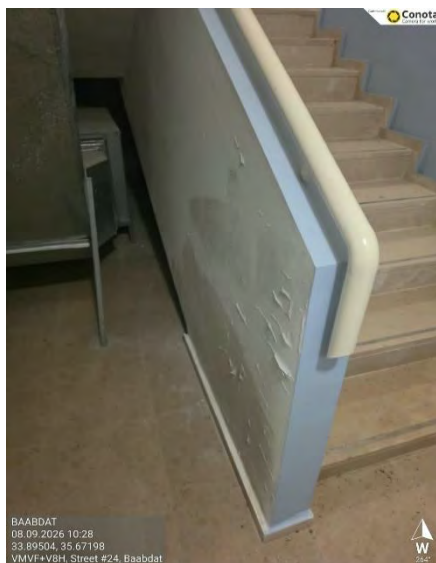
**Figure 16 - Damaged staircase paint**

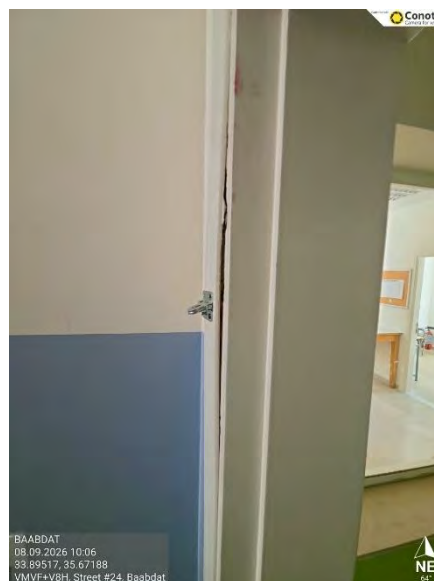
| Trade | Item | Damaged | Location, extent and quantity |
|---|---|---|---|
| Doors | Timber doors | Yes | Several Timber Doors need repairing |

**Figure 17 - Damaged timber door**

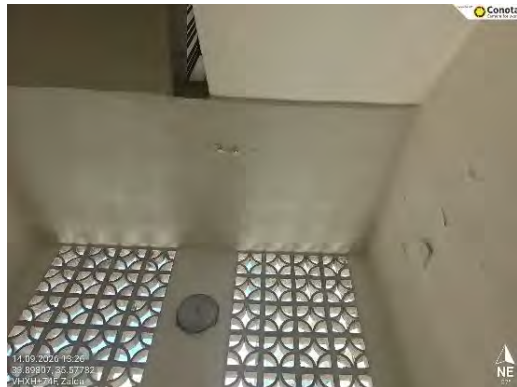
**Figure 4- Damaged staircase paint**

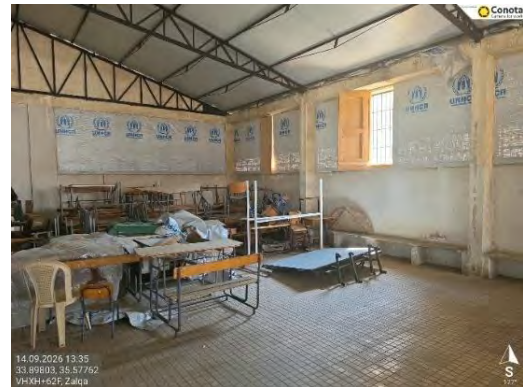
**Figure 5- Broken Windows**

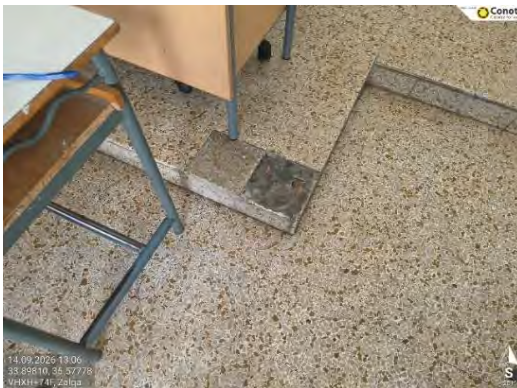
| Trade | Item | Damaged | Location, extent and quantity |
|---|---|---|---|
| | Floor tiles | Yes | Minor repairs are required in several rooms.<br>Total area around: 35m <sup>2</sup> |

**Figure 6- Damaged Tiles**

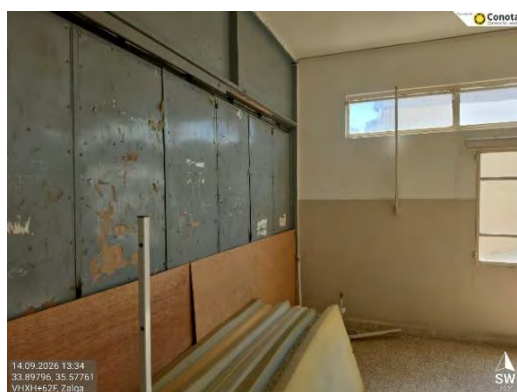
**Figure 8- Damaged walls**

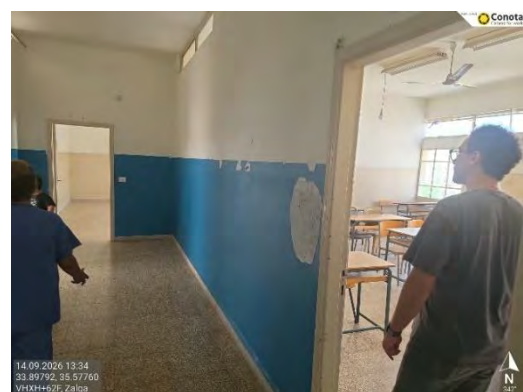
**Figure 9- Damaged walls paints**

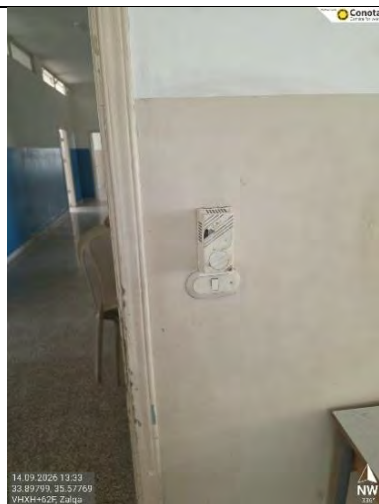
**Figure 10- Broken Switches**

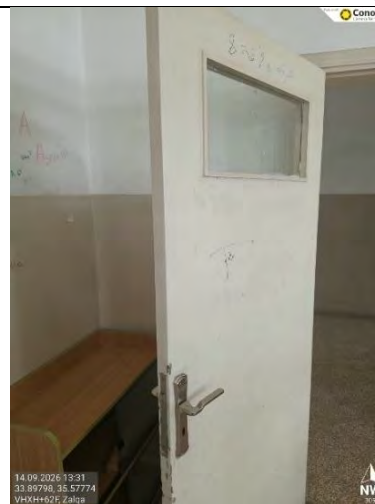
| Trade | Item | Damaged | Location, extent and quantity |
|---|---|---|---|
| | Door accessories and ironmongery | Yes | All door accessories and ironmongery need fixing and repair |

**Figure 11- Damaged door accessories**

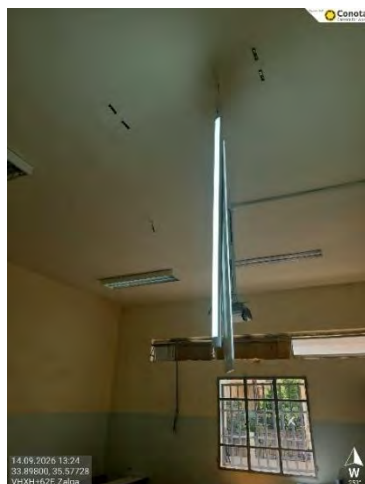
**Figure 12- Broken lamps support**

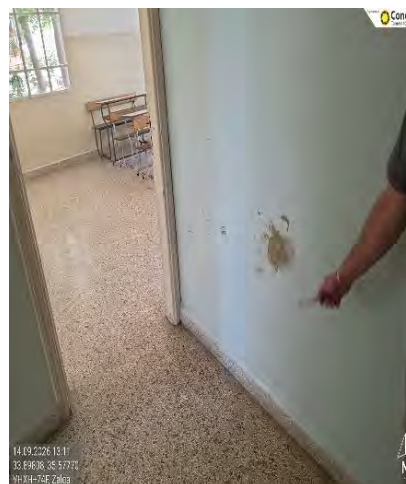
**Figure 13- Damaged wall plaster**

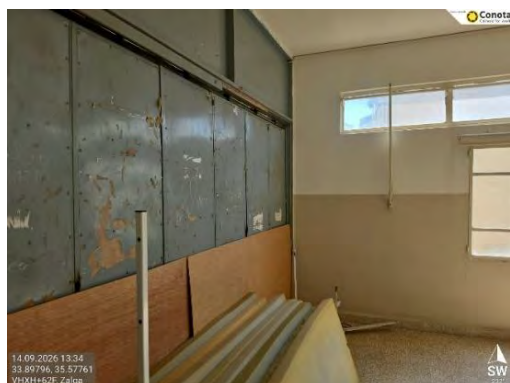
**Figure 4- Damaged wall**

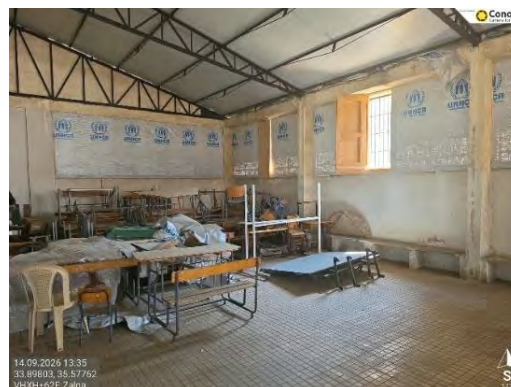
**Figure 5- Broken windows**

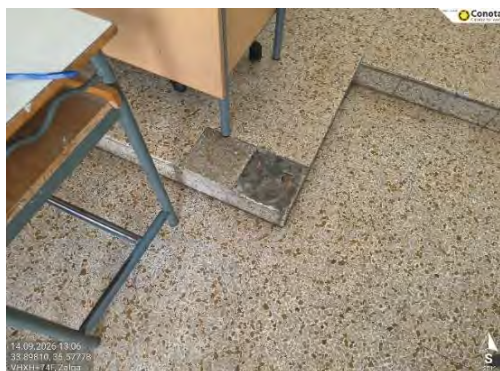
| Trade | Item | Damaged | Location, extent and quantity |
|---|---|---|---|
| | Floor tiles | Yes | Minor repairs are required in several rooms.<br>Total area around: 35m <sup>2</sup> |

**Figure 6- Damaged tiles**

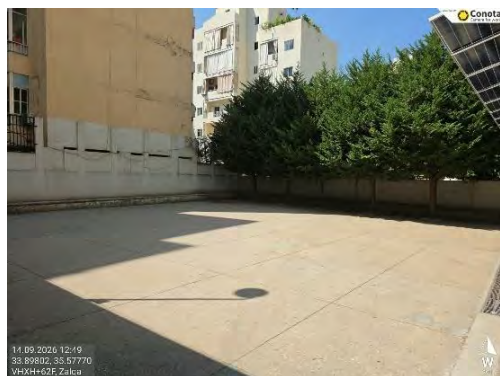
**Figure 8- Damaged paint facade**

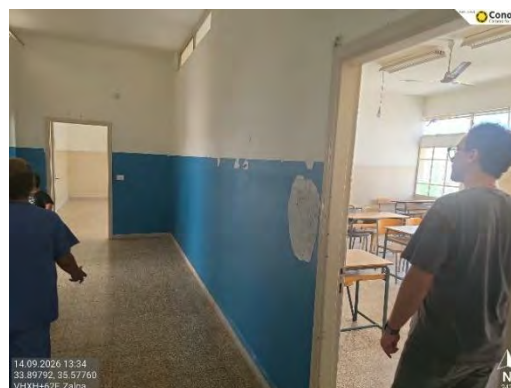
**Figure 9- Damaged walls paints**

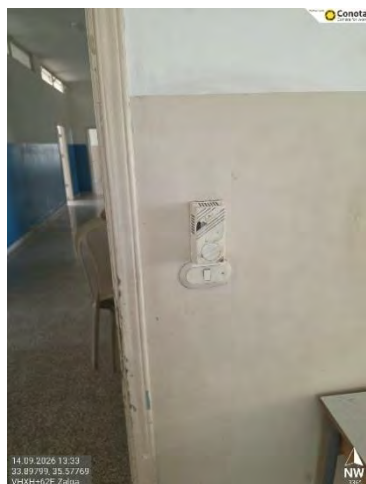
**Figure 10- Broken switches**

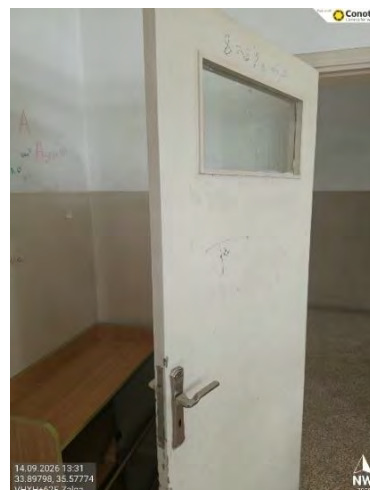
| Trade | Item | Damaged | Location, extent and quantity |
|---|---|---|---|
| | Door accessories and ironmongery | Yes | All door accessories and ironmongery need fixing and repair |

**Figure 11- Damaged door accessories**

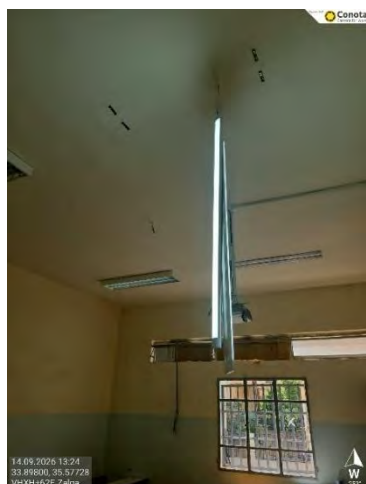
**Figure 12- Broken lamps support**

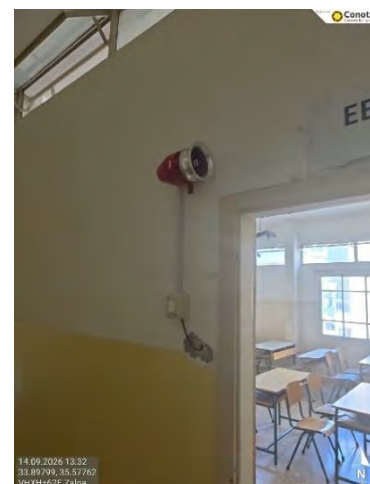
**Figure 13- Damaged wall Plaster**

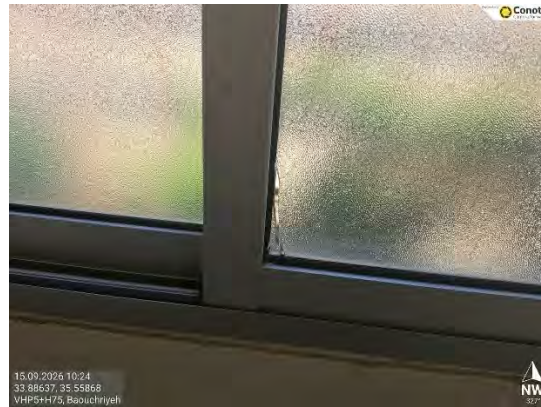
**Figure 5 - Damaged Aluminum Glazing**

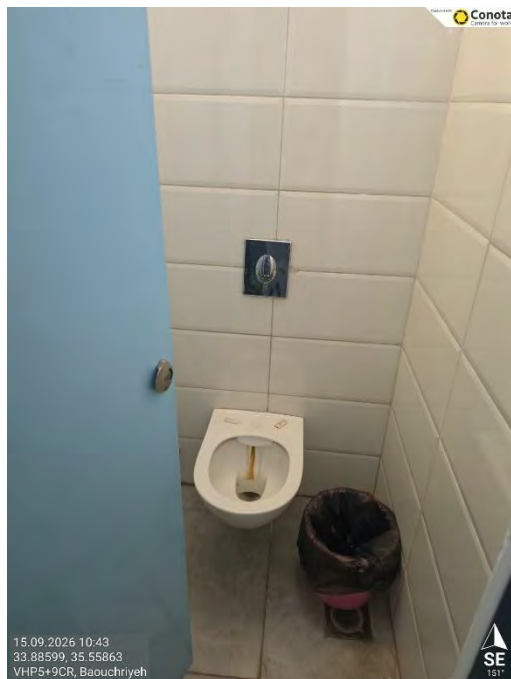
| Trade | Item | Damaged | Location, extent and quantity |
|---|---|---|---|
| | Toilet finishing | Yes | Some toilets are missing accessories |

**Figure 6 - Damaged toilet accessories**

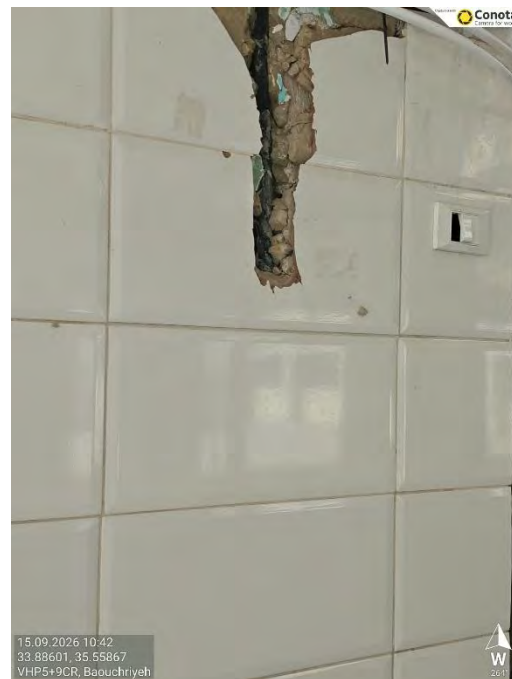
**Figure 7 - Damaged wall tiles**

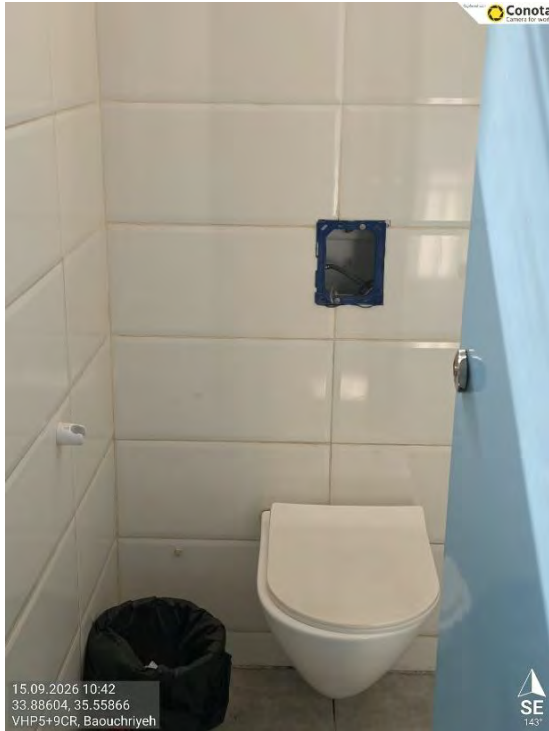
**Figure 8 - Damaged toilet accessories**

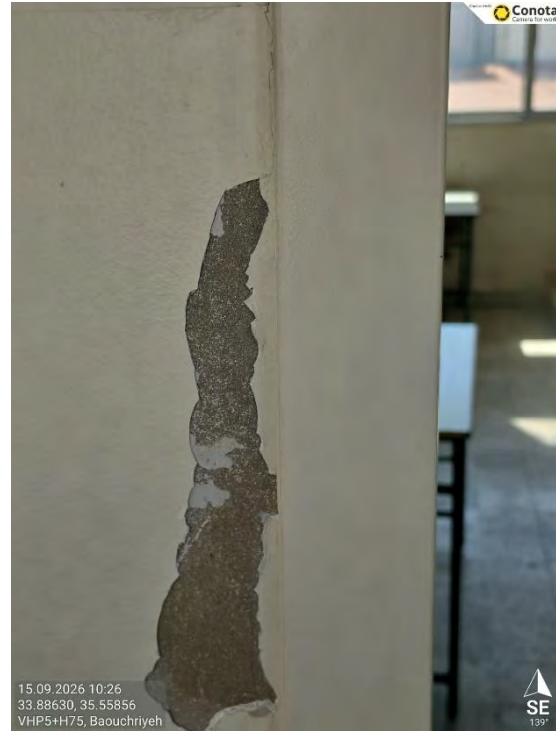
**Figure 9 - Damaged wall paint**

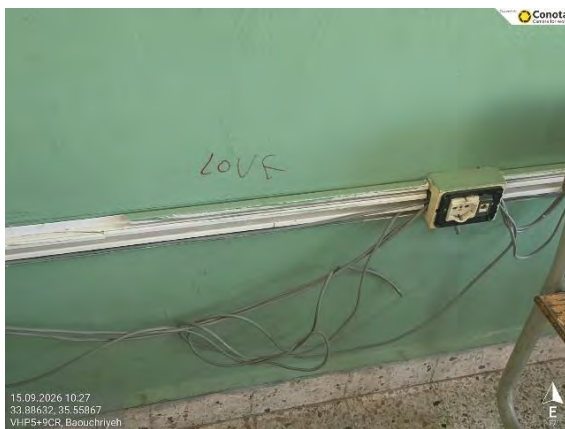
**Figure 10 - Damaged electrical routing**

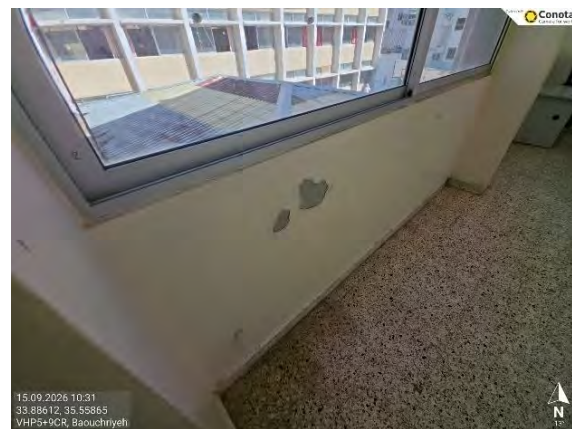
**Figure 11 - Damaged wall paint**

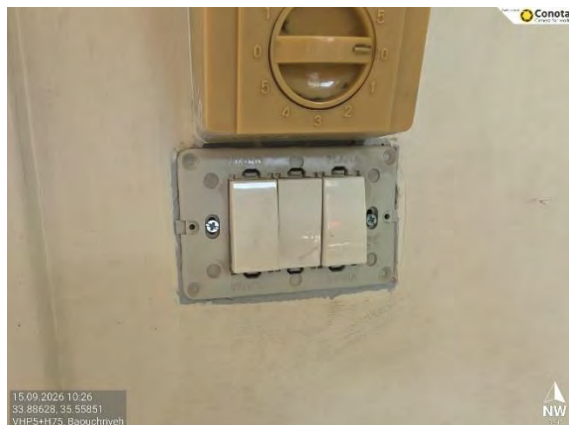
***Figure 12 - Damaged switch***

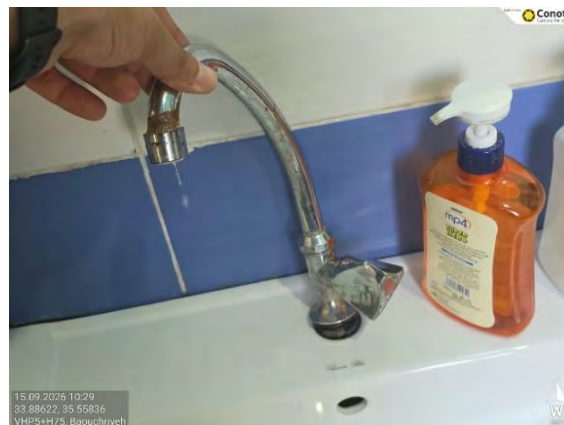
| Trade | Item | Damaged | Location, extent and quantity |
|---|---|---|---|
| Sanitary and plumbing | Wash basins | Yes | Minor repairs are required in several toilets |

***Figure 13 - Damaged wash basin accessories***

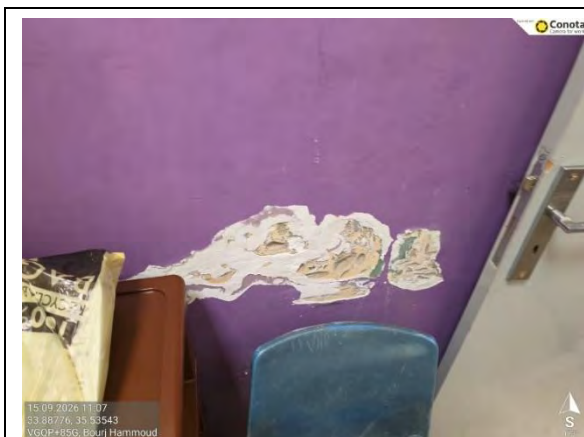
**Figure 4 – Damaged wall plastering**

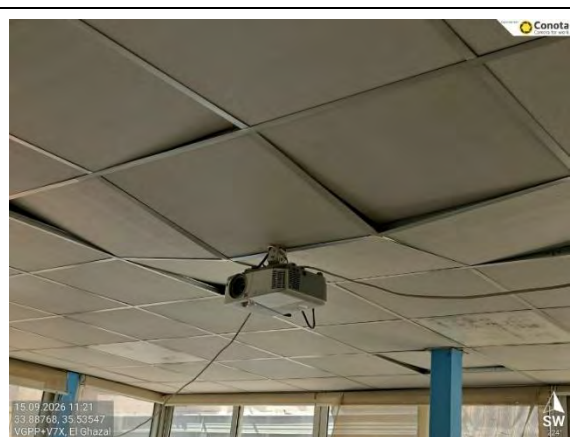
**Figure 5 - Damaged false ceiling**

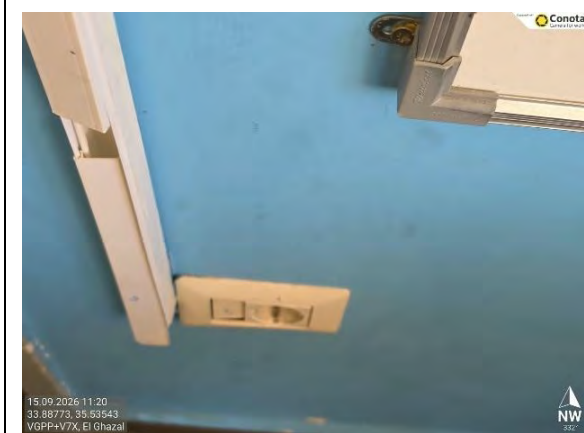
| Trade | Item | Damaged | Location, extent and quantity |
|---|---|---|---|
| Electrical | Sockets and switches | Yes | Several missing sockets and switches |

**Figure 6 – Broken electrical sockets**

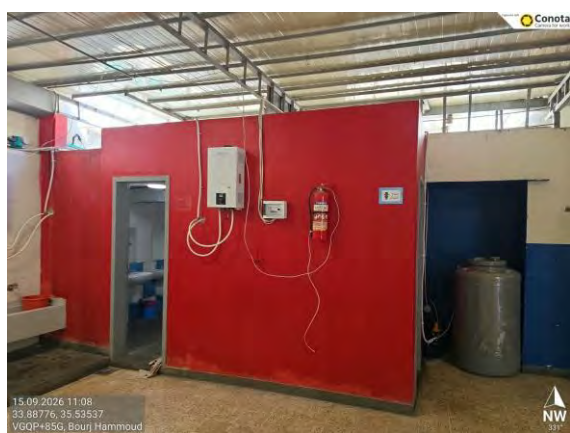
**Figure 7 - Electrical cables in bad condition**

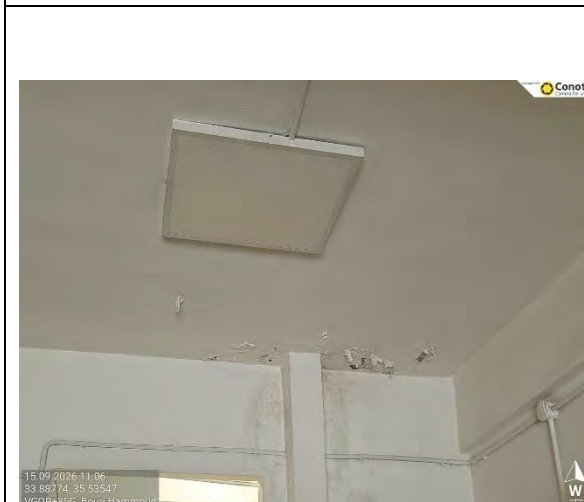
**Figure 8- Damaged wall paint**

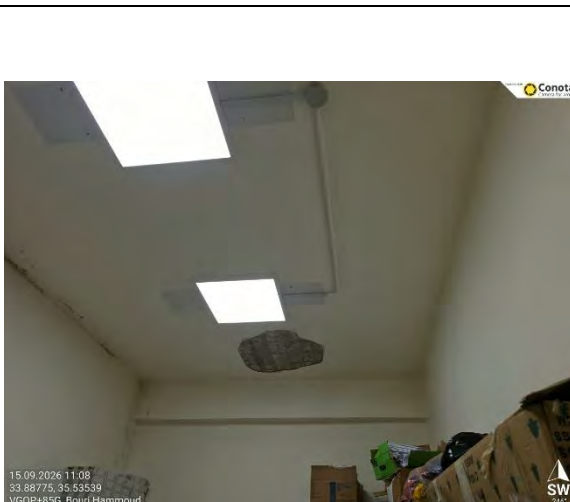
**Figure 9- Damaged roof plastering**

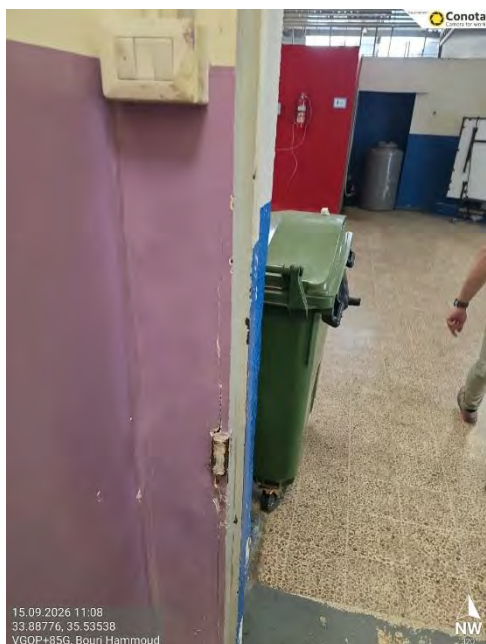
| Trade | Item | Damaged | Location, extent and quantity |
|---|---|---|---|
| | Door accessories and ironmongery | Yes | All door accessories and ironmongery need fixing and repair, and some accessories are missing |

**Figure 10- Damaged door accessories**

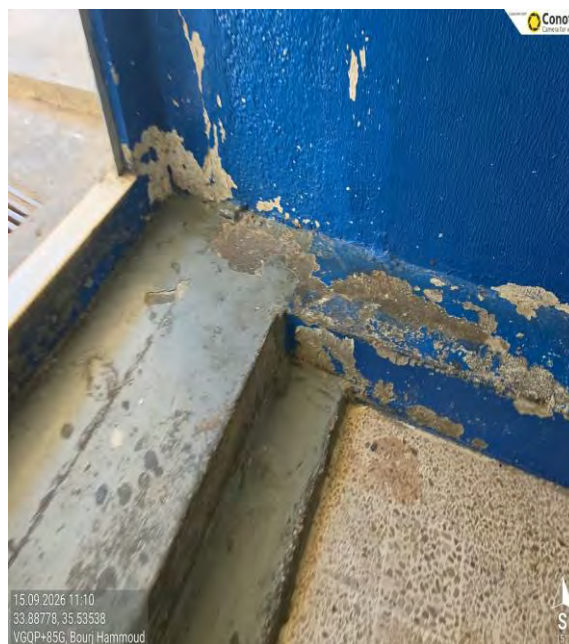
**Figure 11- Wall stairs in bad condition**

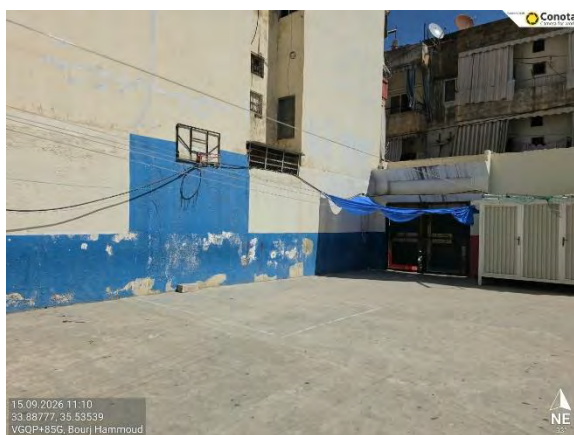
**Figure 12- Damaged paint in the playground wall**

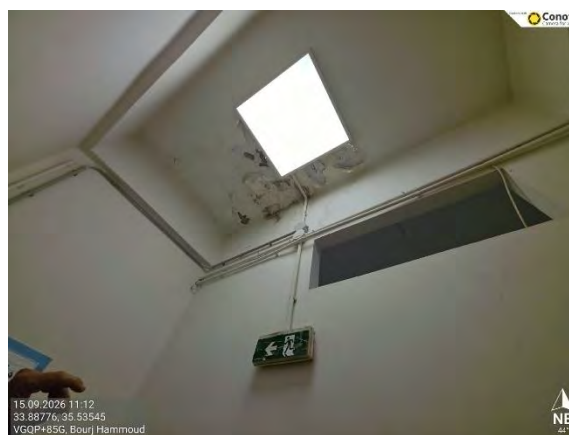
**Figure 13- Water leakage**

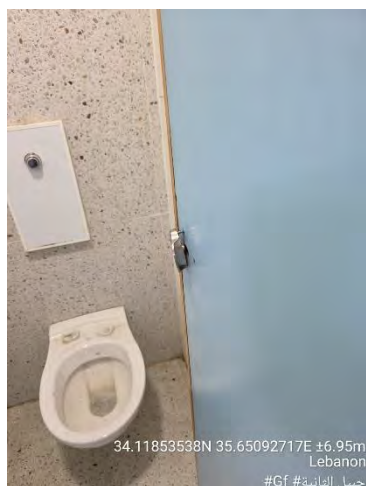
**Figure 8 - Damaged door handle**

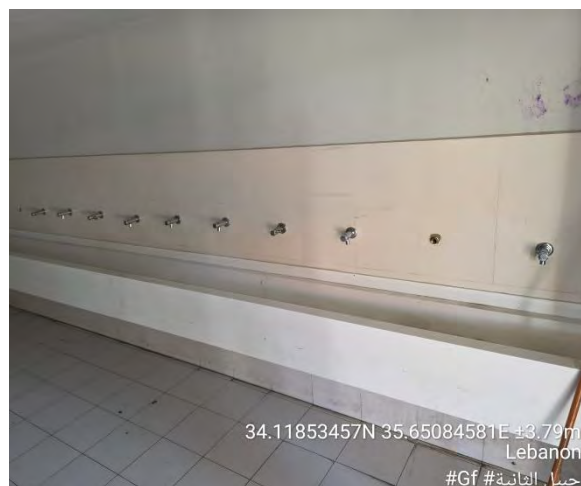
**Figure 9 - Water taps not available**

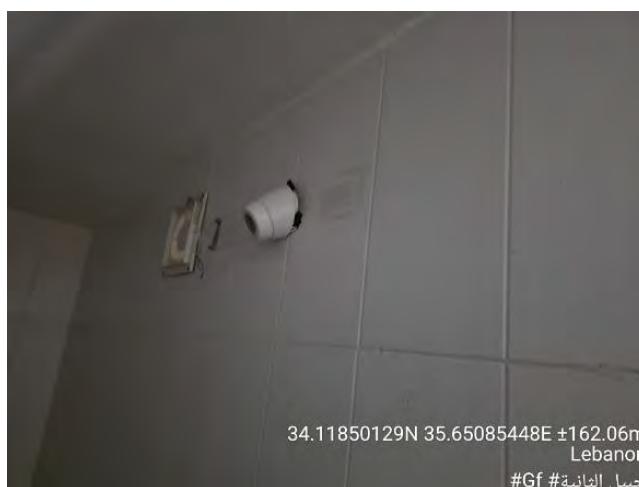
**Figure 10- Broken light fixtures**

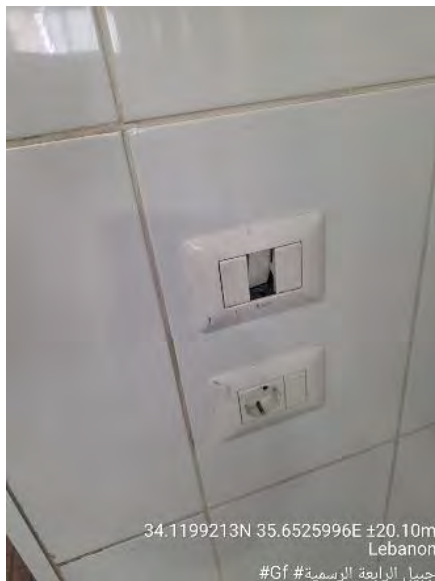
**Figure 7- Damaged Switches and Socket**

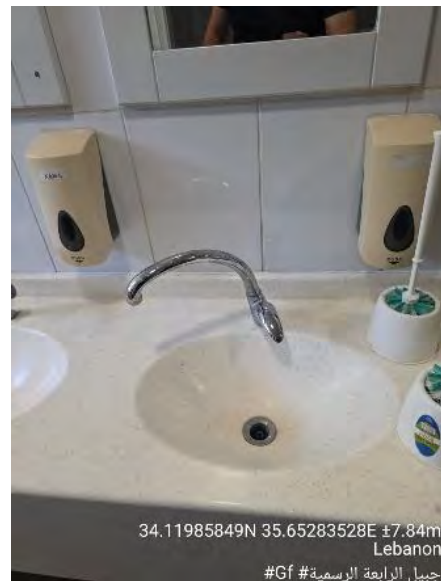
**Figure 8- Damaged Mixers**

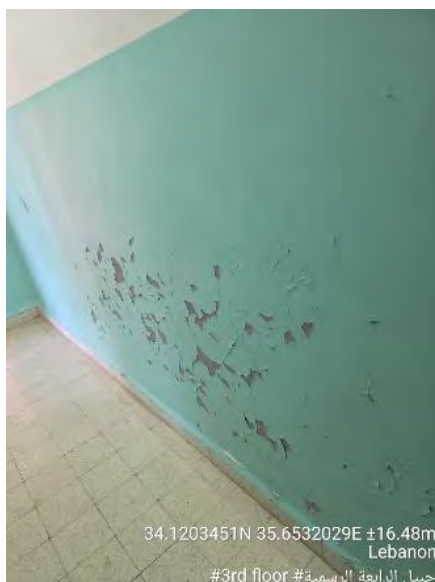
**Figure 9- Walls in bad conditions**

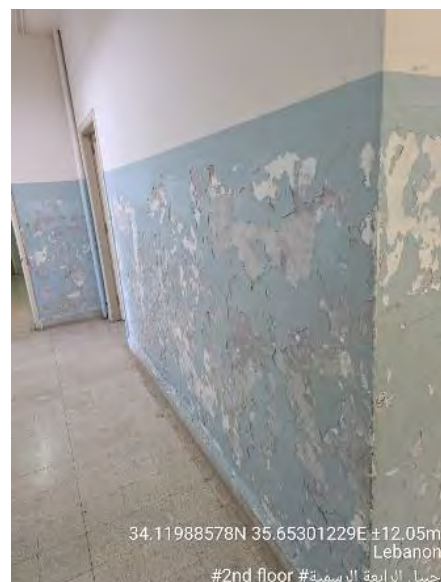
**Figure 10- Walls in bad conditions**

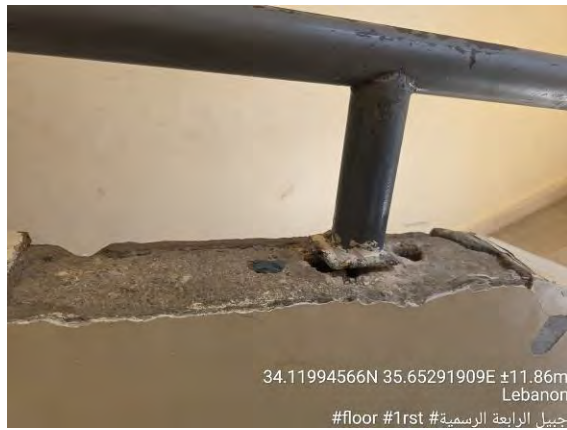
**Figure 11- Damaged Handrails**

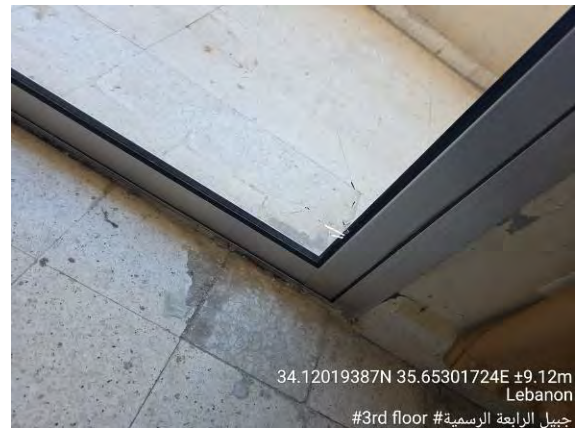
**Figure 12- Broken Glass**
