**CERD 721 - Kousba Mixed Public School**

Lebanon Emergency Assistance Project (LEAP)

## Detailed Assessment and Verification Report

Tender Preparation and Construction Supervision Consultant for Shelters.  
Lebanon Emergency Assistance Project (LEAP)

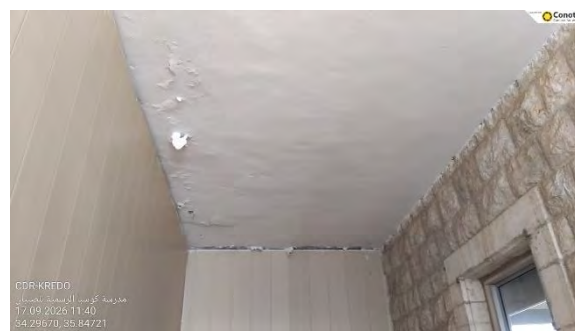
**Figure 6 - Humidity in Ceiling**

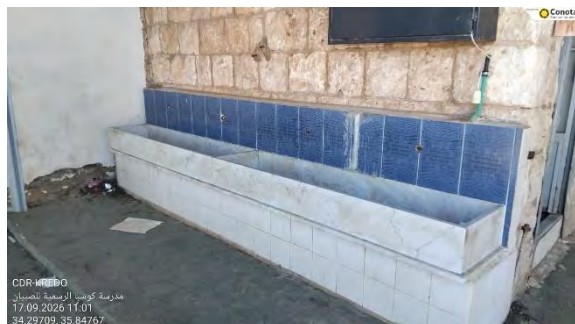
**Figure 14 - Missing Drinking Taps**

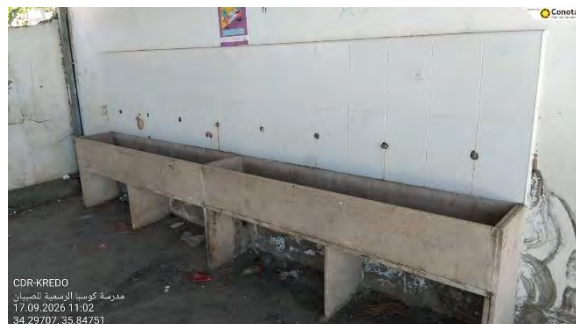
**Figure 15 - Missing Drinking Taps**

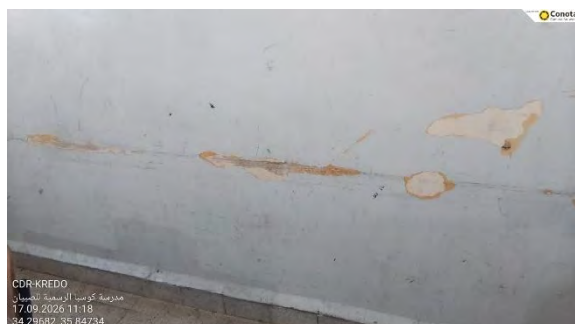
**Figure 18 - Damaged Wall Paint**

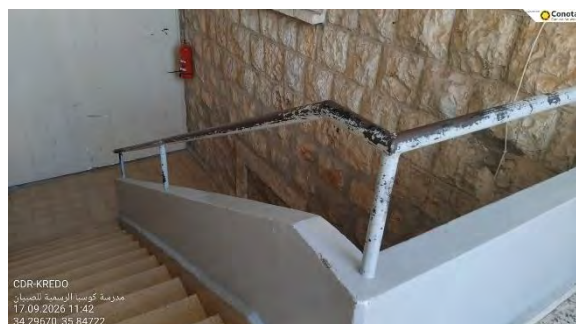
**Figure 19 - Damaged Handrail Paint**

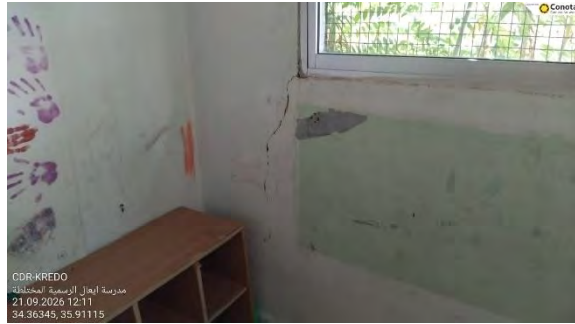
**Figure 10 - Crack in wall**

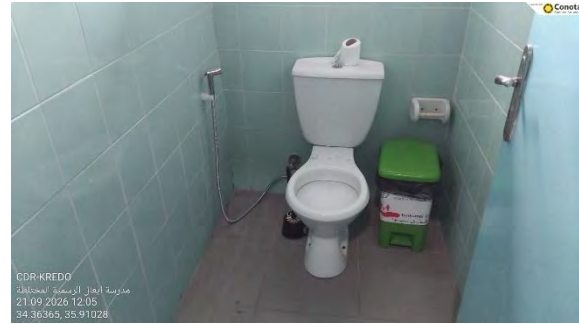
**Figure 11 - Missing Toilet Seat Cover**

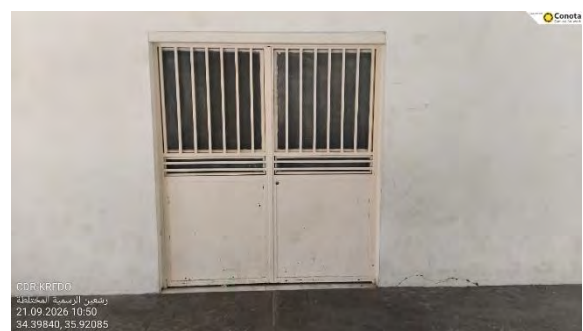
**Figure 7 - Damaged Steel Door Paint**

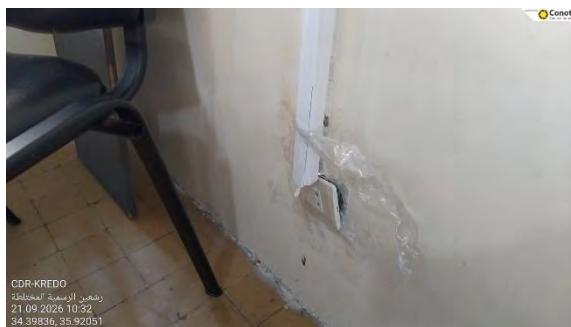
**Figure 12 - Damaged Electrical Socket**

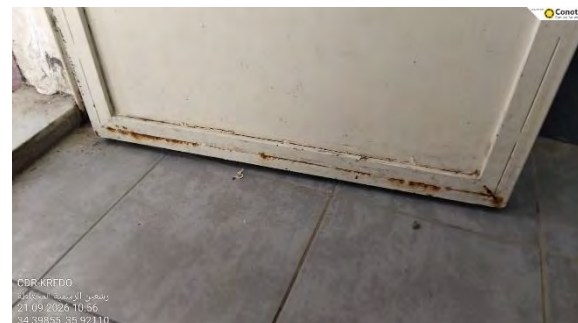
**Figure 15 - Rusty Steel Door**

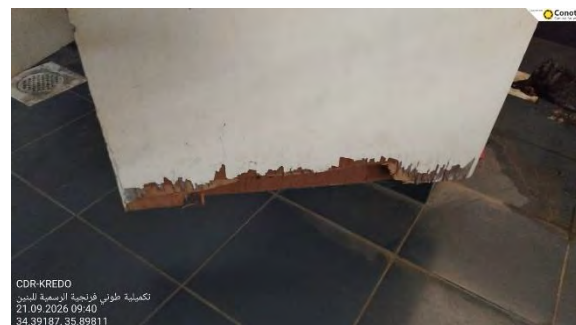
**Figure 8 - Damaged Toilet Door**

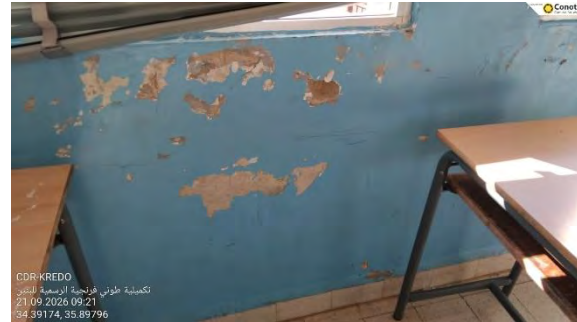
**Figure 13 - Damaged Wall Paint**

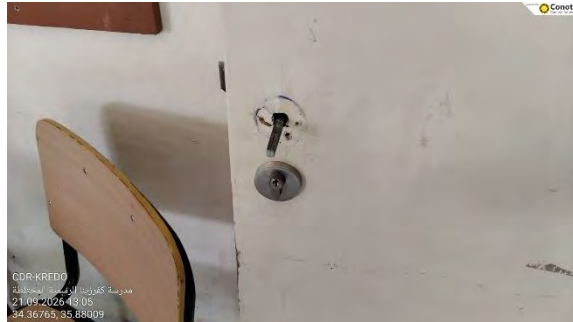
**Figure 12 - Missing Door Handle**

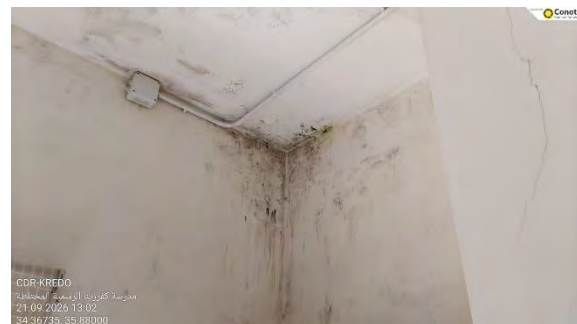
**Figure 15 - Humidity in Wall**

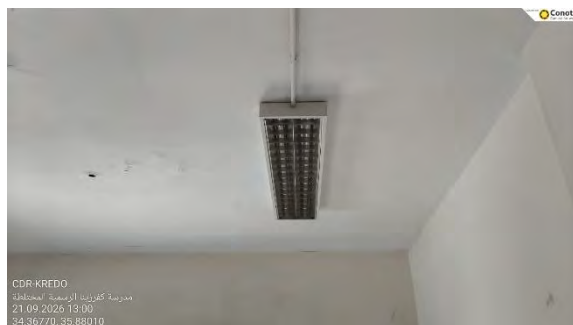
**Figure 16 - Damaged Lighting fixture**

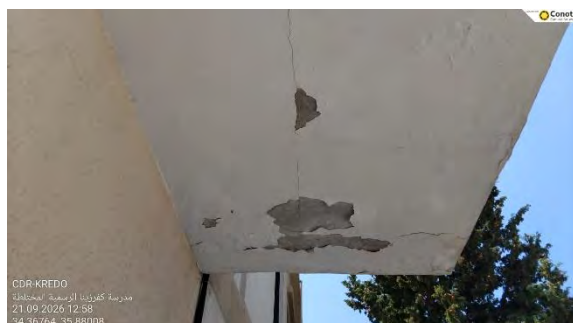
**Figure 18 - Damaged Balcony Roof**

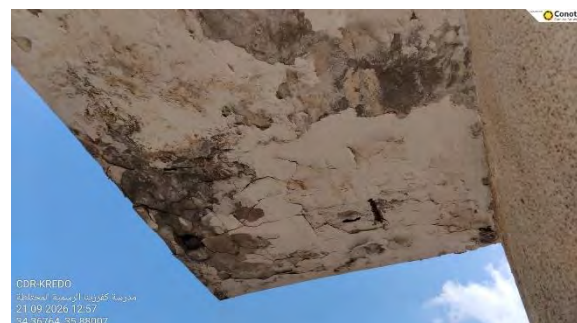
**Figure 19 - Spalled Concrete with Exposed Reinforcement**

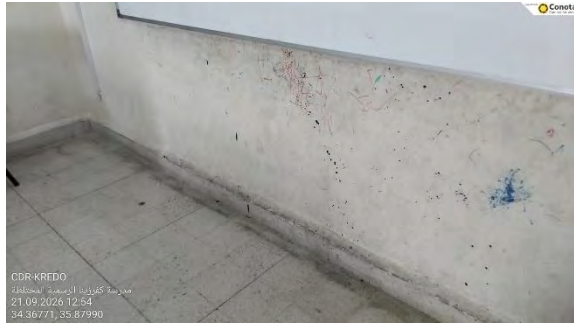
**Figure 20 - Damaged Wall Paint**

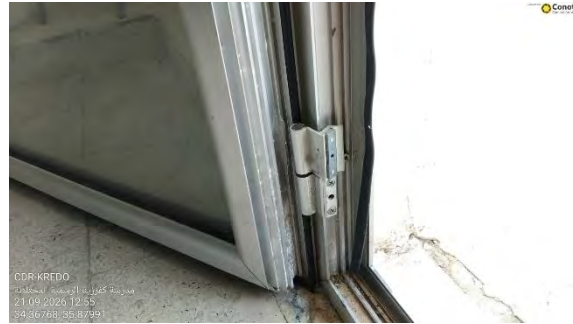
**Figure 21 - Damaged Aluminum Door Accessories**
