**Lebanese Emergency Assistant Project (LEAP)**  
**Rehabilitation of Shelters (Public Schools)**

**Batch 3: Lot 1**

**in Caza of Baalbek**

**DETAILED ASSESSMENT REPORT**

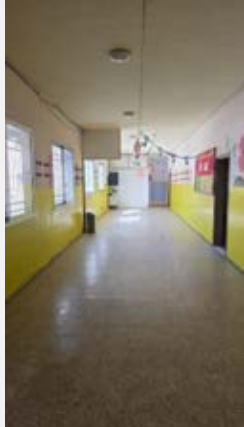
| Floor | Room / Area | Defect Description / Required Works | Qty | Unit | BOQ | Photo |
|---|---|---|---|---|---|---|
| 1st | Coridor (70x 4m + 30x 4m) | Paint | 700 | m2 | 9.5.1 | |

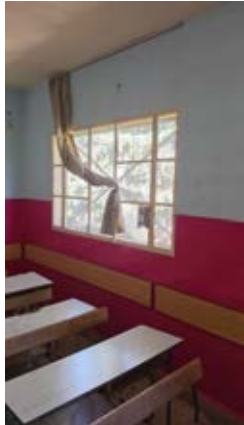
| Floor | Room / Area | Defect Description / Required Works | Qty | Unit | BOQ | Photo |
|---|---|---|---|---|---|---|
| 2nd | 8-11-15- | Window Glass<br>(x1 in each class) | 3 | pcs | 5.2 | |

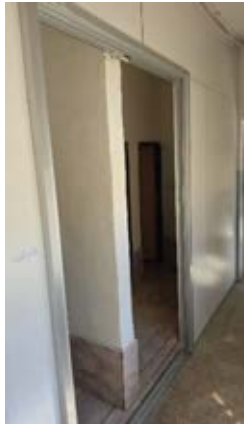
| Floor | Room / Area | Defect Description / Required Works | Qty | Unit | BOQ | Photo |
|---|---|---|---|---|---|---|
| 2nd | Toilets | Install aluminum doors | 1 | pcs | <b>8.2.3</b> | |

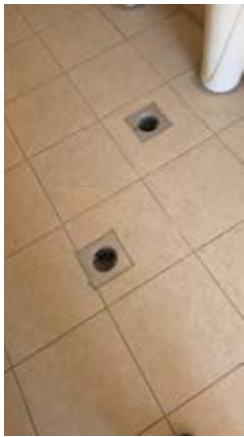
| Floor | Room / Area | Defect Description / Required Works | Qty | Unit | BOQ | Photo |
|---|---|---|---|---|---|---|
| 1st | Toilet- boys | Floor drain cover | 10 | pcs | 1.2.1 | |

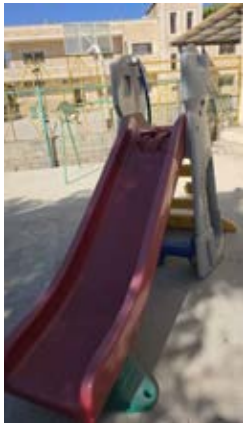
| Floor | Room / Area | Defect Description / Required Works | Qty | Unit | BOQ | Photo |
|---|---|---|---|---|---|---|
| 1st | Playground | Replace kids slider | 2 | pcs | <b>11.1</b> | |

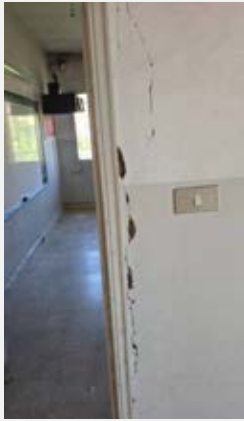
| Floor | Room / Area | Defect Description / Required Works | Qty | Unit | BOQ | Photo |
|---|---|---|---|---|---|---|
| 2nd | 1 | Repair plaster around the door's frame | 1 | pcs | 9.1.2 | |

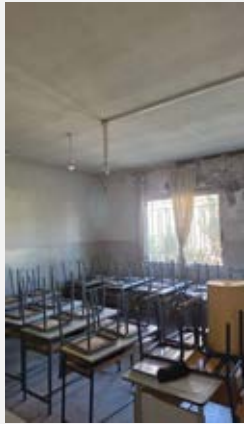
| Floor | Room / Area | Defect Description / Required Works | Qty | Unit | BOQ | Photo |
|---|---|---|---|---|---|---|
| 2nd | 1-2-3-4-5-6-7-8-9-10-11-12-13 | Paint wooden door<br>(x13 doors: x1 in each class) | 52 | m2 | <b>8.1.3</b> | |

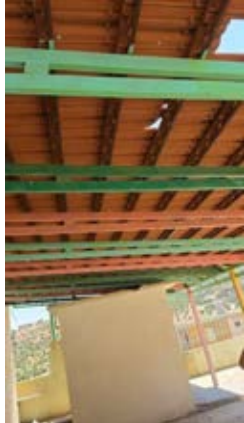
| Floor | Room / Area | Defect Description / Required Works | Qty | Unit | BOQ | Photo |
|---|---|---|---|---|---|---|
| Exterior | Playground roof | Clay Tile Roof | 80 | m2 | 5.4 | |

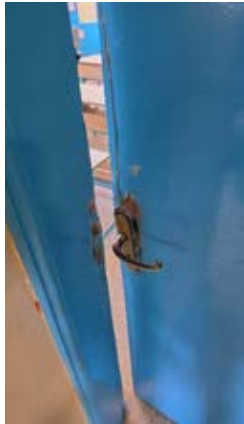
| Floor | Room / Area | Defect Description / Required Works | Qty | Unit | BOQ | Photo |
|---|---|---|---|---|---|---|
| 1st | 2 | New wooden door | 1 | pcs | <b>8.1.1</b> | |

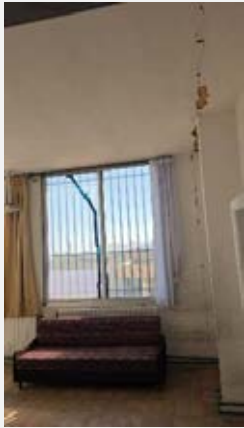
| Floor | Room / Area | Defect Description / Required Works | Qty | Unit | BOQ | Photo |
|---|---|---|---|---|---|---|
| 2nd | 2 | Plaster | 10 | m2 | 9.1.2 | |

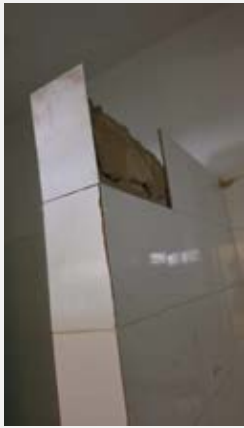
| Floor | Room / Area | Defect Description / Required Works | Qty | Unit | BOQ | Photo |
|---|---|---|---|---|---|---|
| 3rd | Toilets-girls | Repair Ceramic Tiles | | LS | 9.2.4 | |

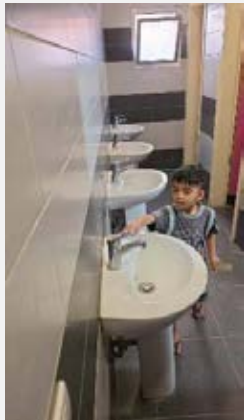
| Floor | Room / Area | Defect Description / Required Works | Qty | Unit | BOQ | Photo |
|---|---|---|---|---|---|---|
| 2nd | Toilets-2 | Faucets | 4 | pcs | 5.6 | |

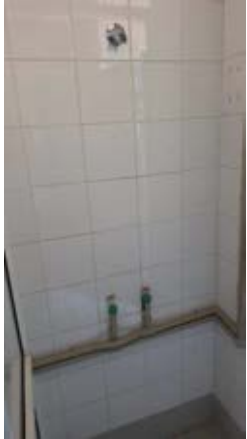
| Floor | Room / Area | Defect Description / Required Works | Qty | Unit | BOQ | Photo |
|---|---|---|---|---|---|---|
| 1st | Toilets-boys<br>Toilets-girls | Mixer tap<br>(x1 in each toilet) | 2 | pcs | 5.7 | |

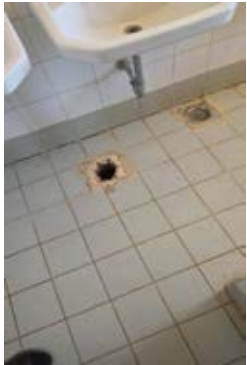
| Floor | Room / Area | Defect Description / Required Works | Qty | Unit | BOQ | Photo |
|---|---|---|---|---|---|---|
| 3rd | Toilets | Install new floor drain cover | 1 | pcs | 2.2 | |

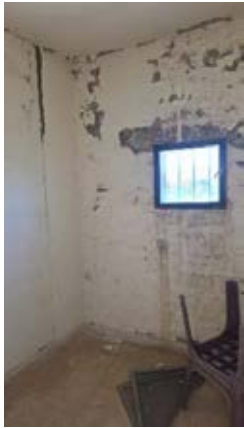
| Floor | Room / Area | Defect Description / Required Works | Qty | Unit | BOQ | Photo |
|---|---|---|---|---|---|---|
| 3rd | Toilets (3 x3m) | Paint walls | 36 | m2 | 9.5.1 | |

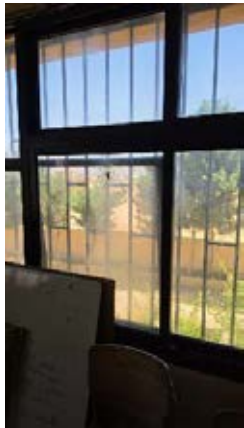
| Floor | Room / Area | Defect Description / Required Works | Qty | Unit | BOQ | Photo |
|---|---|---|---|---|---|---|
| 2nd | 1-2-4-5-6-7-8-9-10 | Repair windows | 40 | pcs | 8.2.3 | |

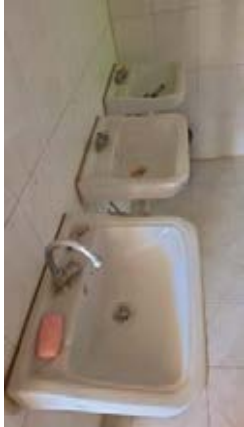
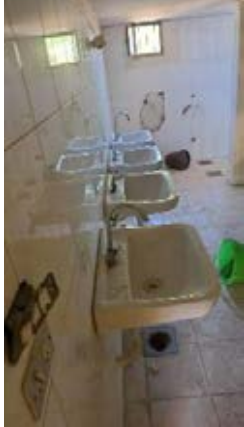
| Floor | Room / Area | Defect Description / Required Works | Qty | Unit | BOQ | Photo |
|---|---|---|---|---|---|---|
| 1st | Toilets-boys<br>Toilets-girls | Mixer tap<br>(x4 in boys toilet<br>x5 in girls toilet) | 9 | pcs | 5.6 | <br> |

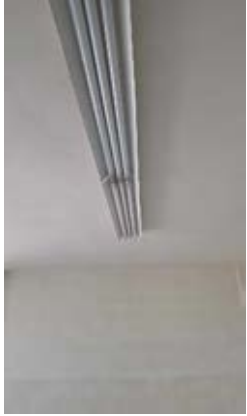
| Floor | Room / Area | Defect Description / Required Works | Qty | Unit | BOQ | Photo |
|---|---|---|---|---|---|---|
| 2nd | 1-2-3-4-5-6-7-8-9-10 | Neon Lights<br>(x18 in class 1<br>x12 in each of the other classes) | 126 | pcs | <b>1.1.1</b> | |

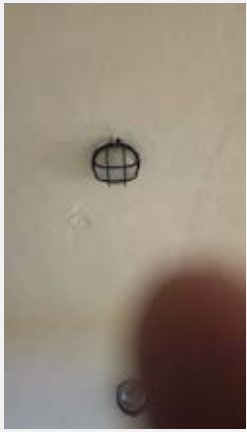
| Floor | Room / Area | Defect Description / Required Works | Qty | Unit | BOQ | Photo |
|---|---|---|---|---|---|---|
| 2nd | Coridor | New lamps | 14 | pcs | <b>1.1.1</b> | |

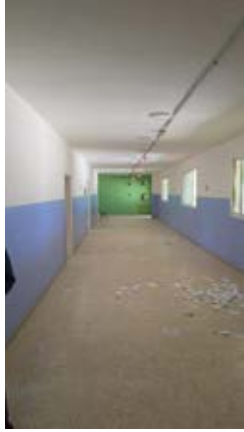
| Floor | Room / Area | Defect Description / Required Works | Qty | Unit | BOQ | Photo |
|---|---|---|---|---|---|---|
| 2nd | coridor (25x 3m) | Paint walls of coridor | 168 | m2 | 9.5.1 | |

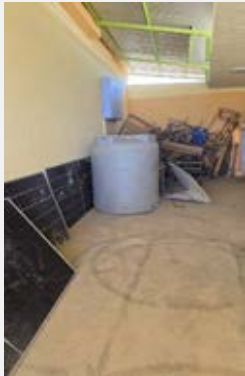
| Floor | Room / Area | Defect Description / Required Works | Qty | Unit | BOQ | Photo |
|---|---|---|---|---|---|---|
| Roof | | Water storage tank | 4 | pcs | 3.1 | |

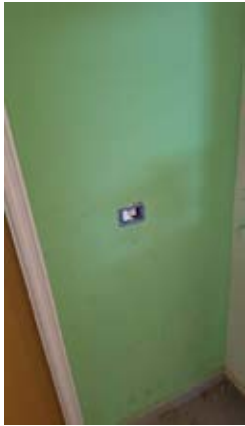
| Floor | Room / Area | Defect Description / Required Works | Qty | Unit | BOQ | Photo |
|---|---|---|---|---|---|---|
| 1st | | Electrical outlet | 2 | pcs | <b>1.1.3</b> | |

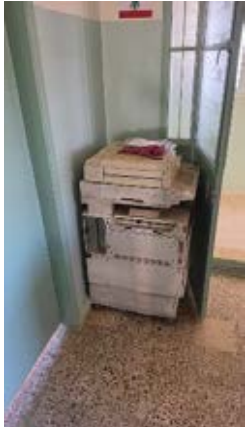
| Floor | Room / Area | Defect Description / Required Works | Qty | Unit | BOQ | Photo |
|---|---|---|---|---|---|---|
| 1st | Printing room | Provide a new paper printer | 1 | pcs | <b>12.1.3</b> | |

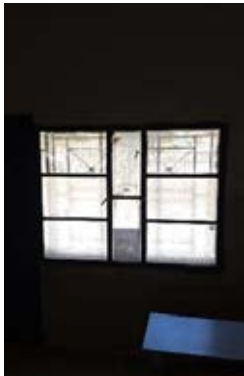
| Floor | Room / Area | Defect Description / Required Works | Qty | Unit | BOQ | Photo |
|---|---|---|---|---|---|---|
| 1st | 1 | Glass for windows | 1 | pcs | 5.2 | |

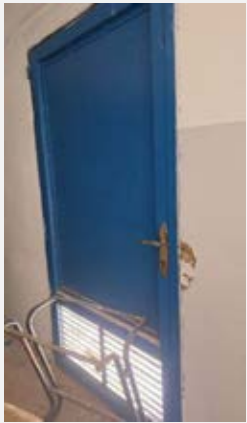
| Floor | Room / Area | Defect Description / Required Works | Qty | Unit | BOQ | Photo |
|---|---|---|---|---|---|---|
| 3rd | | Repair metal door | 1 | pcs | 5.2 | |

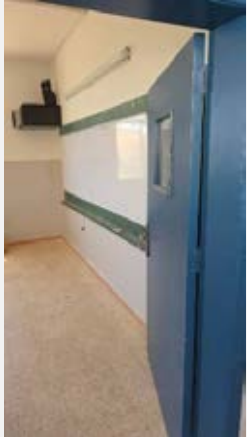
| Floor | Room / Area | Defect Description / Required Works | Qty | Unit | BOQ | Photo |
|---|---|---|---|---|---|---|
| 2nd | 1-2-3- | Paint wooden door | 12 | m2 | 8.1.3 | |

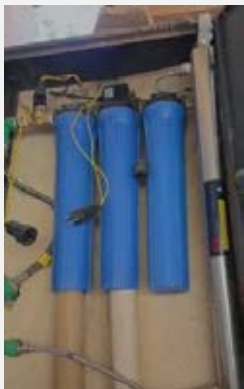
| Floor | Room / Area | Defect Description / Required Works | Qty | Unit | BOQ | Photo |
|---|---|---|---|---|---|---|
| Water Filters | | Maintenance of water filters | | LS | <b>1.2.1</b> | |

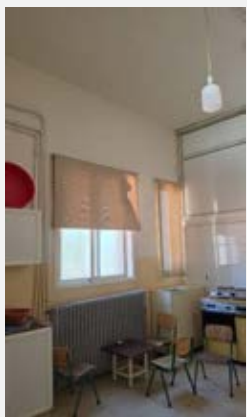
| Floor | Room / Area | Defect Description / Required Works | Qty | Unit | BOQ | Photo |
|---|---|---|---|---|---|---|
| 2nd | Kitchen | Paint | 70 | m2 | 9.5.1 | |

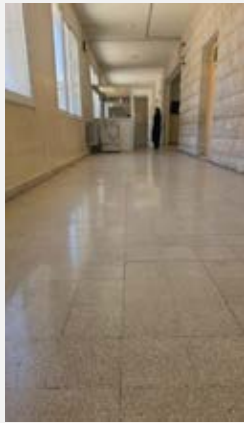
| Floor | Room / Area | Defect Description / Required Works | Qty | Unit | BOQ | Photo |
|---|---|---|---|---|---|---|
| 3rd | Coridor (2.5 ×50m) | Paint | 240 | m2 | 9.5.1 | |

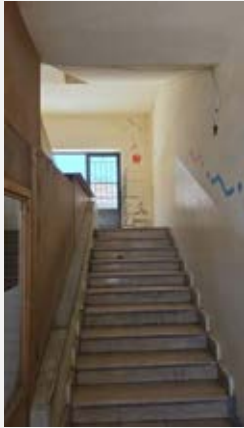
| Floor | Room / Area | Defect Description / Required Works | Qty | Unit | BOQ | Photo |
|---|---|---|---|---|---|---|
| All Floors<br>(1 to 3) | Staircase | Paint walls of staircase | 260 | m2 | 9.5.1 | |

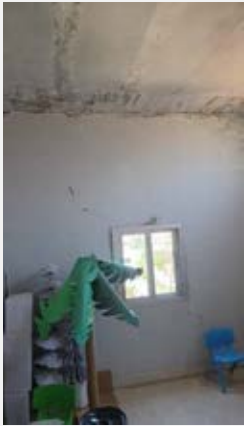
| Floor | Room / Area | Defect Description / Required Works | Qty | Unit | BOQ | Photo |
|---|---|---|---|---|---|---|
| 3rd | | Paint | 50 | m2 | 9.5.1 | |
