**CERD 174 - El Fidar Mixed Intermediate Public School**

Lebanon Emergency Assistance Project (LEAP)

## Detailed Assessment and Verification Report

Tender Preparation and Construction Supervision Consultant for Shelters.

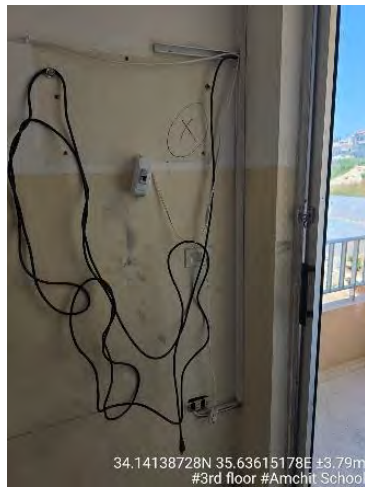
**Figure 5- Electrical wires to be properly installed**

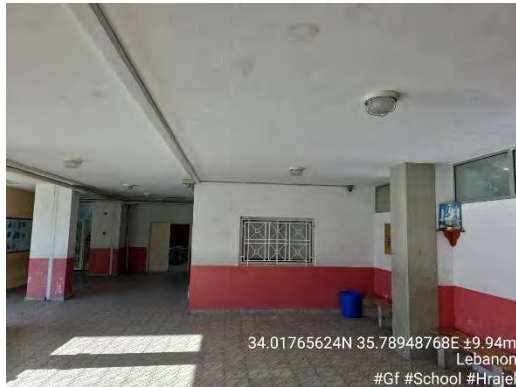
**Figure 6- Damaged Wall Paint**
