**Lebanese Emergency Assistant Project (LEAP)**  
**Rehabilitation of Shelters (Public Schools)**

**Batch 3: Lot 4**

**DETAILED ASSESSMENT REPORT**

**Detailed Site Assessment and Verification Report**

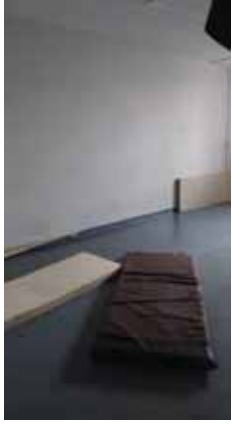
| Floor | Room / Area | Defect Description / Required Works | Qty | Unit | BOQ | Photo |
|---|---|---|---|---|---|---|
| | | Repair vinyl & skirting | 30 | m2 | 9.2.10 | — |

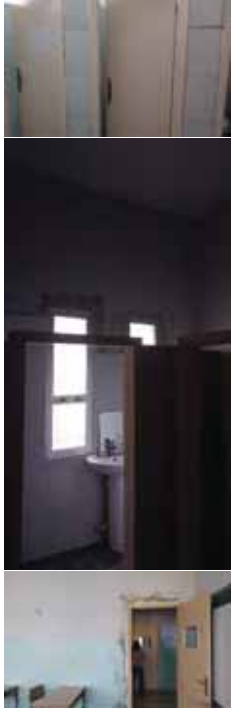
| Floor | Room / Area | Defect Description / Required Works | Qty | Unit | BOQ | Photo |
|---|---|---|---|---|---|---|
| 3d | 1 | Paint | 70 | m2 | 9.5.1 | |

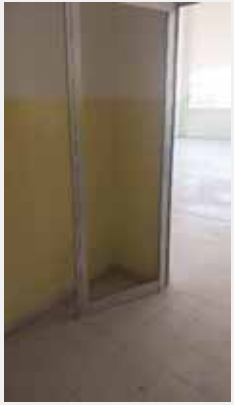
| Floor | Room / Area | Defect Description / Required Works | Qty | Unit | BOQ | Photo |
|---|---|---|---|---|---|---|
| 1st | coridor | Install glass for aluminum door | 1 | pcs | 8.2.3 | |

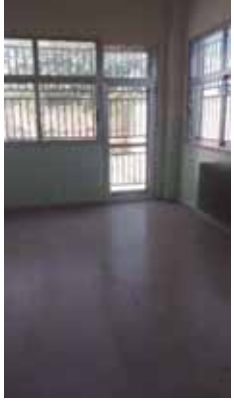
| Floor | Room / Area | Defect Description / Required Works | Qty | Unit | BOQ | Photo |
|---|---|---|---|---|---|---|
| 1st | coridor | Install handle for aluminum door (playground side) | 1 | pcs | 8.2.3 | |

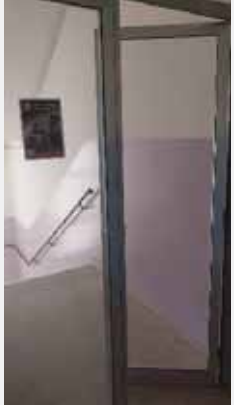
| Floor | Room / Area | Defect Description / Required Works | Qty | Unit | BOQ | Photo |
|---|---|---|---|---|---|---|
| 2nd | Coridor | Repair aluminum door | 1 | pcs | 8.2.3 | |

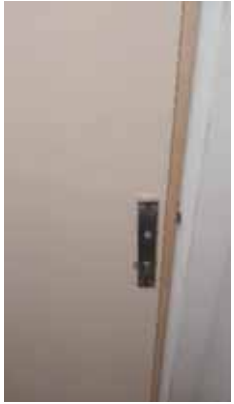
| Floor | Room / Area | Defect Description / Required Works | Qty | Unit | BOQ | Photo |
|---|---|---|---|---|---|---|
| 1st | Toilets | New handles for doors | 2 | pcs | 8.1.3 | |

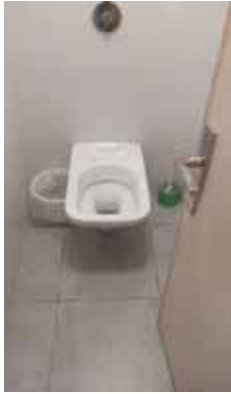
| Floor | Room / Area | Defect Description / Required Works | Qty | Unit | BOQ | Photo |
|---|---|---|---|---|---|---|
| 1st | Toilets | Supply & Install new toilet lids | 1 | pcs | 1.2.1 | |

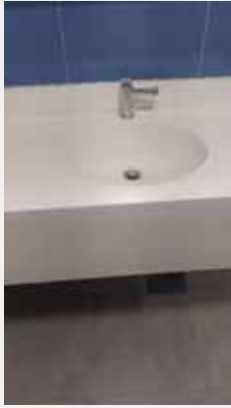
| Floor | Room / Area | Defect Description / Required Works | Qty | Unit | BOQ | Photo |
|---|---|---|---|---|---|---|
| 1st | Toilets | Supply & Install new faucets | 1 | pcs | 5.6 | |

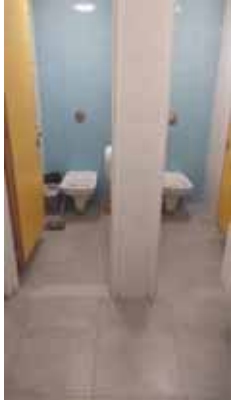
| Floor | Room / Area | Defect Description / Required Works | Qty | Unit | BOQ | Photo |
|---|---|---|---|---|---|---|
| 2nd | Toilets | Supply & Install new toilet lids<br>(x2 for the boys toilets and x1 for the girls toilet) | 3 | pcs | 1.2.1 | |

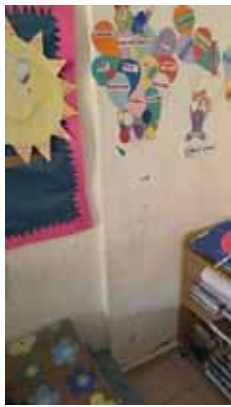
| Floor | Room / Area | Defect Description / Required Works | Qty | Unit | BOQ | Photo |
|---|---|---|---|---|---|---|
| 1st | 1-2-Toilets x2 -<br>3-4-5-6-corridor-<br>entrance-stairs<br>walls | Paint spray the walls & ceilings | 2150 | m2 | 9.5.1 | |

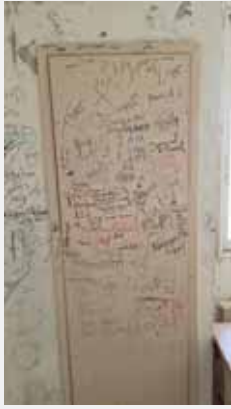
| Floor | Room / Area | Defect Description / Required Works | Qty | Unit | BOQ | Photo |
|---|---|---|---|---|---|---|
| 2nd | 2 | Paint Closet's door | 4 | m2 | <b>6.1.2</b> | |

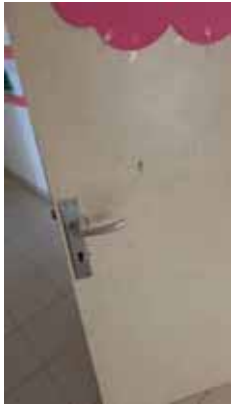
| Floor | Room / Area | Defect Description / Required Works | Qty | Unit | BOQ | Photo |
|---|---|---|---|---|---|---|
| 2nd | 5 | Change the door's lock | 1 | pcs | 8.1.3 | |

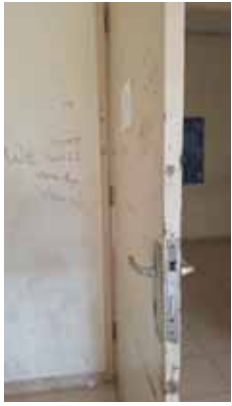
| Floor | Room / Area | Defect Description / Required Works | Qty | Unit | BOQ | Photo |
|---|---|---|---|---|---|---|
| 2nd | 11-14 | Fix the door's lock | 2 | pcs | 8.1.3 | |

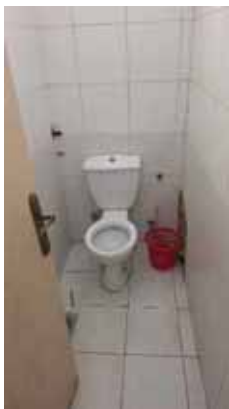
| Floor | Room / Area | Defect Description / Required Works | Qty | Unit | BOQ | Photo |
|---|---|---|---|---|---|---|
| 1st & 2nd | Toilet | Supply & Install new toilet lids<br><br>(x2 in girls toilet 1st floor - x1 in boys toilet 1st floor - x1 on 2nd floor) | 4 | pcs | 1.2.1 | |

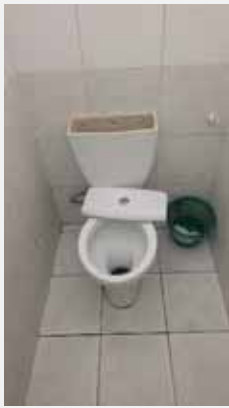
| Floor | Room / Area | Defect Description / Required Works | Qty | Unit | BOQ | Photo |
|---|---|---|---|---|---|---|
| 1st | Toilet | Supply & Install Flushing system<br><br>(x1 for girls & x1 for boys) | 2 | pcs | 1.2.1 | |

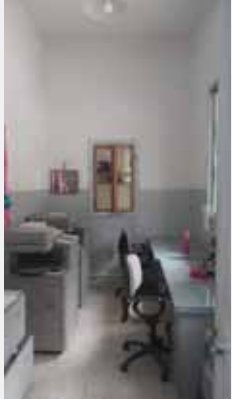
| Finishing | | | | | | |
|---|---|---|---|---|---|---|
| 1st | Entrance/<br>separated room<br>02 | Paint Walls | 60 | m2 | 9.5.1 | |

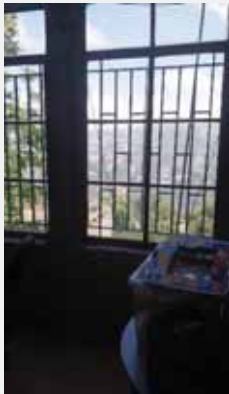
| Floor | Room / Area | Defect Description / Required Works | Qty | Unit | BOQ | Photo |
|---|---|---|---|---|---|---|
| 1st | Entrance | New handles for metal windows | 1 | pcs | 5.2 | |

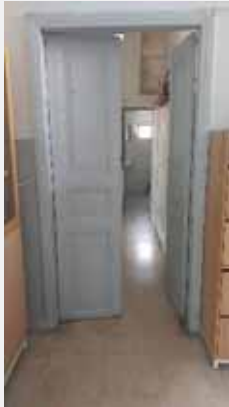
| Floor | Room / Area | Defect Description / Required Works | Qty | Unit | BOQ | Photo |
|---|---|---|---|---|---|---|
| 1st | Entrance | Paint x5 wooden doors of rooms | 30 | m2 | 8.1.3 | |

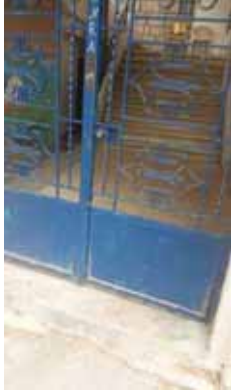
| Floor | Room / Area | Defect Description / Required Works | Qty | Unit | BOQ | Photo |
|---|---|---|---|---|---|---|
| 0 | Entrance | Change the lock of the school's entrance door | 1 | pcs | 5.2 | |

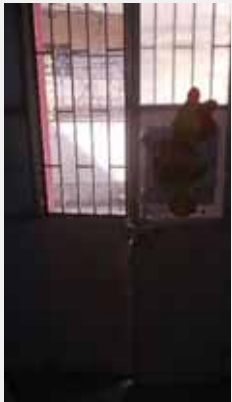
| Floor | Room / Area | Defect Description / Required Works | Qty | Unit | BOQ | Photo |
|---|---|---|---|---|---|---|
| 1st | Entrance | Install a new handle on the window section of the metal entrance door | 1 | pcs | 5.2 | |

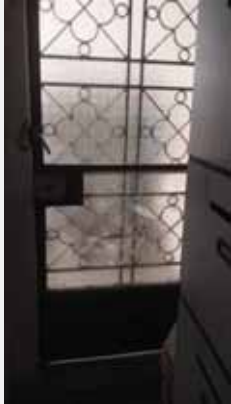
| Floor | Room / Area | Defect Description / Required Works | Qty | Unit | BOQ | Photo |
|---|---|---|---|---|---|---|
| 1st | 4 | Replace glass panel of metal kitchen door | 1 | pcs | 5.2 | |

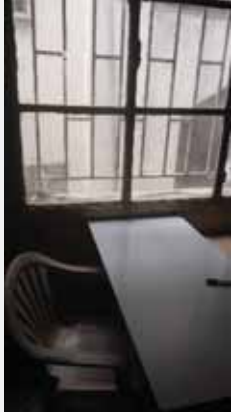
| Floor | Room / Area | Defect Description / Required Works | Qty | Unit | BOQ | Photo |
|---|---|---|---|---|---|---|
| 3rd | 5-6- | Insert net for window | 2 | pcs | 5.2 | |

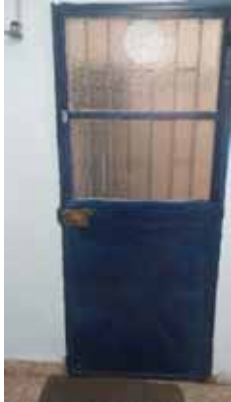
| Floor | Room / Area | Defect Description / Required Works | Qty | Unit | BOQ | Photo |
|---|---|---|---|---|---|---|
| 1st | 5 | Install a new wooden door | 1 | pcs | <b>8.1.1</b> | |

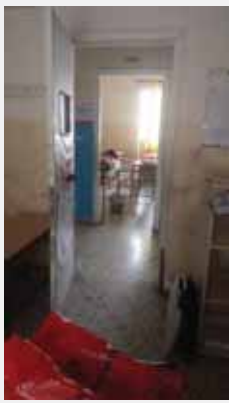
| Floor | Room / Area | Defect Description / Required Works | Qty | Unit | BOQ | Photo |
|---|---|---|---|---|---|---|
| 3rd | 5 | Repair Wooden door's frame | 1 | pcs | 8.1.3 | |

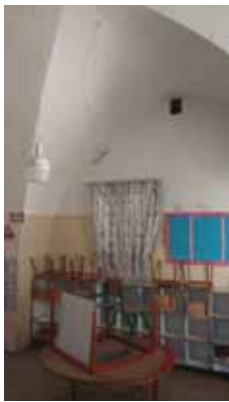
| Floor | Room / Area | Defect Description / Required Works | Qty | Unit | BOQ | Photo |
|---|---|---|---|---|---|---|
| 1st | 1-2-3-5- | Install new aspirator | 4 | pcs | 1.2.2 | |

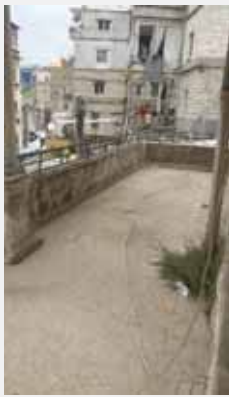
| Floor | Room / Area | Defect Description / Required Works | Qty | Unit | BOQ | Photo |
|---|---|---|---|---|---|---|
| 2nd | 2 | Repair manholes | 2 | pcs | 1.2.1 | |

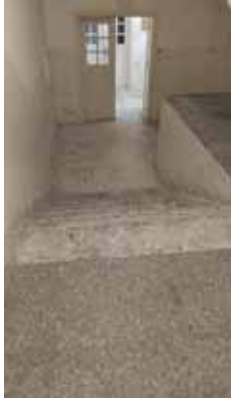
| Finishing | | | | | | |
|---|---|---|---|---|---|---|
| Staircase | Section shown in the image | Floor Tile Polishing | 12 | m2 | 9.2.7 | |

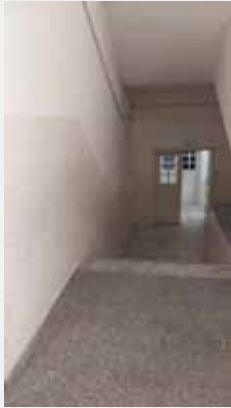
| Finishing | | | | | | |
|---|---|---|---|---|---|---|
| Staircase | Section shown in the image | Paint walls | 85 | m2 | 9.5.1 | |

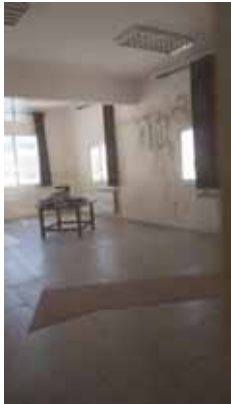
| Finishing | | | | | | |
|---|---|---|---|---|---|---|
| 2nd | Library | Paint walls | 80 | m2 | 9.5.1 | |

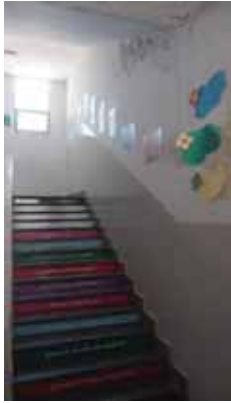
| Floor | Room / Area | Defect Description / Required Works | Qty | Unit | BOQ | Photo |
|---|---|---|---|---|---|---|
| Staircase | Staircase-walls<br>Floor 2-3 | Paint walls of staircase | 250 | m2 | 9.5.1 | |

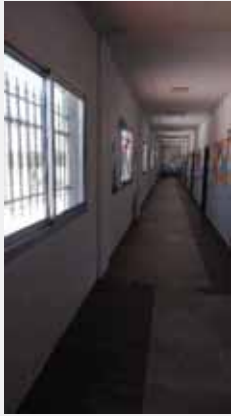
| Floor | Room / Area | Defect Description / Required Works | Qty | Unit | BOQ | Photo |
|---|---|---|---|---|---|---|
| 3rd | Coridor | Paint walls | 100 | m2 | 9.5.1 | |

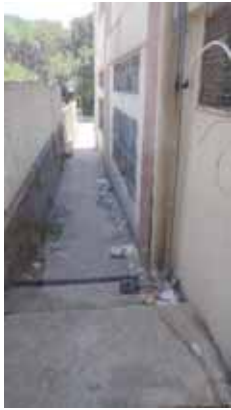
| Floor | Room / Area | Defect Description / Required Works | Qty | Unit | BOQ | Photo |
|---|---|---|---|---|---|---|
| Exterior | | Replacement of metal mesh for windows | 1 | pcs | 5.1.2 | |

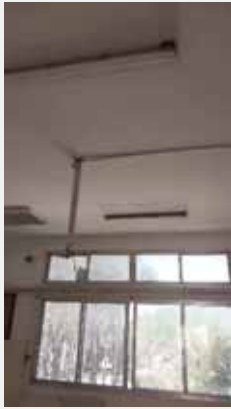
| Floor | Room / Area | Defect Description / Required Works | Qty | Unit | BOQ | Photo |
|---|---|---|---|---|---|---|
| | | Replacement of metal mesh for windows | 30 | pcs | 5.1.2 | |

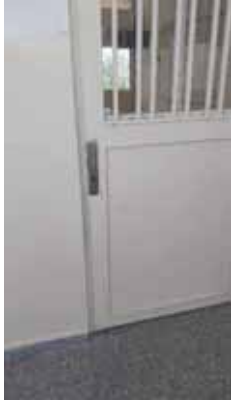
| Floor | Room / Area | Defect Description / Required Works | Qty | Unit | BOQ | Photo |
|---|---|---|---|---|---|---|
| 3rd | | Replace handles for 5 metal doors (x2 for each door) | 10 | pcs | 5.2 | |

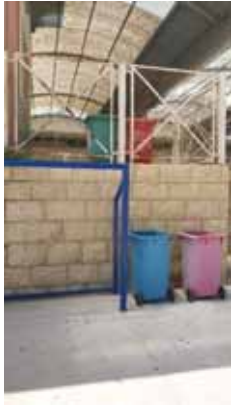
| Floor | Room / Area | Defect Description / Required Works | Qty | Unit | BOQ | Photo |
|---|---|---|---|---|---|---|
| 3rd | Playground | Replacement of metal mesh for windows | 2 | pcs | 5.1.2 | |

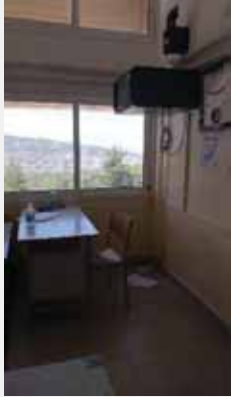
| Floor | Room / Area | Defect Description / Required Works | Qty | Unit | BOQ | Photo |
|---|---|---|---|---|---|---|
| 3rd | Classes | Replacement of aluminium window glass. | 2 | pcs | 8.2.3 | |

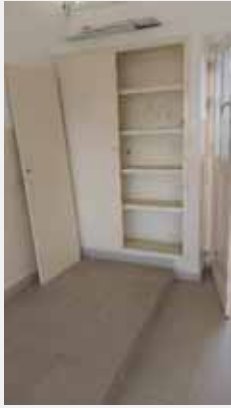
| Floor | Room / Area | Defect Description / Required Works | Qty | Unit | BOQ | Photo |
|---|---|---|---|---|---|---|
| 3rd | | Repair doors of wooden storage cabinets | 2 | cabinets | 6.1.2 | |

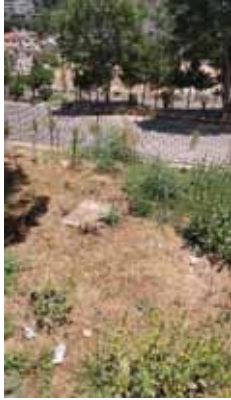
| Floor | Room / Area | Defect Description / Required Works | Qty | Unit | BOQ | Photo |
|---|---|---|---|---|---|---|
| School's sewer network | | <p>The school should be connected to the main public sewer network located along the road, with an approximate length of 20 meters, as the issue became apparent due to the increased pressure on the existing system during the displacement period.</p> <p>It may require a booster pump due to the difference in elevation</p> | | LS | 2.1 | |

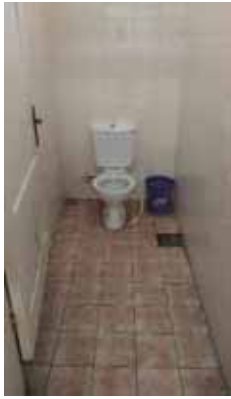
| Floor | Room / Area | Defect Description / Required Works | Qty | Unit | BOQ | Photo |
|---|---|---|---|---|---|---|
| 1st | Toilets | Washbasin/sink maintenance | 1 | pcs | 1.2.1 | |

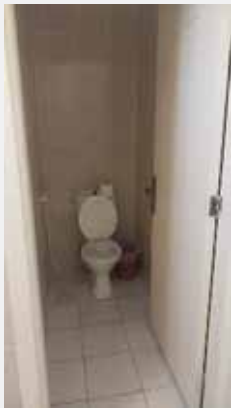
| Floor | Room / Area | Defect Description / Required Works | Qty | Unit | BOQ | Photo |
|---|---|---|---|---|---|---|
| 1st | Toilets-boys | Replace Flushing system of toilet seat | 1 | pcs | 1.2.1 | |

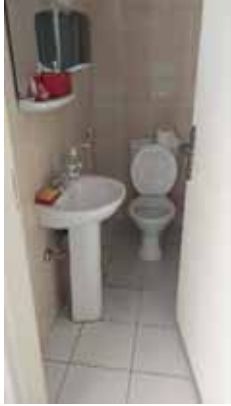
| Floor | Room / Area | Defect Description / Required Works | Qty | Unit | BOQ | Photo |
|---|---|---|---|---|---|---|
| 1st | Toilets-boys | Repair of wash basin | 1 | pcs | 1.2.1 | |

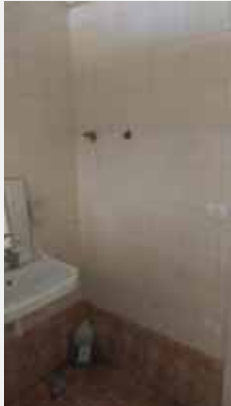
| Floor | Room / Area | Defect Description / Required Works | Qty | Unit | BOQ | Photo |
|---|---|---|---|---|---|---|
| 1st | Toilets-2 | Replacement of water stop valves | 2 | pcs | 1.2.1 | |

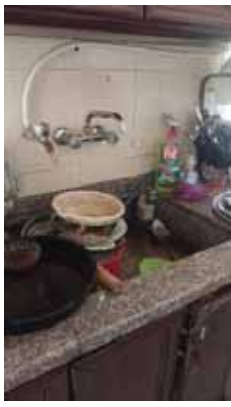
| Floor | Room / Area | Defect Description / Required Works | Qty | Unit | BOQ | Photo |
|---|---|---|---|---|---|---|
| 1st | Kitchen | Install new faucet | 1 | pcs | 5.7 | |

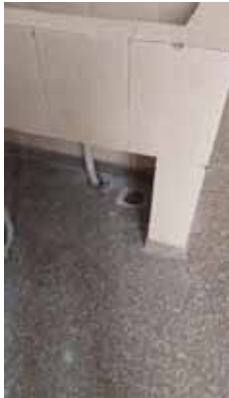
| Floor | Room / Area | Defect Description / Required Works | Qty | Unit | BOQ | Photo |
|---|---|---|---|---|---|---|
| 1st | Washbasin unit-2 | Maintenance of floor drain | 1 | pcs | 1.2.1 | |

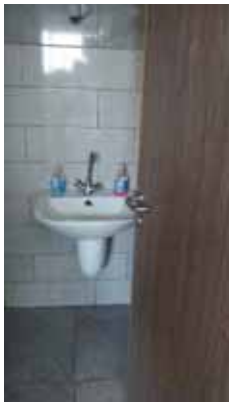
| Floor | Room / Area | Defect Description / Required Works | Qty | Unit | BOQ | Photo |
|---|---|---|---|---|---|---|
| 2nd | Toilets-teacher | Install new faucet | 1 | pcs | 5.6 | |

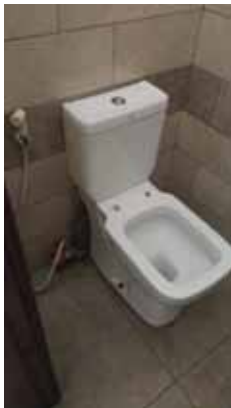
| Floor | Room / Area | Defect Description / Required Works | Qty | Unit | BOQ | Photo |
|---|---|---|---|---|---|---|
| 3rd | Toilets | Maintenance of bathrooms | 6 | bathrooms | 1.2.1 | |

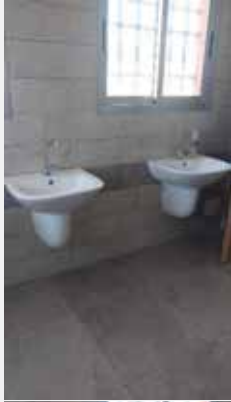
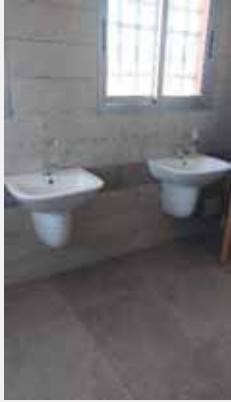
| Floor | Room / Area | Defect Description / Required Works | Qty | Unit | BOQ | Photo |
|---|---|---|---|---|---|---|
| 4th | Toilets | Install new faucets | 2 | pcs | 5.6 | |

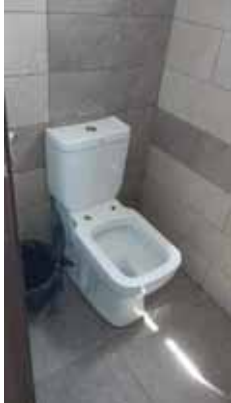
| Floor | Room / Area | Defect Description / Required Works | Qty | Unit | BOQ | Photo |
|---|---|---|---|---|---|---|
| 4th | Toilets | Install new toilet seat lids | 2 | pcs | 1.2.1 | |

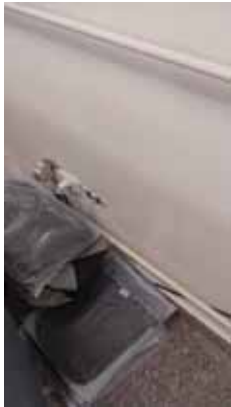
| Floor | Room / Area | Defect Description / Required Works | Qty | Unit | BOQ | Photo |
|---|---|---|---|---|---|---|
| Old School | | Replacement of electrical sockets | 30 | pcs | 1.1.3 | |

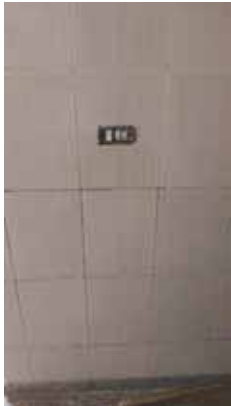
| Floor | Room / Area | Defect Description / Required Works | Qty | Unit | BOQ | Photo |
|---|---|---|---|---|---|---|
| | | Repair Electrical Socket | 1 | pcs | 1.1.3 | |

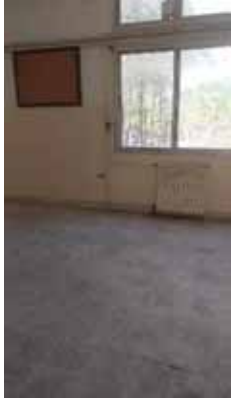
| Floor | Room / Area | Defect Description / Required Works | Qty | Unit | BOQ | Photo |
|---|---|---|---|---|---|---|
| 2nd | | Supply and installation of new electrical sockets | 60 | pcs | 1.1.3 | |

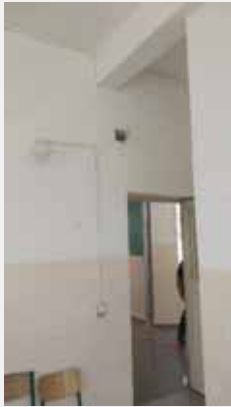
| Floor | Room / Area | Defect Description / Required Works | Qty | Unit | BOQ | Photo |
|---|---|---|---|---|---|---|
| 2nd | Entrance | Electrical maintenance. | | LS | 1.1 | |

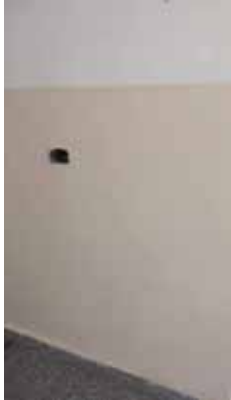
| Floor | Room / Area | Defect Description / Required Works | Qty | Unit | BOQ | Photo |
|---|---|---|---|---|---|---|
| 3rd | | Replacement of electrical sockets | 30 | pcs | 1.1.3 | |

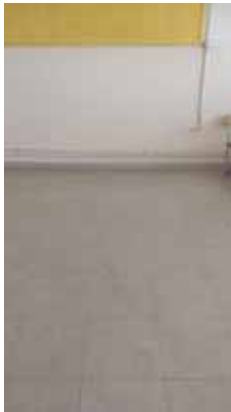
| Floor | Room / Area | Defect Description / Required Works | Qty | Unit | BOQ | Photo |
|---|---|---|---|---|---|---|
| 3rd | Classes (x6) | Supply & Installation of metal hooks/holders in 6 classrooms | 6 | classrooms | 12.1.6 | |

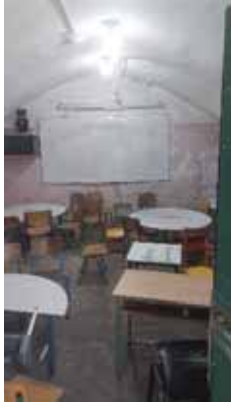
| Finishing | | | | | | |
|---|---|---|---|---|---|---|
| 1st | 1-2-<br>(4x4 m) | Paint ceiling & Walls | 128 | m2 | 9.5.1 | |

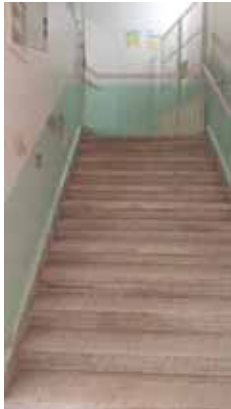
| Finishing | | | | | | |
|---|---|---|---|---|---|---|
| Staircase | Floor 1-2-3 | Paint Staircase walls | 350 | m2 | 9.5.1 | |

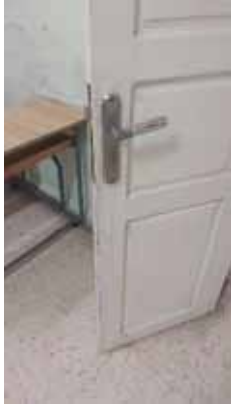
| Floor | Room / Area | Defect Description / Required Works | Qty | Unit | BOQ | Photo |
|---|---|---|---|---|---|---|
| 1st | 3 | Replace Door's Handles | 2 | pcs | <b>8.1.3</b> | |

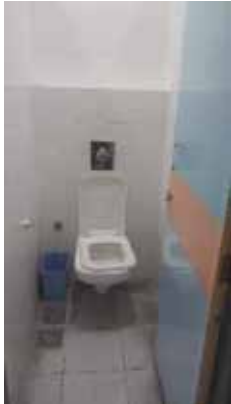
| Floor | Room / Area | Defect Description / Required Works | Qty | Unit | BOQ | Photo |
|---|---|---|---|---|---|---|
| 1st | Toilets -boys<br>Toilets-girls | Install new door locks<br>(x5 in each toilet) | 10 | pcs | <b>8.1.3</b> | |

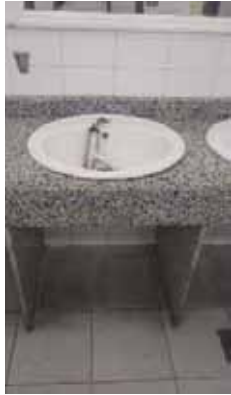
| Floor | Room / Area | Defect Description / Required Works | Qty | Unit | BOQ | Photo |
|---|---|---|---|---|---|---|
| 1st | Toilets-girls | Install new faucet | 1 | pcs | 5.6 | |

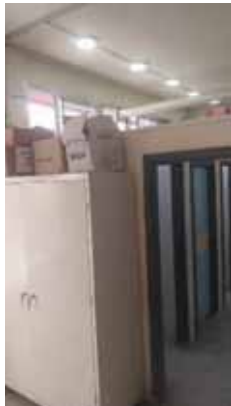
| Floor | Room / Area | Defect Description / Required Works | Qty | Unit | BOQ | Photo |
|---|---|---|---|---|---|---|
| 1st | Toilets | Installation of a bathroom exhaust fan. | 1 | pcs | 1.2.2 | |

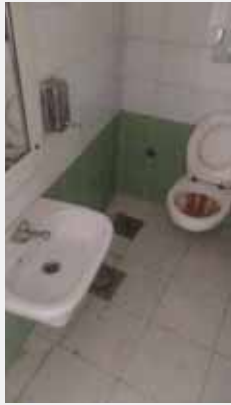
| Floor | Room / Area | Defect Description / Required Works | Qty | Unit | BOQ | Photo |
|---|---|---|---|---|---|---|
| 1st | Toilets-Nursery | Replace faucets | 1 | pcs | 5.6 | |

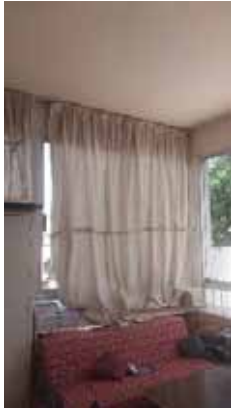
| Floor | Room / Area | Defect Description / Required Works | Qty | Unit | BOQ | Photo |
|---|---|---|---|---|---|---|
| 2nd | Printing room | New Curtains | 4 | windows | 10.5 | |

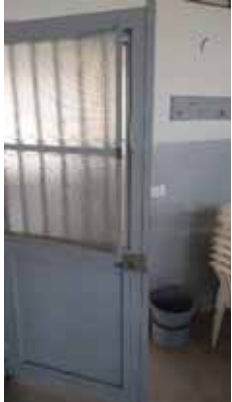
| Metal | | | | | | |
|---|---|---|---|---|---|---|
| 2nd | 6 | Install new handle for the window section in a metal door (classroom entrance) | 1 | pcs | 5.2 | |

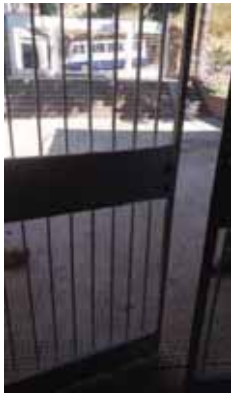
| Floor | Room / Area | Defect Description / Required Works | Qty | Unit | BOQ | Photo |
|---|---|---|---|---|---|---|
| 1st | Rear playground Gate | New handles | 2 | pcs | 5.2 | |

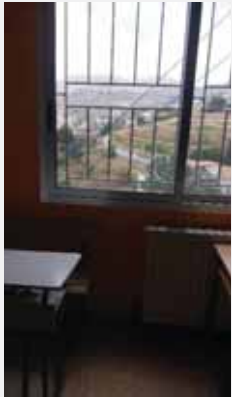
| Aluminum | | | | | | |
|---|---|---|---|---|---|---|
| 1st | 3 | Install glass of aluminum windows | 1 | pcs | 8.2.3 | |

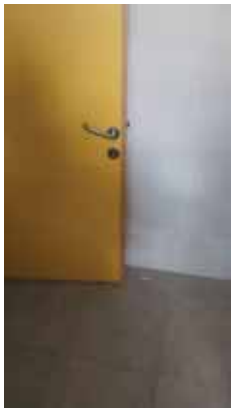
| Wood Doors | | | | | | |
|---|---|---|---|---|---|---|
| 0 | Toilet | Replace handle for toilet's door<br>(x1 for boy's WC one for girls WC) | 2 | pcs | 8.1.3 | |

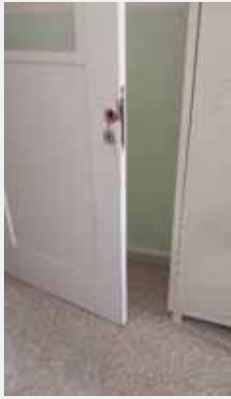
| Floor | Room / Area | Defect Description / Required Works | Qty | Unit | BOQ | Photo |
|---|---|---|---|---|---|---|
| 1st | Doctor's room | Provide & Install wooden door's handle & lock | 1 | pcs | 8.1.3 | |

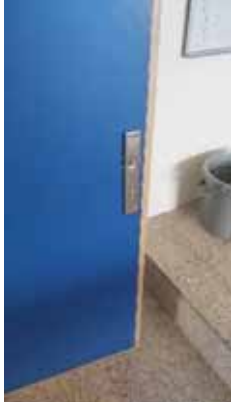
| Floor | Room / Area | Defect Description / Required Works | Qty | Unit | BOQ | Photo |
|---|---|---|---|---|---|---|
| 1st | 5 | Provide new door's handle | 1 | pcs | 8.1.3 | |

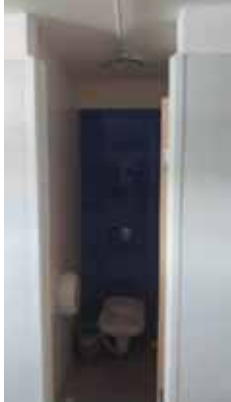
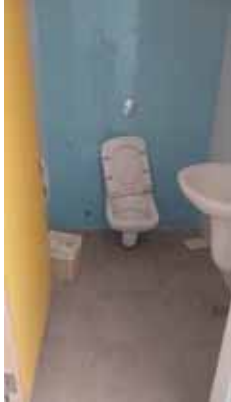
| Floor | Room / Area | Defect Description / Required Works | Qty | Unit | BOQ | Photo |
|---|---|---|---|---|---|---|
| 0 | Toilet | Supply & Install new toilet lids | 2 | pcs | 1.2.1 | |

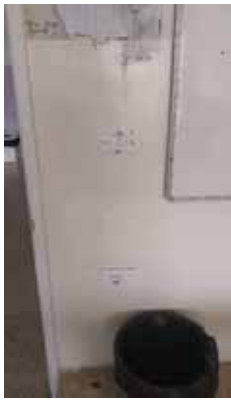
| Floor | Room / Area | Defect Description / Required Works | Qty | Unit | BOQ | Photo |
|---|---|---|---|---|---|---|
| 1st | 3 | Electrical outlet cover | 1 | pcs | 1.1.3 | |

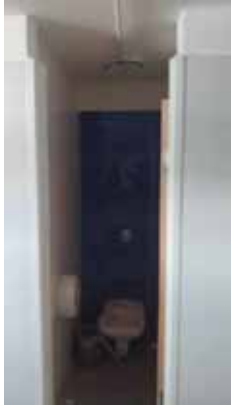
| Floor | Room / Area | Defect Description / Required Works | Qty | Unit | BOQ | Photo |
|---|---|---|---|---|---|---|
| 0 | Toilet | Instal new toilet lamps | 3 | pcs | 1.1.1 | |

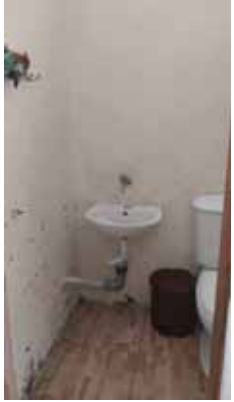
| Finishing | | | | | | |
|---|---|---|---|---|---|---|
| 1st | 1-Toilets (x2) | Paint all bathrooms walls and ceilings | 70 | m2 | 9.5.1 | |

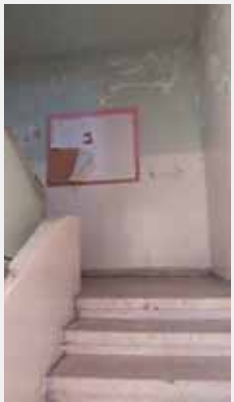
| Finishing | | | | | | |
|---|---|---|---|---|---|---|
| 1st | Staircase | Paint all walls of staircase from floor 1 to floor 3 | 150 | m2 | 9.5.1 | |

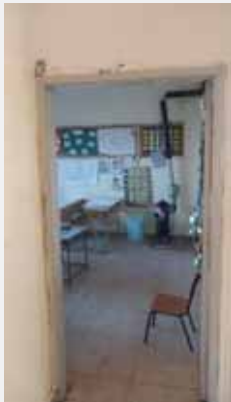
| Floor | Room / Area | Defect Description / Required Works | Qty | Unit | BOQ | Photo |
|---|---|---|---|---|---|---|
| 2nd | 2 | Repair plastering around the door | 1 | area | 9.1.2 | |

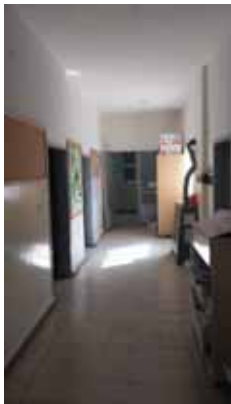
| Floor | Room / Area | Defect Description / Required Works | Qty | Unit | BOQ | Photo |
|---|---|---|---|---|---|---|
| 2nd | Hallway | Paint walls | 120 | m2 | 9.5.1 | |

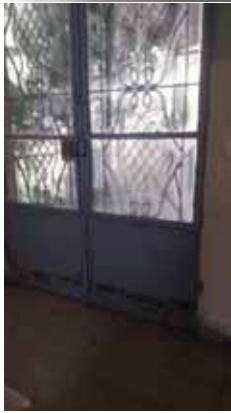
| Floor | Room / Area | Defect Description / Required Works | Qty | Unit | BOQ | Photo |
|---|---|---|---|---|---|---|
| Entrance | | Paint metal door | 1 | pcs | 5.2 | |

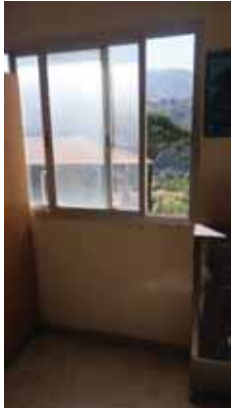
| Floor | Room / Area | Defect Description / Required Works | Qty | Unit | BOQ | Photo |
|---|---|---|---|---|---|---|
| 2nd | Hallway | Repair aluminum windows | 7 | pcs | 8.2.3 | |
| 2nd | Hallway | Replacement of window's screen mesh (net) | 7 | pcs | 8.2.3 | — |

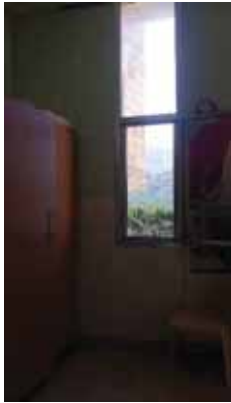
| Floor | Room / Area | Defect Description / Required Works | Qty | Unit | BOQ | Photo |
|---|---|---|---|---|---|---|
| 3rd | coridor | Change window's glass | 1 | pcs | 8.2.3 | |

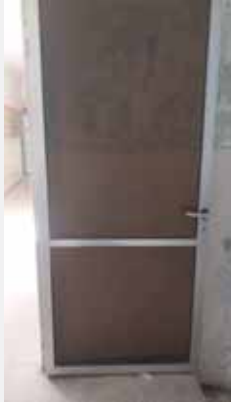
| Floor | Room / Area | Defect Description / Required Works | Qty | Unit | BOQ | Photo |
|---|---|---|---|---|---|---|
| 3rd | coridor | Change glass of aluminum door | 1 | pcs | 8.2.3 | |

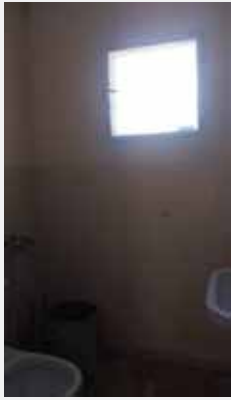
| Floor | Room / Area | Defect Description / Required Works | Qty | Unit | BOQ | Photo |
|---|---|---|---|---|---|---|
| 3rd | Toilets | Repair aluminum window | 1 | pcs | 8.2.3 | |
| 3rd | Toilets | Replace window's screen mesh (net) | 1 | pcs | 8.2.3 | — |

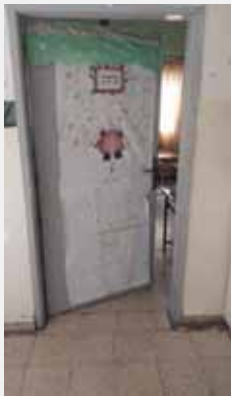
| Floor | Room / Area | Defect Description / Required Works | Qty | Unit | BOQ | Photo |
|---|---|---|---|---|---|---|
| 2nd | Classrooms doors | Paint door + frame | 1 | PCS | 8.1.3 | |

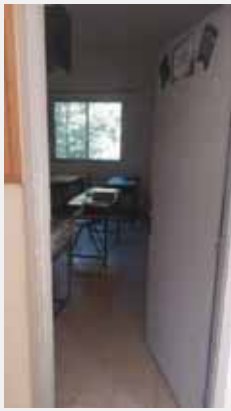
| Floor | Room / Area | Defect Description / Required Works | Qty | Unit | BOQ | Photo |
|---|---|---|---|---|---|---|
| 3rd | 1-2-3-4-5 | Repair wooden doors and frame | 5 | pcs | 8.1.3 | |

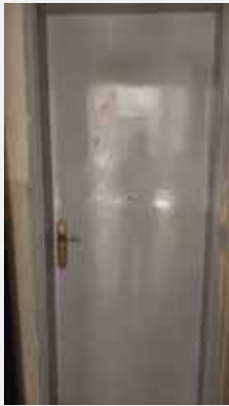
| Floor | Room / Area | Defect Description / Required Works | Qty | Unit | BOQ | Photo |
|---|---|---|---|---|---|---|
| 3rd | Toilets | Repair and paint wooden door and frame | 1 | pcs | <b>8.1.3</b> | |

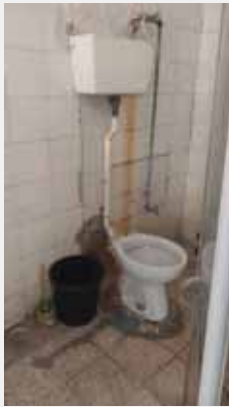
| Floor | Room / Area | Defect Description / Required Works | Qty | Unit | BOQ | Photo |
|---|---|---|---|---|---|---|
| 1st | Toilet: girls | New complete set of toilet seat | 1 | pcs | <b>1.2.1</b> | |

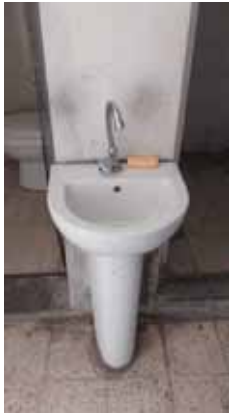
| Floor | Room / Area | Defect Description / Required Works | Qty | Unit | BOQ | Photo |
|---|---|---|---|---|---|---|
| 1st | Toilet: girls | New Faucet | 1 | pcs | <b>5.6</b> | |

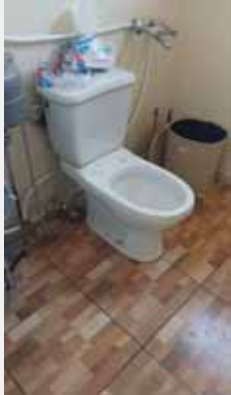
| Floor | Room / Area | Defect Description / Required Works | Qty | Unit | BOQ | Photo |
|---|---|---|---|---|---|---|
| 3rd | Toilets | Toilet Seat Lid | 1 | pcs | 1.2.1 | |

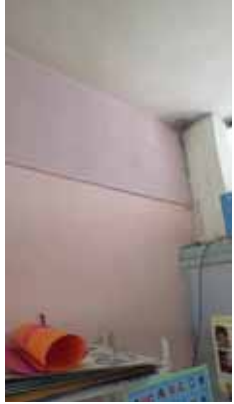
| Finishing | | | | | | |
|---|---|---|---|---|---|---|
| 1st | 1-2-3-4-5-6-7-8 | Paint walls | 680 | m2 | 9.5.1 | |

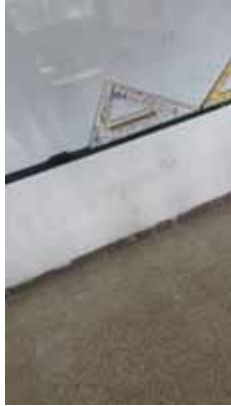
| Floor | Room / Area | Defect Description / Required Works | Qty | Unit | BOQ | Photo |
|---|---|---|---|---|---|---|
| 2nd | 1-2-3-4-5-6-7-8 | Paint | 680 | m2 | 9.5.1 | |

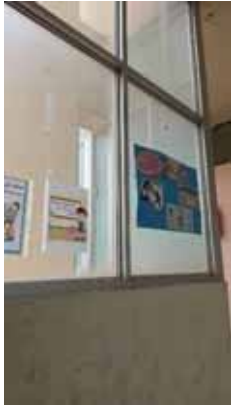
| Floor | Room / Area | Defect Description / Required Works | Qty | Unit | BOQ | Photo |
|---|---|---|---|---|---|---|
| 1st | | Repair aluminum windows | 2 | pcs | 8.2.3 | |

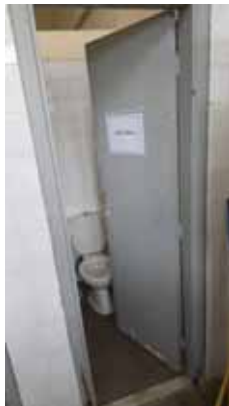
| Floor | Room / Area | Defect Description / Required Works | Qty | Unit | BOQ | Photo |
|---|---|---|---|---|---|---|
| Administrative building: 1st floor | Toilets | Repair wooden doors<br>(3 at the girls toilets + 4 at the boys toilet) | 7 | pcs | 8.1.3 | |

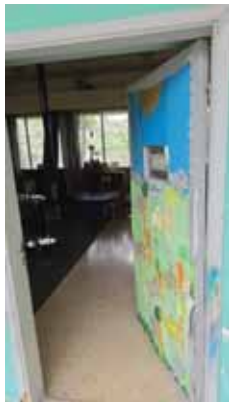
| Floor | Room / Area | Defect Description / Required Works | Qty | Unit | BOQ | Photo |
|---|---|---|---|---|---|---|
| 1st | 1-2-3-4-5-6-7-8 | Paint wooden door | 32 | m2 | 8.1.3 | |

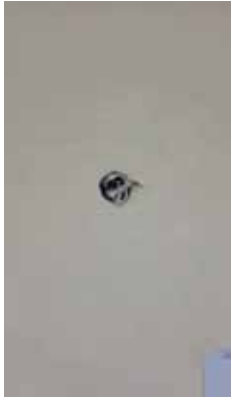
| Floor | Room / Area | Defect Description / Required Works | Qty | Unit | BOQ | Photo |
|---|---|---|---|---|---|---|
| 2nd | Corridor | Electrical boxes cover | 5 | pcs | 1.1.3 | |

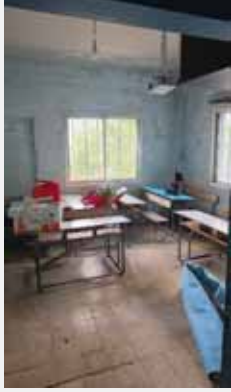
| Finishing | | | | | | |
|---|---|---|---|---|---|---|
| 2nd | 1-2-3-4-5-6 | Paint | 510 | m2 | 9.5.1 | |

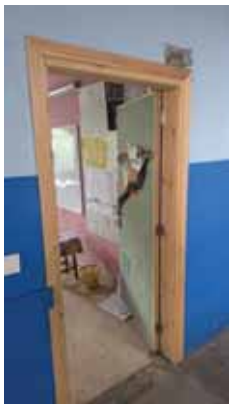
| Floor | Room / Area | Defect Description / Required Works | Qty | Unit | BOQ | Photo |
|---|---|---|---|---|---|---|
| 1st | 1-2-3-4 | Paint wooden door | 16 | m2 | 8.1.3 | |

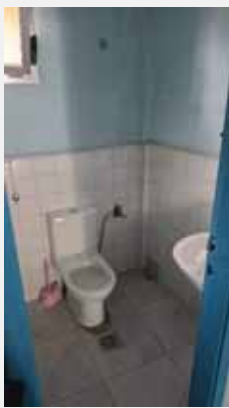
| Floor | Room / Area | Defect Description / Required Works | Qty | Unit | BOQ | Photo |
|---|---|---|---|---|---|---|
| 2nd | Toilets | Supply & Install new toilet lids | 1 | pcs | 1.2.1 | |

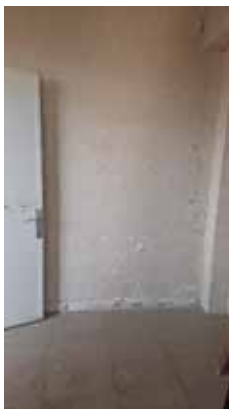
| Floor | Room / Area | Defect Description / Required Works | Qty | Unit | BOQ | Photo |
|---|---|---|---|---|---|---|
| 3rd | Coridor | Paint walls | 25 | m2 | 9.5.1 | |

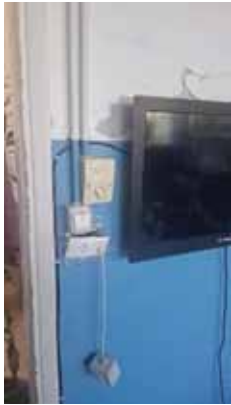
| Floor | Room / Area | Defect Description / Required Works | Qty | Unit | BOQ | Photo |
|---|---|---|---|---|---|---|
| Ground floor | 2 | Provide & install new electrical socket | 1 | pcs | 1.1.3 | |

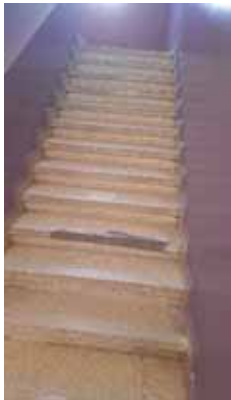
| Floor | Room / Area | Defect Description / Required Works | Qty | Unit | BOQ | Photo |
|---|---|---|---|---|---|---|
| Ground floor | Staircase | Repair and replacement of damaged staircase tread tiles | 6 | items | 9.2.5 | |

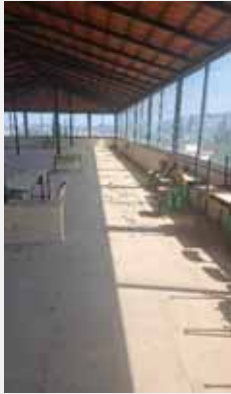
| Floor | Room / Area | Defect Description / Required Works | Qty | Unit | BOQ | Photo |
|---|---|---|---|---|---|---|
| 3rd | Hall | Repair tiling | 20 | m2 | 9.2.4 | |

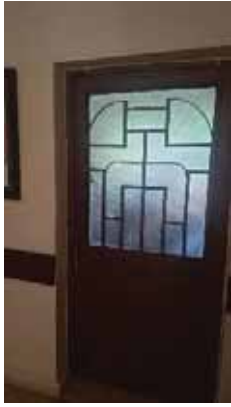
| Floor | Room / Area | Defect Description / Required Works | Qty | Unit | BOQ | Photo |
|---|---|---|---|---|---|---|
| Ground Floor | 2-3- | Glass in metal door | 2 | pcs | 5.2 | |

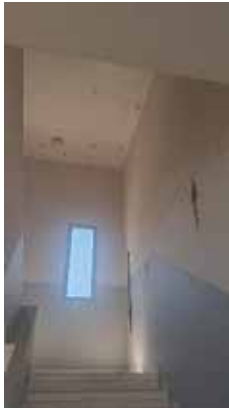
| Floor | Room / Area | Defect Description / Required Works | Qty | Unit | BOQ | Photo |
|---|---|---|---|---|---|---|
| Staircase | Roof & Walls | Waterproofing problem | 35 | m2 | 7.1 | |

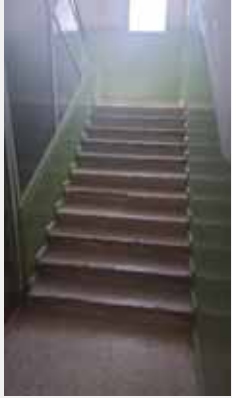
| Finishing | | | | | | |
|---|---|---|---|---|---|---|
| Ground Floor | Staircase | Repair steps | 8 | steps | 9.2.5 | |

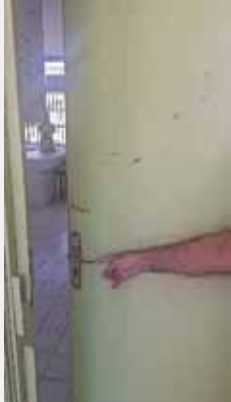
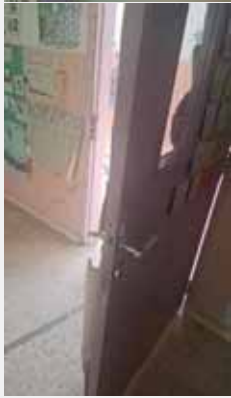
| Floor | Room / Area | Defect Description / Required Works | Qty | Unit | BOQ | Photo |
|---|---|---|---|---|---|---|
| Ground Floor | Kindergarten 1, Kindergarten 3, Kindergarten 2, Kindergarten 1 (Class 2) | Repair/replace wooden door locks (x1 in each class) | 4 | pcs | 8.1.3 | |

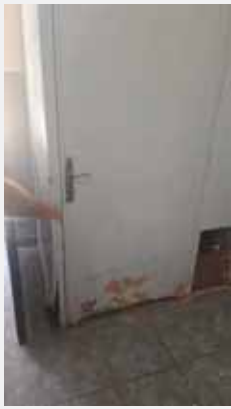
| Floor | Room / Area | Defect Description / Required Works | Qty | Unit | BOQ | Photo |
|---|---|---|---|---|---|---|
| | Pump room | New wooden door | 1 | pcs | 8.1.1 | |

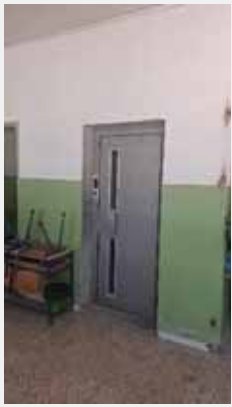
| Floor | Room / Area | Defect Description / Required Works | Qty | Unit | BOQ | Photo |
|---|---|---|---|---|---|---|
| Ground Floor | Corridor | Lift now working | 1 | Item | 10.1 | |

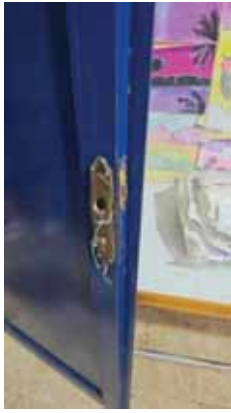
| Floor | Room / Area | Defect Description / Required Works | Qty | Unit | BOQ | Photo |
|---|---|---|---|---|---|---|
| 1st | 02/03/2004 | Repair lock for metal door | 3 | pcs | 5.2 | |

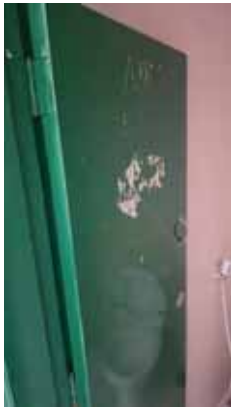
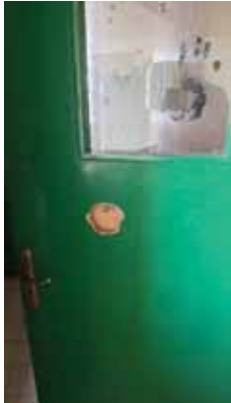
| Floor | Room / Area | Defect Description / Required Works | Qty | Unit | BOQ | Photo |
|---|---|---|---|---|---|---|
| 2nd | Toilet | Repair Toilet's door | 1 | pcs | 8.1.3 | |

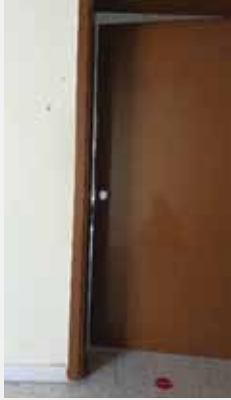
| Floor | Room / Area | Defect Description / Required Works | Qty | Unit | BOQ | Photo |
|---|---|---|---|---|---|---|
| 3rd | 5 | Repair of a wooden door | 1 | pcs | 8.1.3 | |

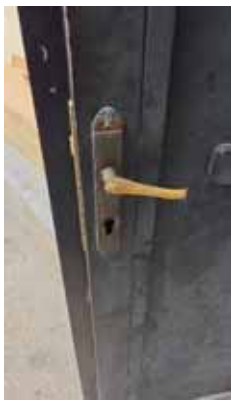
| Metal | | | | | | |
|---|---|---|---|---|---|---|
| School Entrance | | Repair entrance metal door | 1 | pcs | 5.2 | |

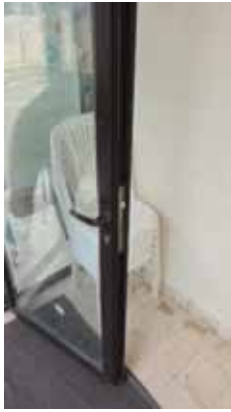
| Floor | Room / Area | Defect Description / Required Works | Qty | Unit | BOQ | Photo |
|---|---|---|---|---|---|---|
| School Entrance | | Repair aluminum door | 2 | pcs | 8.2.3 | |

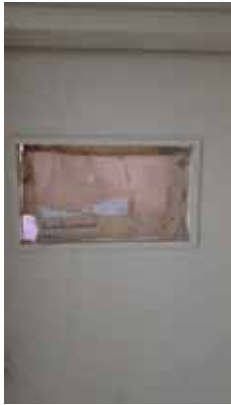
| Floor | Room / Area | Defect Description / Required Works | Qty | Unit | BOQ | Photo |
|---|---|---|---|---|---|---|
| 2nd | 1 | Repair glass of wooden door | 1 | pcs | 8.1.3 | |

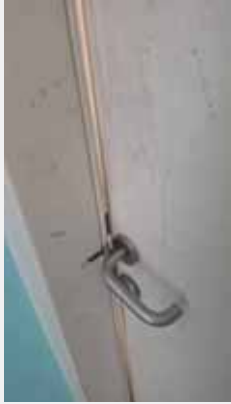
| Floor | Room / Area | Defect Description / Required Works | Qty | Unit | BOQ | Photo |
|---|---|---|---|---|---|---|
| 3rd | 2-3-4- | Repair wooden door | 3 | pcs | 8.1.3 | |

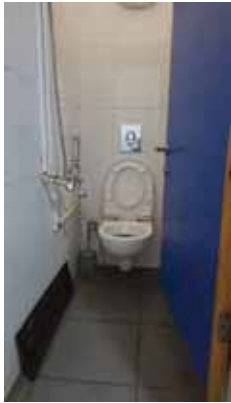
| Floor | Room / Area | Defect Description / Required Works | Qty | Unit | BOQ | Photo |
|---|---|---|---|---|---|---|
| 1st | Toilet | Repair Flushing System | 7 | pcs | 1.2.1 | |

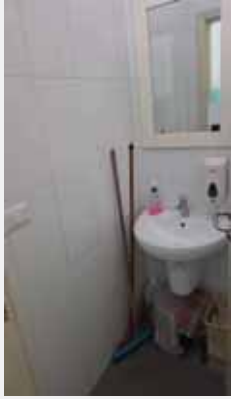
| Floor | Room / Area | Defect Description / Required Works | Qty | Unit | BOQ | Photo |
|---|---|---|---|---|---|---|
| 3rd | Toilets | New Flusing system | 2 | pcs | 1.2.1 | |

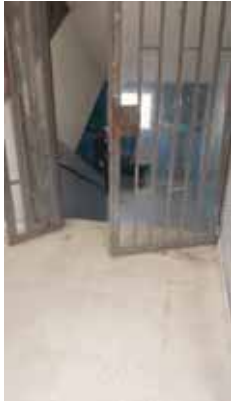
| Floor | Room / Area | Defect Description / Required Works | Qty | Unit | BOQ | Photo |
|---|---|---|---|---|---|---|
| 3rd | Entrance | Replace plastic cover for metal entrance door<br>(2 pieces for each door) | 4 | pcs | 5.2 | |

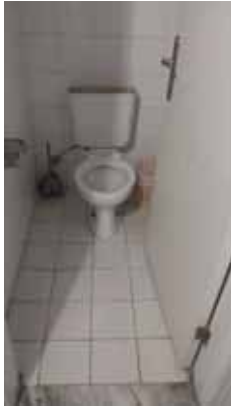
| Floor | Room / Area | Defect Description / Required Works | Qty | Unit | BOQ | Photo |
|---|---|---|---|---|---|---|
| 3rd-4th | Toilet | Supply & Install new toilet lids | 2 | pcs | 1.2.1 | |
