**Lebanese Emergency Assistant Project (LEAP)**  
**Rehabilitation of Shelters (Public Schools)**

**Batch 3: Lot 2**  
**in Caza of Zahle**

**DETAILED ASSESSMENT REPORT**

**Batch 3-LOT 2 — ZAHLE**

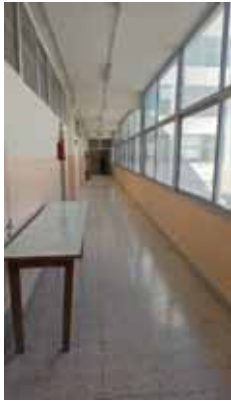
| Floor | Room / Area | Defect Description / Required Works | Qty | Unit | BOQ | Photo |
|---|---|---|---|---|---|---|
| 2nd | Coridor | Paint Walls | 150 | m2 | 9.5.1 | |

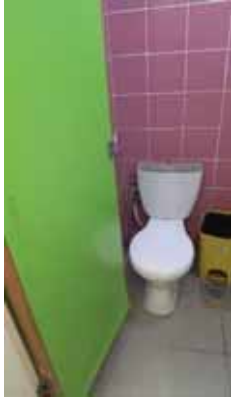
| Floor | Room / Area | Defect Description / Required Works | Qty | Unit | BOQ | Photo |
|---|---|---|---|---|---|---|
| 1st | Toilets | New door handles (2) | 2 | pcs | 8.1.3 | |

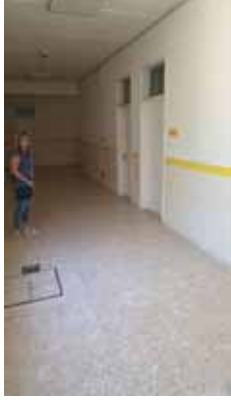
| Finishing | | | | | | |
|---|---|---|---|---|---|---|
| 1st | Coridors | Paint all hallways walls | 150 | m2 | 9.5.1 | |

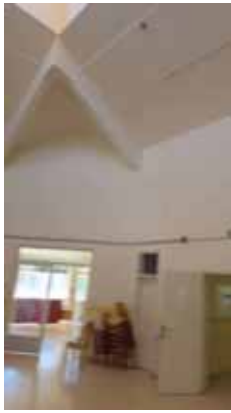
| Floor | Room / Area | Defect Description / Required Works | Qty | Unit | BOQ | Photo |
|---|---|---|---|---|---|---|
| 3rd | Kindergarten | Paint | 150 | m2 | 9.5.1 | |

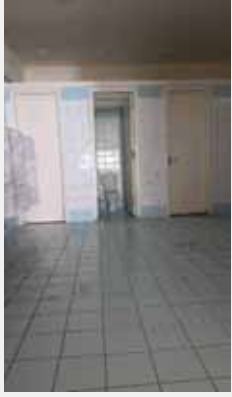
| Floor | Room / Area | Defect Description / Required Works | Qty | Unit | BOQ | Photo |
|---|---|---|---|---|---|---|
| 1st | Toilet girls #2 - boys#2 | Flushing system for toilet seat<br>(x6 in girls#2 wc - x4 in boys#2 wc) | 10 | pcs | 1.2.1 | — |

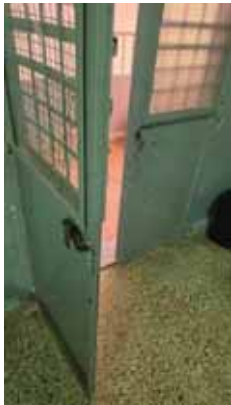
| Floor | Room / Area | Defect Description / Required Works | Qty | Unit | BOQ | Photo |
|---|---|---|---|---|---|---|
| 2nd | 4 | Paint door | 10 | m2 | 5.2 | |

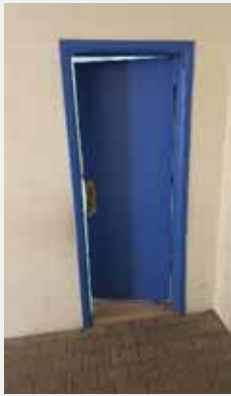
| Floor | Room / Area | Defect Description / Required Works | Qty | Unit | BOQ | Photo |
|---|---|---|---|---|---|---|
| 1st | Toilet: 2 | New wooden door | 1 | pcs | 8.1.1 | |

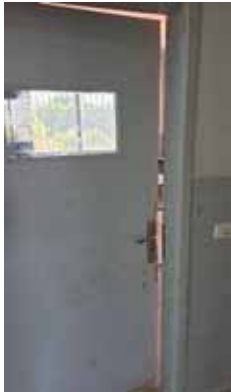
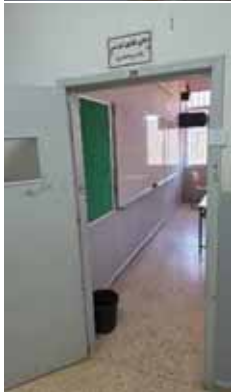
| Floor | Room / Area | Defect Description / Required Works | Qty | Unit | BOQ | Photo |
|---|---|---|---|---|---|---|
| 2nd | 2 | Repair of wooden door. | 1 | pcs | 8.1.3 | |

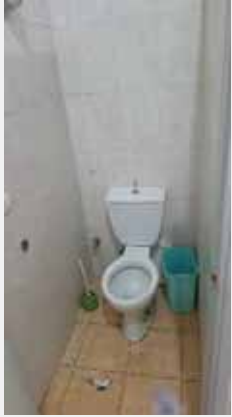
| Floor | Room / Area | Defect Description / Required Works | Qty | Unit | BOQ | Photo |
|---|---|---|---|---|---|---|
| 3rd | Toilets | New toilet seat lid | 1 | pcs | 1.2.1 | |

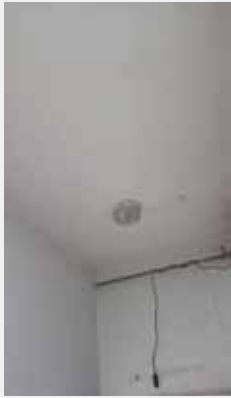
| Floor | Room / Area | Defect Description / Required Works | Qty | Unit | BOQ | Photo |
|---|---|---|---|---|---|---|
| 1st | Toilet: 1 | New Lamp | 1 | pcs | 1.1.1 | |

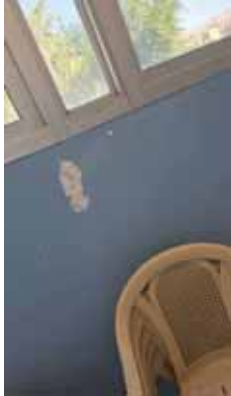
| Floor | Room / Area | Defect Description / Required Works | Qty | Unit | BOQ | Photo |
|---|---|---|---|---|---|---|
| 2nd | Coridor | Repair & Repaint walls sections | 20 | m2 | 9.1.2 & 9.5.1 | |

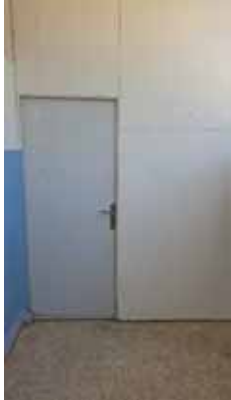
| Floor | Room / Area | Defect Description / Required Works | Qty | Unit | BOQ | Photo |
|---|---|---|---|---|---|---|
| 3rd | Coridor | Paint Hallway wooden door | 4 | m2 | 9.5.1 | |

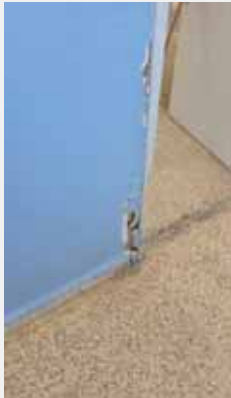
| Floor | Room / Area | Defect Description / Required Works | Qty | Unit | BOQ | Photo |
|---|---|---|---|---|---|---|
| 3rd | Coridor | Repair Wall | 20 | m2 | 9.1.2 & 9.5.1 | |

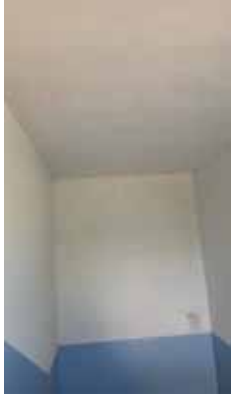
| Floor | Room / Area | Defect Description / Required Works | Qty | Unit | BOQ | Photo |
|---|---|---|---|---|---|---|
| 3rd | Staircase | Paint walls | 30 | m2 | 9.5.1 | |

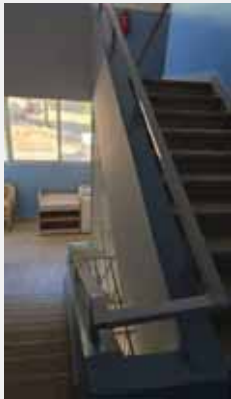
| Floor | Room / Area | Defect Description / Required Works | Qty | Unit | BOQ | Photo |
|---|---|---|---|---|---|---|
| 2nd | Staircase | Painting of staircase handrail | 20 | lm | 5.5 | |

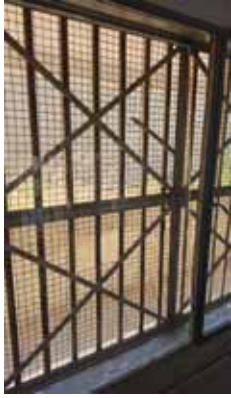
| Floor | Room / Area | Defect Description / Required Works | Qty | Unit | BOQ | Photo |
|---|---|---|---|---|---|---|
| | Administration offices | Glass Window | 1 | pcs | 5.2 | |

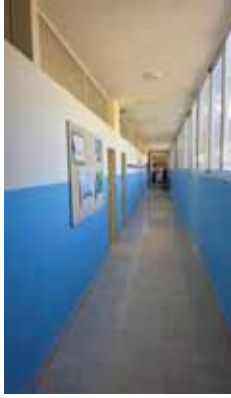
| Floor | Room / Area | Defect Description / Required Works | Qty | Unit | BOQ | Photo |
|---|---|---|---|---|---|---|
| 2nd | Coridor | Paint Walls & Ceiling<br>(40 x 1.2m) | 300 | m2 | 9.5.1 | |

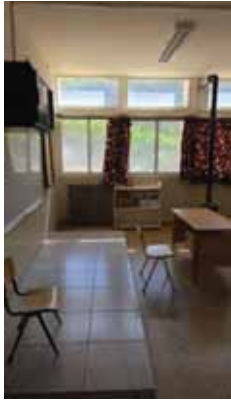
| Floor | Room / Area | Defect Description / Required Works | Qty | Unit | BOQ | Photo |
|---|---|---|---|---|---|---|
| 2nd | 1 | Repair Projector mount box | 1 | pcs | 1.1.9 | |

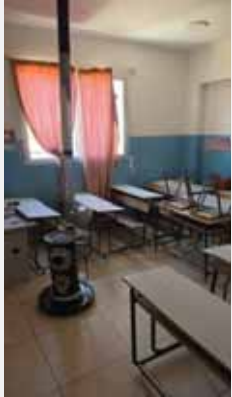
| Floor | Room / Area | Defect Description / Required Works | Qty | Unit | BOQ | Photo |
|---|---|---|---|---|---|---|
| 2nd | 1-2-3-4-5-6-7-8- | Paint | 680 | m2 | 9.5.1 | |

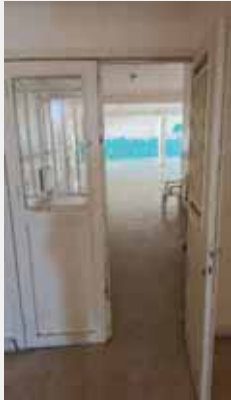
| Floor | Room / Area | Defect Description / Required Works | Qty | Unit | BOQ | Photo |
|---|---|---|---|---|---|---|
| Playground | | Paint door | 2 | pcs | 8.1.3 | |

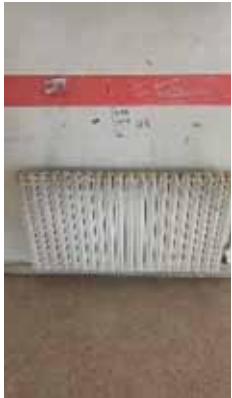
| Floor | Room / Area | Defect Description / Required Works | Qty | Unit | BOQ | Photo |
|---|---|---|---|---|---|---|
| Playground | | Paint Radiators | 5 | pcs | 1.2.2 | |

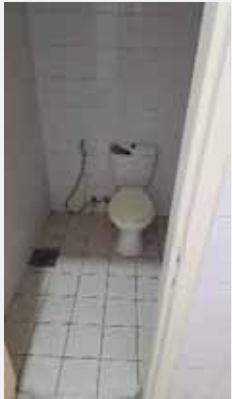
| Floor | Room / Area | Defect Description / Required Works | Qty | Unit | BOQ | Photo |
|---|---|---|---|---|---|---|
| 2nd | Toilets | Toilet tank lid | 1 | pcs | 1.2.1 | |

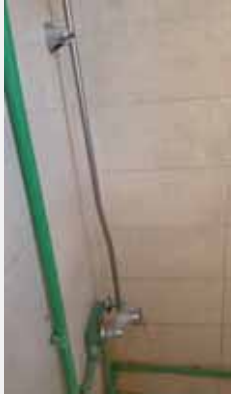
| Floor | Room / Area | Defect Description / Required Works | Qty | Unit | BOQ | Photo |
|---|---|---|---|---|---|---|
| 1st | Toilets 1-2 | Handheld bidet sprayer<br>(x6 in each toilet) | 12 | pcs | 1.2.1 | |

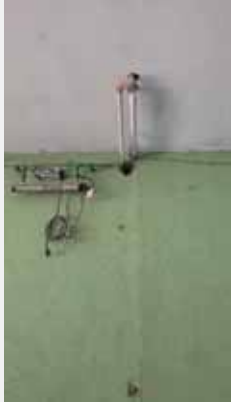
| Finishing | | | | | | |
|---|---|---|---|---|---|---|
| 1st | Playground | Repair plaster | 5 | m2 | 9.1.2 | |

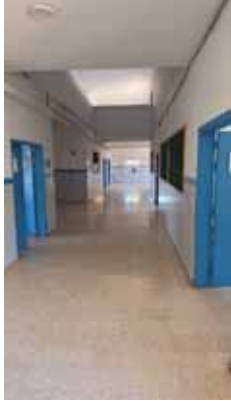
| Floor | Room / Area | Defect Description / Required Works | Qty | Unit | BOQ | Photo |
|---|---|---|---|---|---|---|
| 2nd | Coridor | Paint | 200 | m2 | 9.5.1 | |

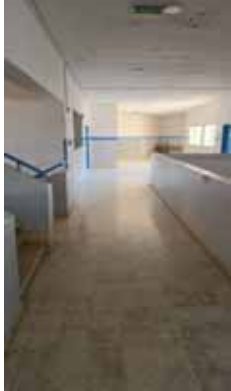
| Floor | Room / Area | Defect Description / Required Works | Qty | Unit | BOQ | Photo |
|---|---|---|---|---|---|---|
| 3rd | Coridor | Paint walls | 100 | m2 | 9.5.1 | |

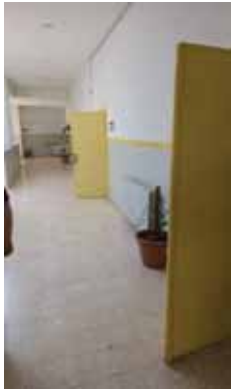
| Floor | Room / Area | Defect Description / Required Works | Qty | Unit | BOQ | Photo |
|---|---|---|---|---|---|---|
| 2nd - Block D | Coridor | Paint | 150 | m2 | 9.5.1 | |

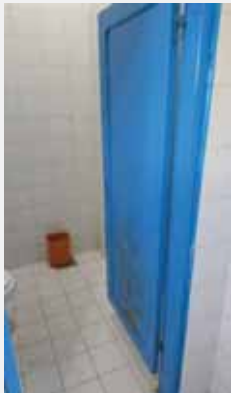
| Floor | Room / Area | Defect Description / Required Works | Qty | Unit | BOQ | Photo |
|---|---|---|---|---|---|---|
| 2nd | Toilets | Replace wooden doors | 3 | pcs | 8.1.1 | |

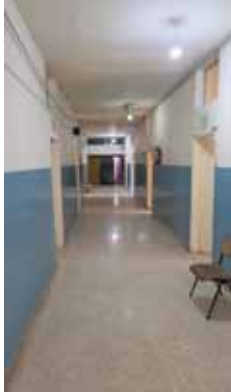
| Finishing | | | | | | |
|---|---|---|---|---|---|---|
| 1st | Corridor L-shape | Paint | 280 | m2 | 9.5.1 | <br> |

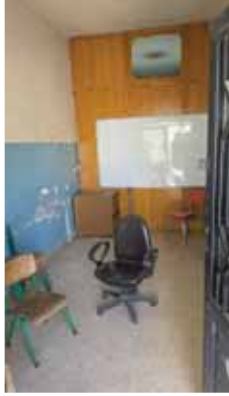
| Floor | Room / Area | Defect Description / Required Works | Qty | Unit | BOQ | Photo |
|---|---|---|---|---|---|---|
| 2nd | 1-2- | Paint | 30 | m2 | 9.5.1 | |
