# **Tender Preparation and Construction Supervision for Shelters**

## **Lebanon Emergency Assistance Project (LEAP)**

### **Detailed Assessment and Verification Report**

### **September 2026**

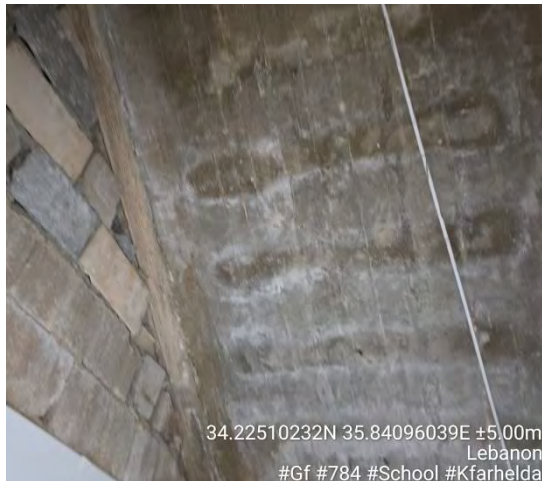
**Figure 5- False ceiling collapse due to using the toilets for shower**

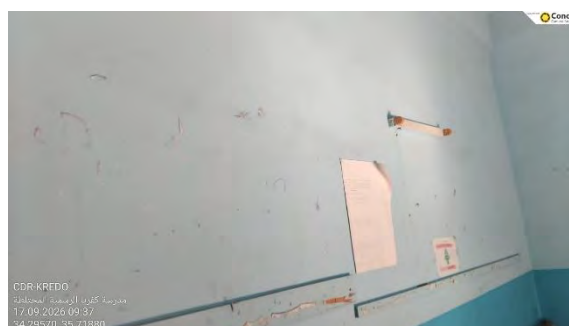
**Figure 8- Walls to paint**

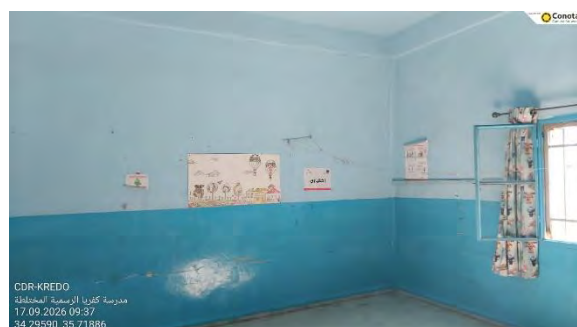
**Figure 9- Walls to paint**
