Consultancy Services for  
Tender Preparation and Construction Supervision Consultant for  
Shelters  
Lebanon Emergency Assistance Project (LEAP)

**ASSESSMENT REPORT**

**BATCH 2 - LOT 3**

**BATCH 2 - LOT 3**  
**MOUNT LEBANON SCHOOLS**  
**GENERAL INDEX**

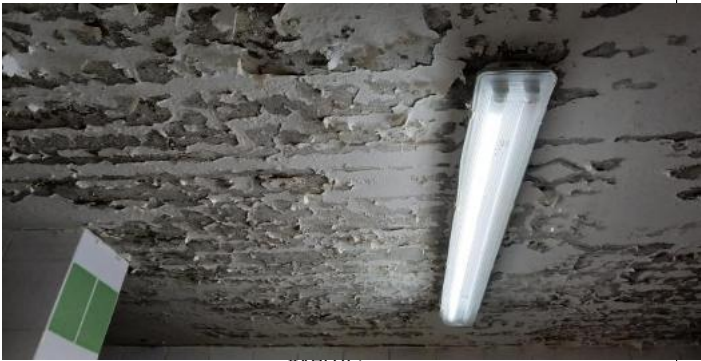
| humidity | present in the school from windows and roof floor |

Humidity and water leak from the roof and elevations shown inside the building
