**CERD 423 - Ebn Rashed Public School for Girls**

Batch 4 - Lot 2 – Tripoli

### Lebanon Emergency Assistance Project (LEAP)

## Detailed Assessment and Verification Report

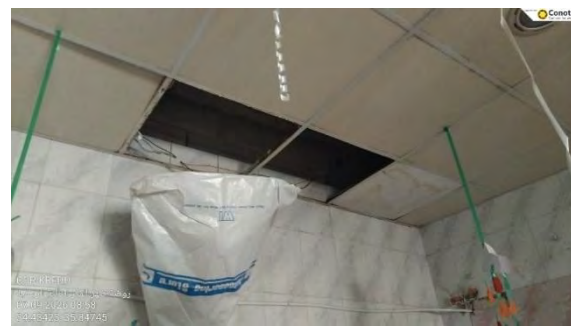
**Figure 5 – Missing False Ceiling Boards**

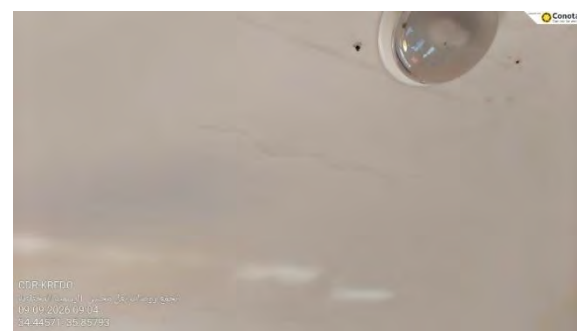
**Figure 7 – Cracks in Ceiling**

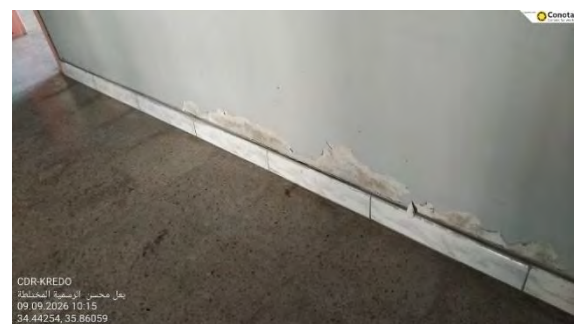
**Figure 19 - Humidity in Wall**

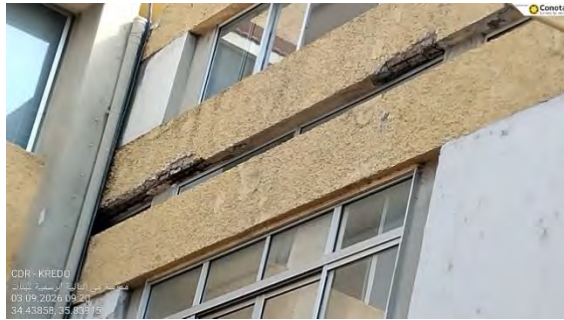
**Figure 16 – Exposed Rebars at Elevation**
