# **Tender Preparation and Construction Supervision for Shelters**

## **Lebanon Emergency Assistance Project (LEAP)**

### **Detailed Assessment and Verification Report**

### **September 2026**

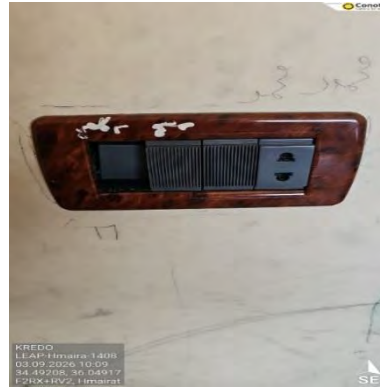
| Trade | Item | Damaged | Location, extent and quantity |
|---|---|---|---|
| Electrical | Sockets and switches | Yes | 5 socket repairs<br>4 new sockets<br>6 socket covers |

**Figure 9 – Damaged socket**

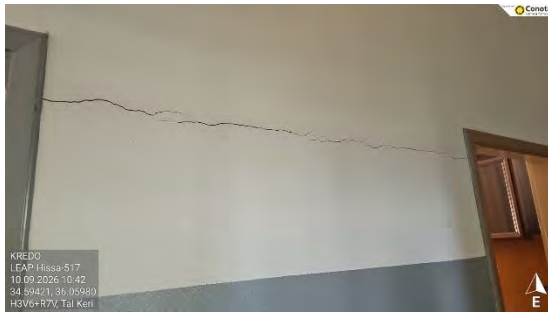
| No. | Element | Yes | No | Location and description |
|---|---|---|---|---|
| 3 | Wall cracks | X | | |

**Figure 4 – Wall Cracks**

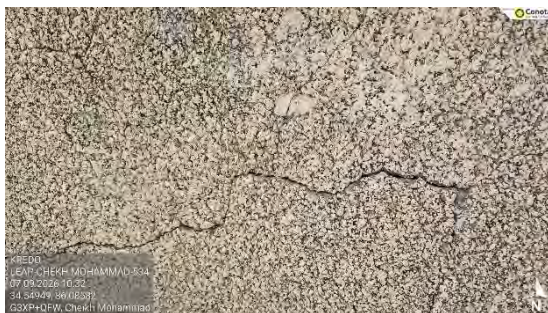
**Figure 6 - Façade Cracks**
