**CERD 66 - Borj Hammoud Third Mixed Intermediate Public School**

Lebanon Emergency Assistance Project (LEAP)

## Detailed Assessment and Verification Report

September 2026

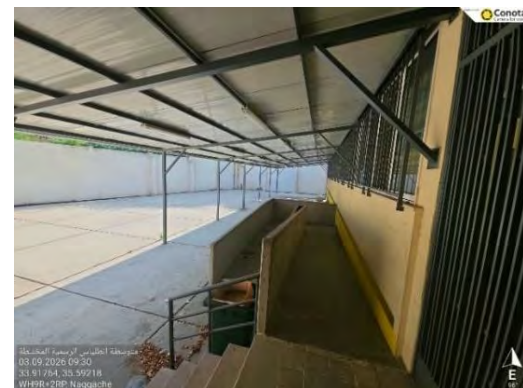
**Figure 7- Accessible ramp in good condition**

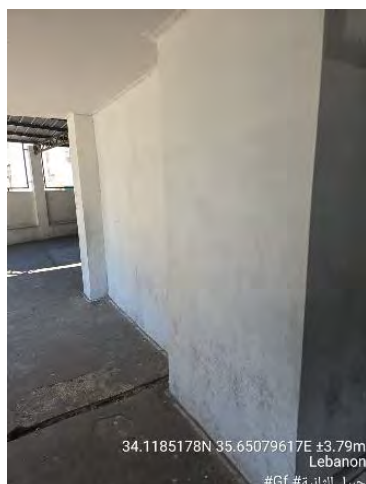
**Figure 6- Dirty playground walls**
