**CERD 721 - Kousba Mixed Public School**

Lebanon Emergency Assistance Project (LEAP)

## Detailed Assessment and Verification Report

Tender Preparation and Construction Supervision Consultant for Shelters.  
Lebanon Emergency Assistance Project (LEAP)

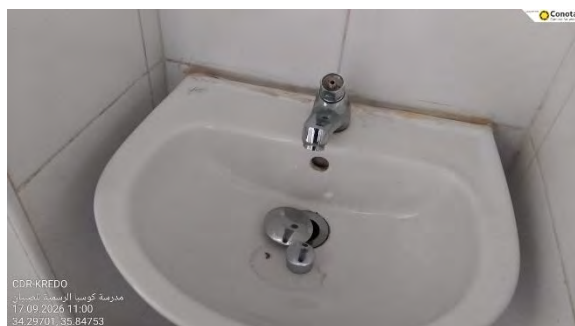
**Figure 16 - Spoiled Tap**

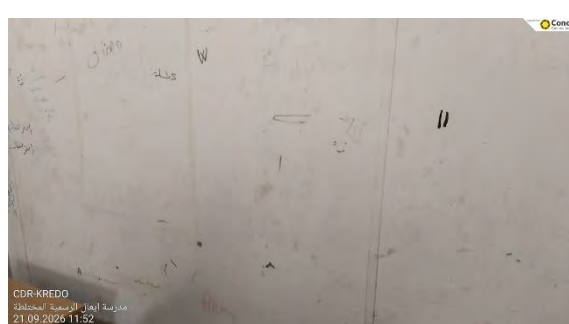
**Figure 7 - Damaged Walls**

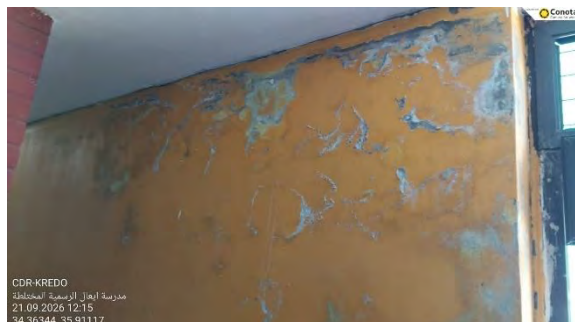
**Figure 8 - Humidity**

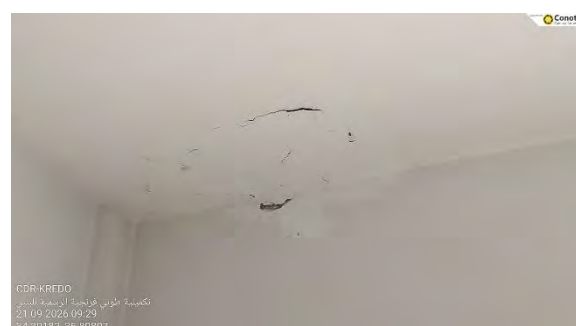
**Figure 10 - Damaged Plaster**

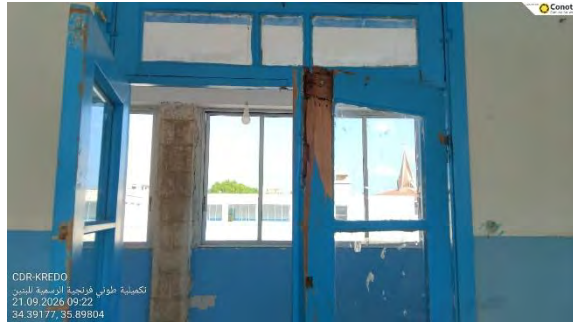
**Figure 12 - Broken Door**

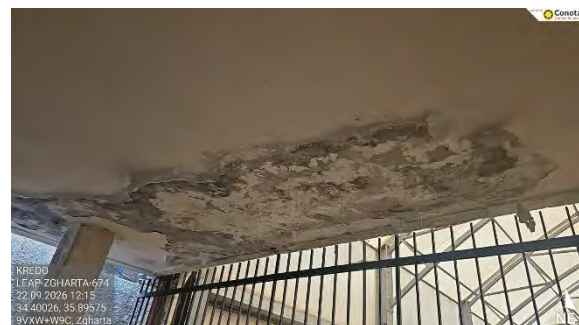
**Figure 10 - Water Leakage**

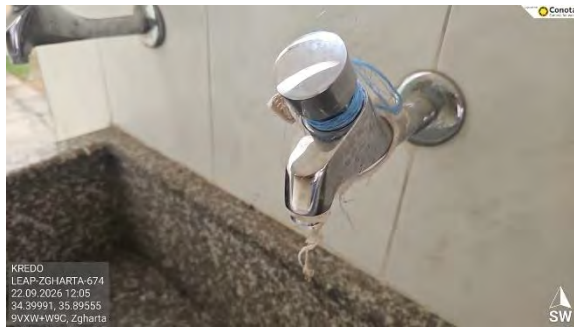
**Figure 11 - Damaged Tap**

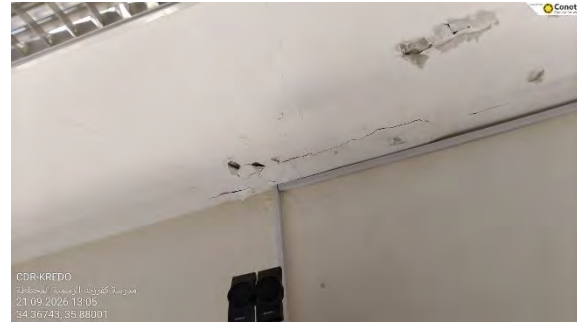
**Figure 13 - Damaged Plaster**
