**CERD 174 - El Fidar Mixed Intermediate Public School**

Lebanon Emergency Assistance Project (LEAP)

## Detailed Assessment and Verification Report

Tender Preparation and Construction Supervision Consultant for Shelters.

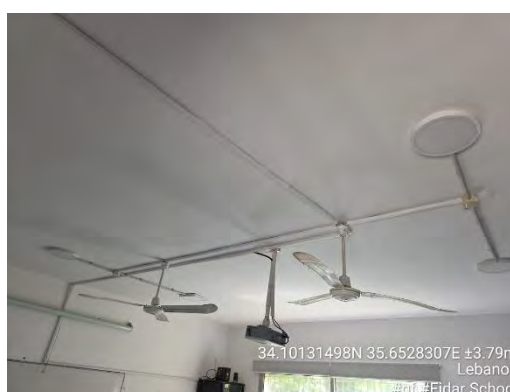
**Figure 8- Lighting Fixtures**

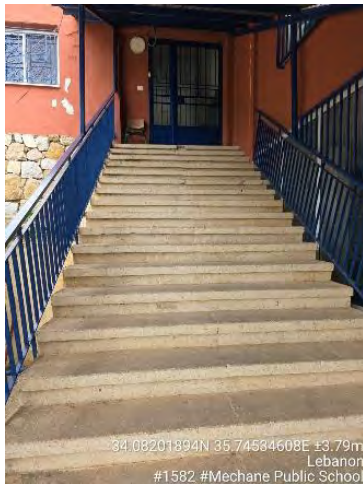
**Figure 4- Stairs**
