Consultancy Services for  
Tender Preparation and Construction Supervision Consultant for  
Shelters  
Lebanon Emergency Assistance Project (LEAP)

**ASSESSMENT REPORT  
BATCH 2 - LOT 2**

July 2026

**BATCH 2 - LOT 2**  
**TRIPOLI & NORTH LEBANON SCHOOLS**  
**GENERAL INDEX**

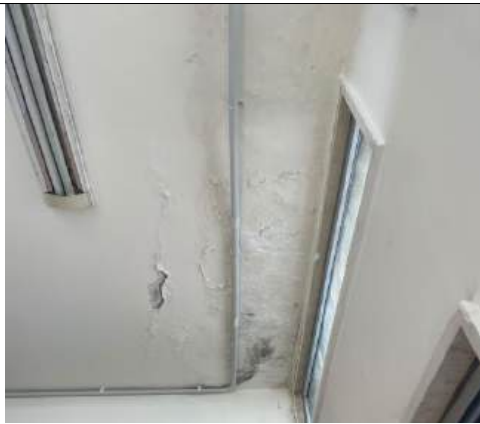
pic showing the leakage from  
the upper windows

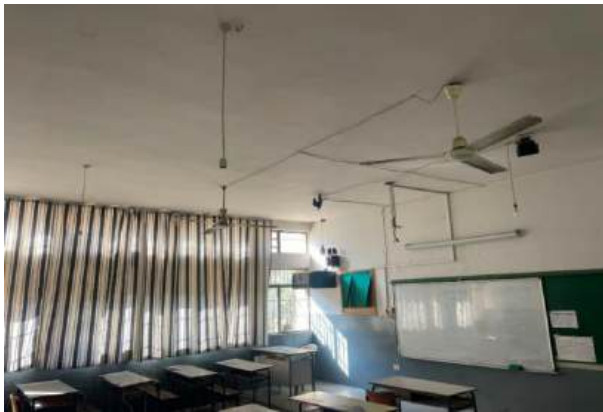
Electrical lamp to be changed

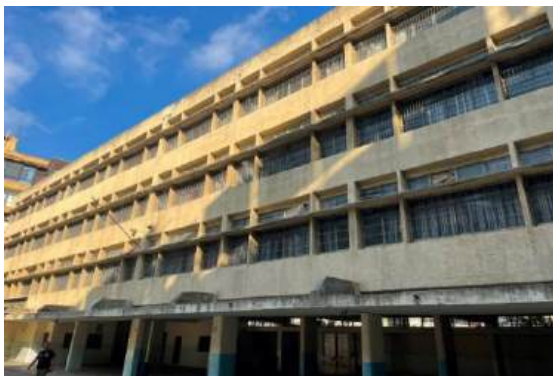
| Façade cracks | yes | | | | Location : | 3rd | | | |

Façade cracks

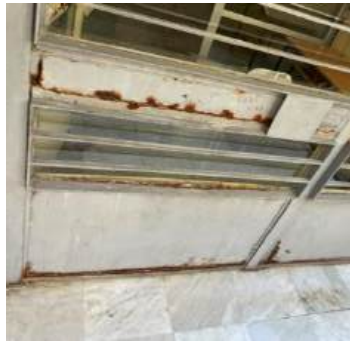
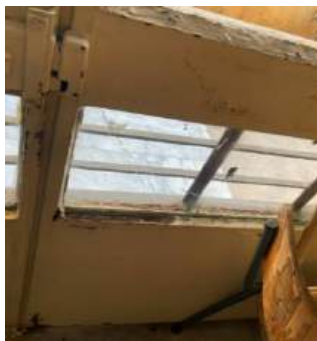
corrosion of the entrance door

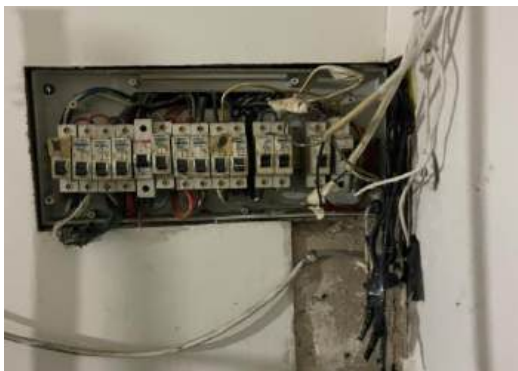
Electrical problem to maintain

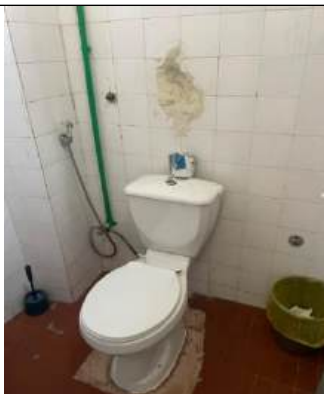
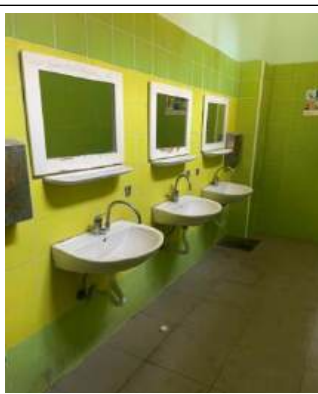
WC need to be rehabilitated

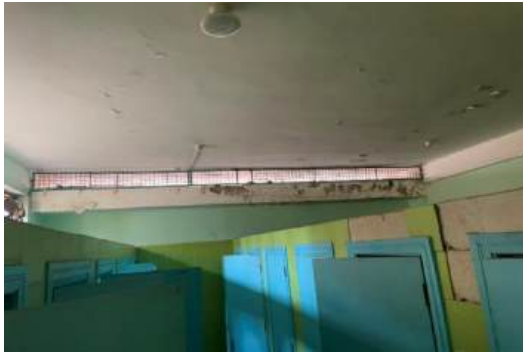
| humidity | present in some areas at the ground floor |

Humidity

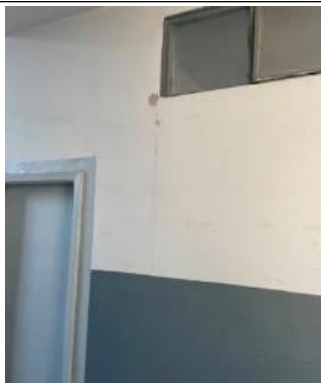
| wall Cracks | yes | | | | Location : | 1st - 2nd | | | |

pic showing cracks in walls

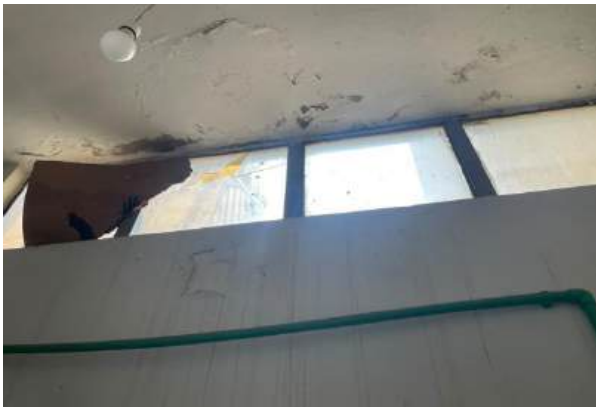
pic showing the glass to be  
changed

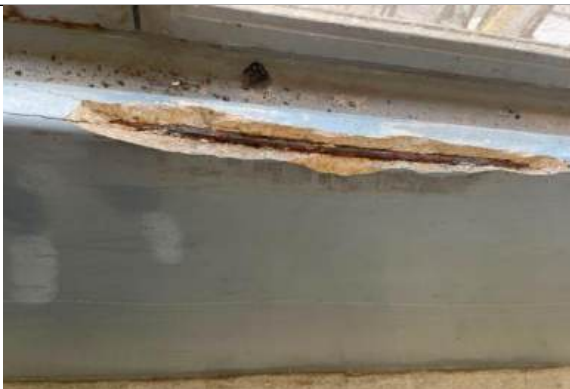
damage in the parapette

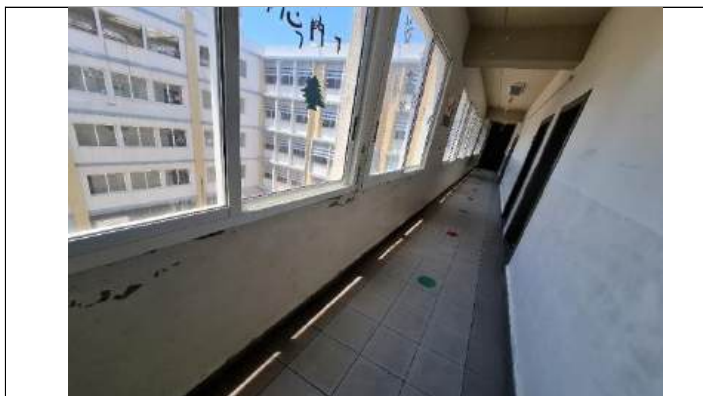
Pic showing the water leak inside the corridor

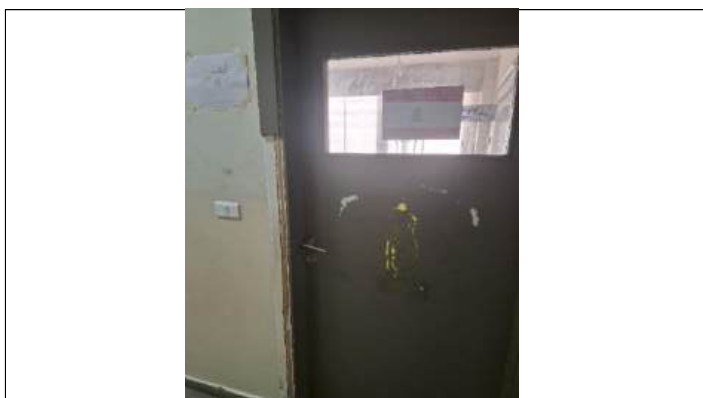
Broken wooden door need to be  
repaired

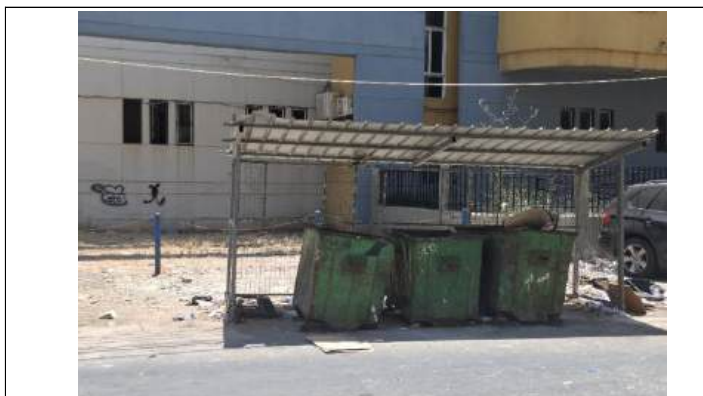
Waste containers in front of  
school's main entrance

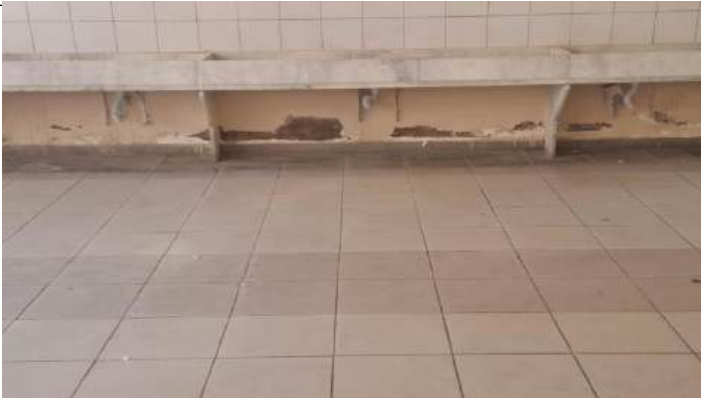
Humidity under drinking basin

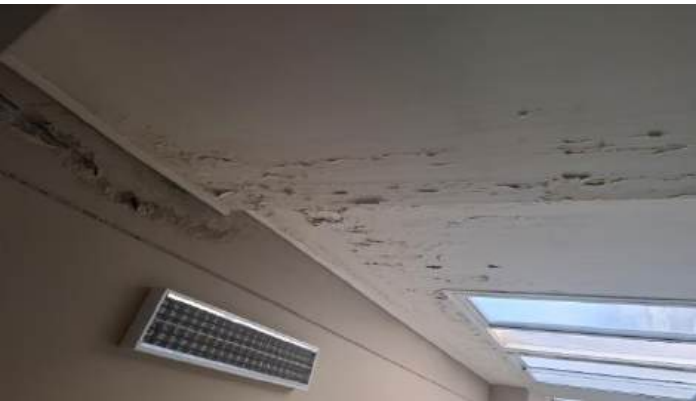
| humidity | present in the school from windows and roof floor | | |

Humidity and water leak from the  
roof and elevations shown inside  
the building

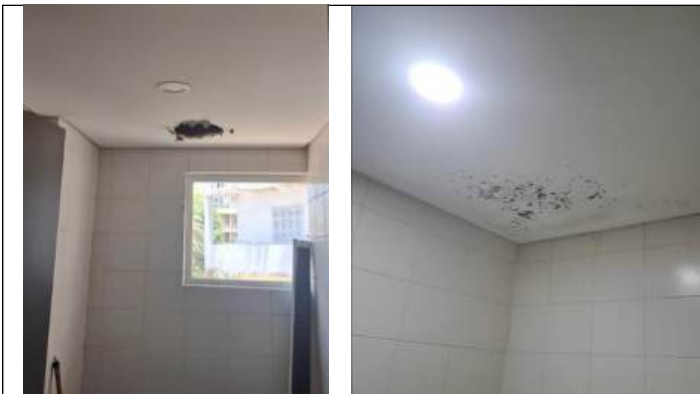
| Env.health condition within school | some wc are leaking to the floors below | | |

Drainage leak pipes from floor to  
floor at WC area

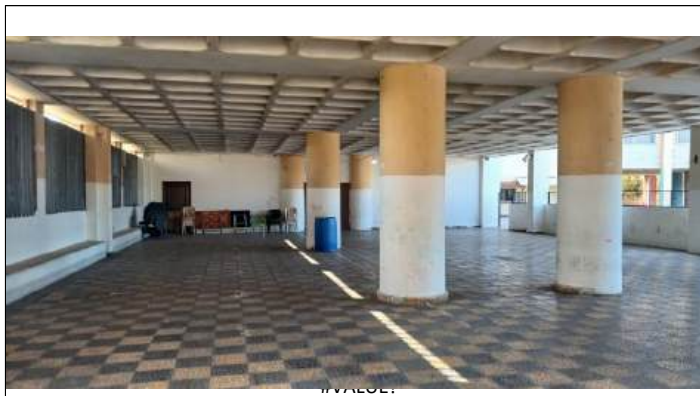
General View to school

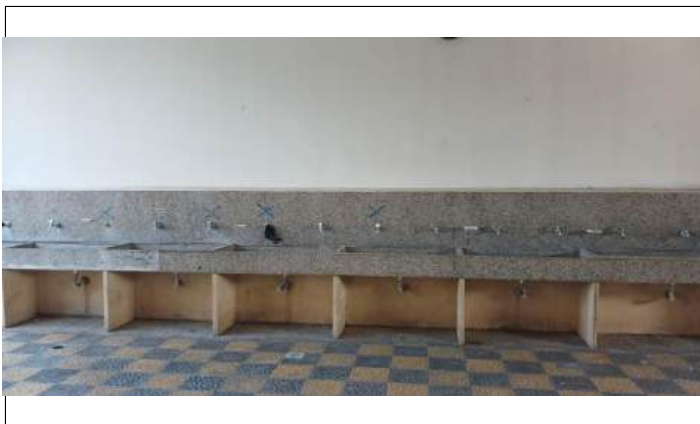
Drinking Basin inside playground

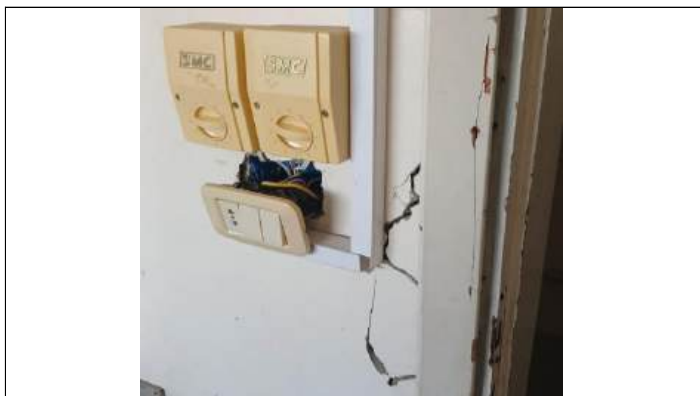
Electrical socket to be repaired

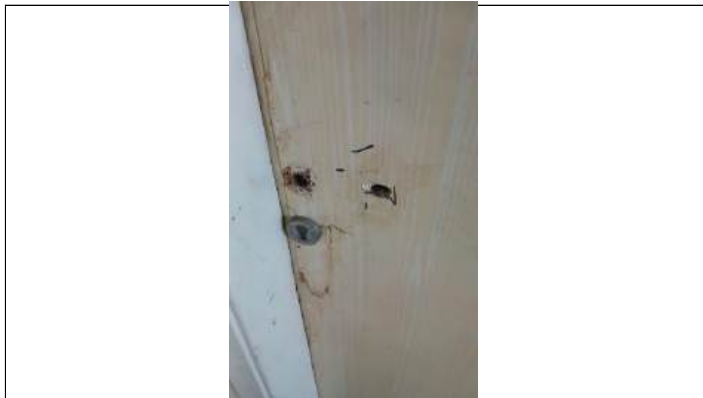
Broken wooden door need to be repaired

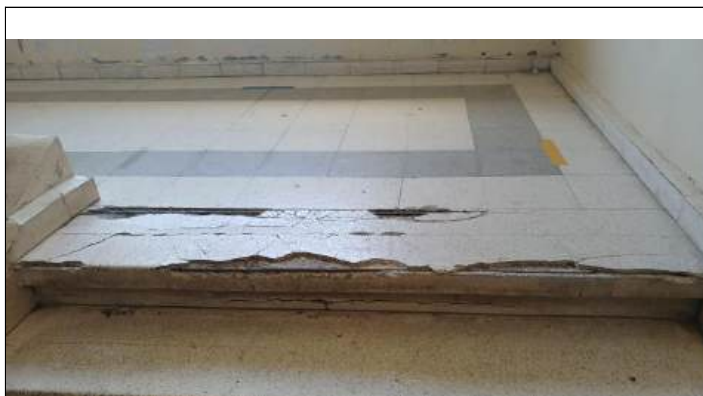
tiles need repair and its slippery

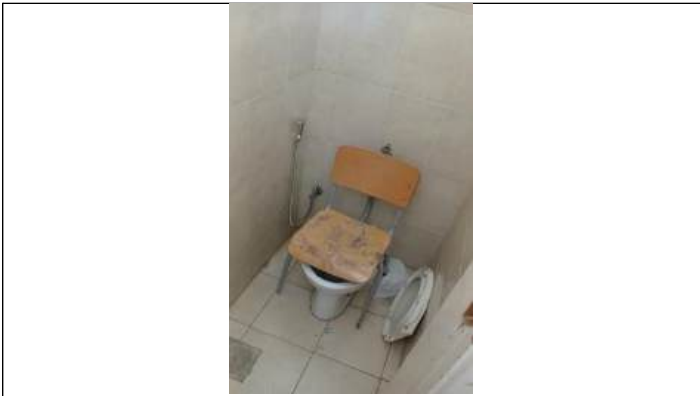
w.c status

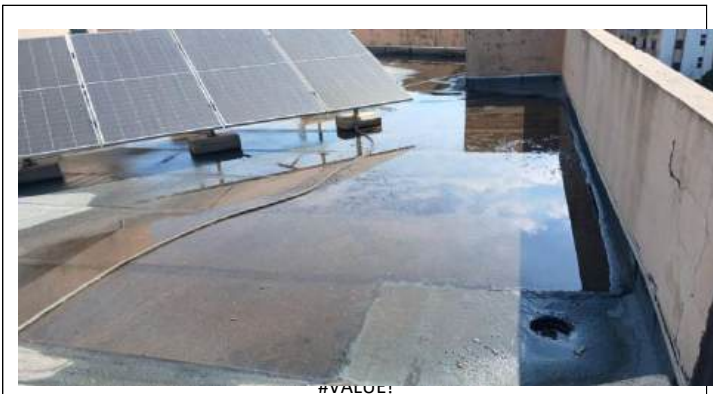
roof status

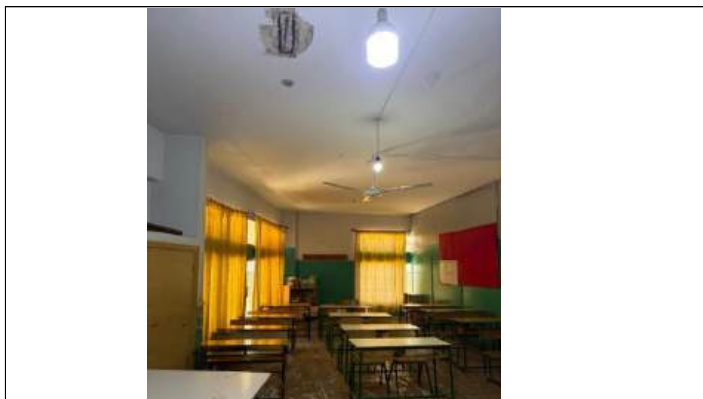
View from inside the school

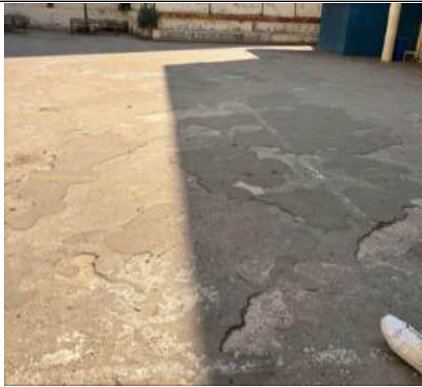
damage in the playground floor

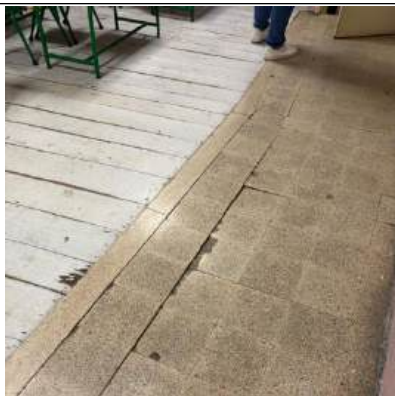
floor settlement

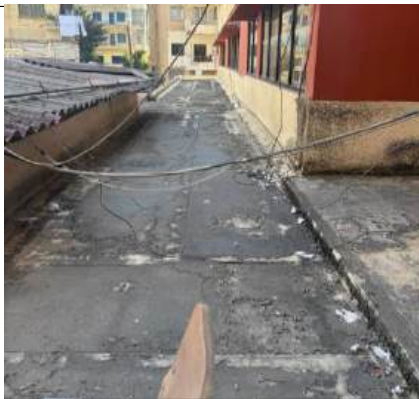
roof need to be waterproofed

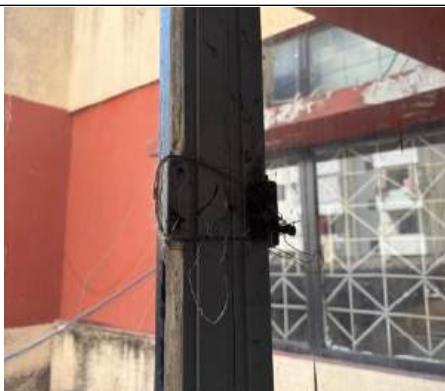
window's handle need to be fixed

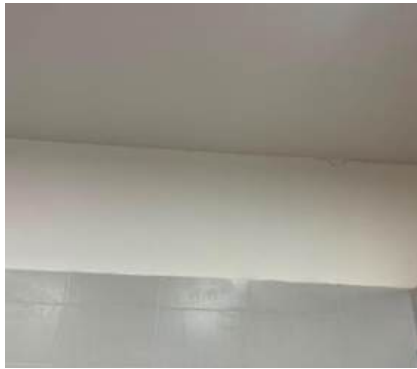
| wall Cracks | yes | | | | <b>Location :</b> | ground floor | | |

Pic showing crack in the walls

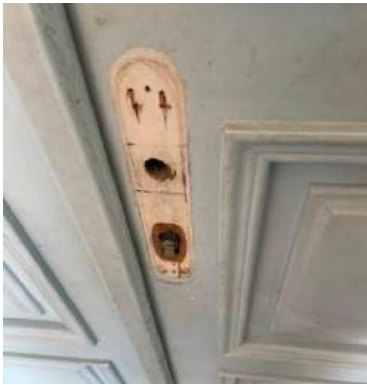
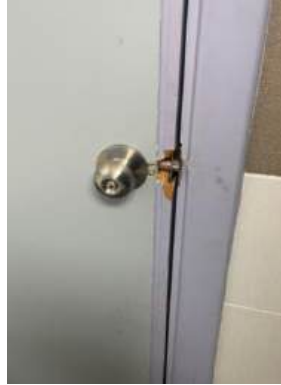
Lever handle and lock to door to  
be replaced and door to be  
painted

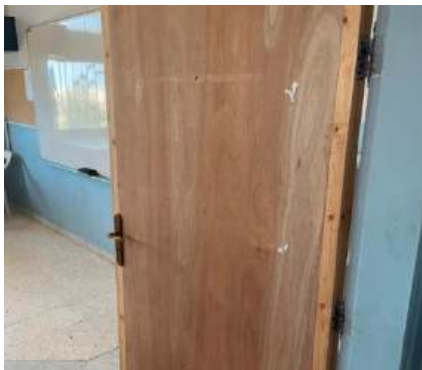
damage in doors needs t be fixed

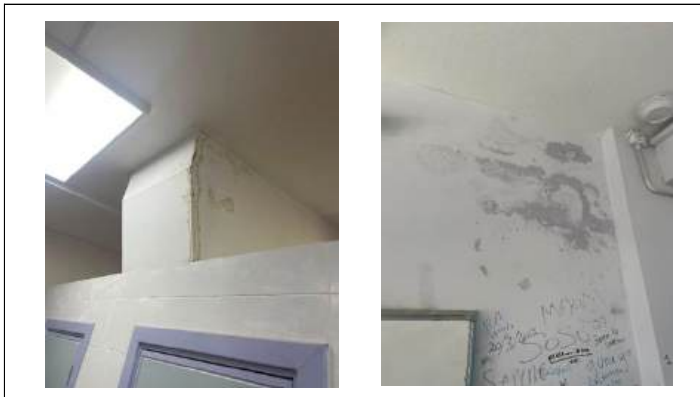
| humidity | present in some areas at the ground floor | | |

pic showing the humidity in the walls

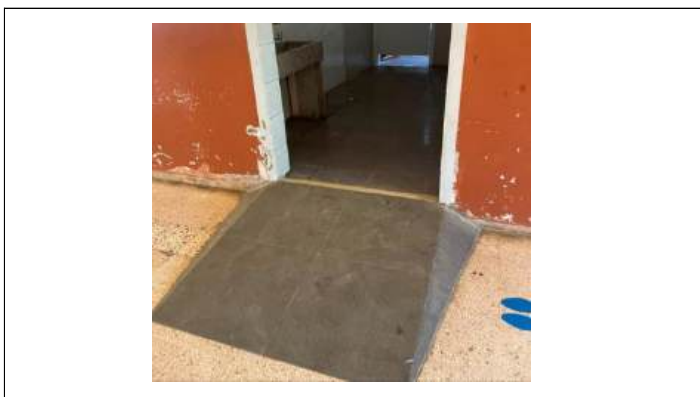
handicap ramp for the toilet

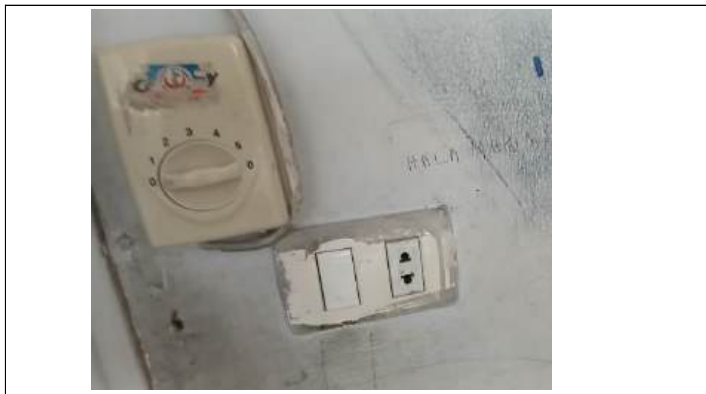
Electrical socket to be repaired

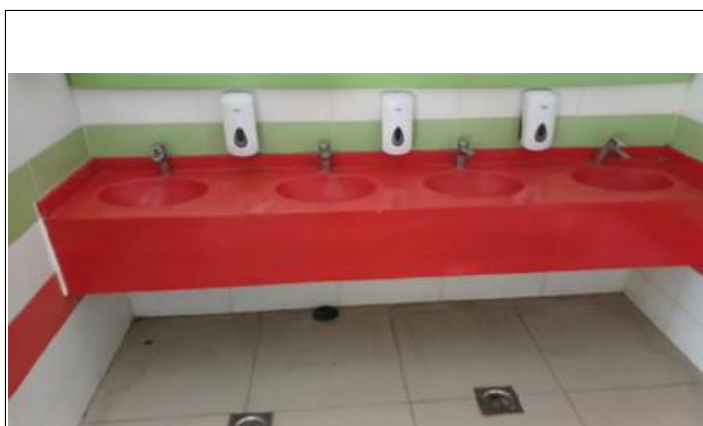
status of the washing basin

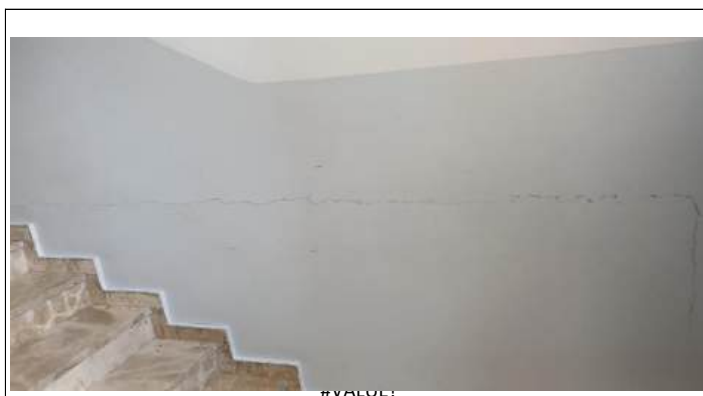
| wall Cracks | yes | | | | Location : | corridor | | |

wall need repair

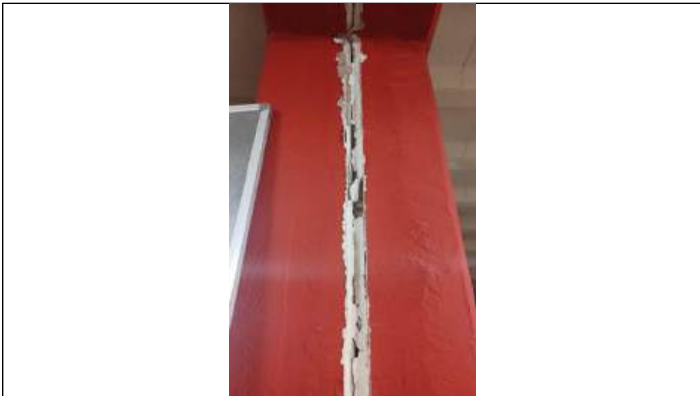
cracks between joints of coulmn

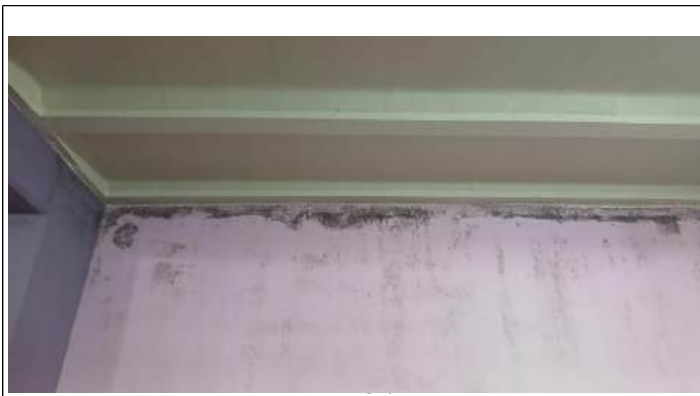
| Façade water leak | yes | | | | Location : | around windows | | |

| humidity | present in the school from windows and roof floor | | |

Humidity and water leak from  
elevations shown inside the  
building

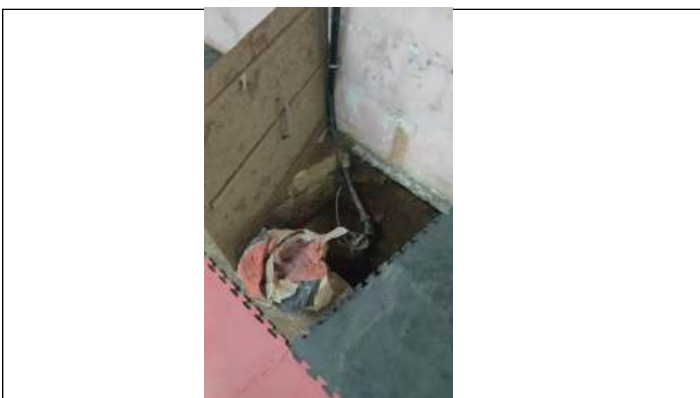
bassment pump status

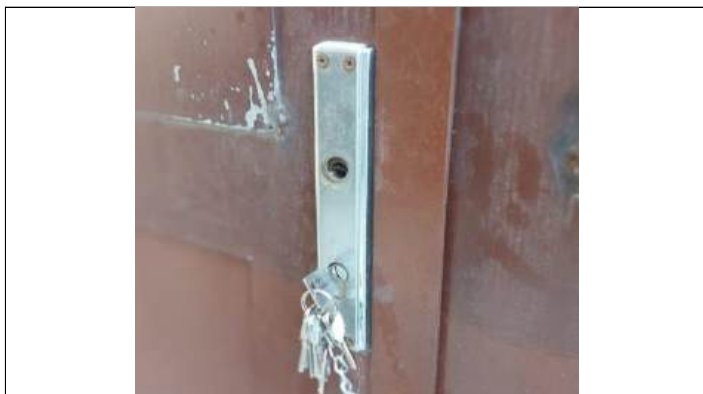
Broken metal door need to be repaired

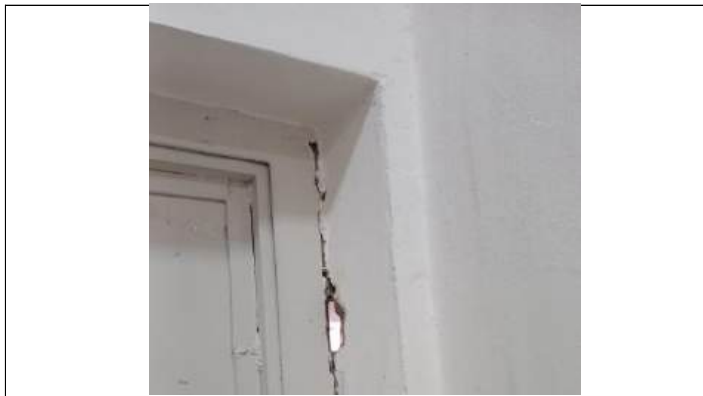
Broken wooden door need to be repaired

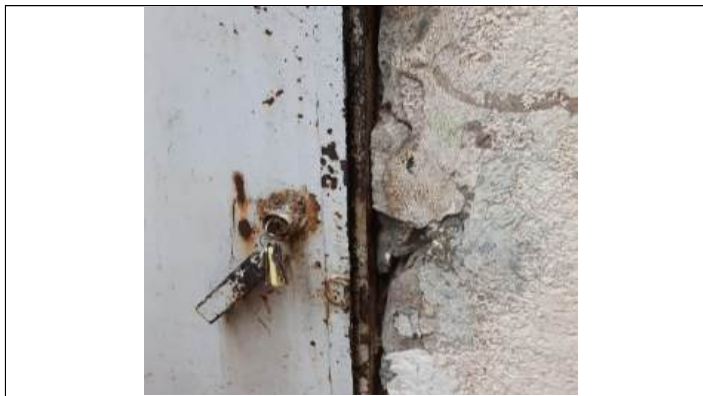
Broken metal door need to be repaired

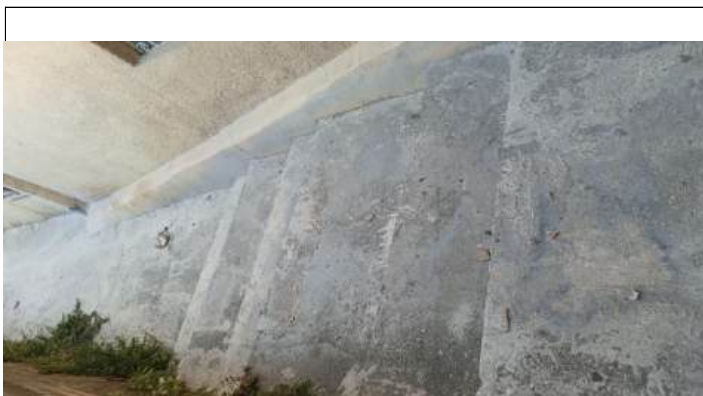
tiles need repair and its slippery

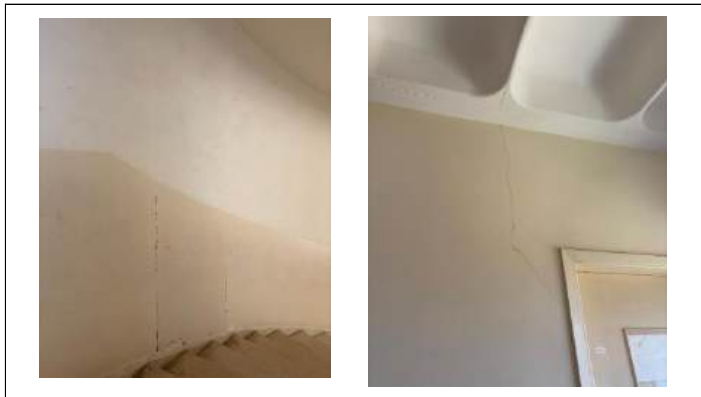
| wall Cracks | yes | | | Location : | third floor | |

Pic showing crack in the walls

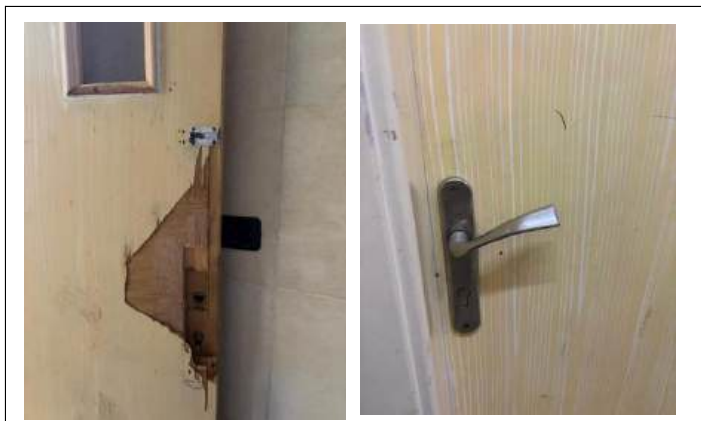
Lever handle and lock to door to be replaced and door to be painted

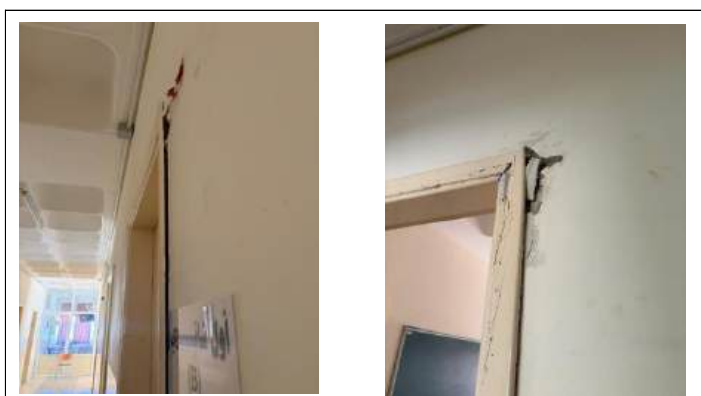
damage in doors needs t be fixed

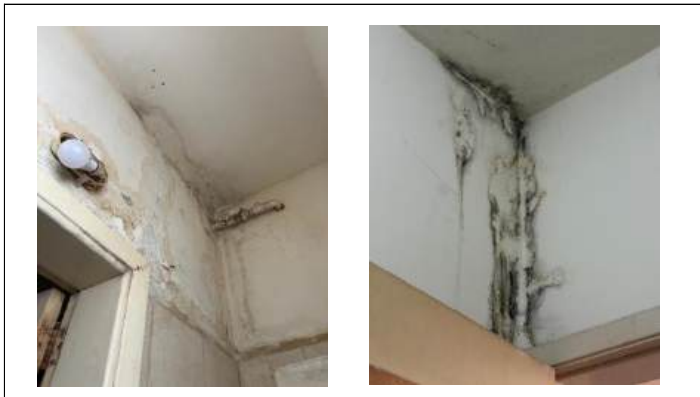
| humidity | present in some areas at the ground floor | | |

pic showing the humidity in the ceiling

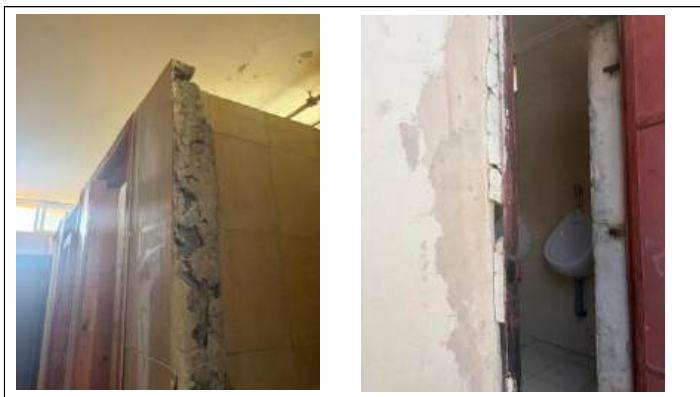
damage in the outdoor toilet

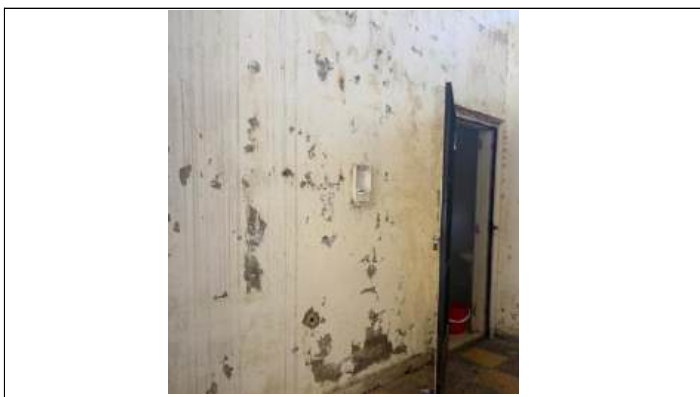
damage in the playground walls

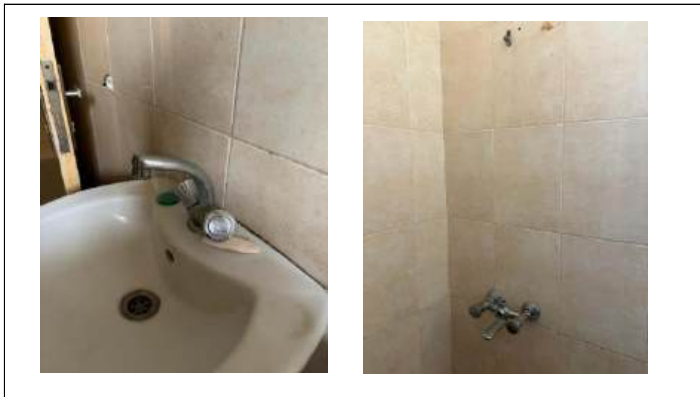
damage in the toilet

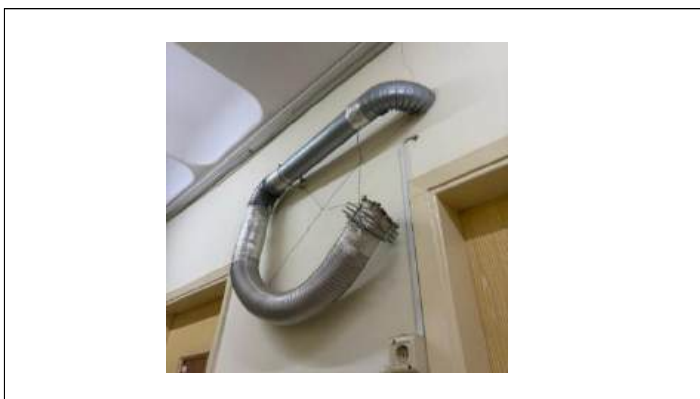
damage of exhost

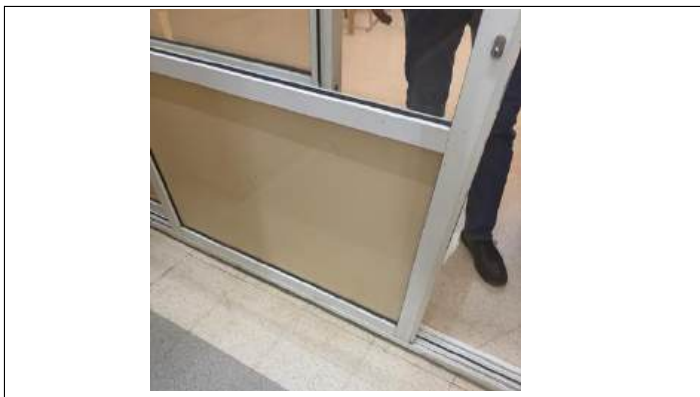
maintenance of aluminium door

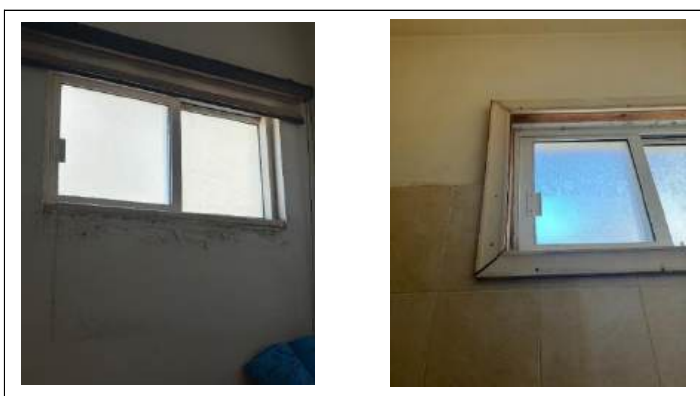
damage in the windows

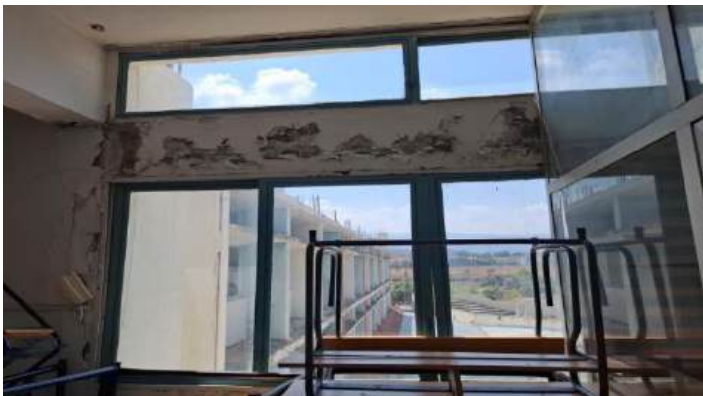
Pic showing the water leak inside  
the building

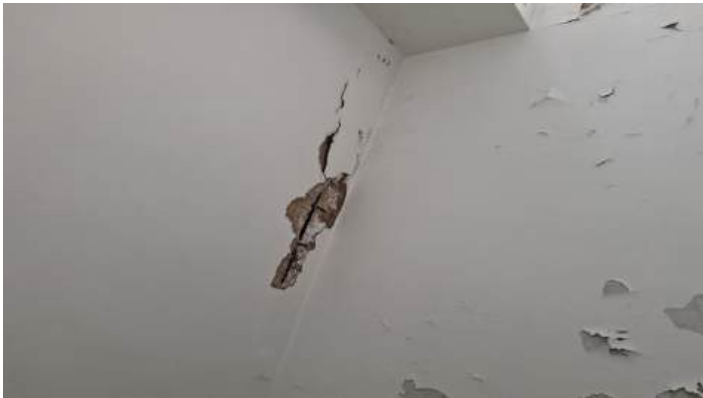
crack and rusted steel which  
required special method to rehab

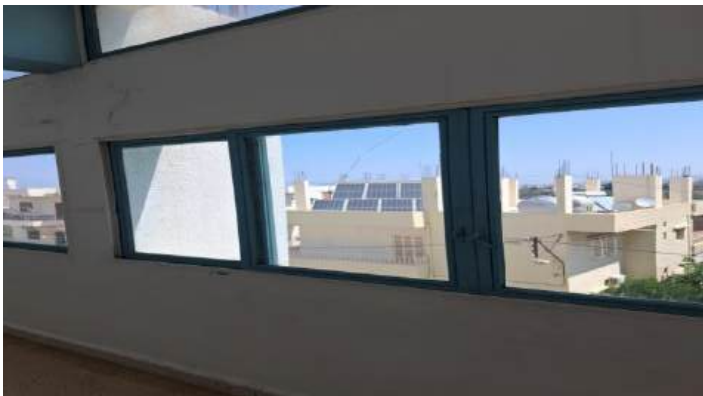
The majority of steel windows are  
not working properly

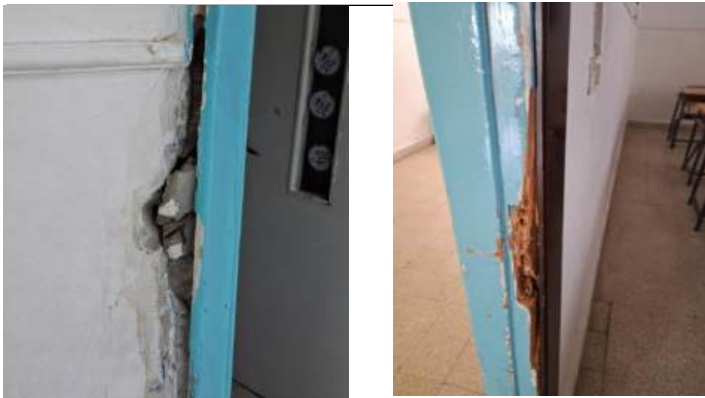
Pic showic the bad situation of woden doors

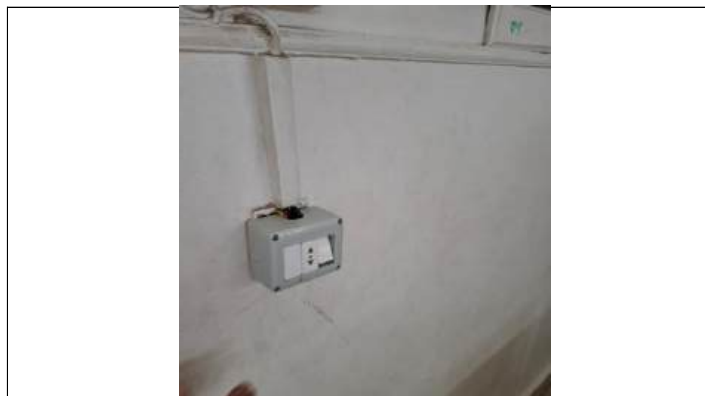
pic showing a malfunctioning electrical socket and switch

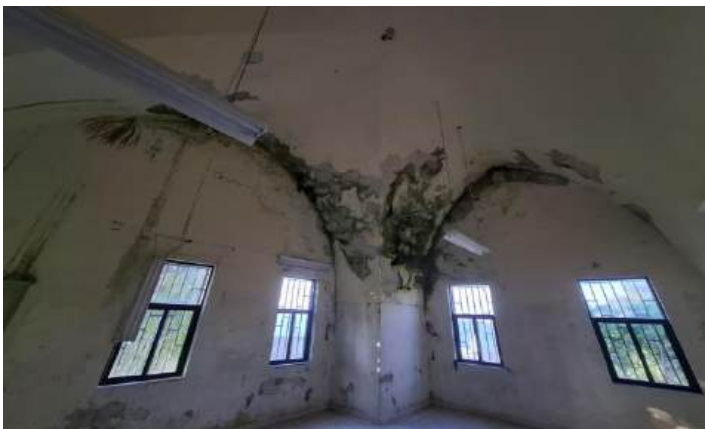
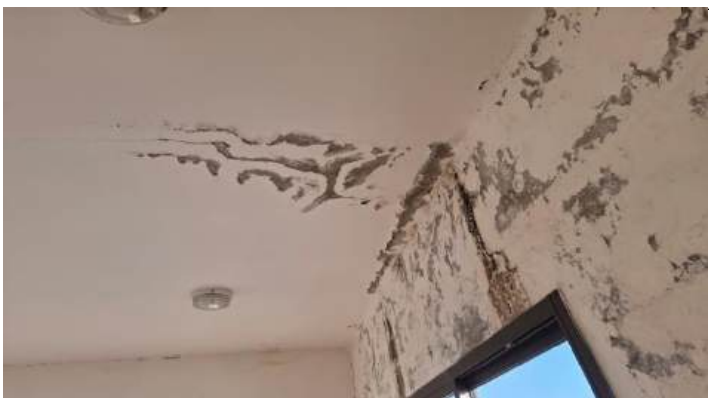
Pic showing the water leak inside  
the building

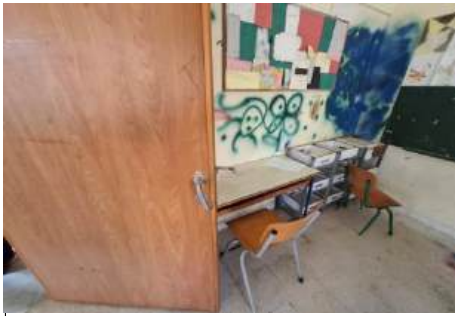
Pic showic the bad situation of woden doors

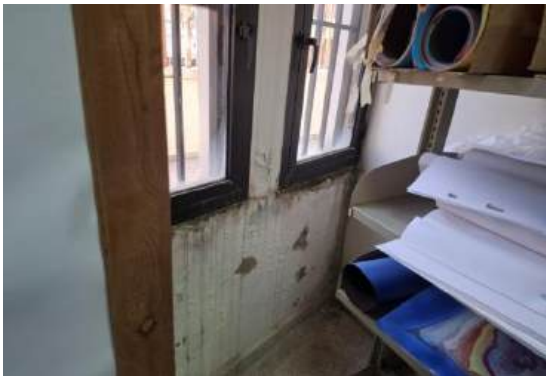
Picture showing the water leak thru wall and windows

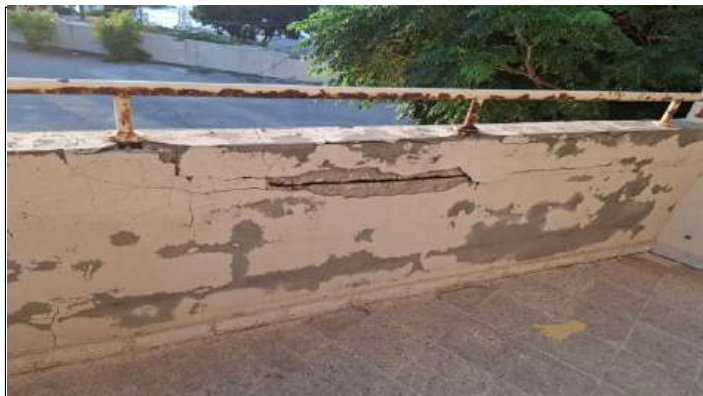
crack and rusted steel which required special method to rehab

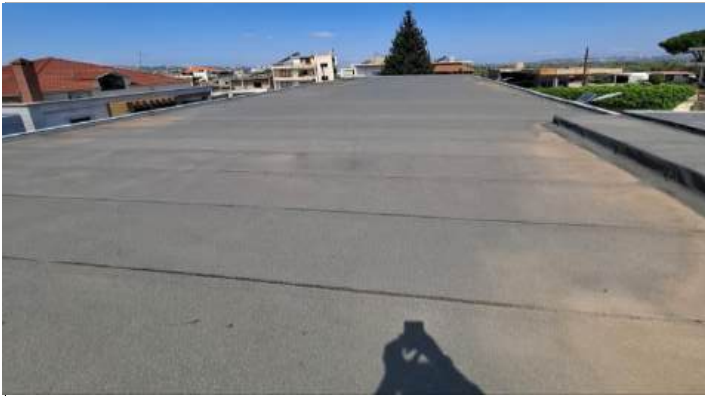
Existing Water proofing  
membrane which required to be  
changed

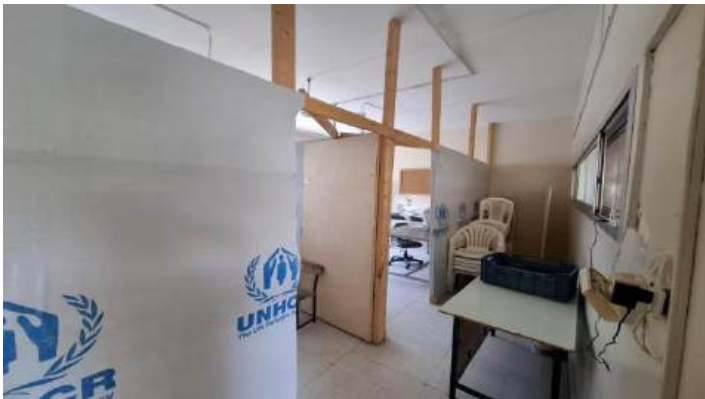
Wooden partition installed by  
shelters inside the room

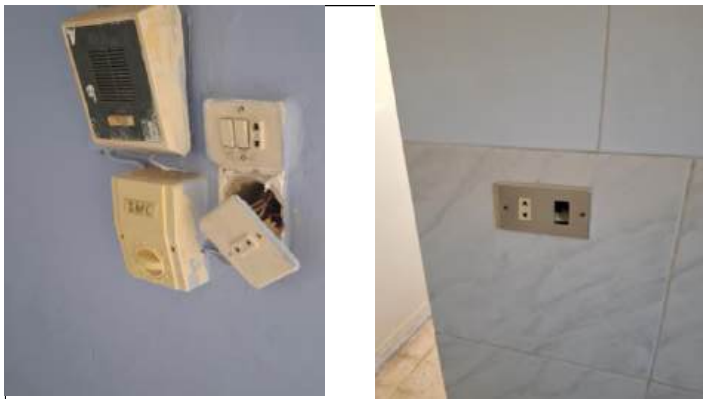
pic showing a malfunctioning electrical socket and switch

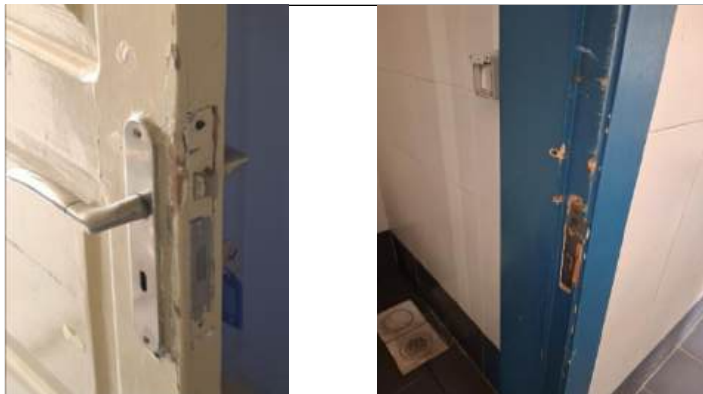
this pic reflect the bad condition of the existing woden doors

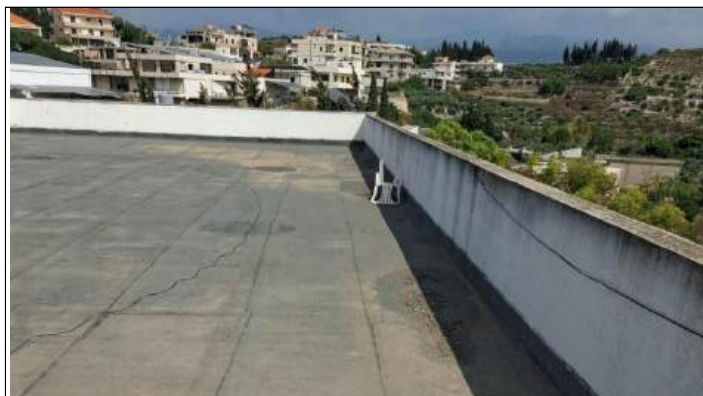
Existing Water proofing  
membrane which required to be  
changed

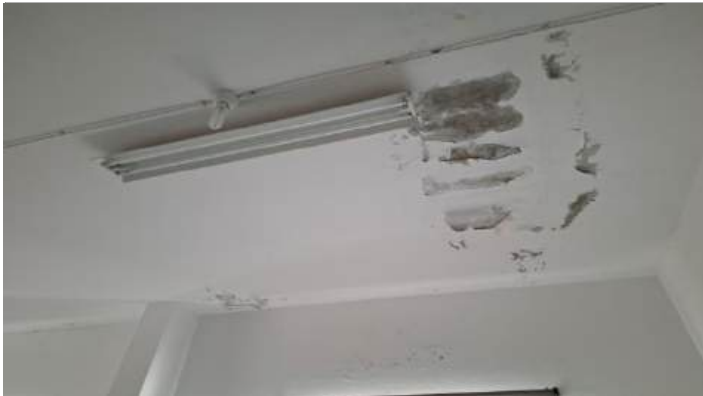
Water leak thru ceiling and  
existing old lighting.

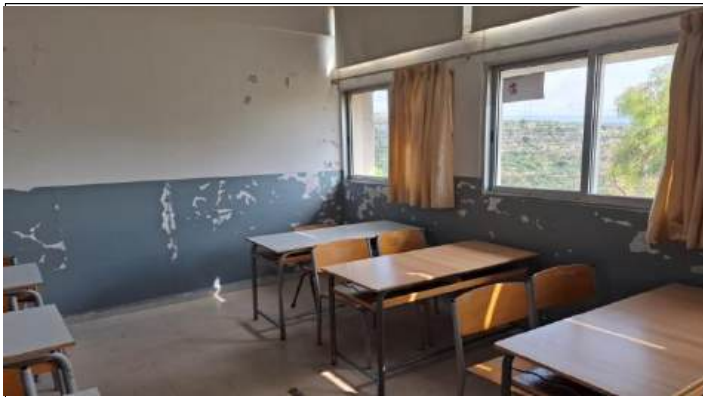
Water leak thru elevation

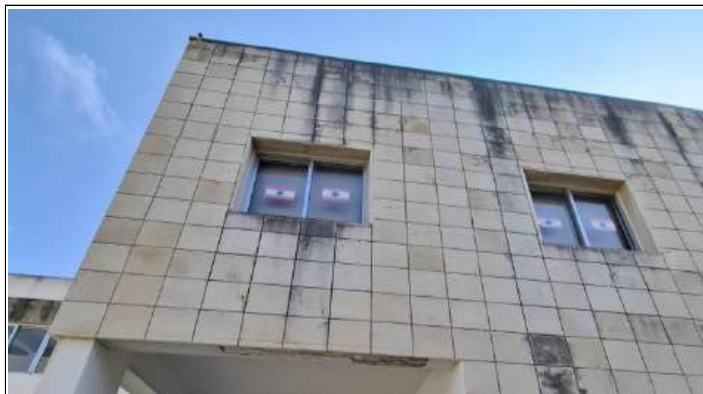
Water leak thru elevation

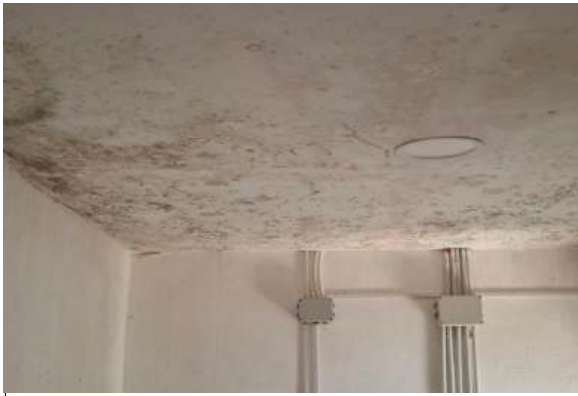
Water leak thru ceiling

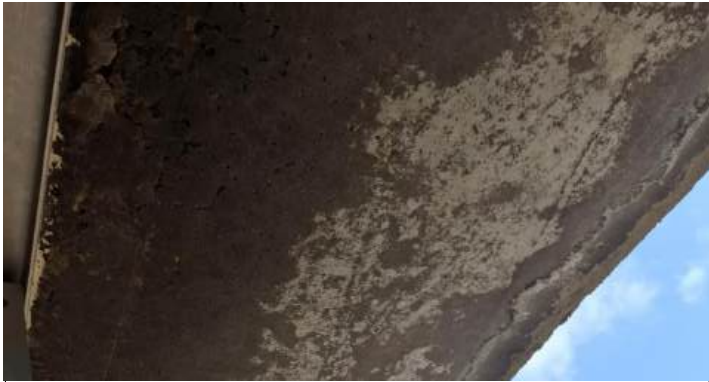
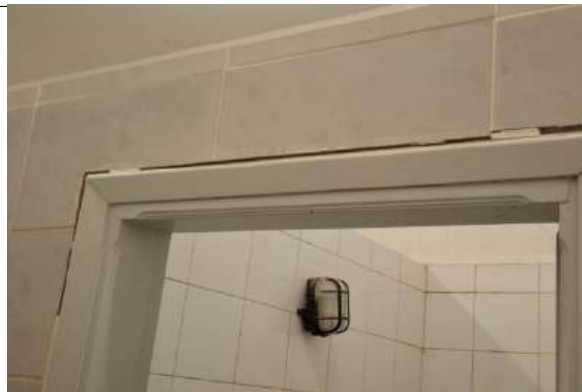
Door and ceramic grout  
rehabilitation is required

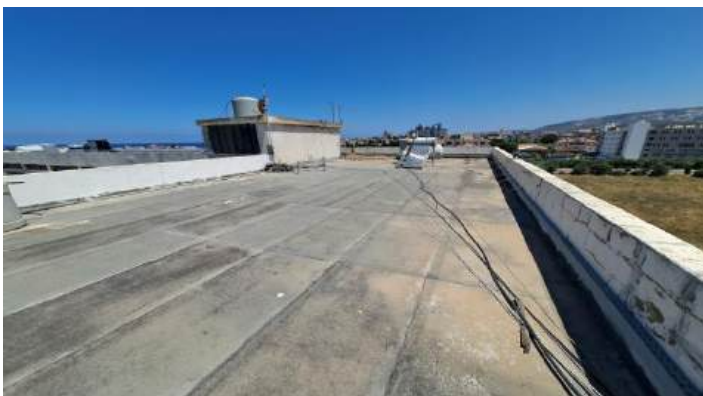
Existing Water proofing  
membrane which required to be  
changed

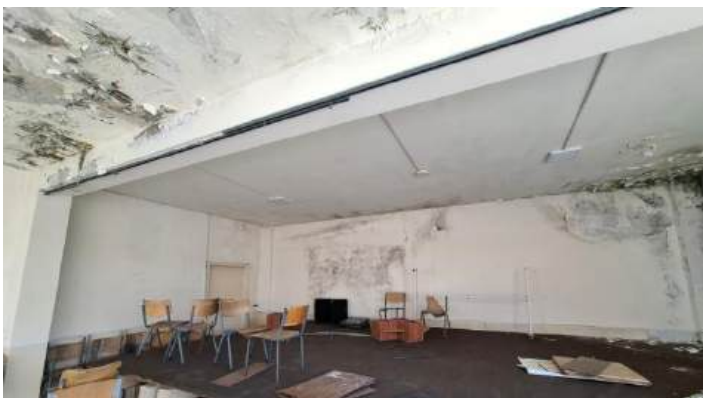
the bad condition of the structure of the slab due to humidity and water leak, and which required maintenance

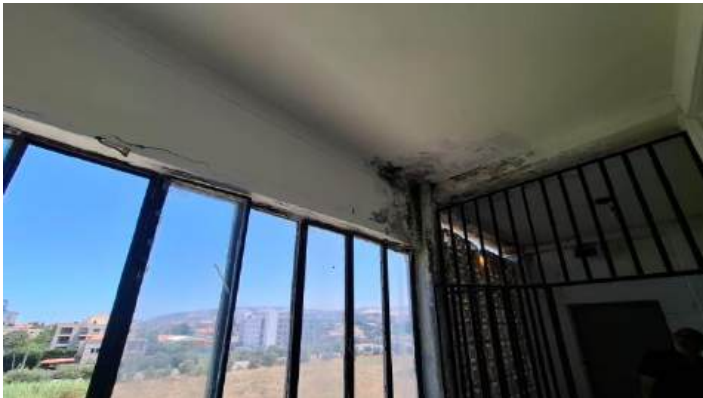
the majority of the existing steel windows are in very bad condition and need to be replaced

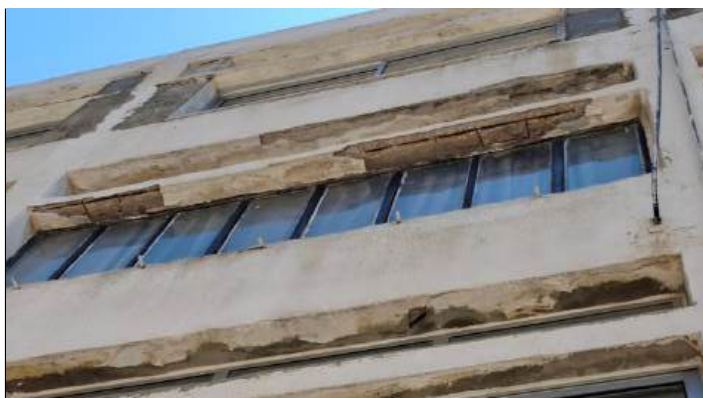
this pic reflect the bad condition of the existing building structure

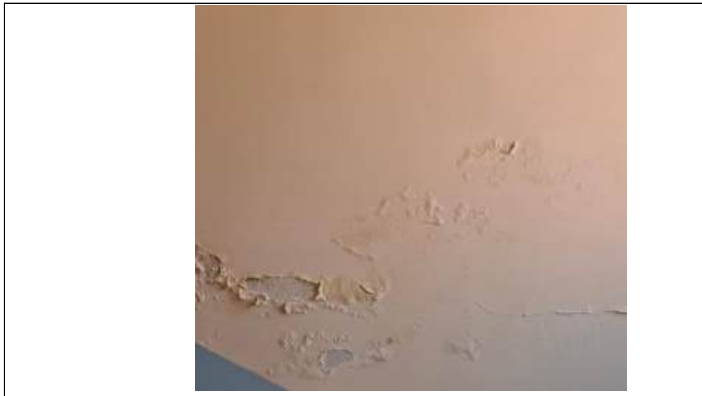
Water leak thru ceiling and elevation

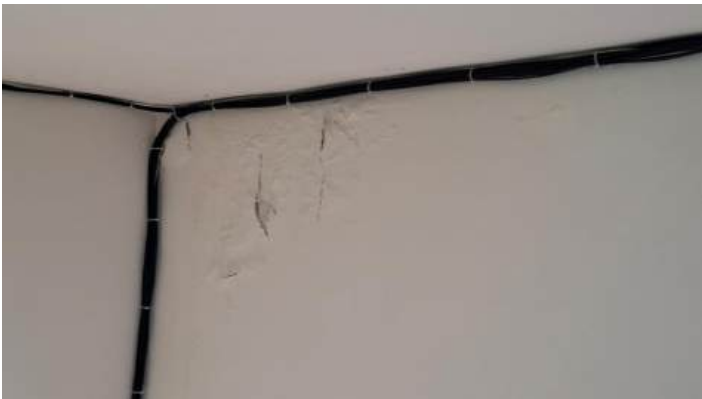
Water leak thru elevation

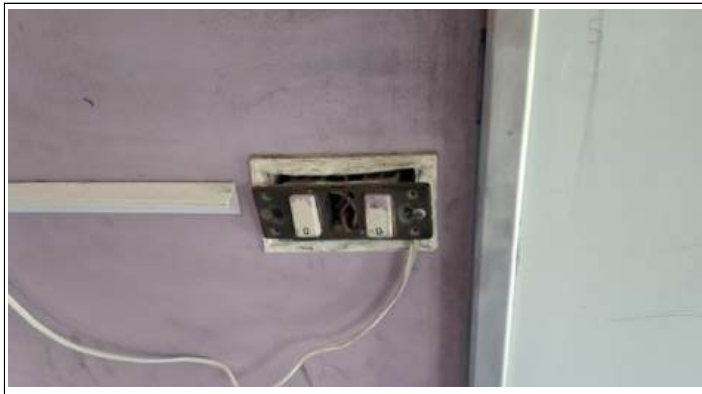
Pic showic the bad situation of electric socket

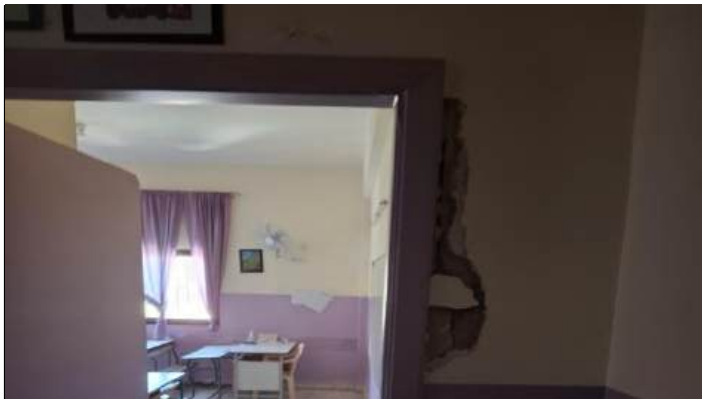
the wall near the wooden frame need to be rehabilitated

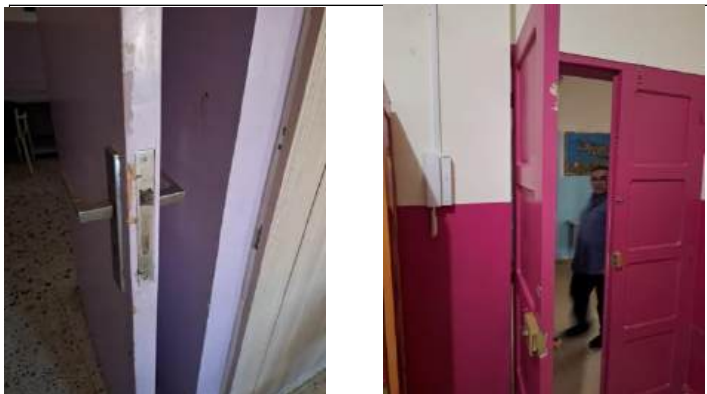
picture showing the wooden doors paint condition

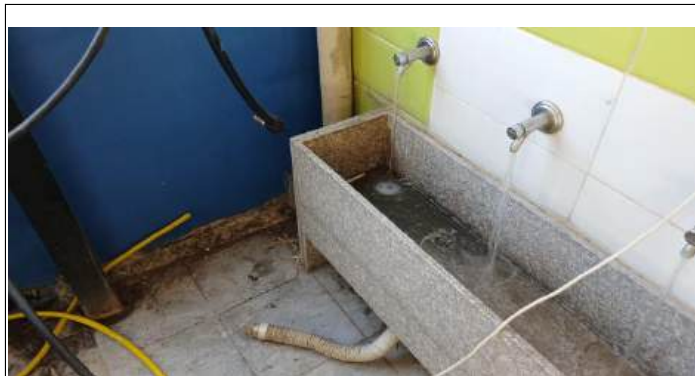
Drinking Basin inside playground

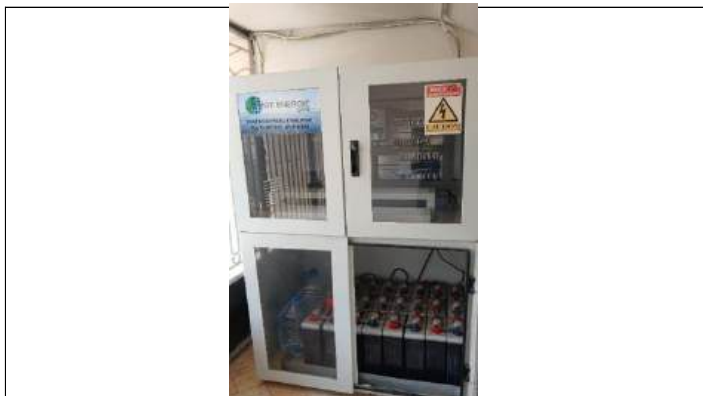
Electrical word to be repaired
