Consultancy Services for  
Tender Preparation and Construction Supervision Consultant for  
Shelters  
Lebanon Emergency Assistance Project (LEAP)

**ASSESSMENT REPORT  
BATCH 2 - LOT 2**

July 2026

**BATCH 2 - LOT 2**  
**TRIPOLI & NORTH LEBANON SCHOOLS**  
**GENERAL INDEX**

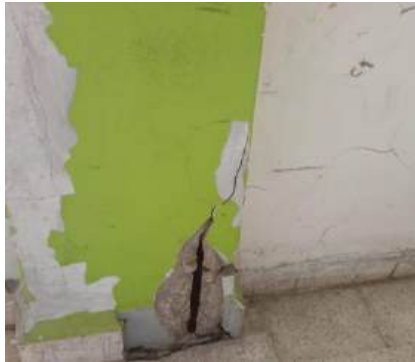
cracks in column need to be repaired

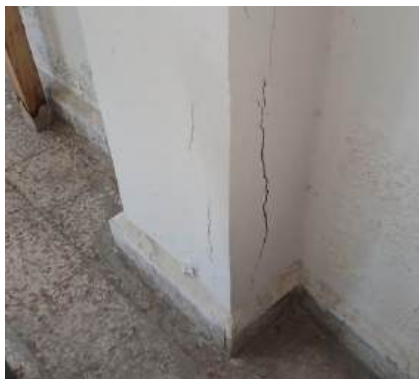
cracks in column need to be repaired

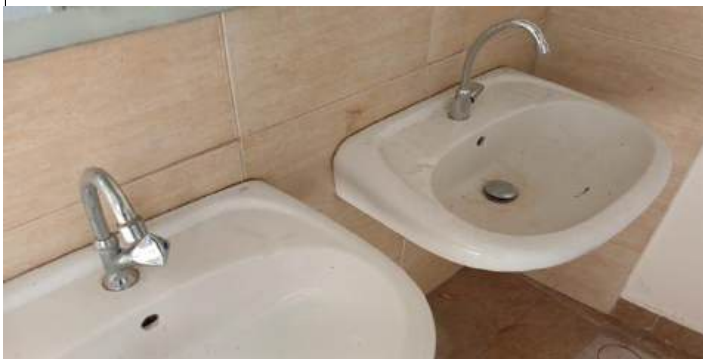
status of the washing basin

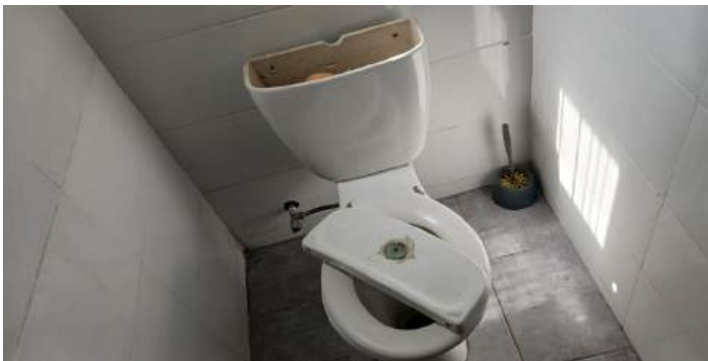
w.c need to be repaired

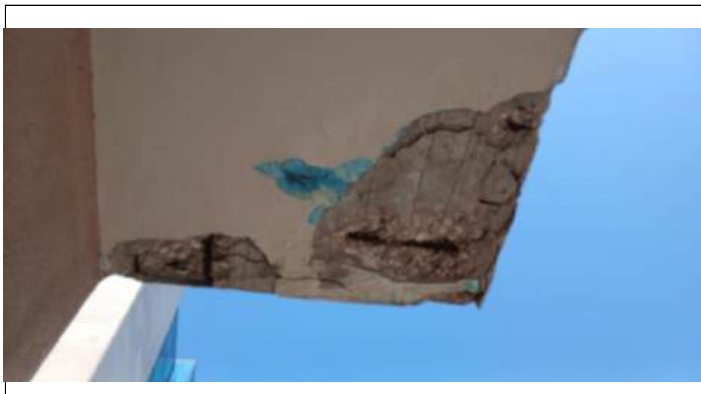
cracks in slab need to be repaired

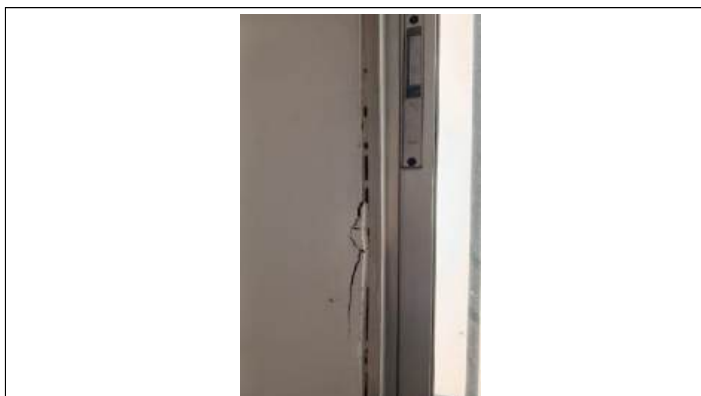
| Environment | | | |
|---|---|---|--|
| humidity | present in the school from windows and roof floor | | |

Humidity and water leak from the  
roof and elevations shown inside  
the building

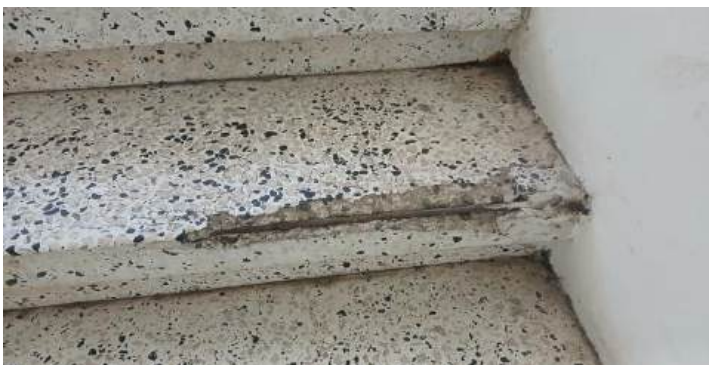
stairs need to be repaired

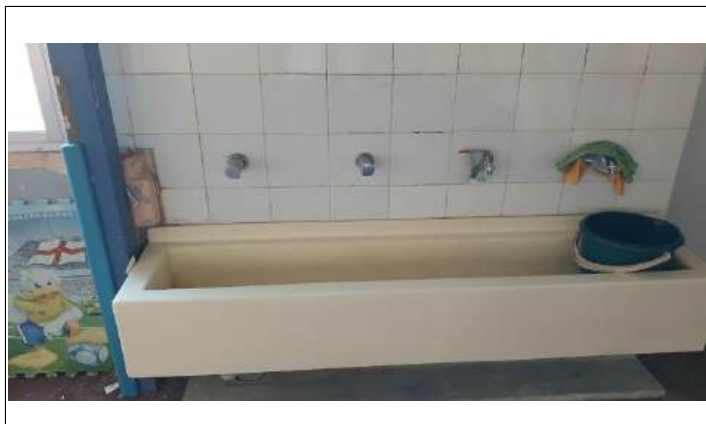
Drinking Basin inside playground

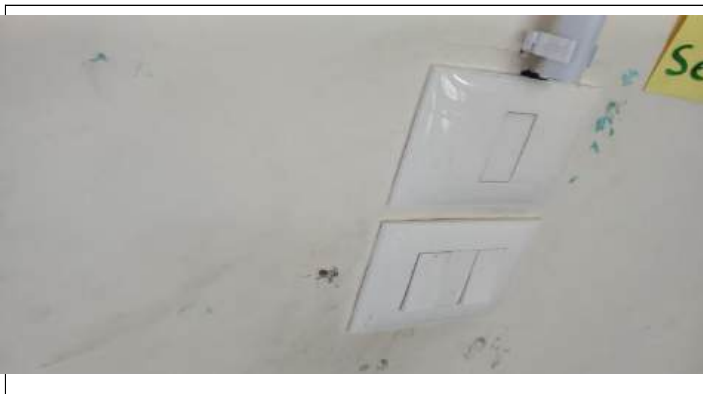
Electrical socket status

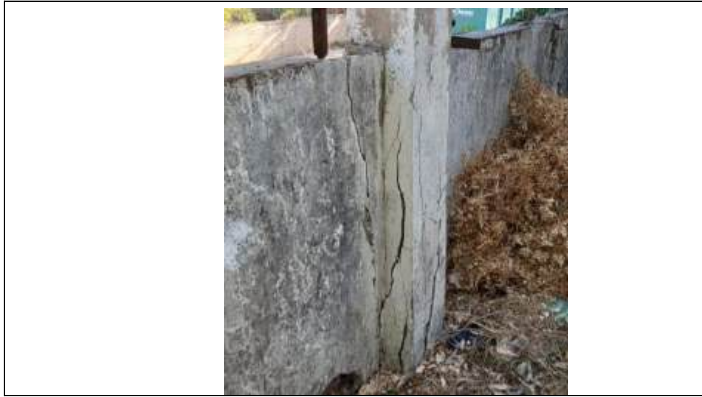
cracks wall &column need to be  
repaired in play ground

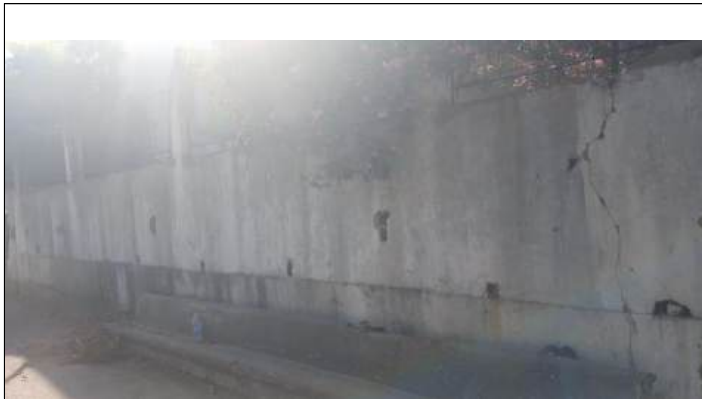
cracks wall &column need to be  
repaired

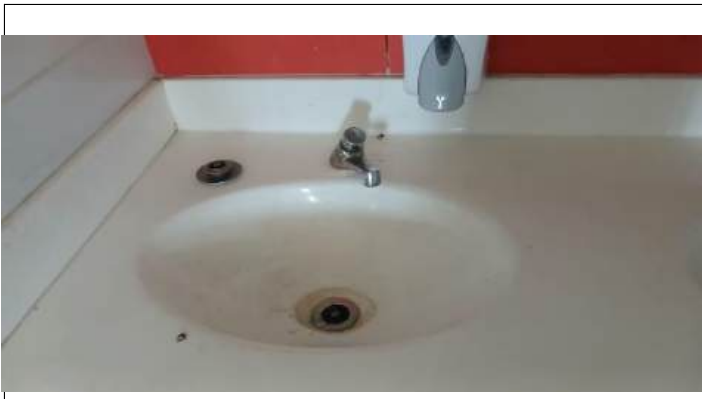
status of the washing basin

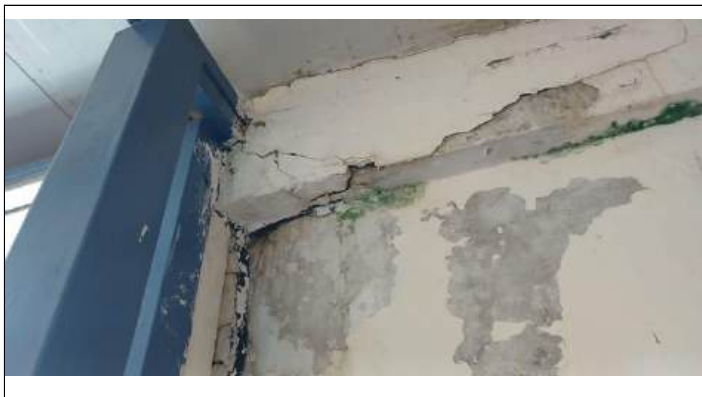
moisture on the wall need to be  
repaired

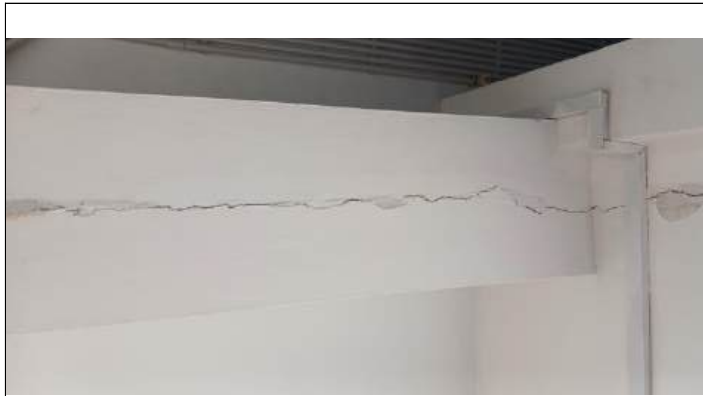
| Beams cracks | yes | | | | Location : | corridor second floor | | |

cracks in beams to be repaired

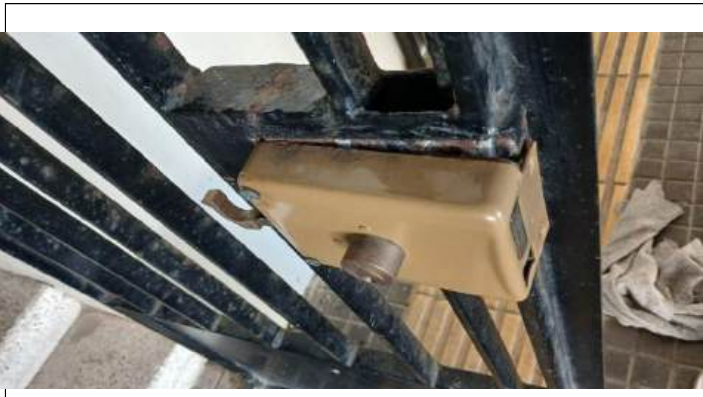
status of the steel locks

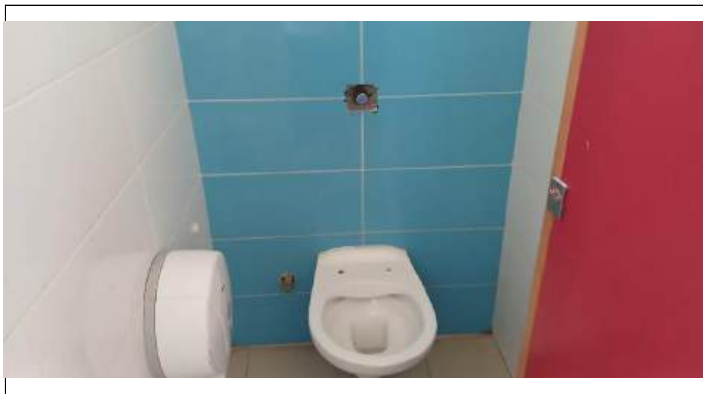
Humidity and water leak at WC  
area and leaking

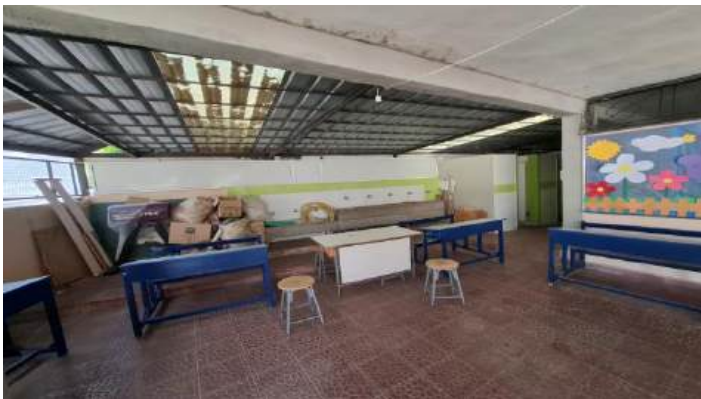
Pic showing the water leak

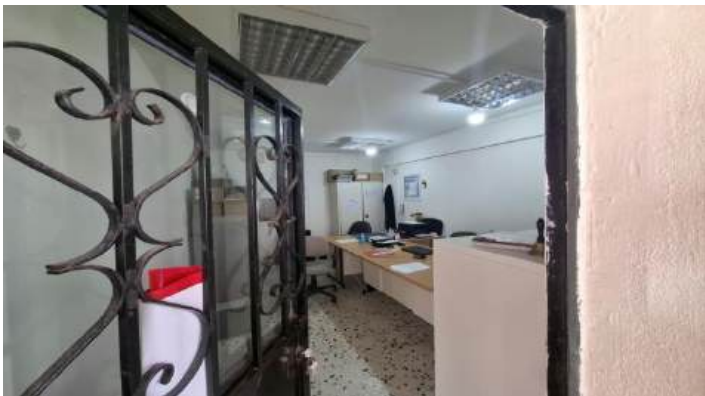
Pic showing the damaged steel door

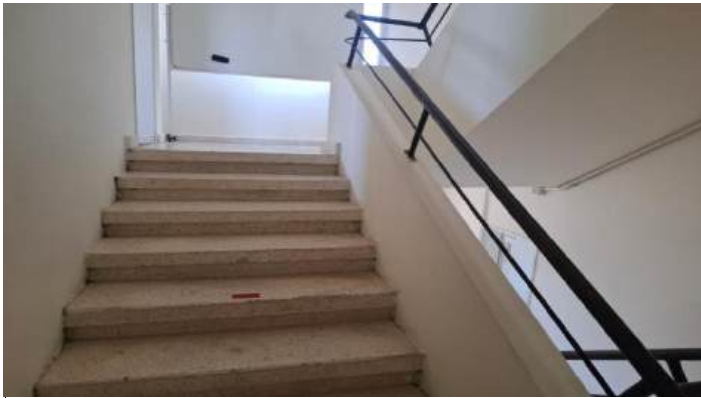
picture inside the school stair  
case

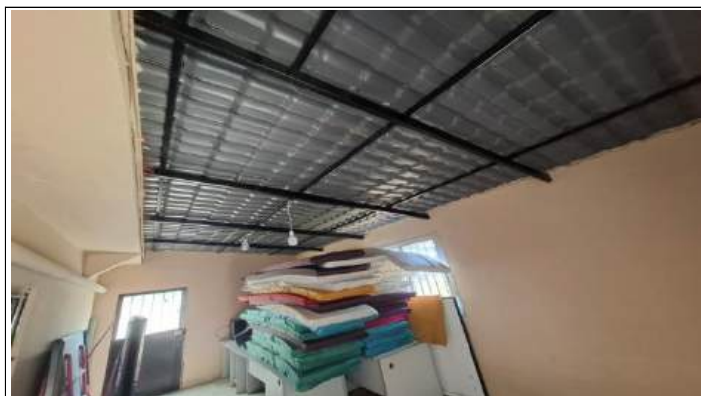
Water leak thru TOT

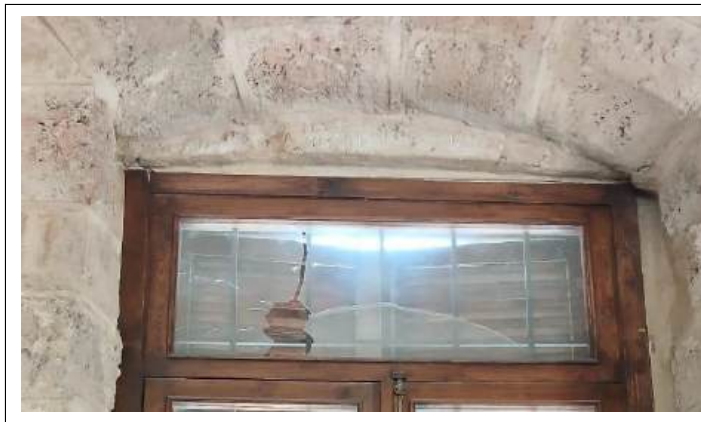
windows status

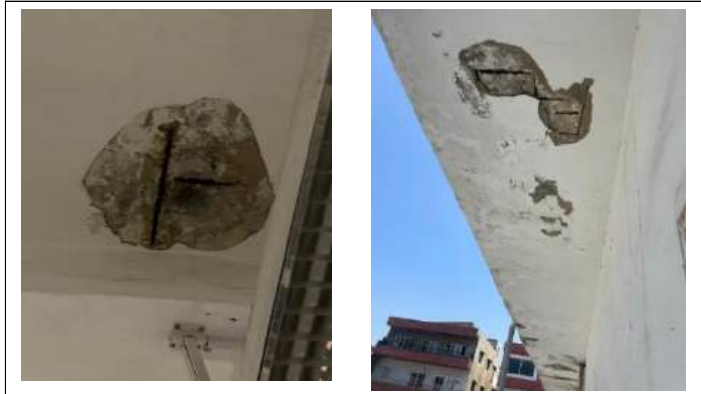
| Roof slab cracks | yes | | | | Location : | 1st |

Pic showing damage in the ceiling

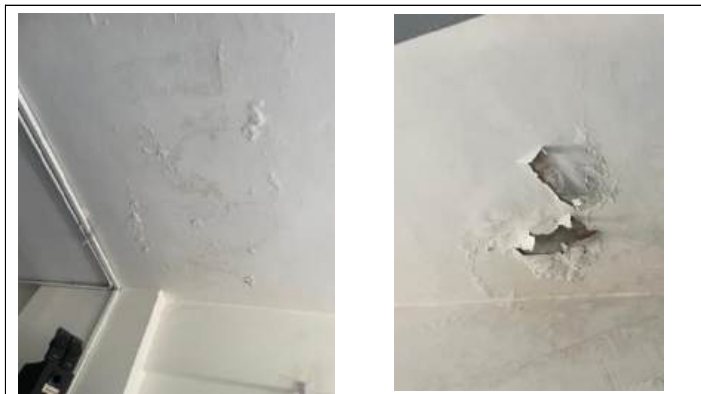
| humidity | present in some areas at first floor between rooms |

Pic showing the humidity

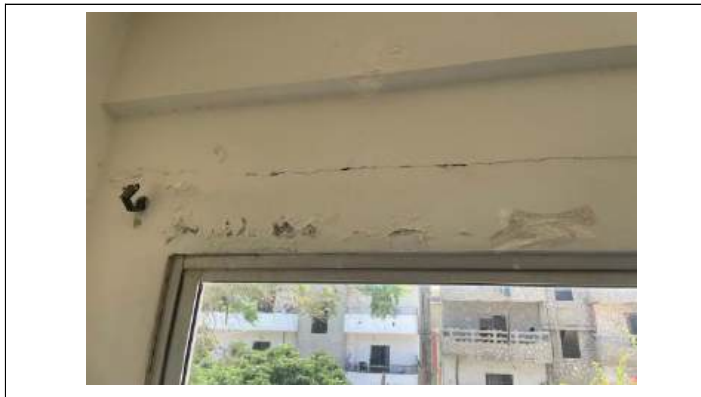
| wall Cracks | yes | | | | Location : | all |

pic showing the cracks of wall inid  
the school

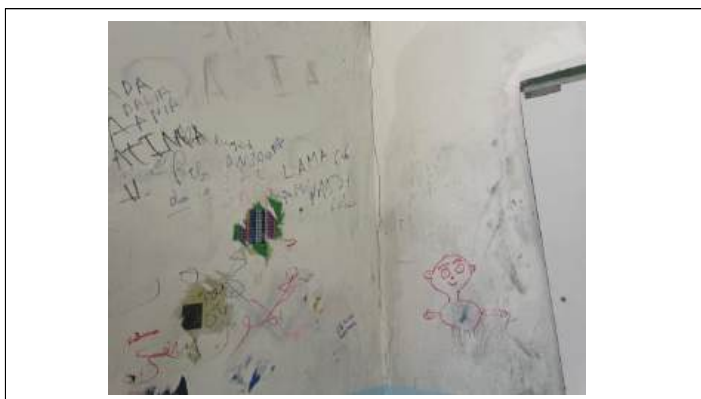
Pic showing the bad conditions if  
the paint

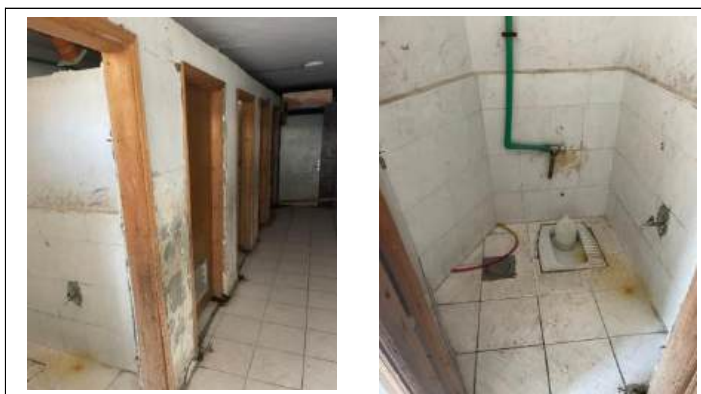
Pics showing the bad conditions  
of Wc in the school

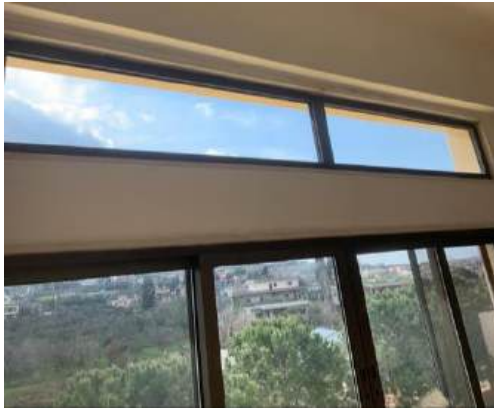
| humidity | present in the school from windows and roof floor | | |

Pic showing the humidity from  
the window

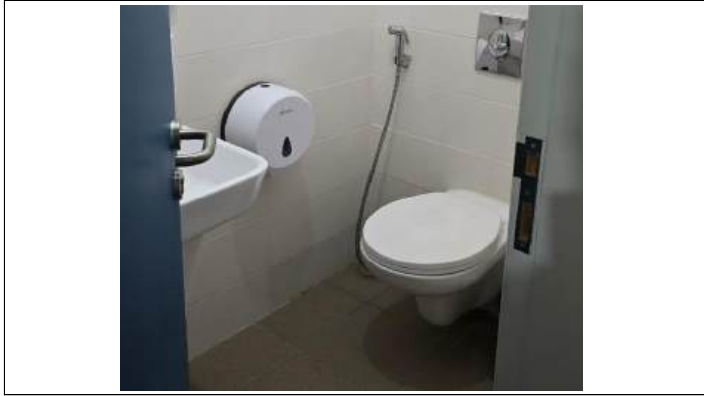
Pic showing the sanitary need to be maintain

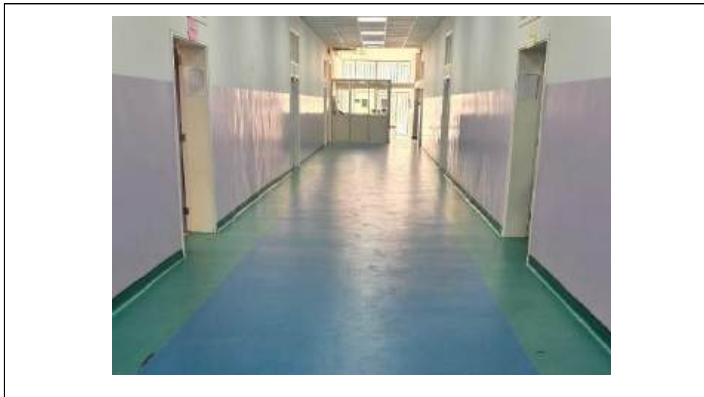
pic showing the vinyl

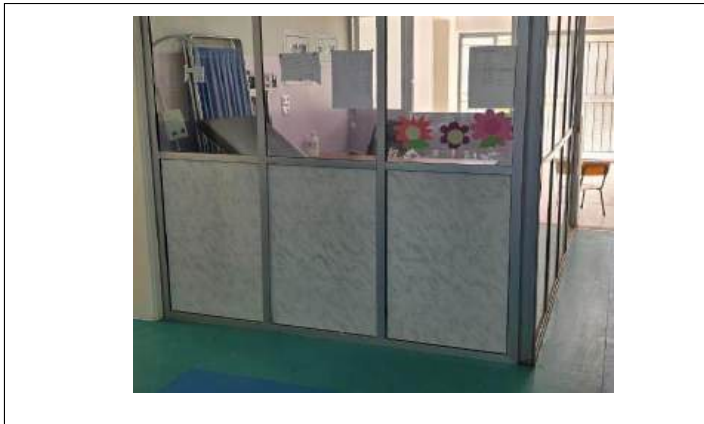
Pic showing the aluminum need to be maitain

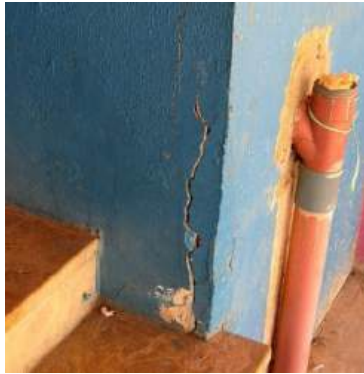
| wall Cracks | yes | | | | Location : | ground floor | | |

Pic showing crack in the walls

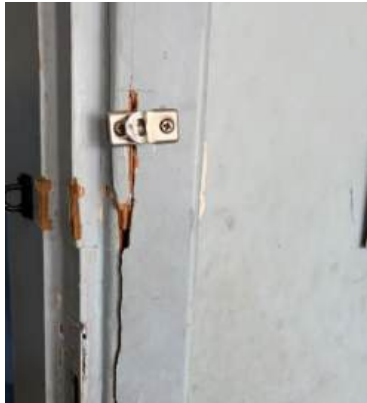
Lever handle and lock to door to be replaced and door to be painted

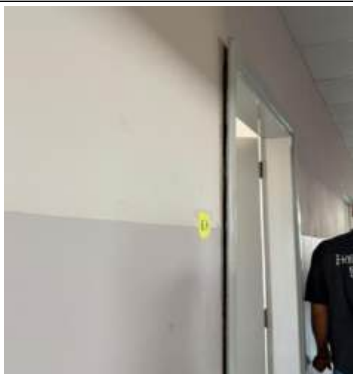
damage in doors needs t be fixed

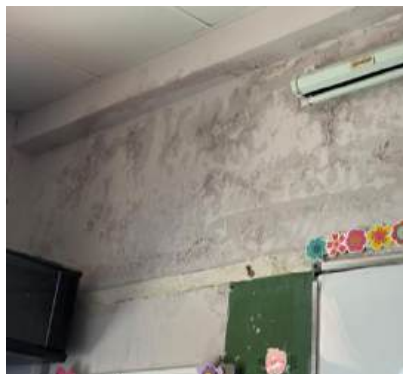
| humidity | present in some areas at the ground floor |

pic showing the humidity in the walls

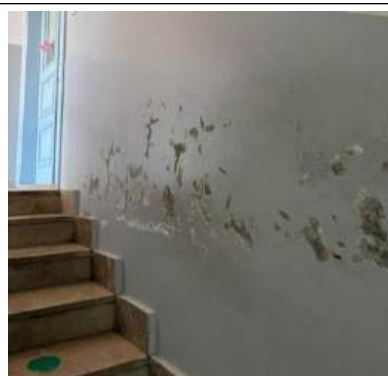
pic showing damage in walls

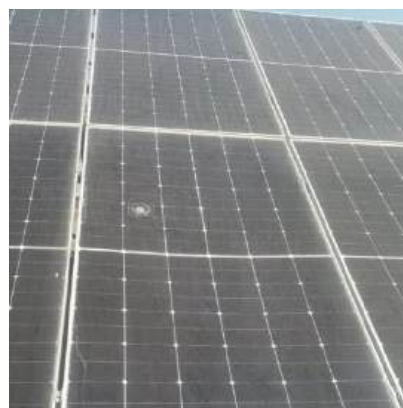
pic showing damage in the solar panel

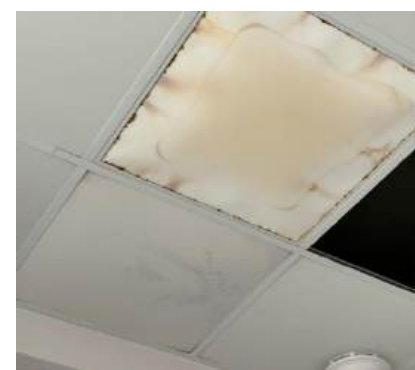
damage in the ceiling

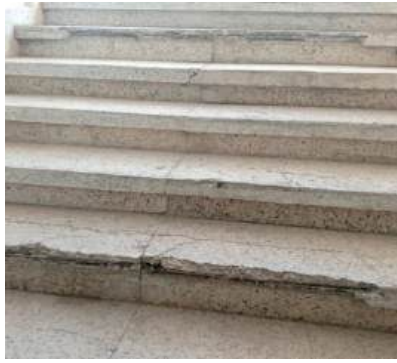
Damage of stairs

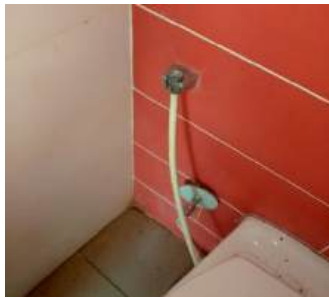
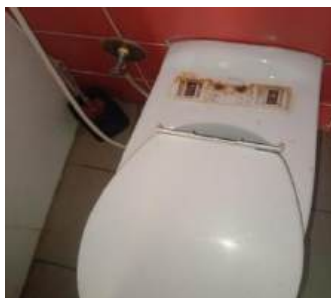
Sanitary ware in a bad condition

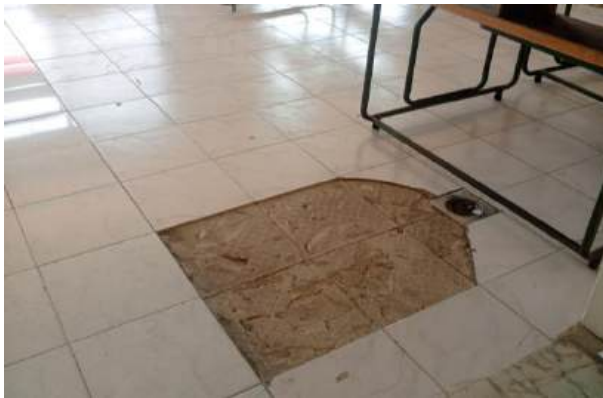
Tiles damage to be replaced

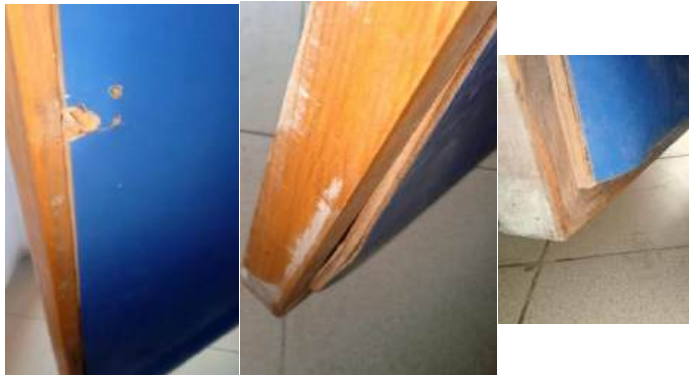
Pic showing the damage of the wooden doors

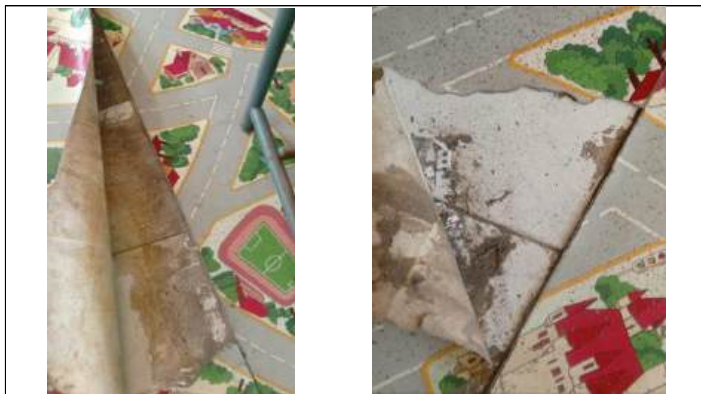
pic showing the vinyle

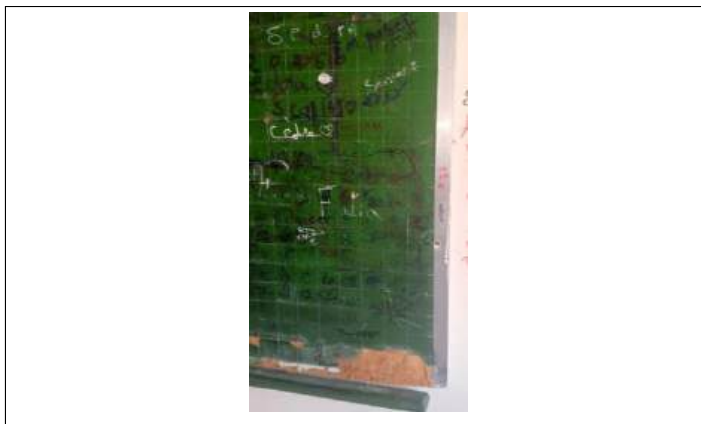
wooden board to be maintain
