# **Tender Preparation and Construction Supervision for Shelters**

## **Lebanon Emergency Assistance Project (LEAP)**

### **Detailed Assessment and Verification Report**

### **September 2026**

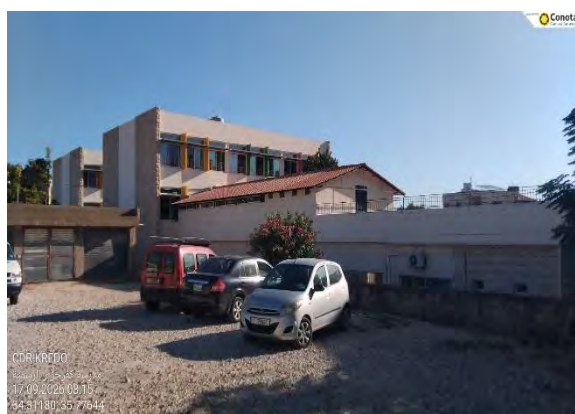
**Figure 5 - Elevation**

| No. | Element | Yes | No | Location and description |
|---|---|---|---|---|
| 2 | Facade water leak | X | | South elevation |

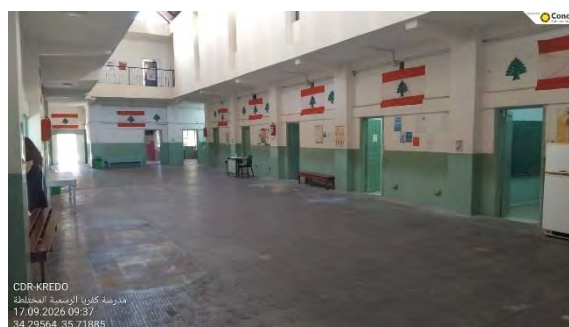
**Figure 10- Classrooms doors to paint**

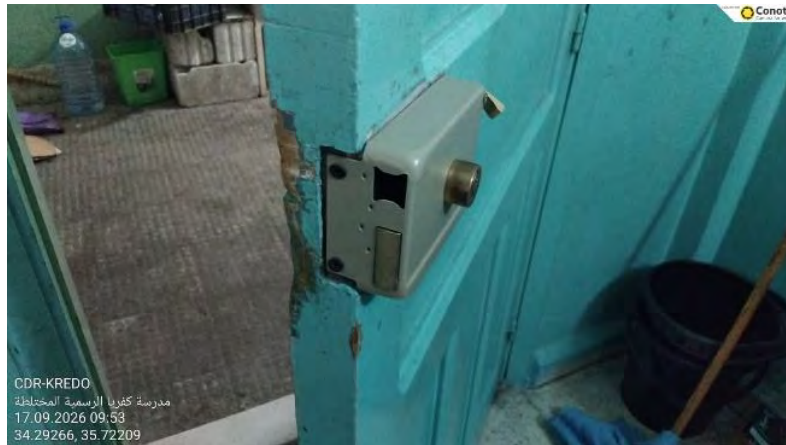
*Figure 11- Door lock to change*
