Consultancy Services for  
Tender Preparation and Construction Supervision Consultant for  
Shelters  
Lebanon Emergency Assistance Project (LEAP)

**ASSESSMENT REPORT**

**BATCH 2 - LOT 3**

**BATCH 2 - LOT 3**  
**MOUNT LEBANON SCHOOLS**  
**GENERAL INDEX**

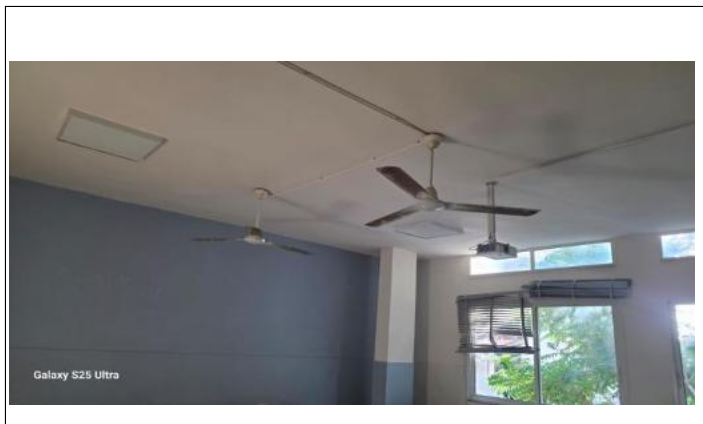
Pic showing the walls to be painted

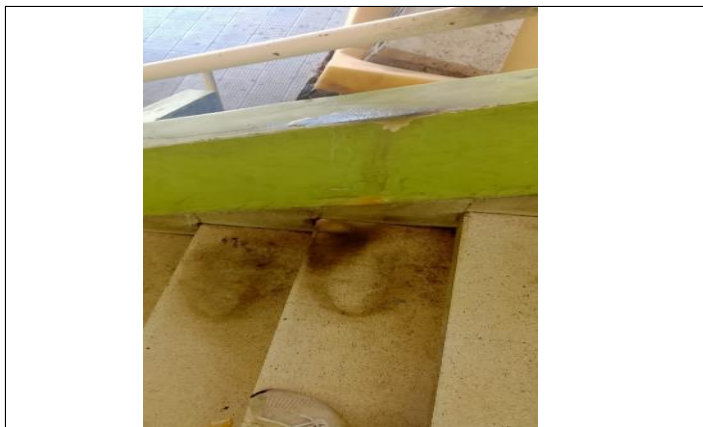
Stair Situation

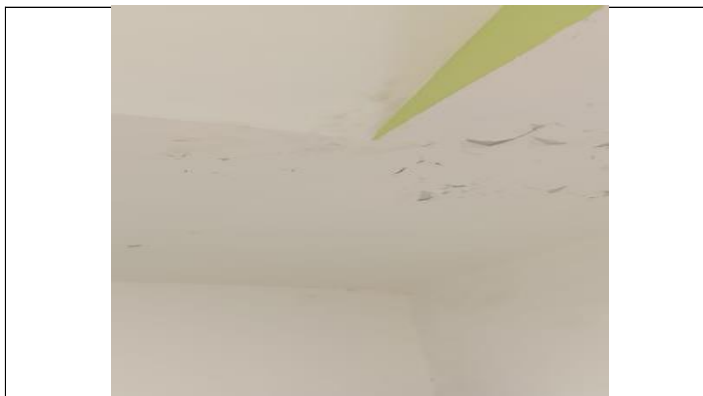
Landing Situation

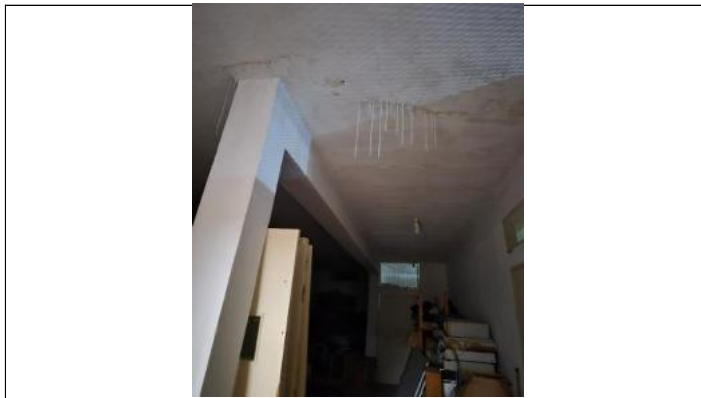
Slab Situation

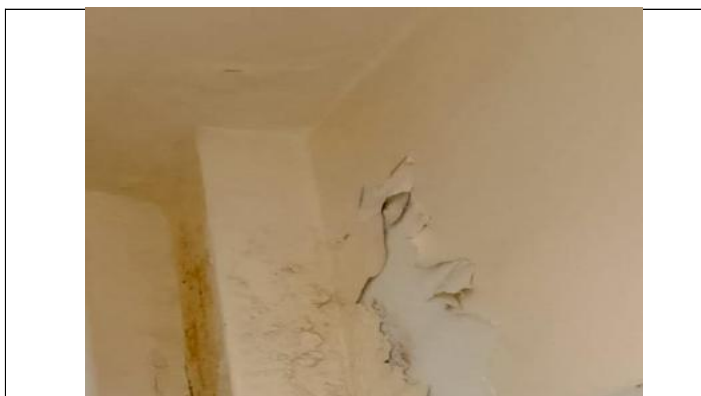
Water leak thru wall

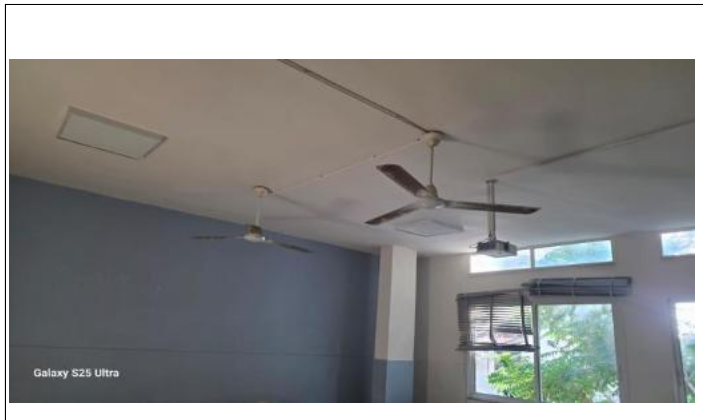
Pic showing the walls to be painted

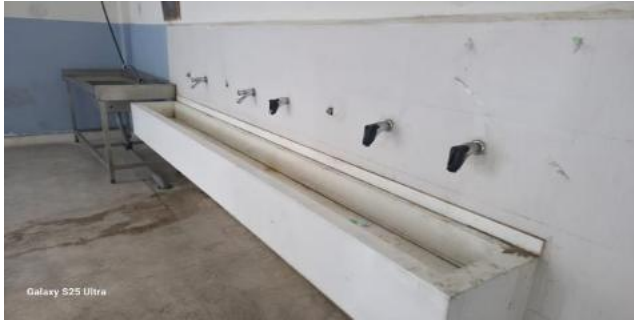
Pic showing the mixers to be replaced

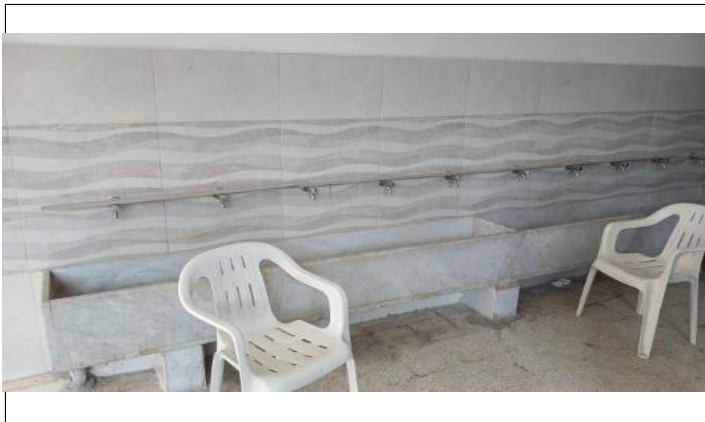
Drinking Basin inside playground

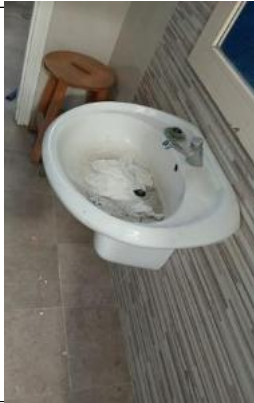
washing basin

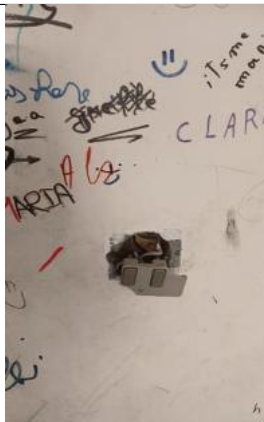
Electrical socket to be repaired

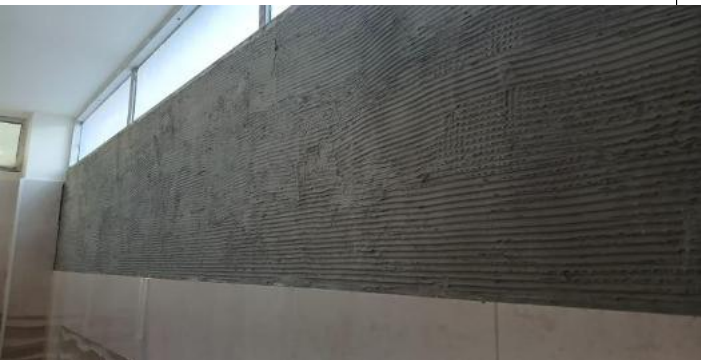
| Env.health condition within school | some WCs are leaking to the floors below |

Humidity and water leak at WC area

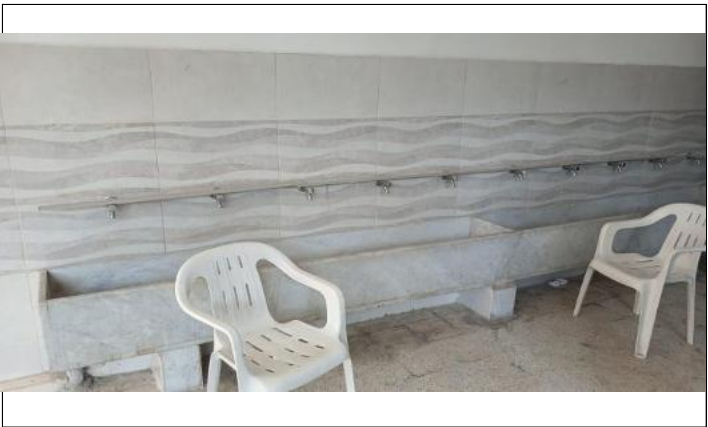
Drinking Basin inside playground

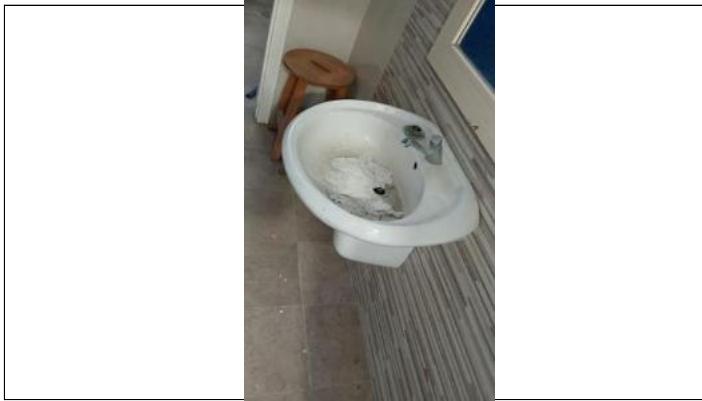
washing basin

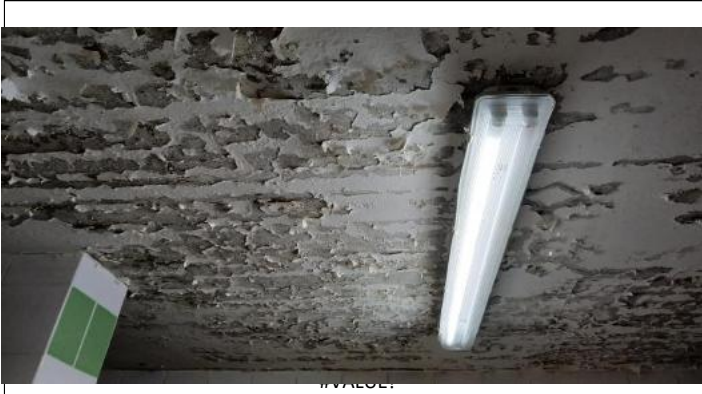
| Enviroment | |
|---|---|
| humidity | present in the school from windows and roof floor |

Humidity and water leak from the roof and elevations shown inside the building

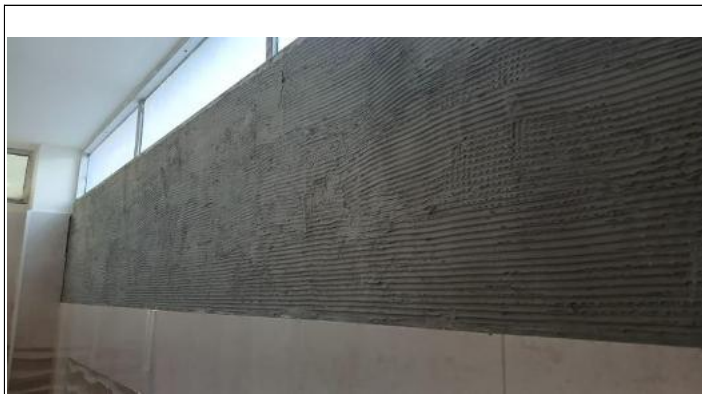
| Enviroment | |
|---|---|
| Env.health condition within school | some wc are leaking to the floors below |

Humidity and water leak at WC area

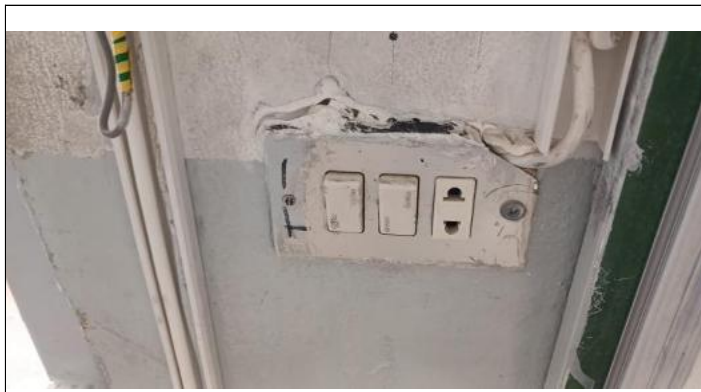
Electrical socket to be repaired

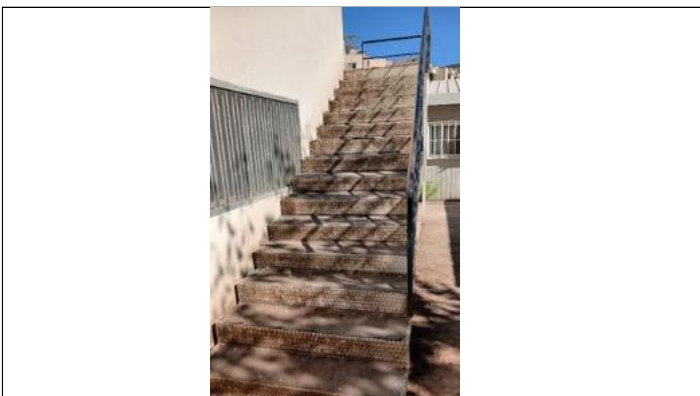
stairs needs main entrance and its slippery

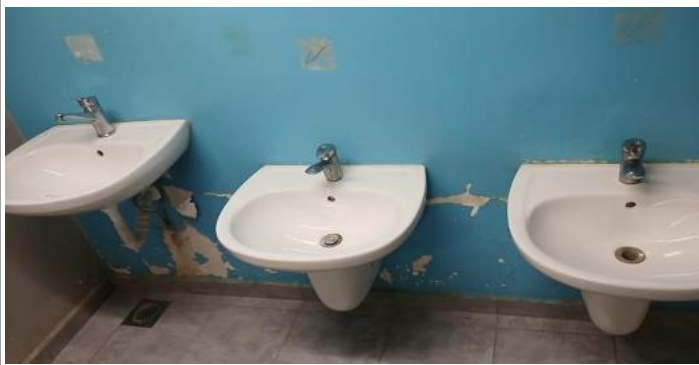
| humidity | present in the school from windows and roof floor | |

Humidity under drinking basin

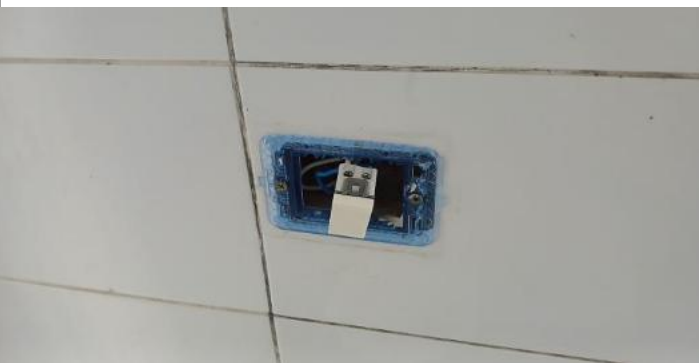
Electrical socket to be repaired

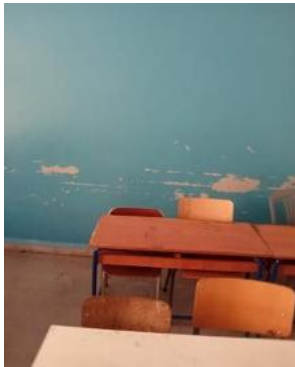
walls need to be painted

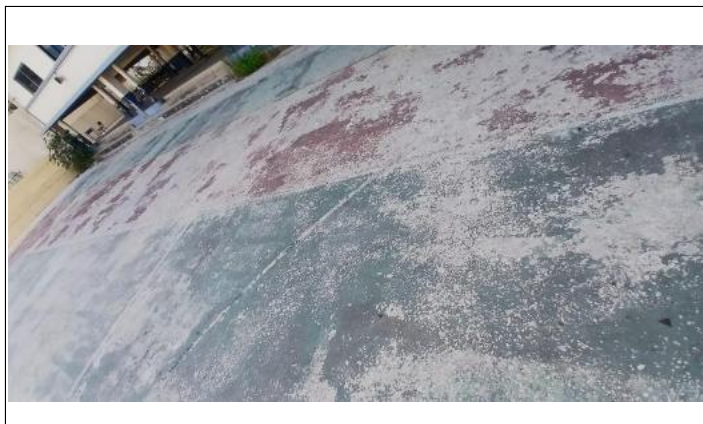
PLAYground chipped and slippery

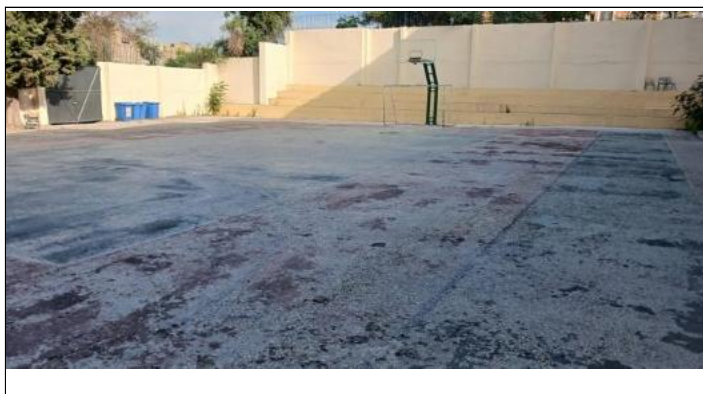
PLAYground unsafe chipped and slippery

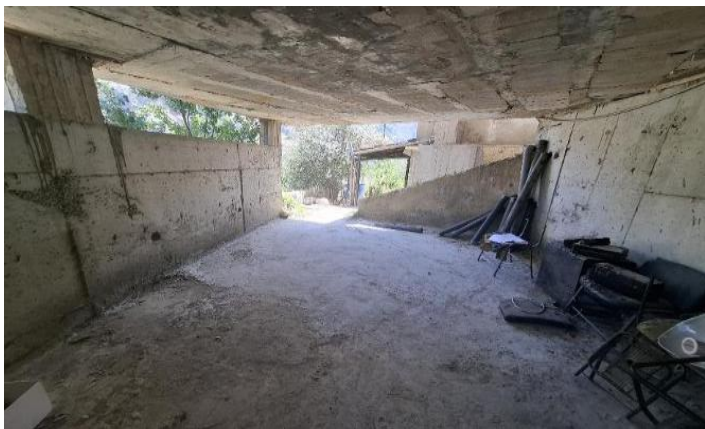
General View to playground

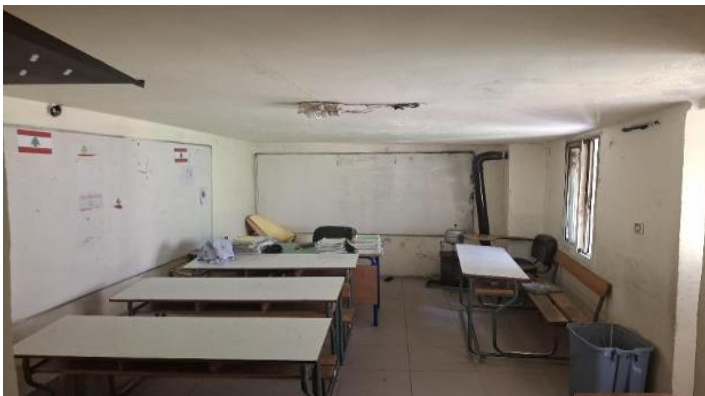
Classroom

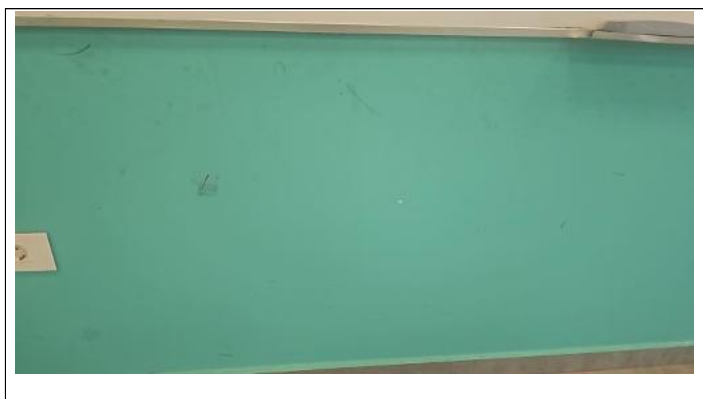
walls need painting

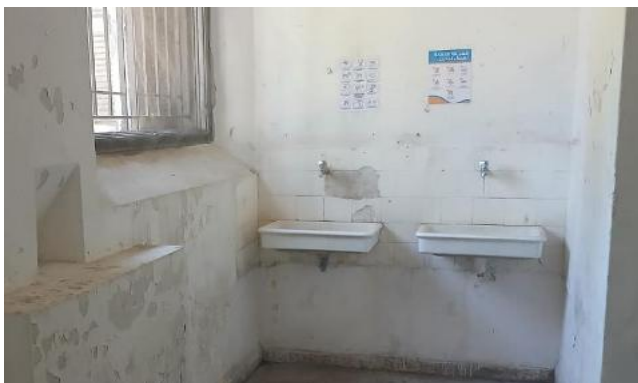
bad condition of wash basin

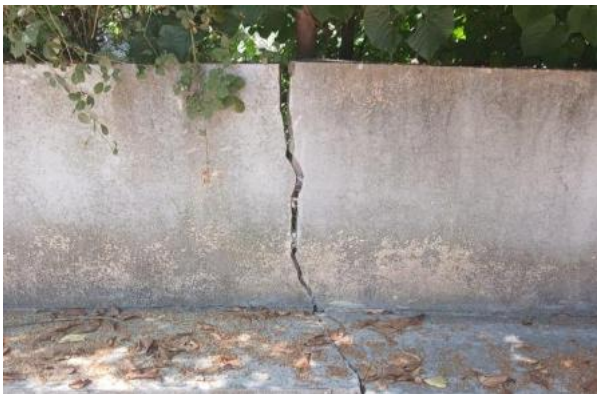
| wall Cracks | yes | | | | Location : | external fence | | |

crack in the outside fence

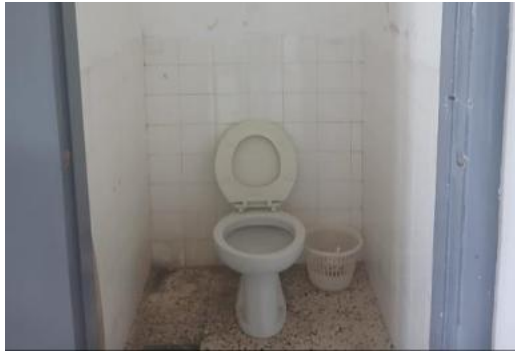
WC in bad condition

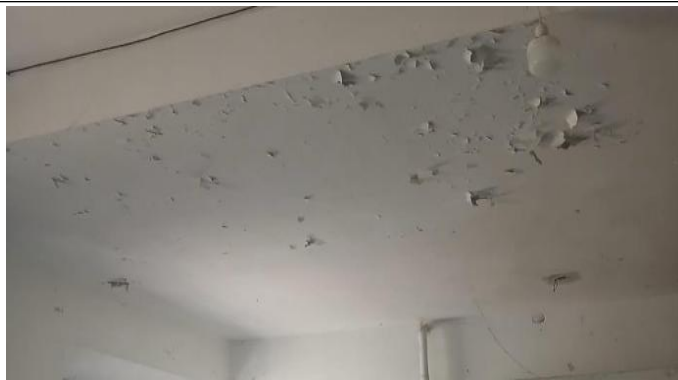
| Environment | | | |
|---|---|---|--|
| humidity | present in some areas at first floor between rooms | | |

Humidity in ceiling

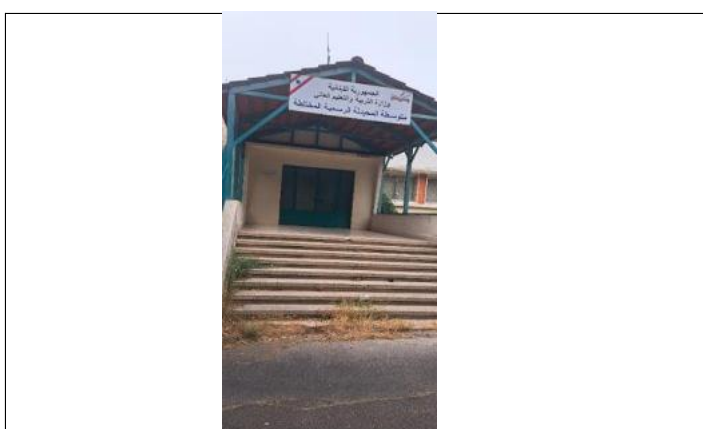
Steel Gate Situation

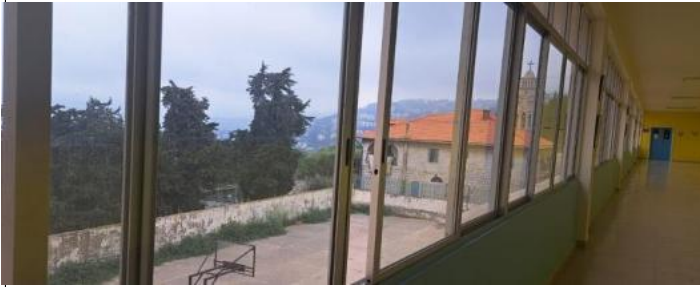
Aluminum Windows need repairs

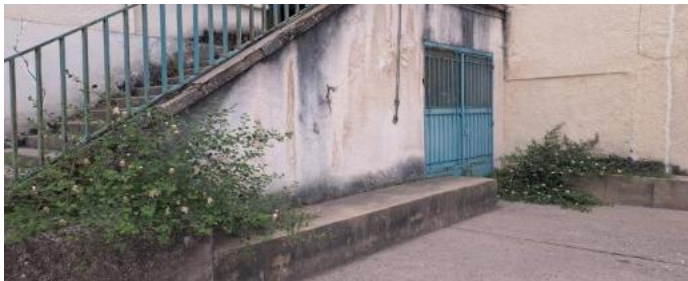
| Façade cracks | yes | | | | Location : | | | | |

Facades need repair

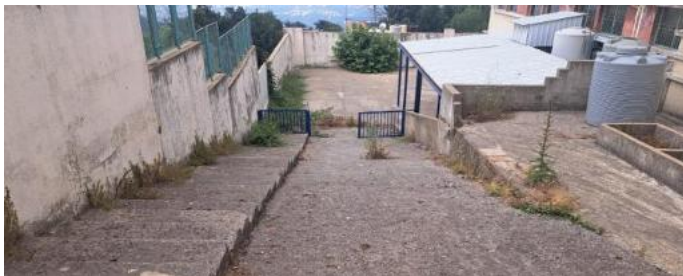
Exterior Ramp Situatation

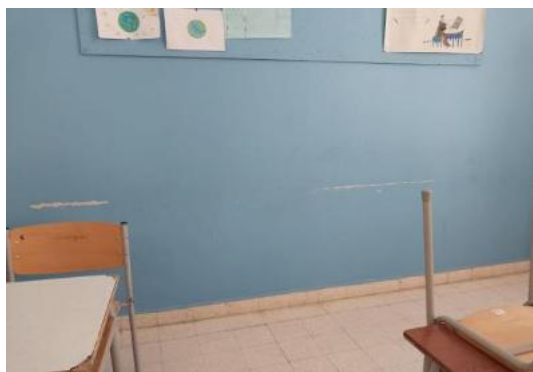
pic showing inside the class

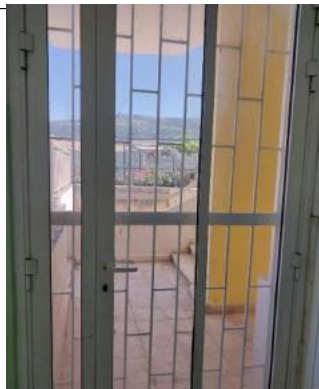
pic showing the door condition

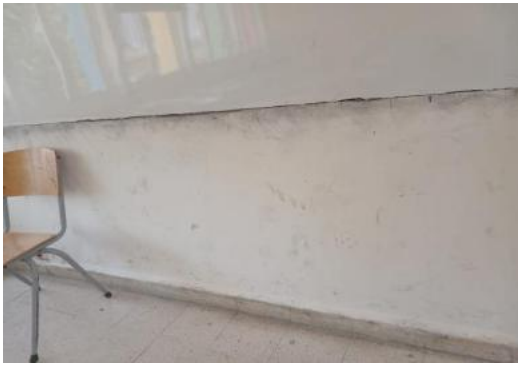
walls need to be painted

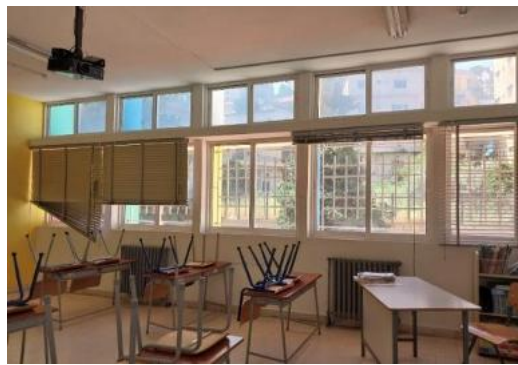
View from inside the school

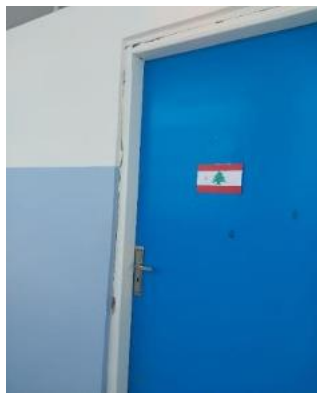
pic showing the classes door

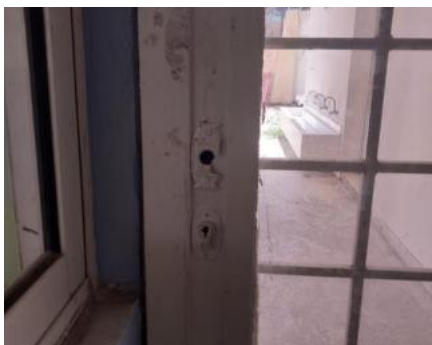
Lever handle and lock to door to  
be replaced and door to be  
painted

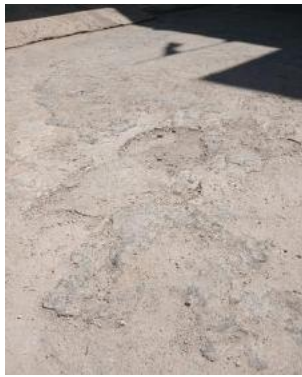
pic showing the playground floor

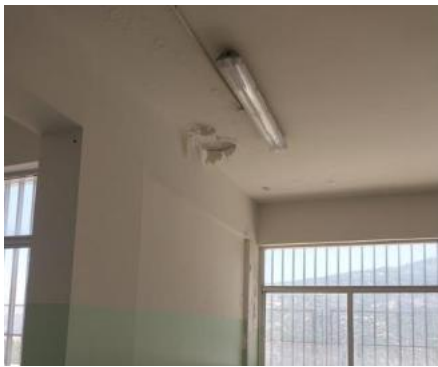
| humidity | present in some areas at the ground floor |

pic showing humidity

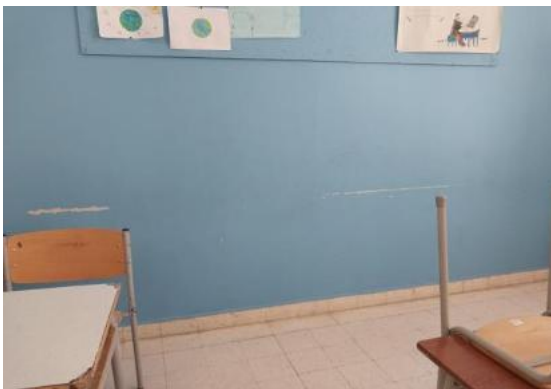
pic showing inside the class

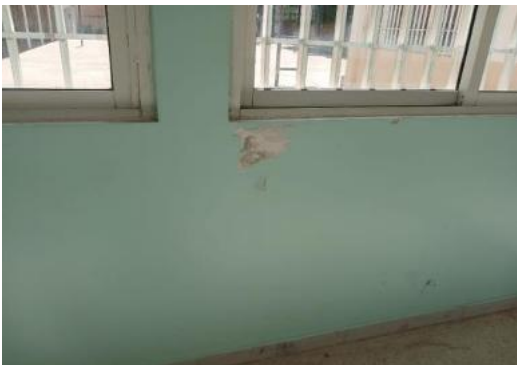
pic showing the walls

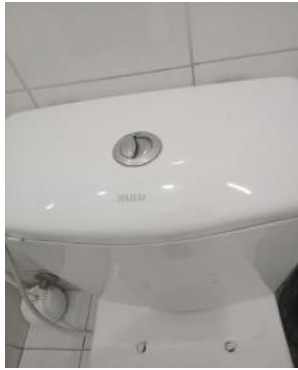
wc seat needs repair

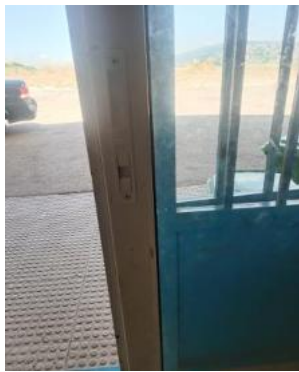
doors accessories

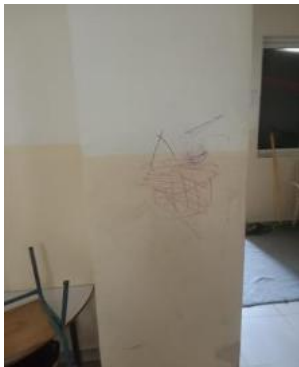
walls need painting

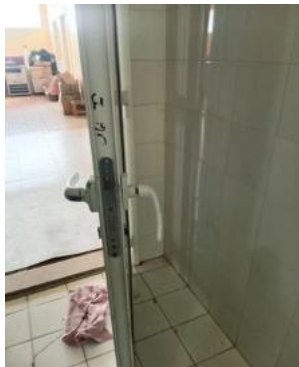
doors accessories

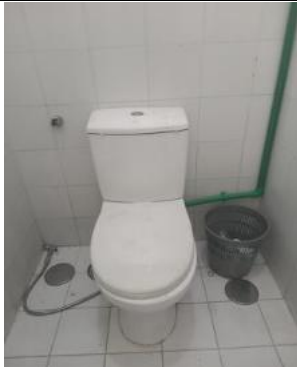
wc situation

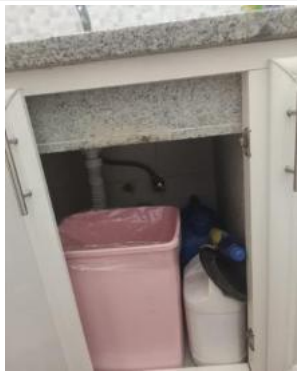
kitchen mechanical accessories  
need repair

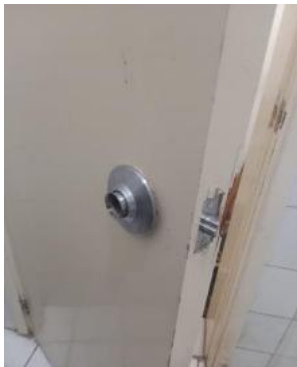
wooden doors accessories

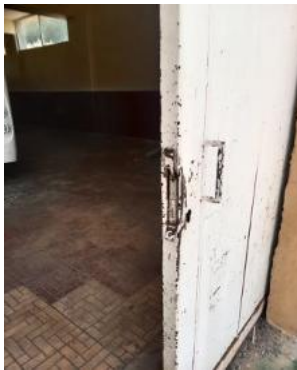
steel doors repair

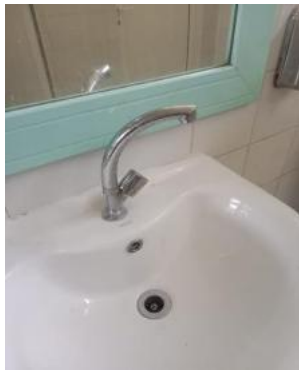
lavatories mixers

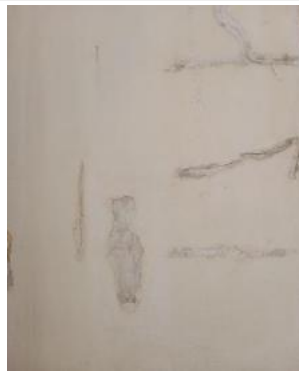
wall cracks

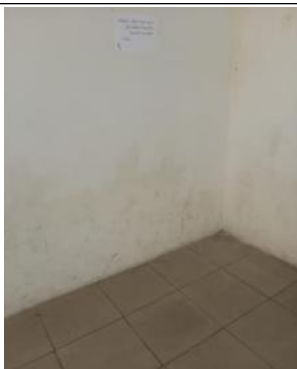
| humidity | present in some area |

humidity in walls

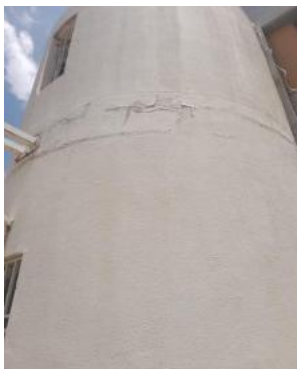
humidity on facades

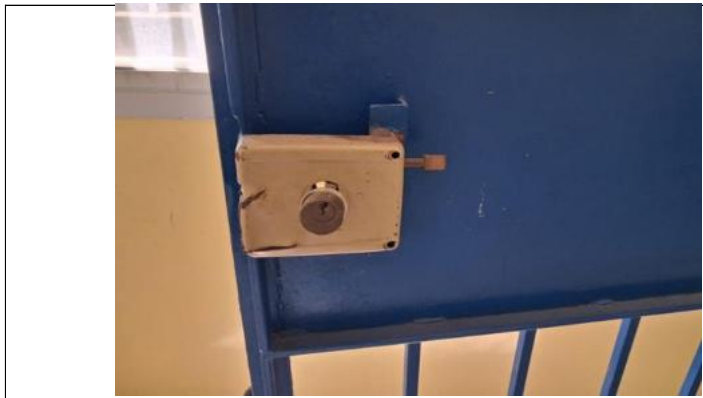
Steel Door Situation

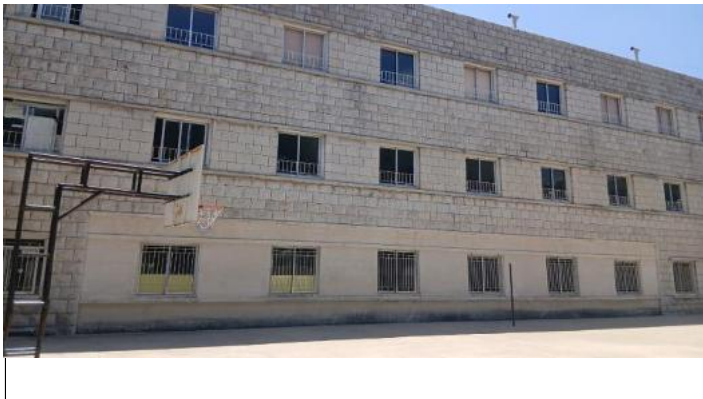
Facades Situation

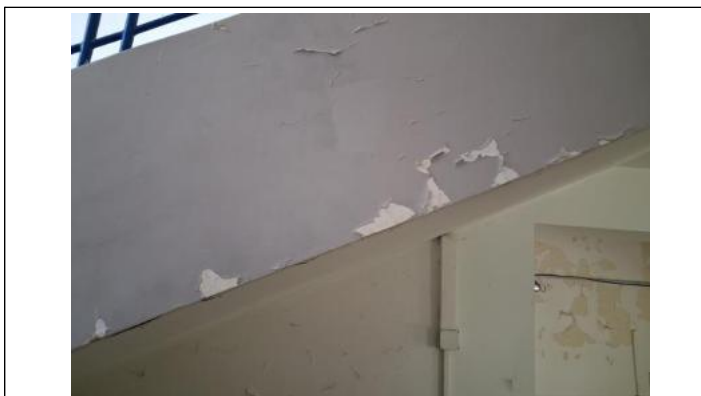
Stair Situation

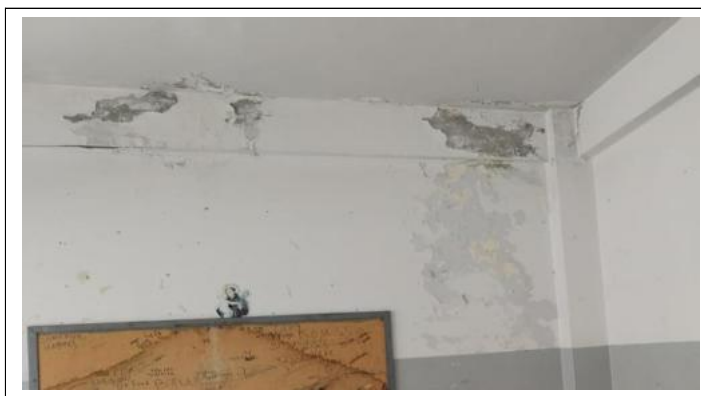
Structural element in bad condition

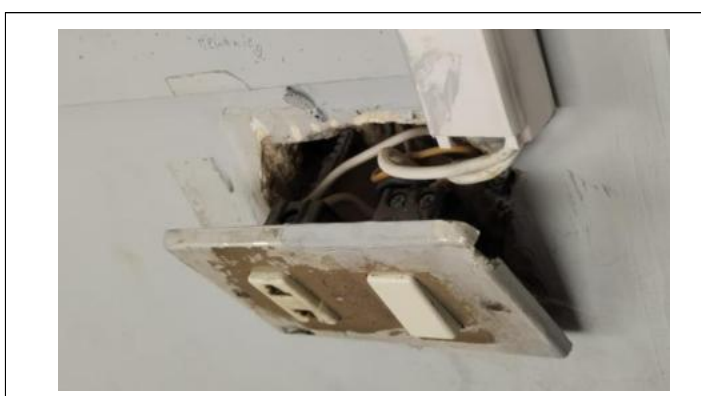
Electrical socket

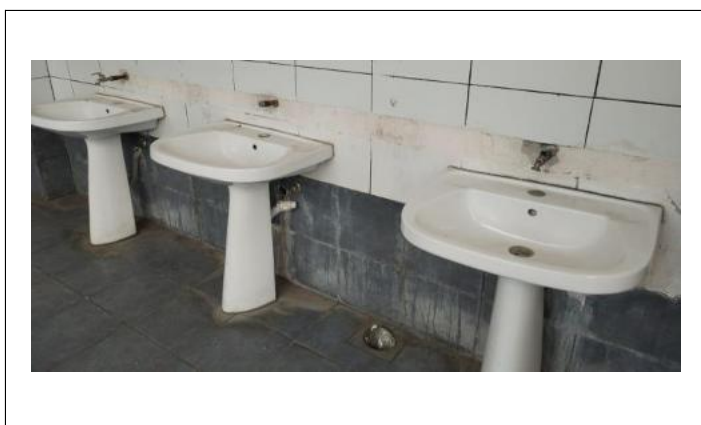
Mixers to be changed

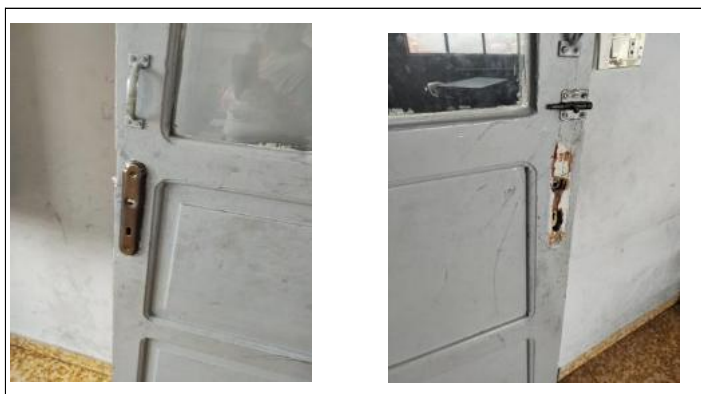
Wooden doors to be rehabilitated

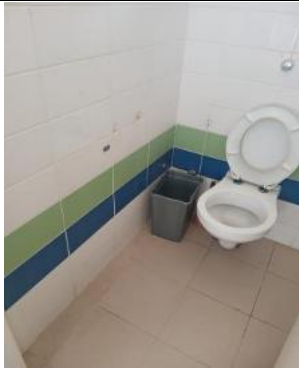
wc situation

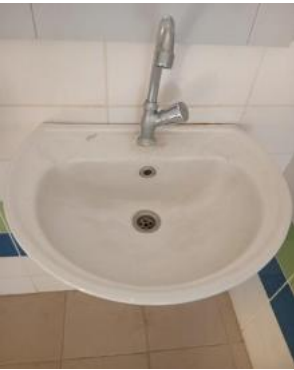
needs mixers

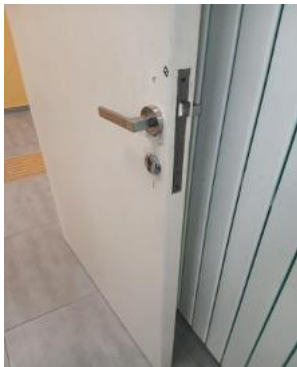
doors accessories

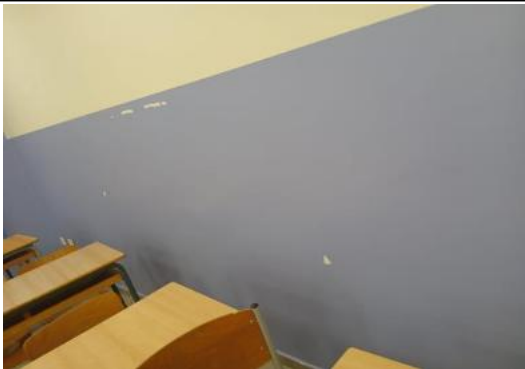
painting
