**CERD 423 - Ebn Rashed Public School for Girls**

Batch 4 - Lot 2 – Tripoli

### Lebanon Emergency Assistance Project (LEAP)

## Detailed Assessment and Verification Report

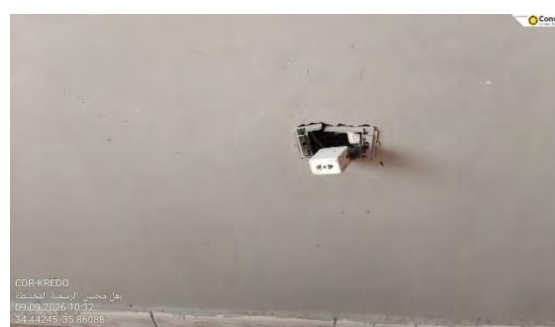
**Figure 13 – Damaged Socket**
