Consultancy Services for  
Tender Preparation and Construction Supervision Consultant for  
Shelters  
Lebanon Emergency Assistance Project (LEAP)

**ASSESSMENT REPORT  
BATCH 2- LOT 1**

July 2026

**BATCH 2 - LOT 1**  
**MINYEH SCHOOLS**  
**GENERAL INDEX**

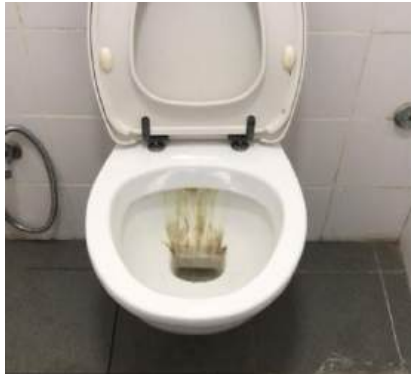
| Env.health condition within school | some wc are leaking to the floors below | | |

Pic showing the bad condition of  
WCs

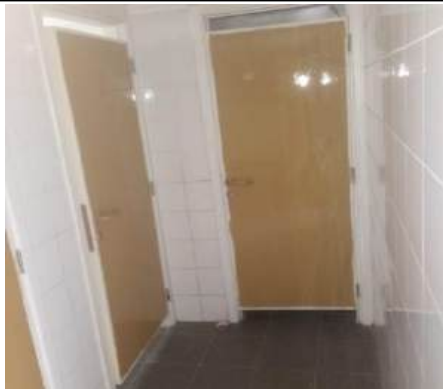
pic showing the WC doors

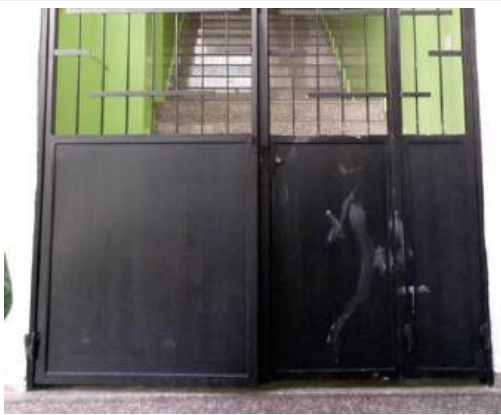
Pic showing the bad condition of  
steel door

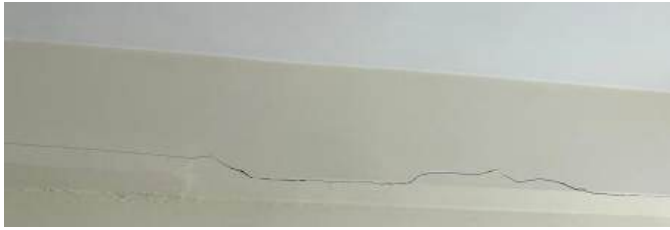
| Beams cracks | yes | | | | Location : | second floor | | |

Pic showing beam crack at the second floor

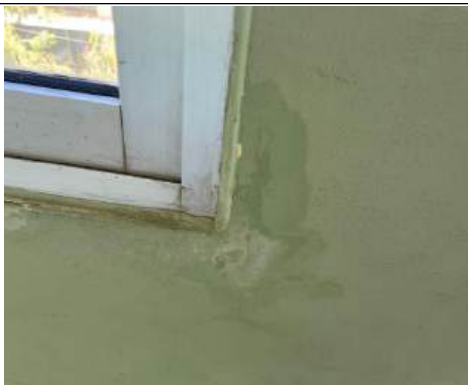
| Façade water leak | minor around some windows | | | | Location : | | | |

Pic showing the leakage from the aluminum window

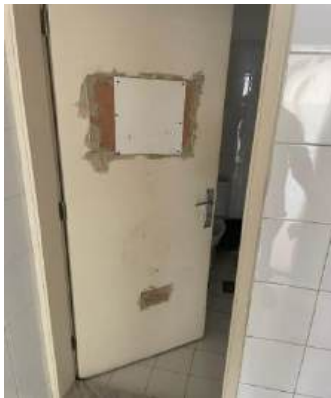
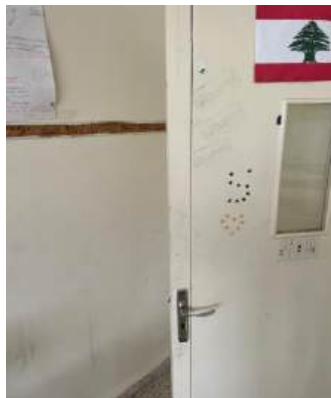
Lever handle and lock to door to be replaced and door to be rehabilitated

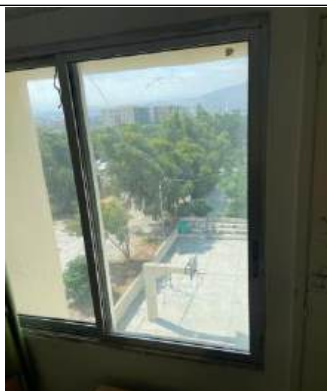
Pic showing the broken glass to be replaced

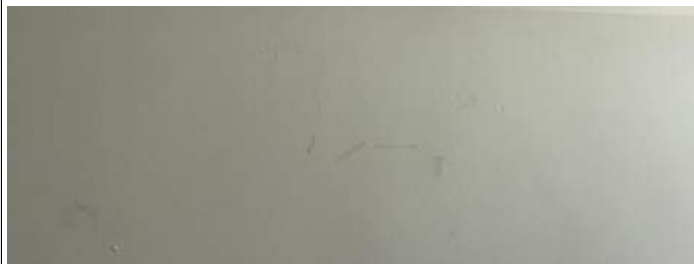
| humidity | present in some areas at first floor between rooms and at the ground floor | | |

pic showing the humidity inside  
the wall

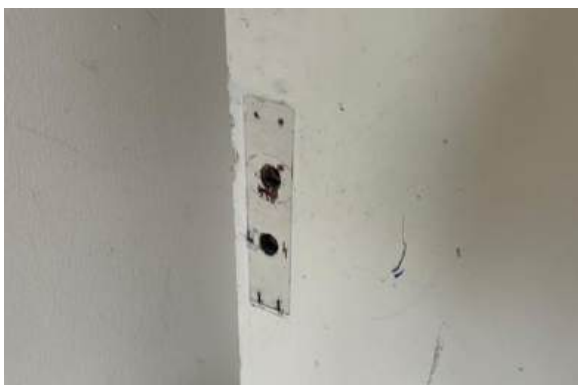
pic showing the handle and lock  
to be changed

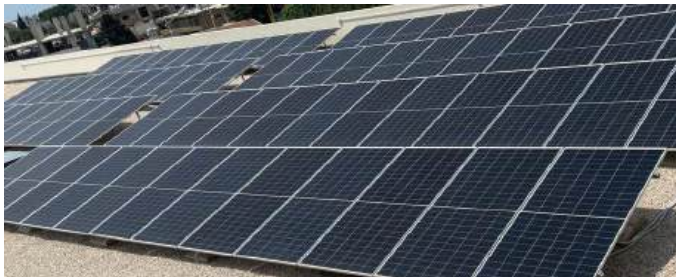
Solar panel in a good condition

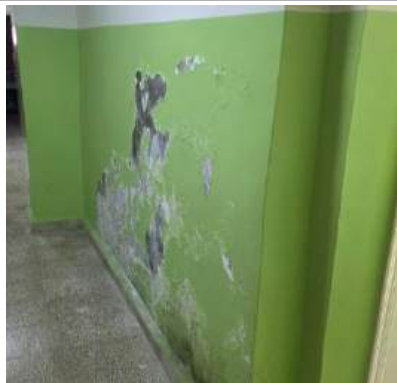
Humidity in wall

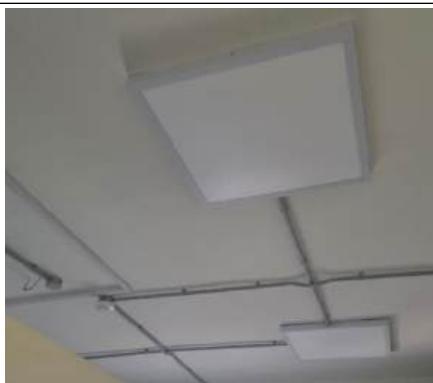
Electrical lighting to be changed

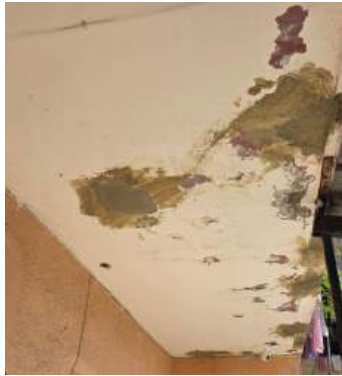
ceiling to be repaired

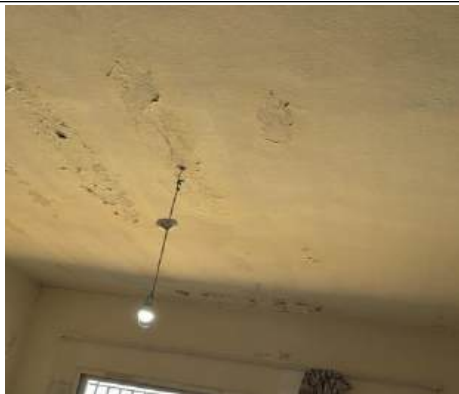
Humidity in ceiling

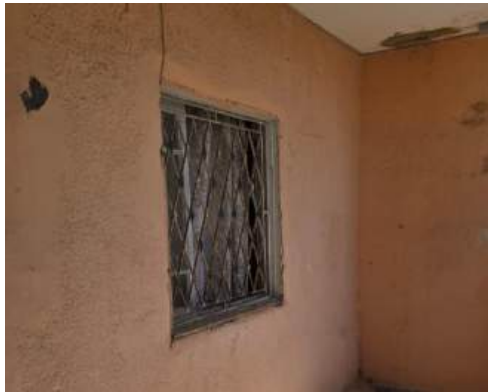
outdoor wall cracks

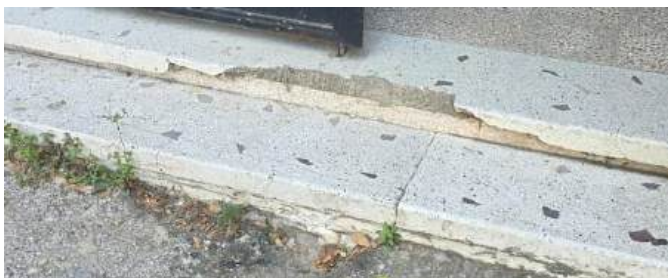
Stair to be rehabilitated

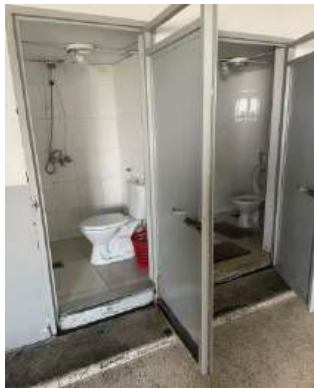
doors in wcs

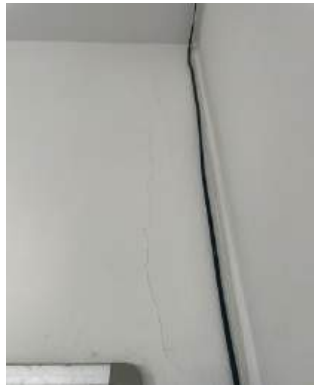
cracks in wall

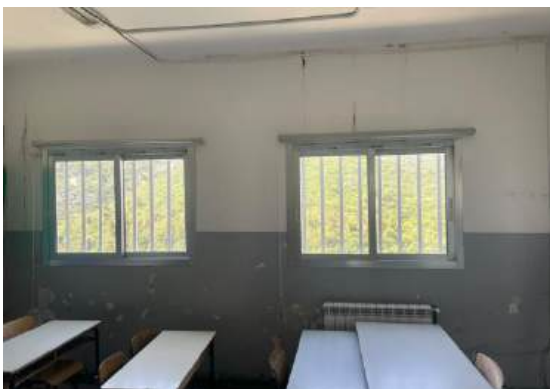
humidity in walls

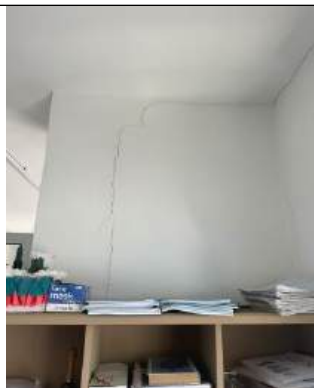
inclined cracks in walls

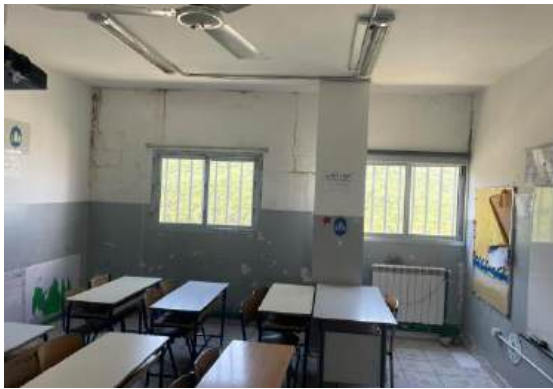
water leakage in walls

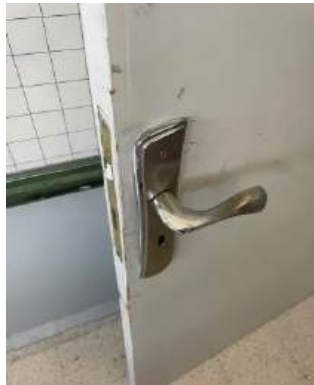
wooden doors accessories

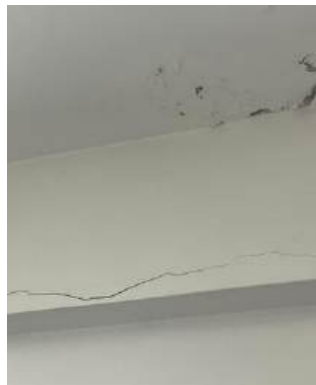
cracks in beams

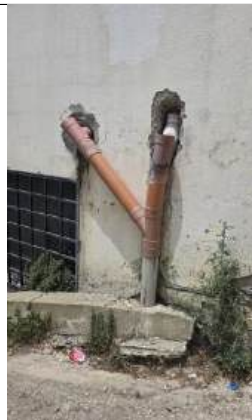
bad connection of wastewater

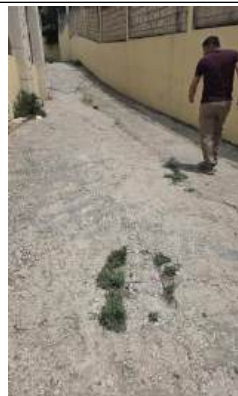
concrete of ramp needs rehabilitation

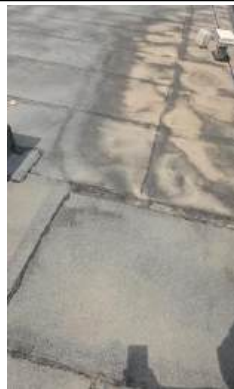
waterproofing membrane needs  
repair in some place on the roof

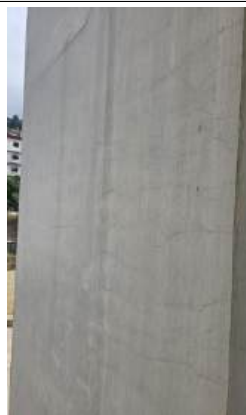
hair cracks and humidity on the  
façade

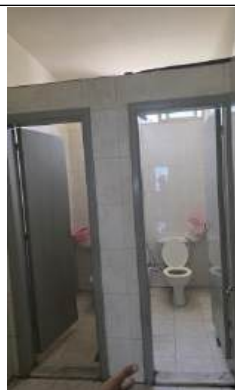
wc situation

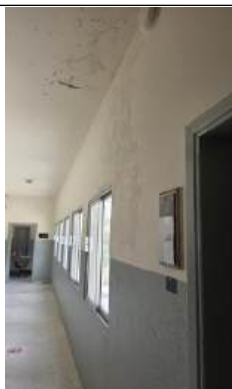
humidity inside the school

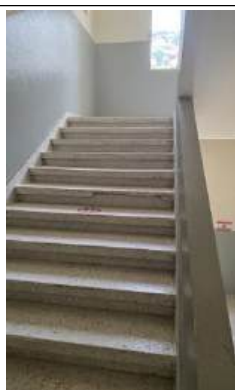
some broken parts in stairs

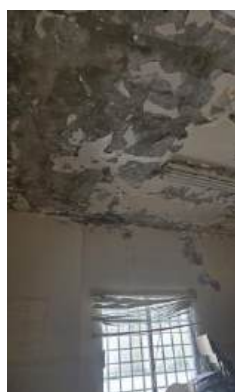
water leakage in some rooms

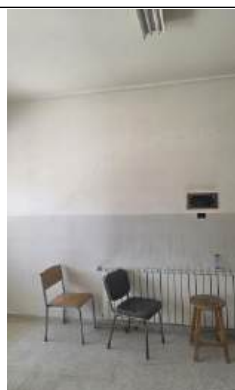
inclined cracks in the walls

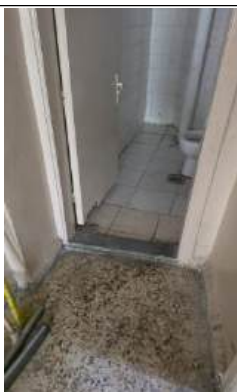
wc condition

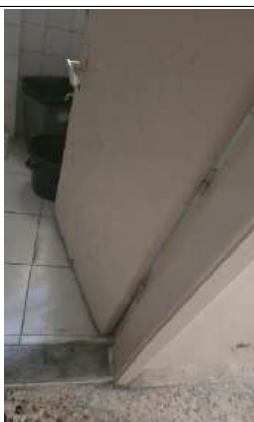
wc wooden doors conditions

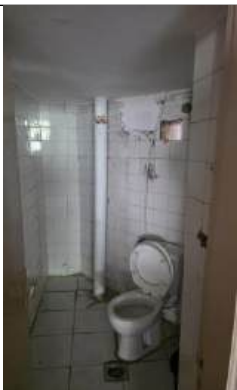
wc finishing conditions

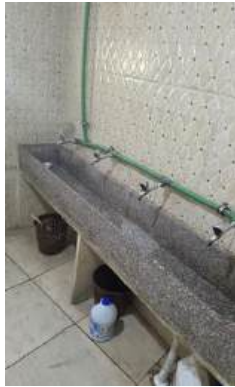
drinking water conditions

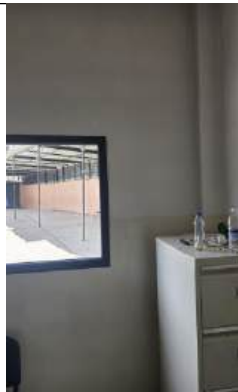
cracks around windows

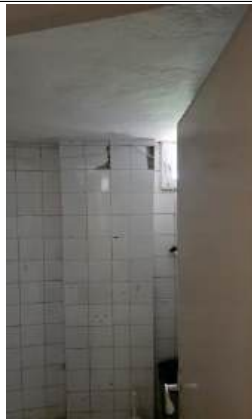
broken tiles in wc

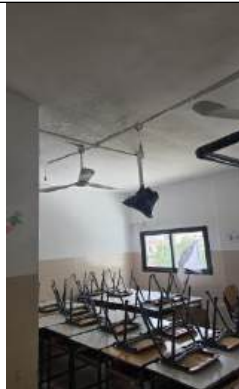
humidity in classes

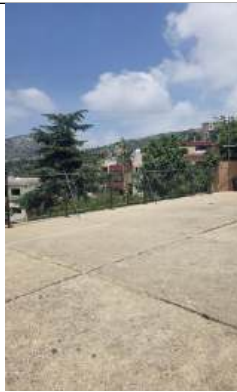
the playground needs safe steel  
fence

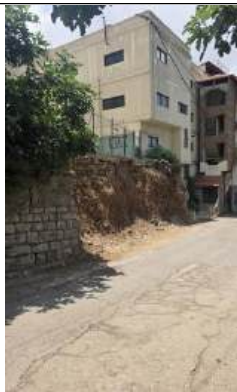
the playground needs retaining  
wall

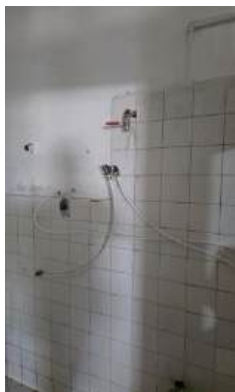
bad installation of sanitation  
pipes at wc

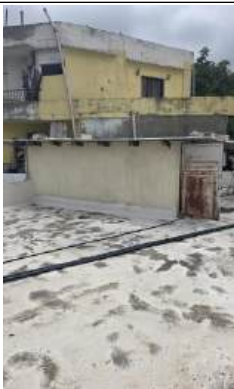
roof needs waterproofing system

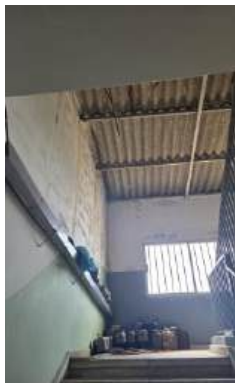
esbestos top roof suffers from  
water leakage

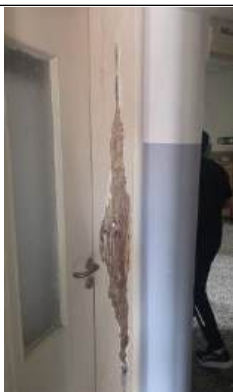
wooden door need repair

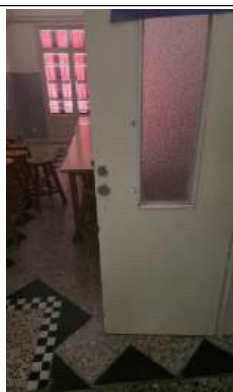
wooden door needs accessories

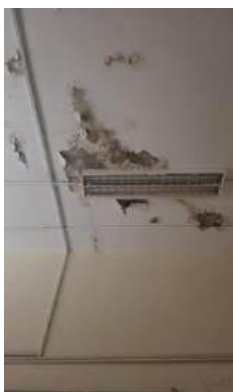
leakage arround lighting fixtures

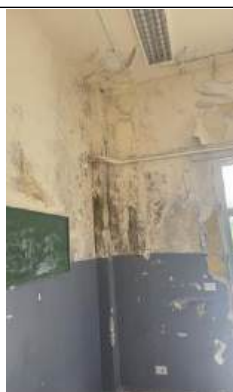
humidity and leakage in most of  
walls

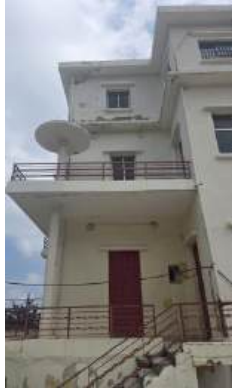
humidity at facades

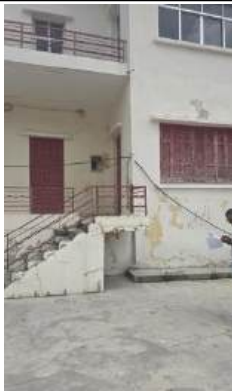
facades need painting with  
waterproofing

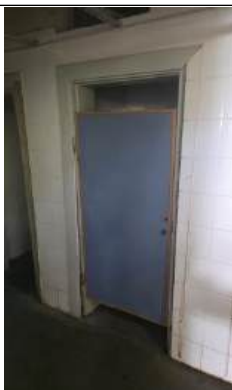
broken door accessories at wc

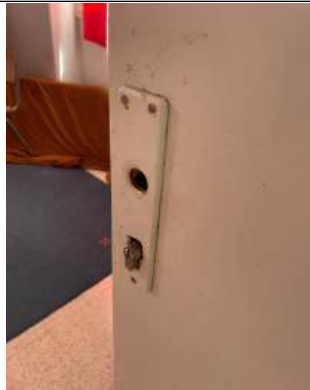
wooden door accessories

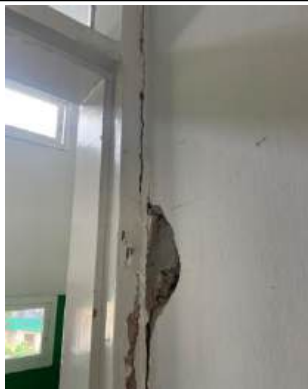
cracks in walls

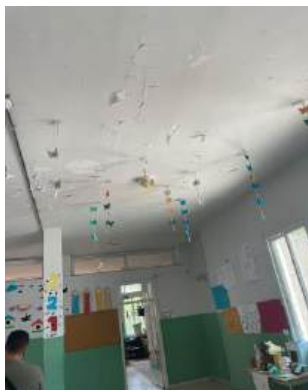
humidity in rooms

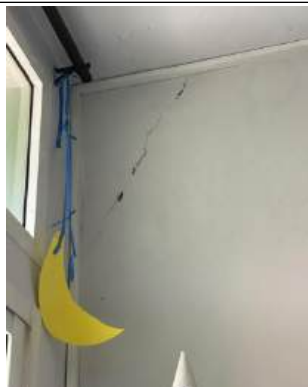
inclined crack in wall

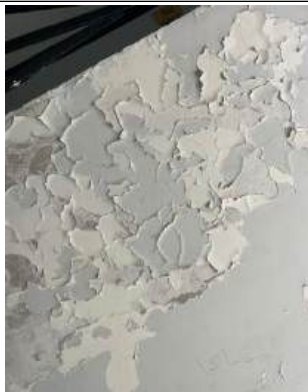
water leakage in walls

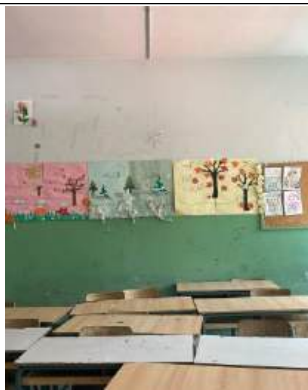
bad conditions of painting

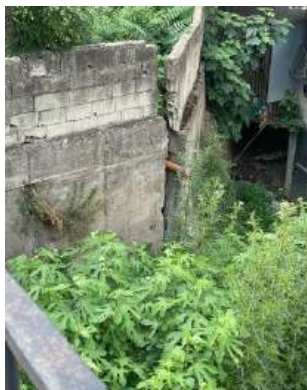
broken retaining wall

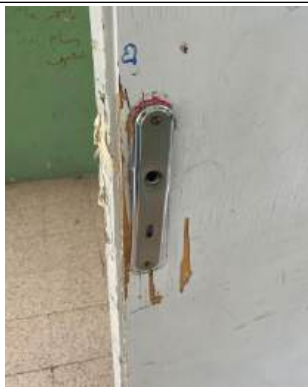
wooden door accessories

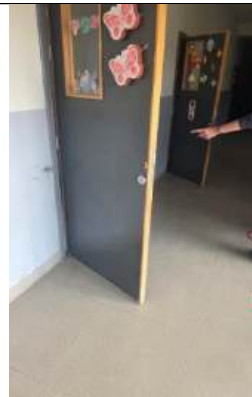
Doors need repair

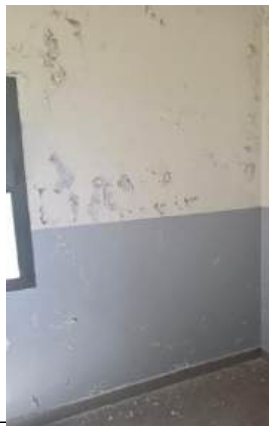
Humidity in the inside of the school

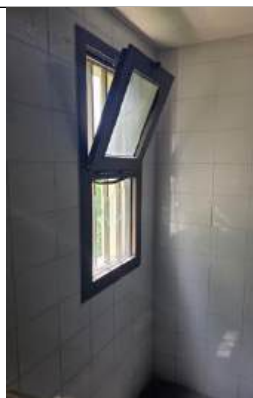
Windows situation need some repair

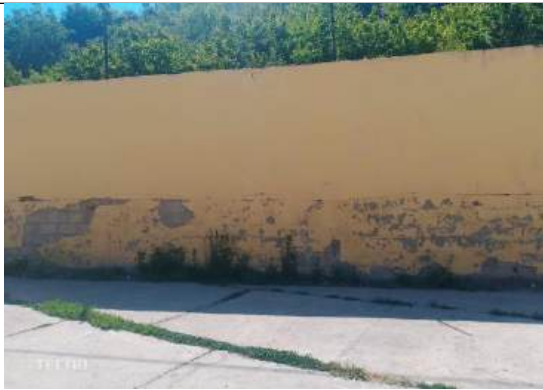
fence needs plastering

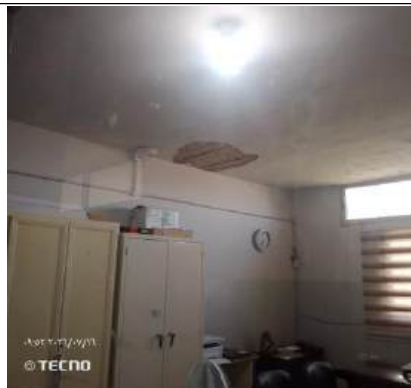
exposed steel in slabs

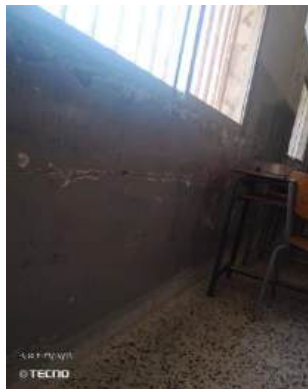
cracks in walls

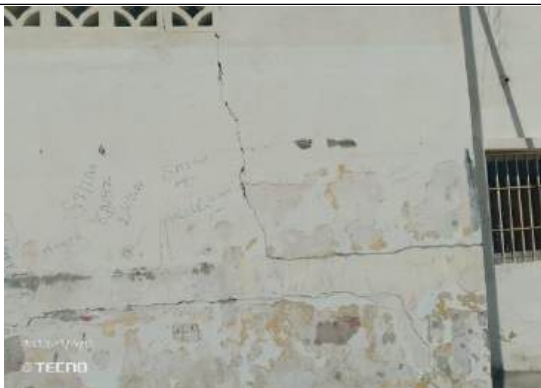
cracks in façade

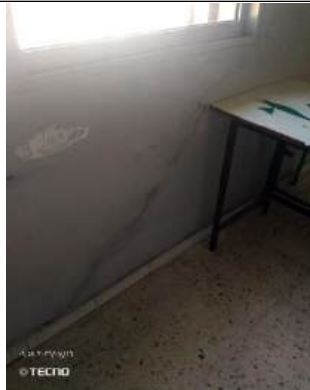
inclined cracks in walls

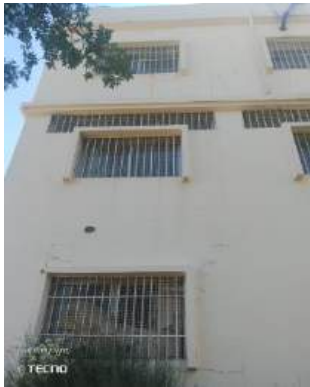
humidity on façade

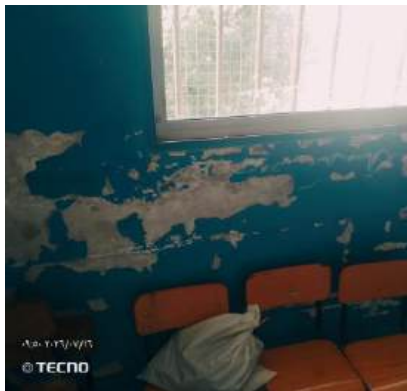
humidity at walls

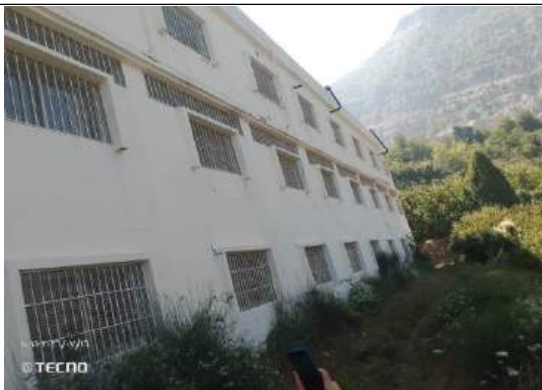
rear elevation of school

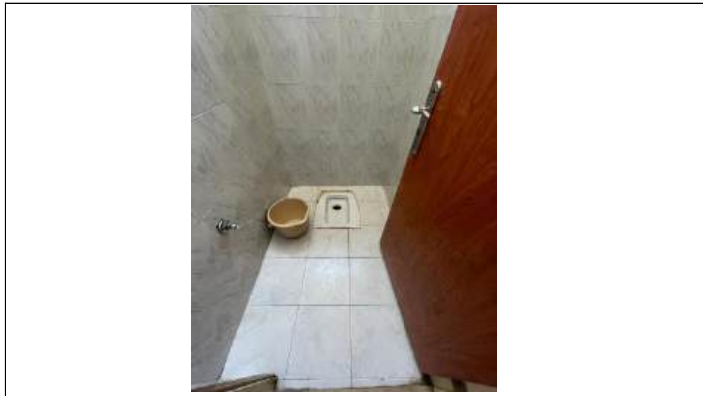
turkish wc

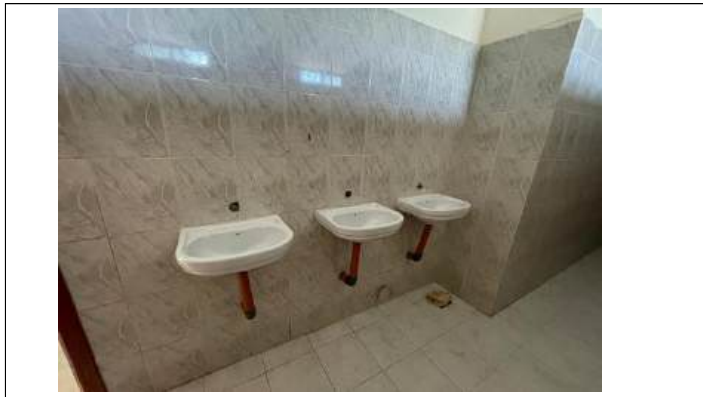
lavatories in wc

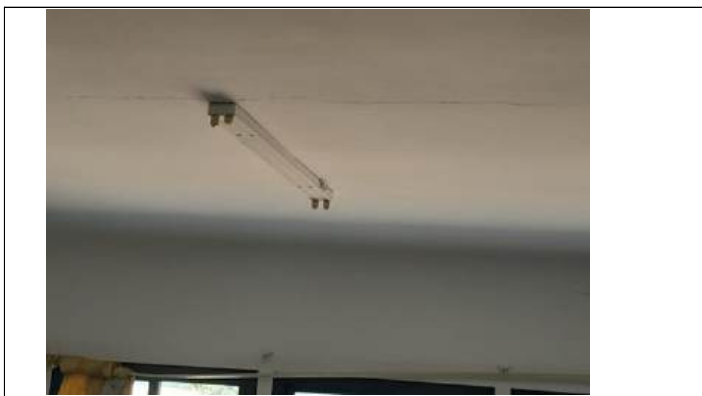
class without lighting fixtures

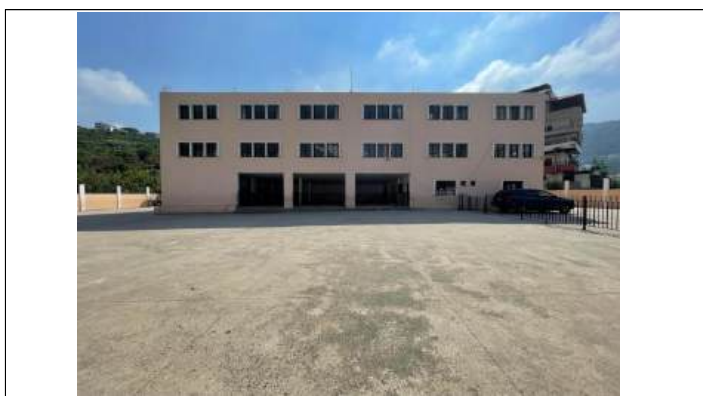
rear elevation

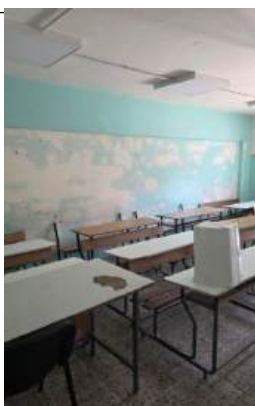
Humidity in the school

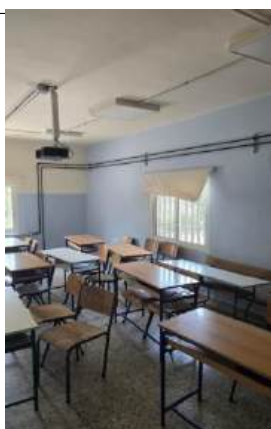
Lighting Fixtures

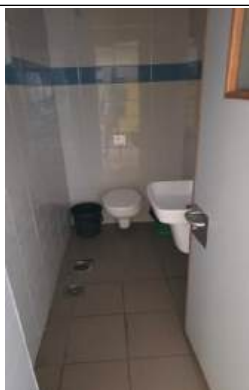
WC Situation

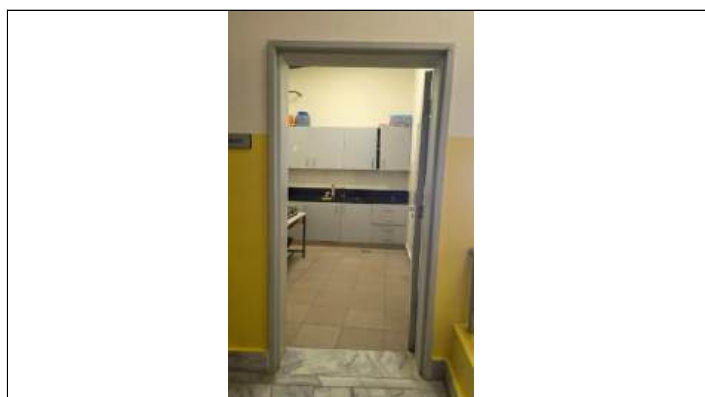
Kitchen Situation

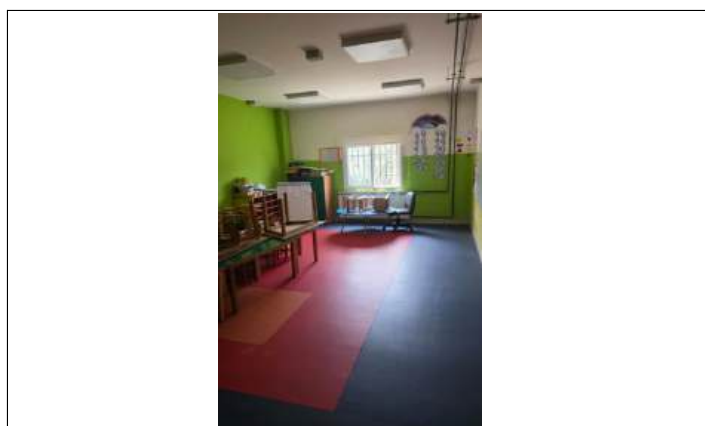
Vinyl Situation

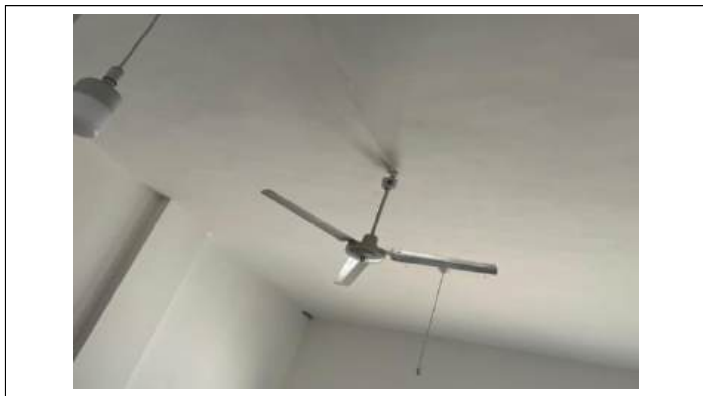
Pic showing the lighting in the school

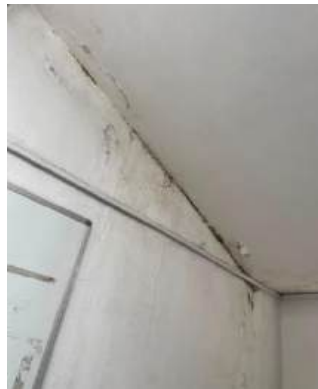
Pic showing the humidity inside the school

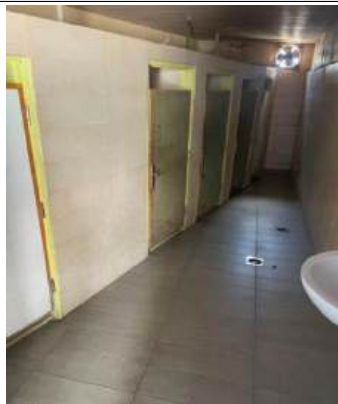
Wooden doors of WC in bad condition

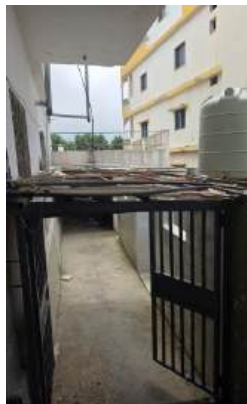
wc area needs covering by  
sandwich panels slab

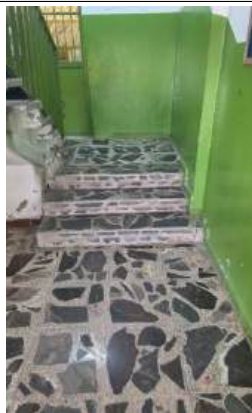
availability for handicapped ramp

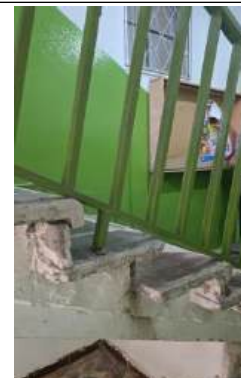
handrails needs some fixing  
support

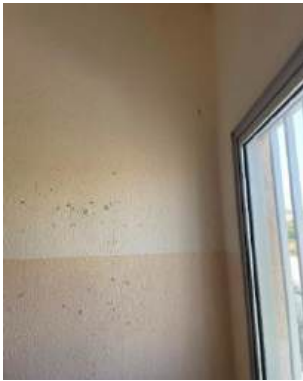
| wall Cracks | yes | | | | Location : | second floor | | | |

Pic showing crack in the walls

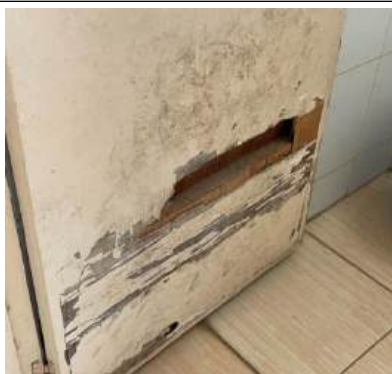
damage in doors needs t be fixed

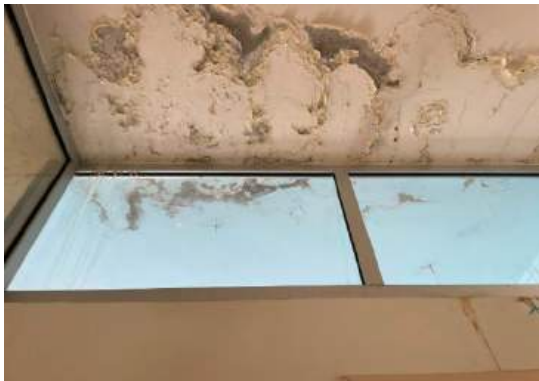
| humidity | present in some areas at the ground floor | | |

pic showing the humidity in the ceiling

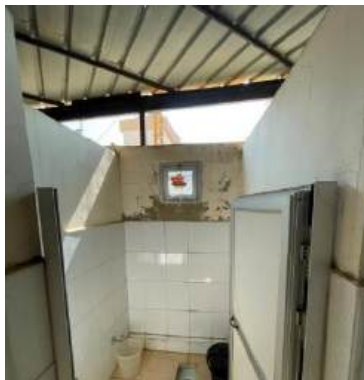
pic showing the outdoor toilet

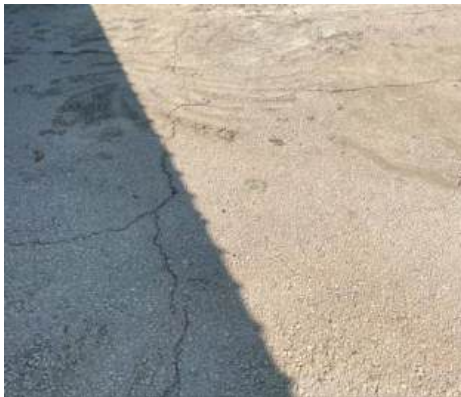
pic showing crack in the playground floor

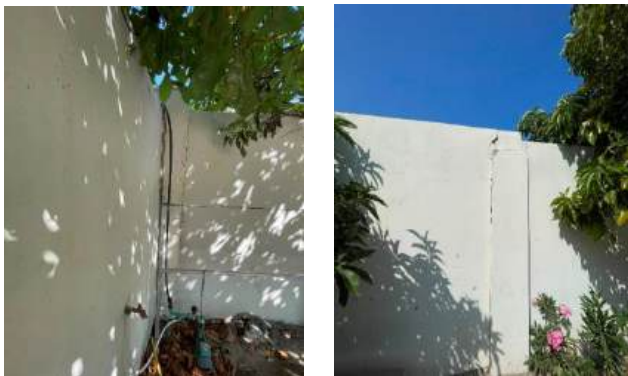
crack in the playground walls

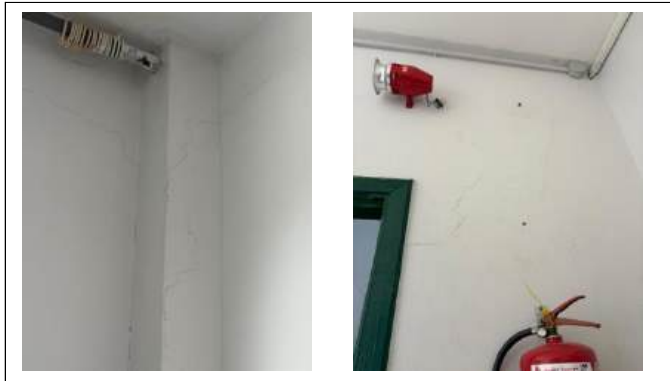
| wall Cracks | yes | | | | Location : | first floor | |

Pic showing crack in the walls

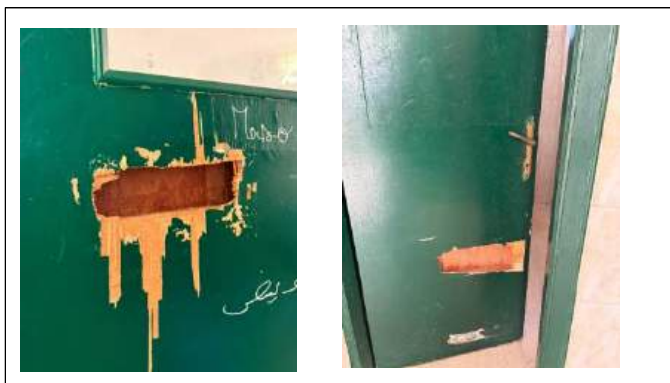
damage in doors needs t be fixed

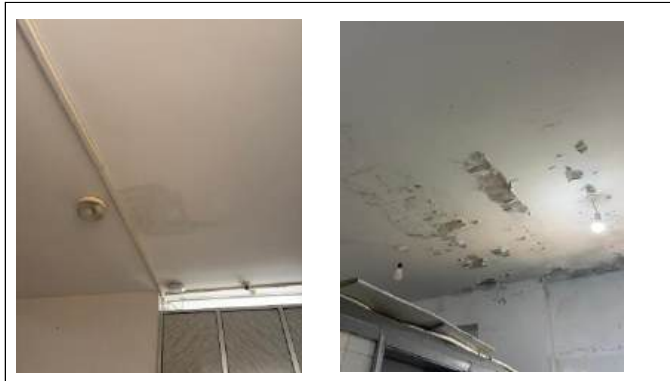
| humidity | present in some areas at the ground floor | | |

pic showing the humidity in the ceiling

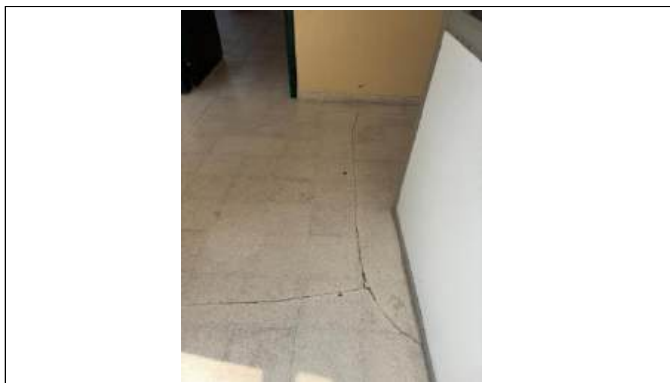
crack in the tiles

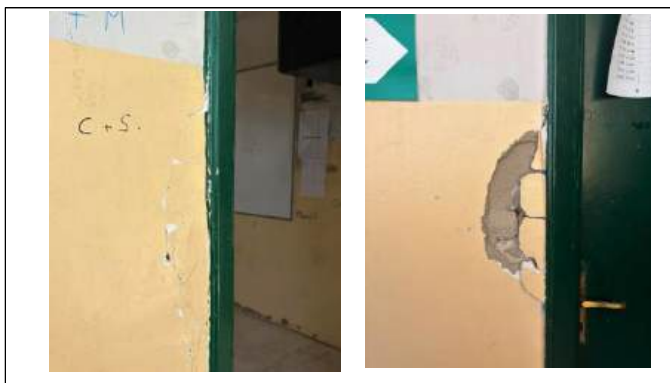
damage in the walls

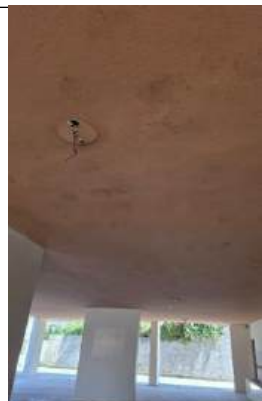
Missing Lighting Fixtures

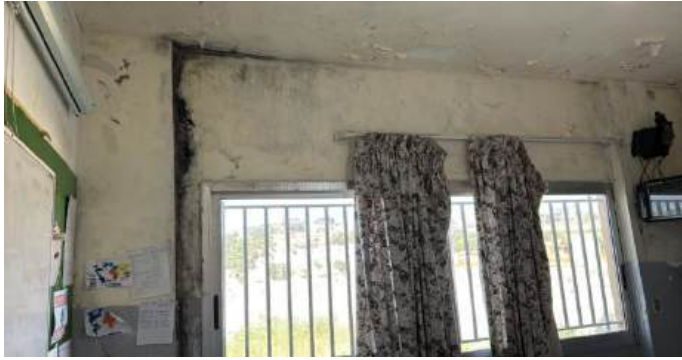
| humidity | present in some areas at the ground floor |

humidity in the classes

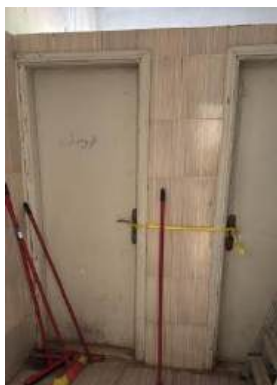
damage in doors needs t be fixed

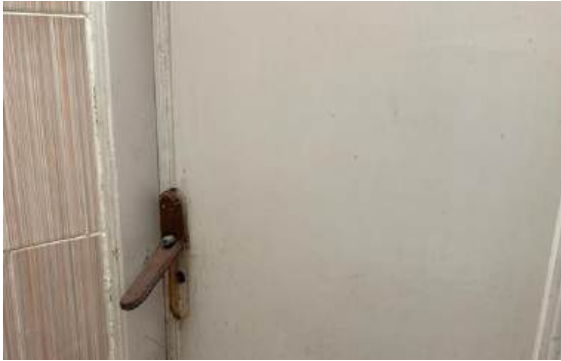
Lever handle and lock to door to  
be replaced and door to be  
painted

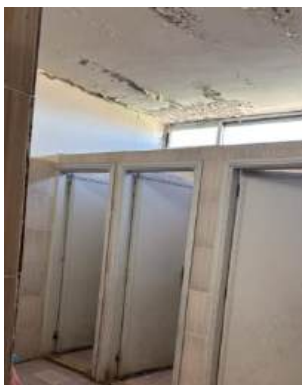
toilet need to be rehabilitated
