**CERD 66 - Borj Hammoud Third Mixed Intermediate Public School**

Lebanon Emergency Assistance Project (LEAP)

## Detailed Assessment and Verification Report

September 2026

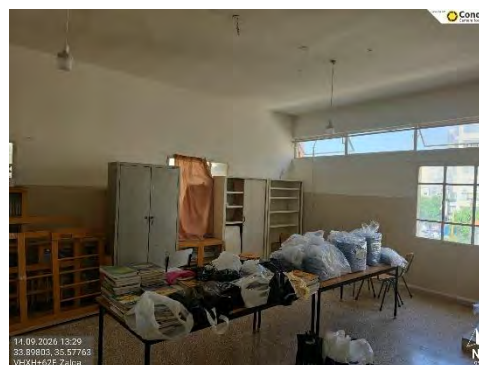
**Figure 7- Broken glass**

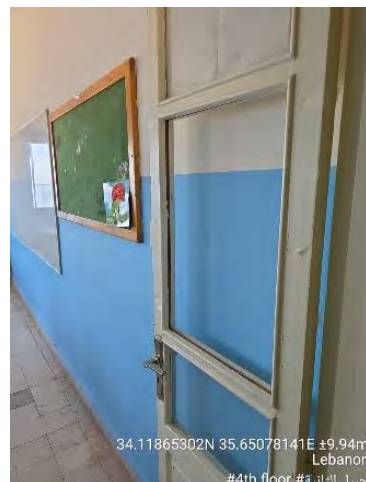
**Figure 7- Broken glass**
